RE: Ross Outdoor Training Center, PM-23-00015

The purpose of this technical memorandum is to address the designation of Type 2 (F) water as identified on parcels 880833 and 840833 by the DNR Water Type layer in the Kittitas County COMPAS (Map 1). Parcel 890833 does not indicate this feature.

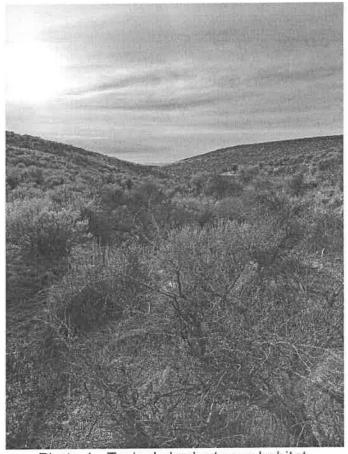
The site was surveyed on February 3, 2024. The project site is characterized as a typical shrub steppe habitat (Photo 1). No Type 2 (f) water identified on COMPAS was observed in those areas, nor were Types 3, 4, or 5. No defined stream channel, stream bank, or stream bed existed (Photo 2). Fish habitat is not present at this location.

Photo 1. Typical shrub steppe habitat.

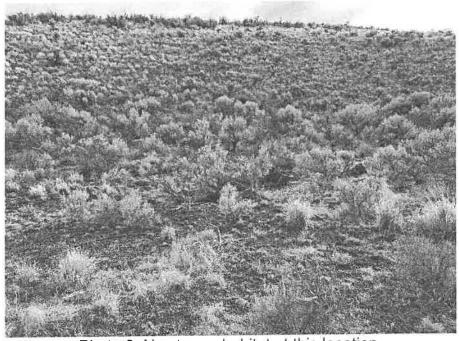
Photo 2. No stream habitat at this location.

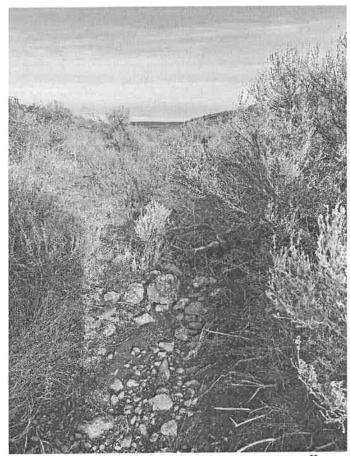
A recent rain-on-snow event resulted in storm water flow down each of the East and West draws. Those washes saturated the soil, suspended the top sandy loam surface layer and exposed cobble-size rock (Photo 3). Some storm water remained in the water course entering the old impoundment area (Photo 4), but this is not a defined channel.

Photo 3. Evidence of storm water runoff.

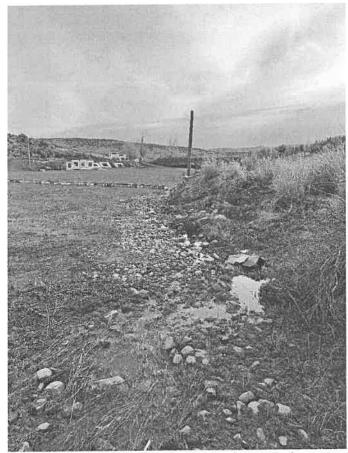
Photo 4. Storm runoff entering the impoundment area.

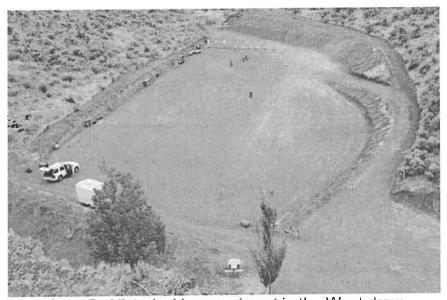
The area classified as wetland on COMPAS in the West draw used to be an impoundment that may have retained storm water flow (Photo 5). Both draws are tree-less except for two unidentified trees on the downslope bank of the impoundment area that are irrigated. Typical wetland habitat is not present at this location.

Photo 5. Historical impoundment in the West draw.
