**Preliminary Report  
Geotechnical Engineering Services  
Proposed Residential Development  
Forest Ridge Plat  
Section 24, Township 20 North, Range 15 East  
Cle Elum Area, Kittitas County, Washington**

**August 23, 2018  
ICE File No. 1283-001**

**Prepared For:  
Iron Snowshoe, LLC**

**Prepared By:  
Icicle Creek Engineers, Inc.**

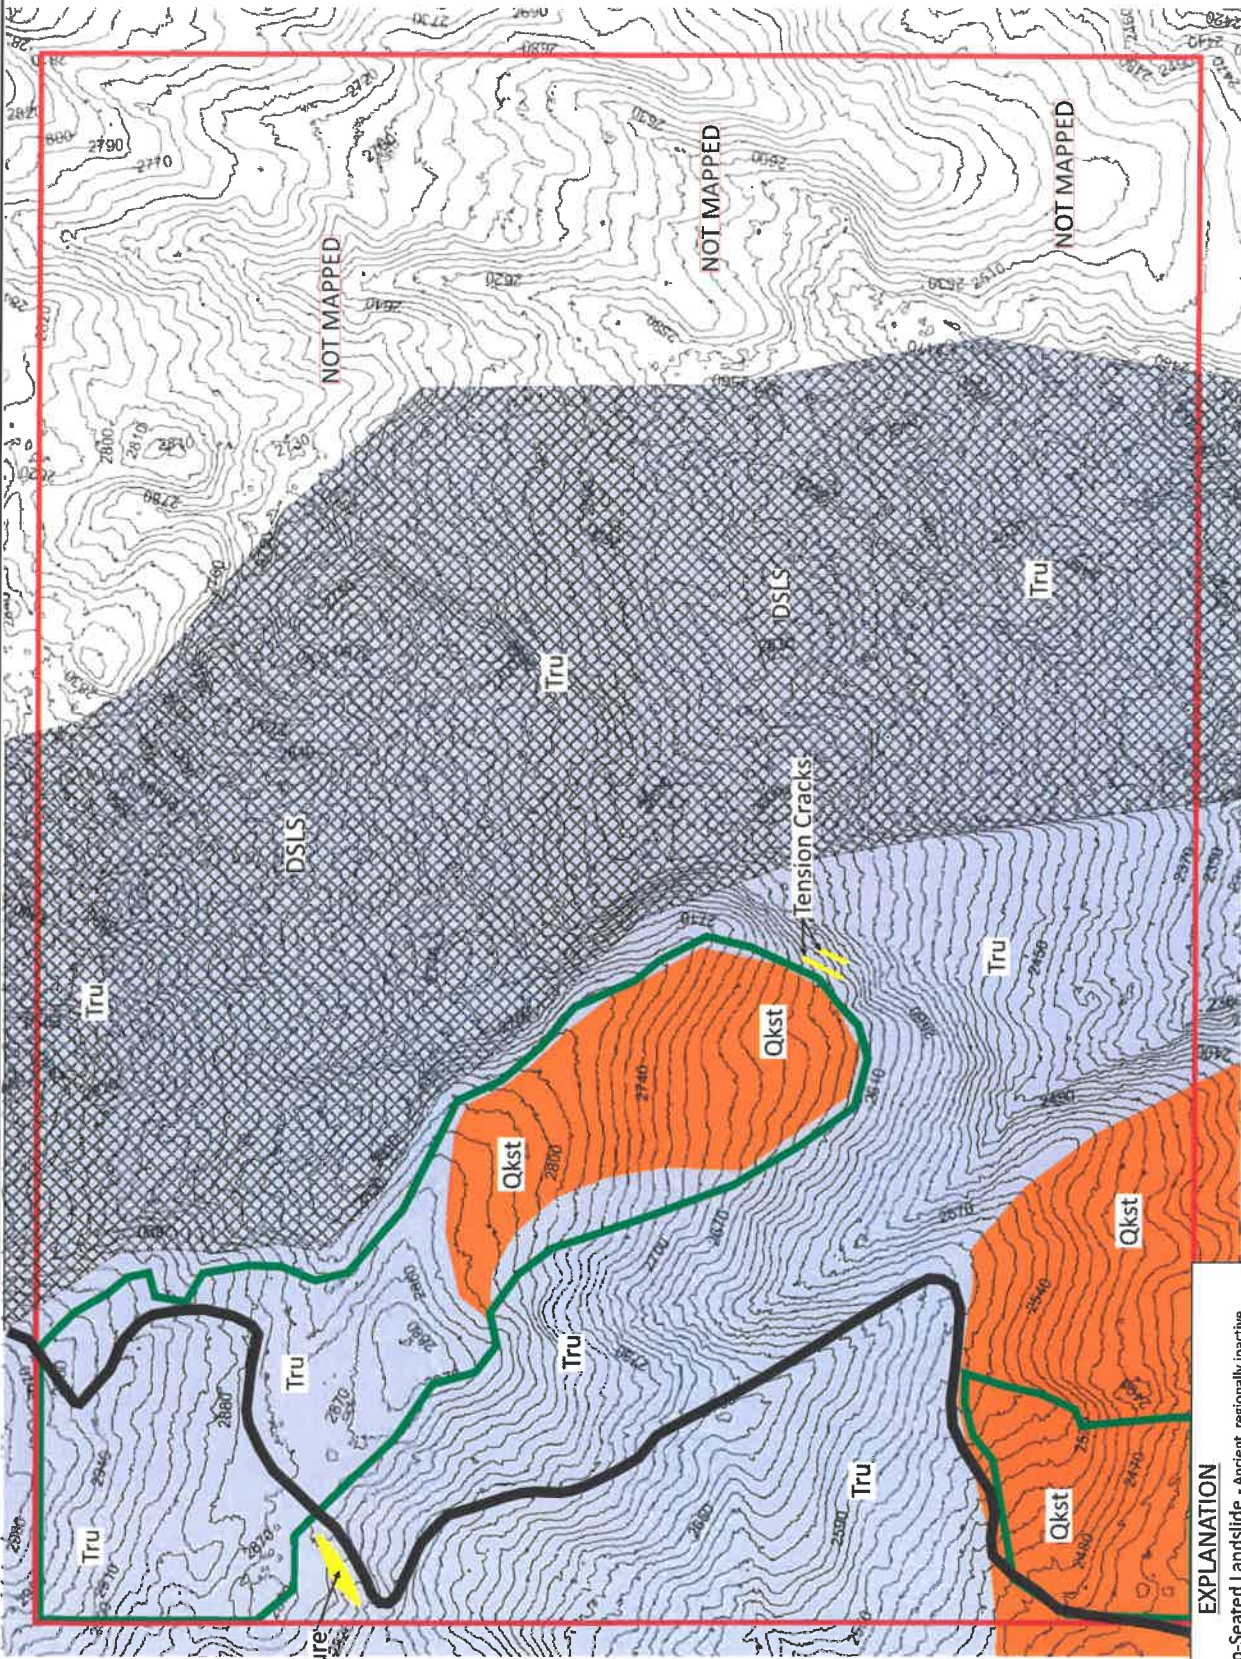
SCALE: As Shown	ICE FILE NO.
DESIGNED: —	1283-001
DRAWN: RBK	Figure
CHECKED: RBK	3
DATE: 08/27/16

- A large, deep-seated landslide (DSLS) complex occurs in the central and east part of the property and has been previously identified by the US Geological Survey (Tabor, R.W., et al, 1982, *Geologic Map of the Wenatchee Quadrangle*, Miscellaneous Investigations Series Map I-1311) and the Washington State Department of Natural Resources (DNR, May 11, 2014, *Mass Wasting Assessment: Landslide Hazard Inventory Project: West Fork Teanaway Watershed, Kittitas County, Washington*; and DNR Geologic Information Portal, Landslide Database (<https://www.dnr.wa.gov/geologyportal>)). Based on our review of the LiDAR Image, Figure 4 and field observations, we concur that the DSLS complex exists; the ICE interpreted location and perimeter of the DSLS is shown on Figure 3.

A tension crack was observed at the slope crest about 250 feet southeast of Test Pit TP-25 as shown on Figure 3. The tension crack was arcuate-shaped and approximately 150-feet long. The crack was about 6-feet deep and 8-feet wide and contained bedrock exposures on both sides approximately 1- to 2-feet below the ground surface. Fir trees up to about 4 inches in diameter were observed growing from the crack. The area contains numerous jackstrawed trees up to about 2 feet in diameter. A secondary scarp was observed about 50 feet southeast (downhill) of the tension crack. The secondary scarp was about 4-feet high and 90-feet long. Bedrock was exposed in the secondary scarp and appears to be a developing shallow landslide.

We also observed a recent road cut failure (slump) along the uphill side of the access road in the northwest part of the property as shown on Figure 3; this feature was also noted in our aerial photograph review as previously described. Soil conditions in the slump area consisted of clayey silty fine sand.

We foot-traversed the DSLS area to the east of the Phase 1 and Phase 2 areas as shown on Figure 3. We walked existing forest roads (some abandoned) where possible to complete our foot-traverse. Within the DSLS, the ground surface was observed to be uneven and hummocky, generally sloping down to the south at an average 10 to 15 percent grade. We observed isolated steep slopes (up to about 100 percent grade) in the more hummocky terrain. At the north end of the property, our field review was focused on an area of highly variable blocky terrain that was observed on the LiDAR imagery. We observed a series of irregular rounded hills and swales in this area. The area was vegetated with mature conifers (generally vertical with some sweep to the trunks) and vertical stumps. We did not observe areas of currently active slope movement, however, the hummocky ground within a large area is a clear indicator that ground movement has occurred in the past.

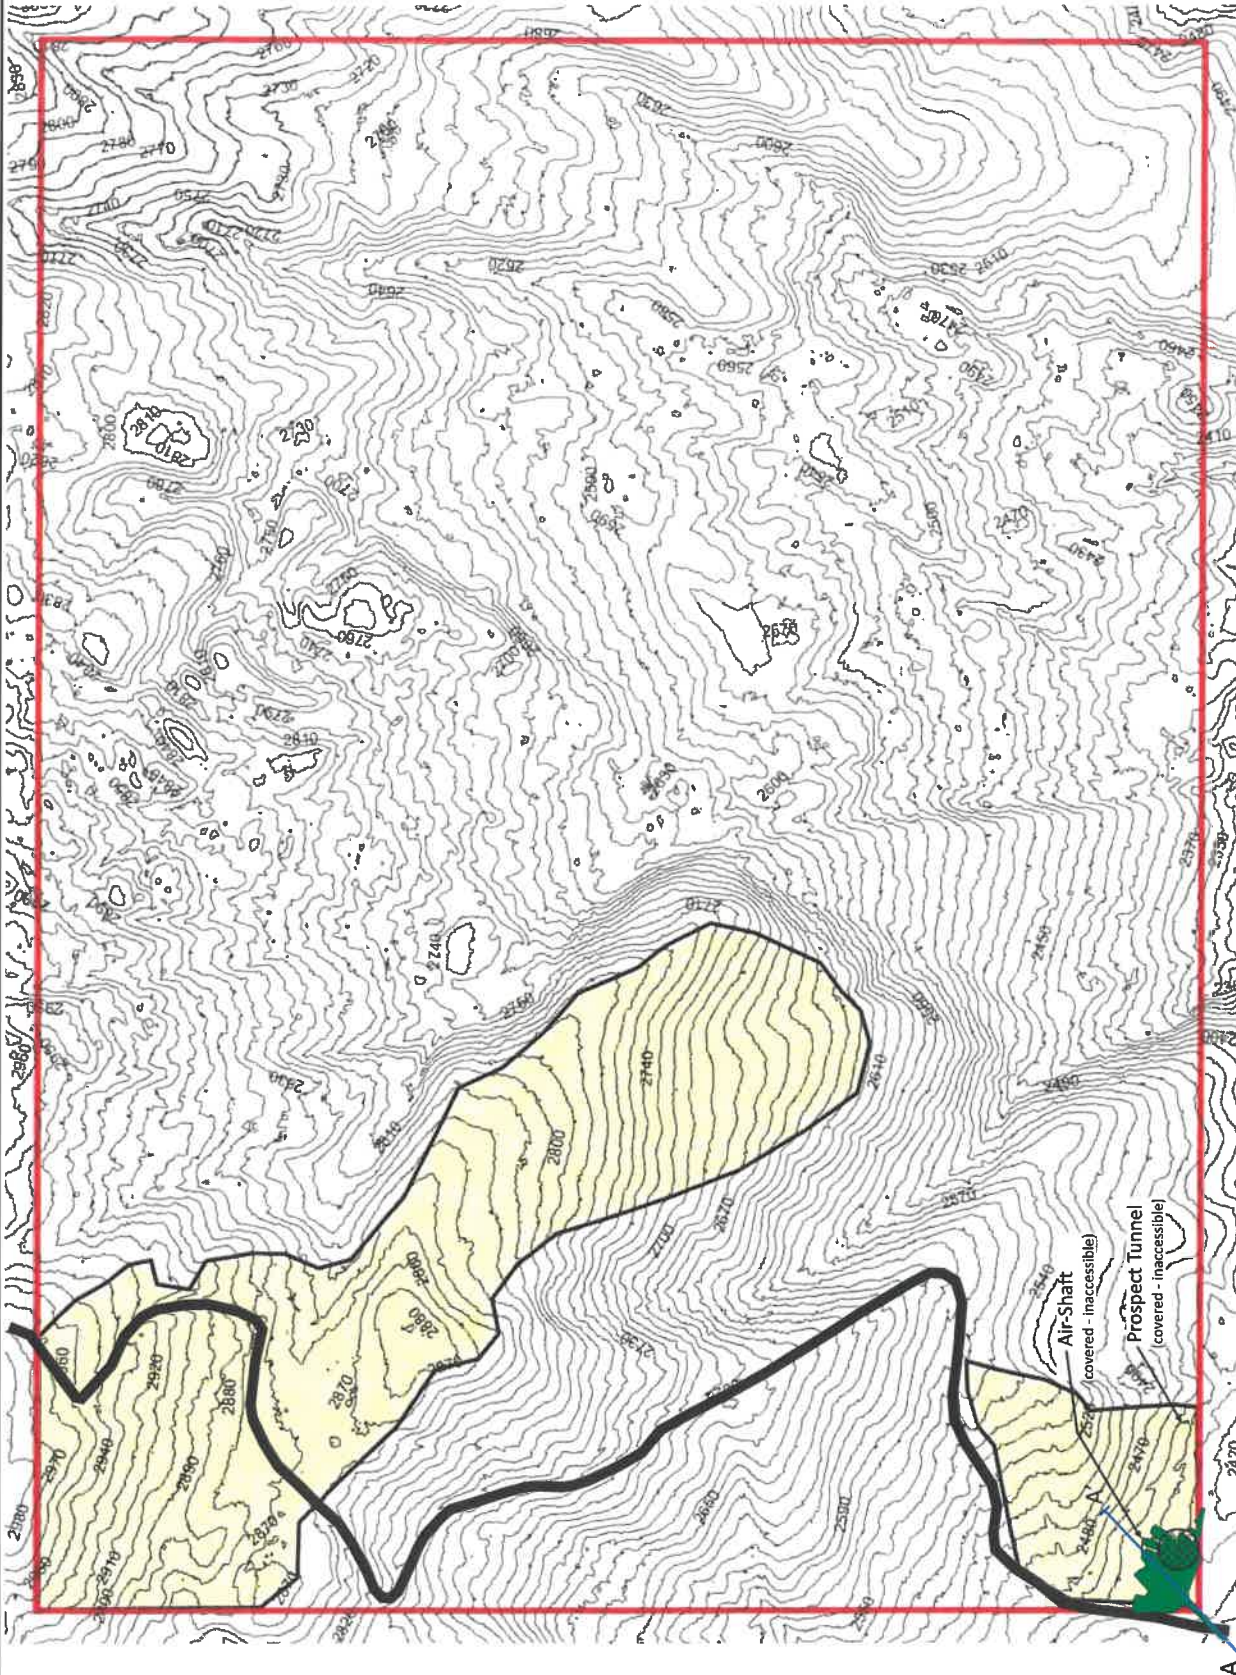
29335 NE 20th Street Carnation, Washington 98014 (425) 333-0093	SCALE AS SHOWN: DESIGNED: --- DRAWN: BRB CHECKED: BSK DATE: 06/23/18	ICE FILE NO. <b>1283-001</b> Figure <b>5</b>
	<b>COAL MINE LOCATION MAP</b> <b>IRON SNOWSHOE, LLC - FOREST RIDGE PLAT AREA</b>

- An abandoned underground coal mine is present in the southwest corner of the property (Phase 1 South Parcel) as shown on Figure 5. The abandoned underground coal mine is relatively shallow (less than 100 feet below the ground surface and should be considered a Severe Coal Mine Hazard Area (no development – passive, open space use only).

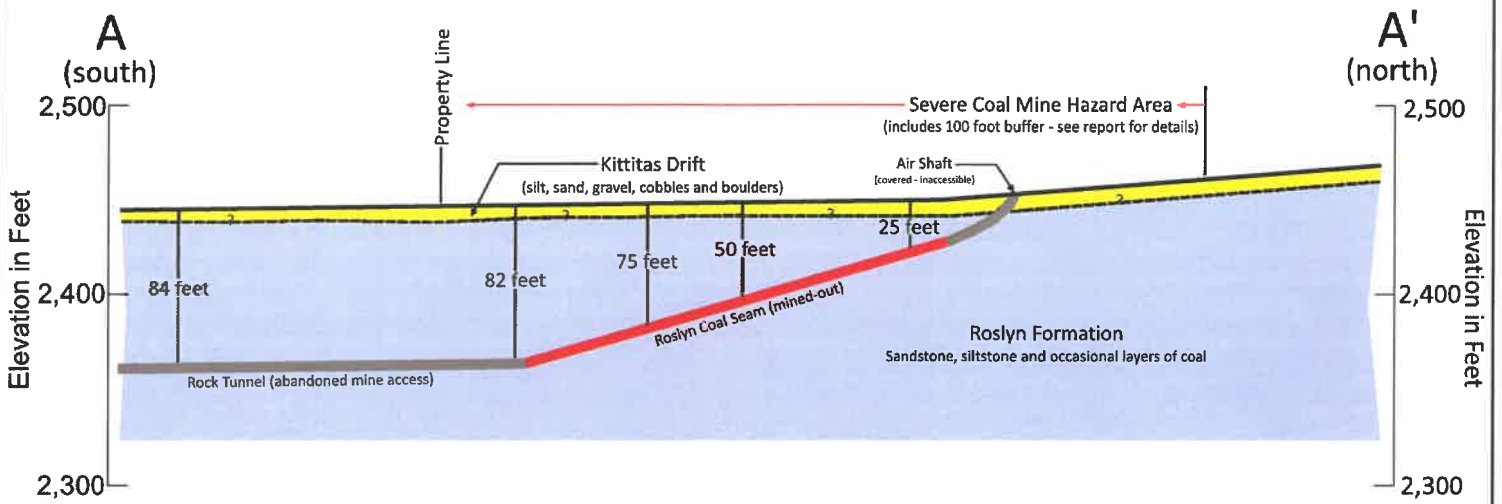
ICE FILE NO.  
**1283-001**  
 Figure  
**6**

- Geologically Hazardous Areas within or adjacent to the Phase 1 area include Mine Hazards, Steep Slopes and Landslide Hazard Areas as shown on the Coal Mine Location Map, Geologic Cross-Section A-A’ and Geologically Hazardous Areas Map, Figures 5, 6 and 7, respectively. We expect that Mine Hazards and Landslide Hazards will be avoided and left as open space. Some of the Phase 1 area is bordered by Steep Slopes that will require a structure setback from the top of the Steep Slope. The purpose of the structure setback is to provide a buffer should a slope failure occur that will protect the structure from damage and to also allow for equipment access for slope repair/stabilization, if necessary.
