**Preliminary Report  
Geotechnical Engineering Services  
Proposed Residential Development  
Forest Ridge Plat  
Section 24, Township 20 North, Range 15 East  
Cle Elum Area, Kittitas County, Washington**

**August 23, 2018  
ICE File No. 1283-001**

**Prepared For:  
Iron Snowshoe, LLC**

**Prepared By:  
Icicle Creek Engineers, Inc.**

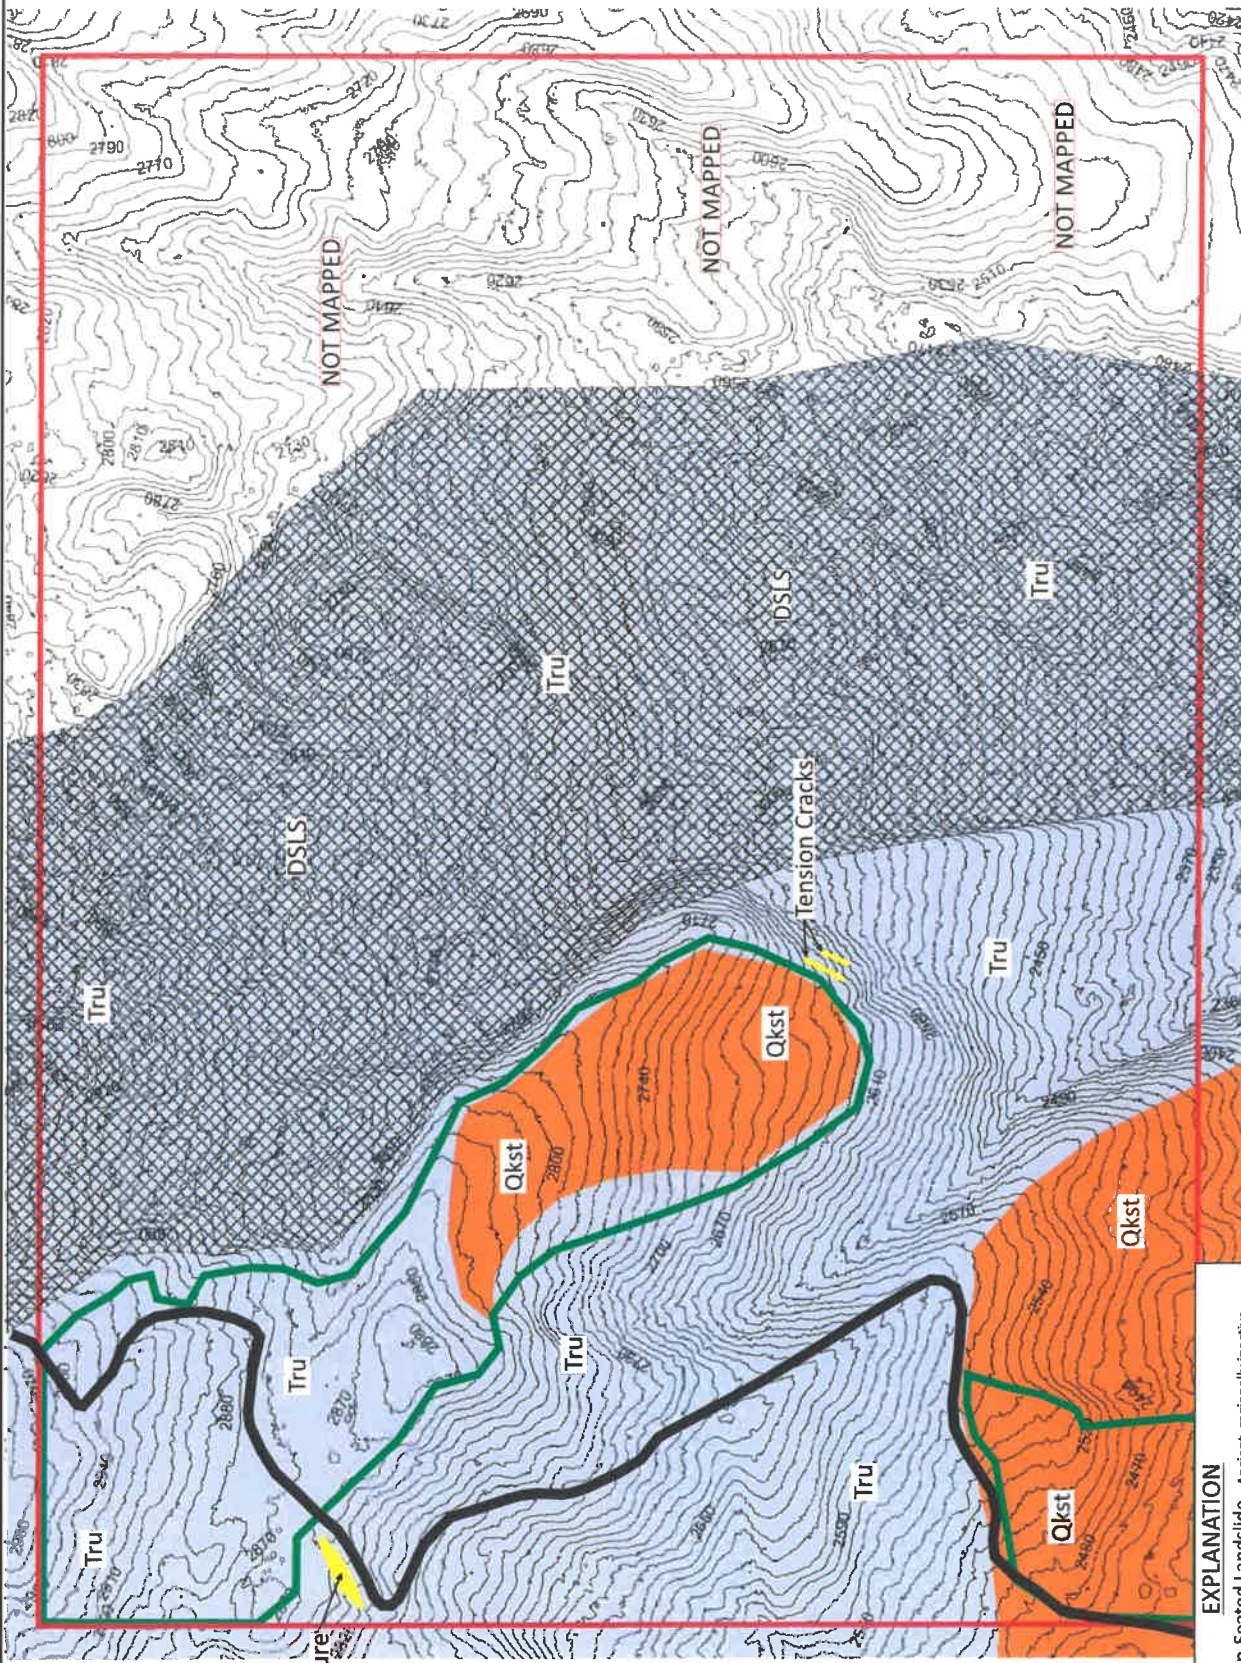
ICE FILE NO. 1283-001  
 Figure 3

A tension crack was observed at the slope crest about 250 feet southeast of Test Pit TP-25 as shown on Figure 3. The tension crack was arcuate-shaped and approximately 150-feet long. The crack was about 6-feet deep and 8-feet wide and contained bedrock exposures on both sides approximately 1- to 2-feet below the ground surface. Fir trees up to about 4 inches in diameter were observed growing from the crack. The area contains numerous jackstrawed trees up to about 2 feet in diameter. A secondary scarp was observed about 50 feet southeast (downhill) of the tension crack. The secondary scarp was about 4-feet high and 90-feet long. Bedrock was exposed in the secondary scarp and appears to be a developing shallow landslide.

We also observed a recent road cut failure (slump) along the uphill side of the access road in the northwest part of the property as shown on Figure 3; this feature was also noted in our aerial photograph review as previously described. Soil conditions in the slump area consisted of clayey silty fine sand.

Road Cut Failure

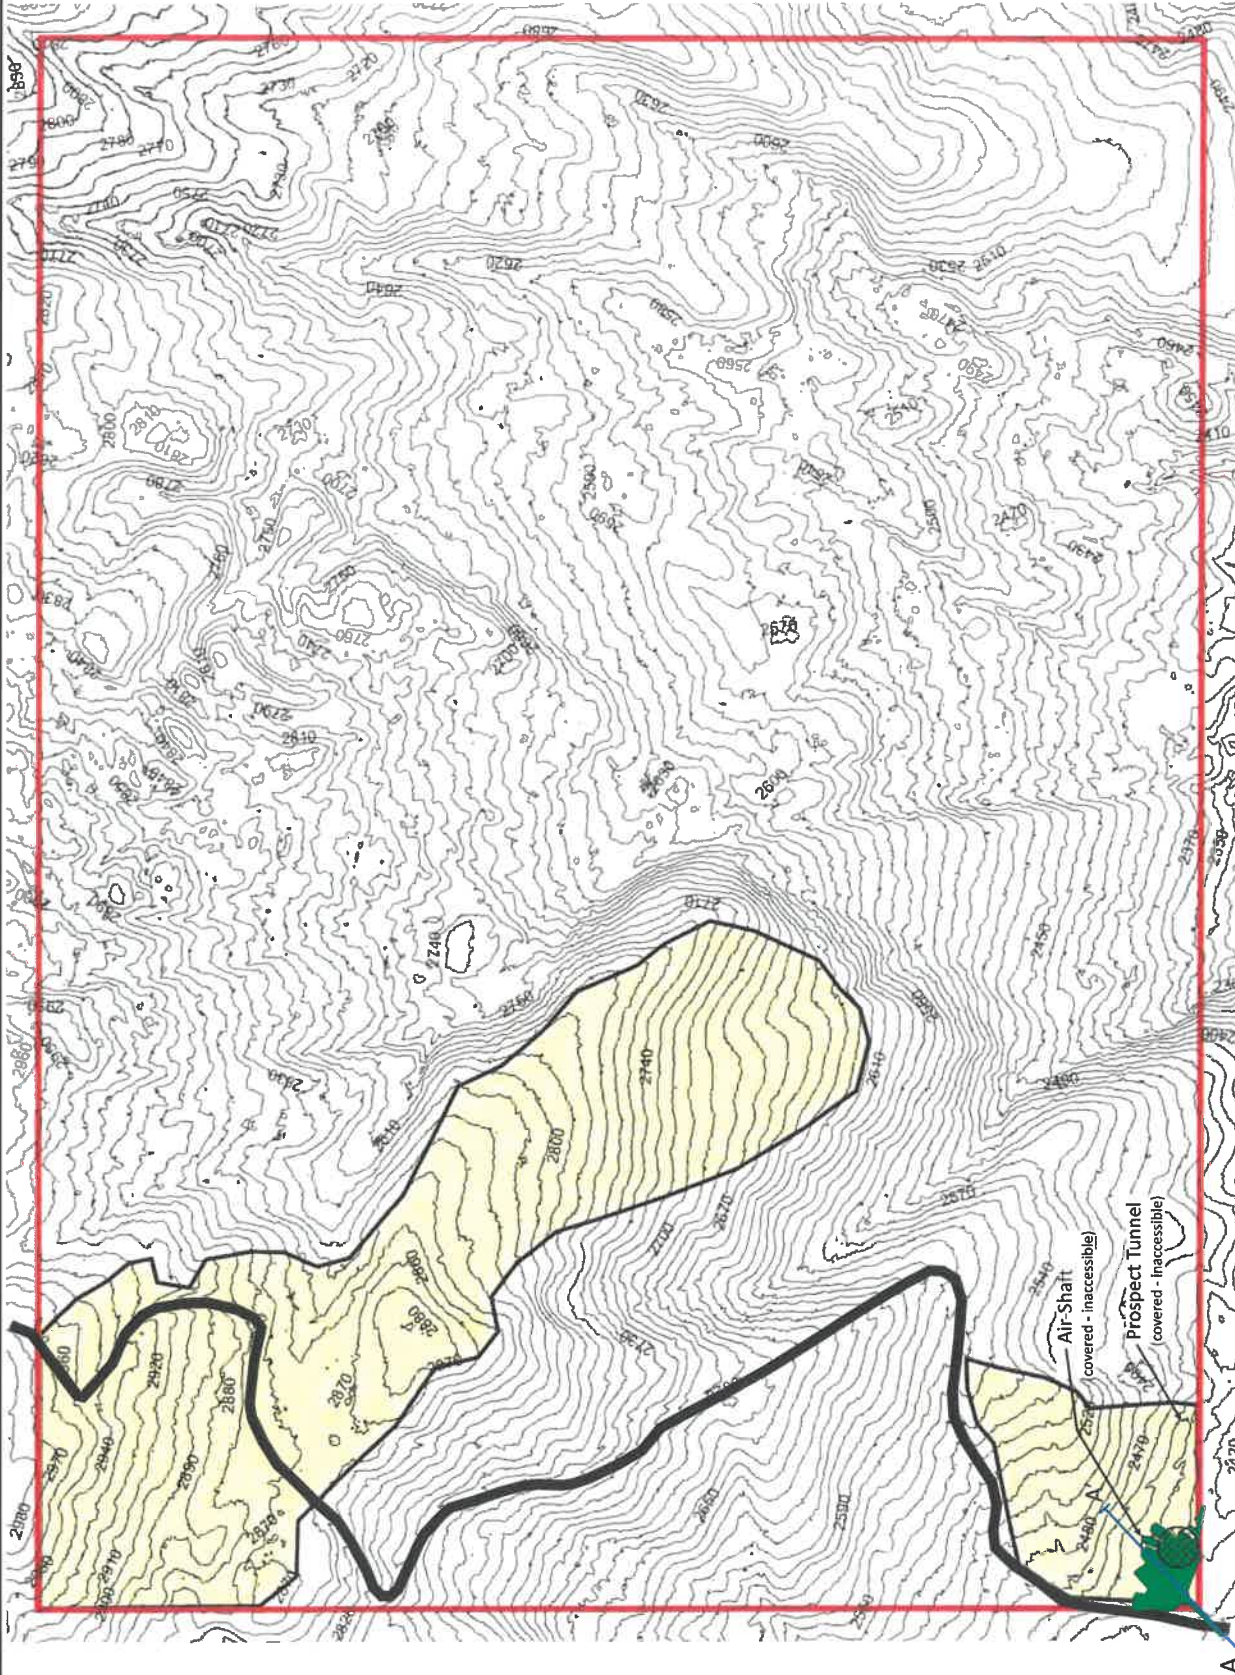
**COAL MINE LOCATION MAP**

- An abandoned underground coal mine is present in the southwest corner of the property (Phase 1 South Parcel) as shown on Figure 5. The abandoned underground coal mine is relatively shallow (less than 100 feet below the ground surface and should be considered a Severe Coal Mine Hazard Area (no development – passive, open space use only).

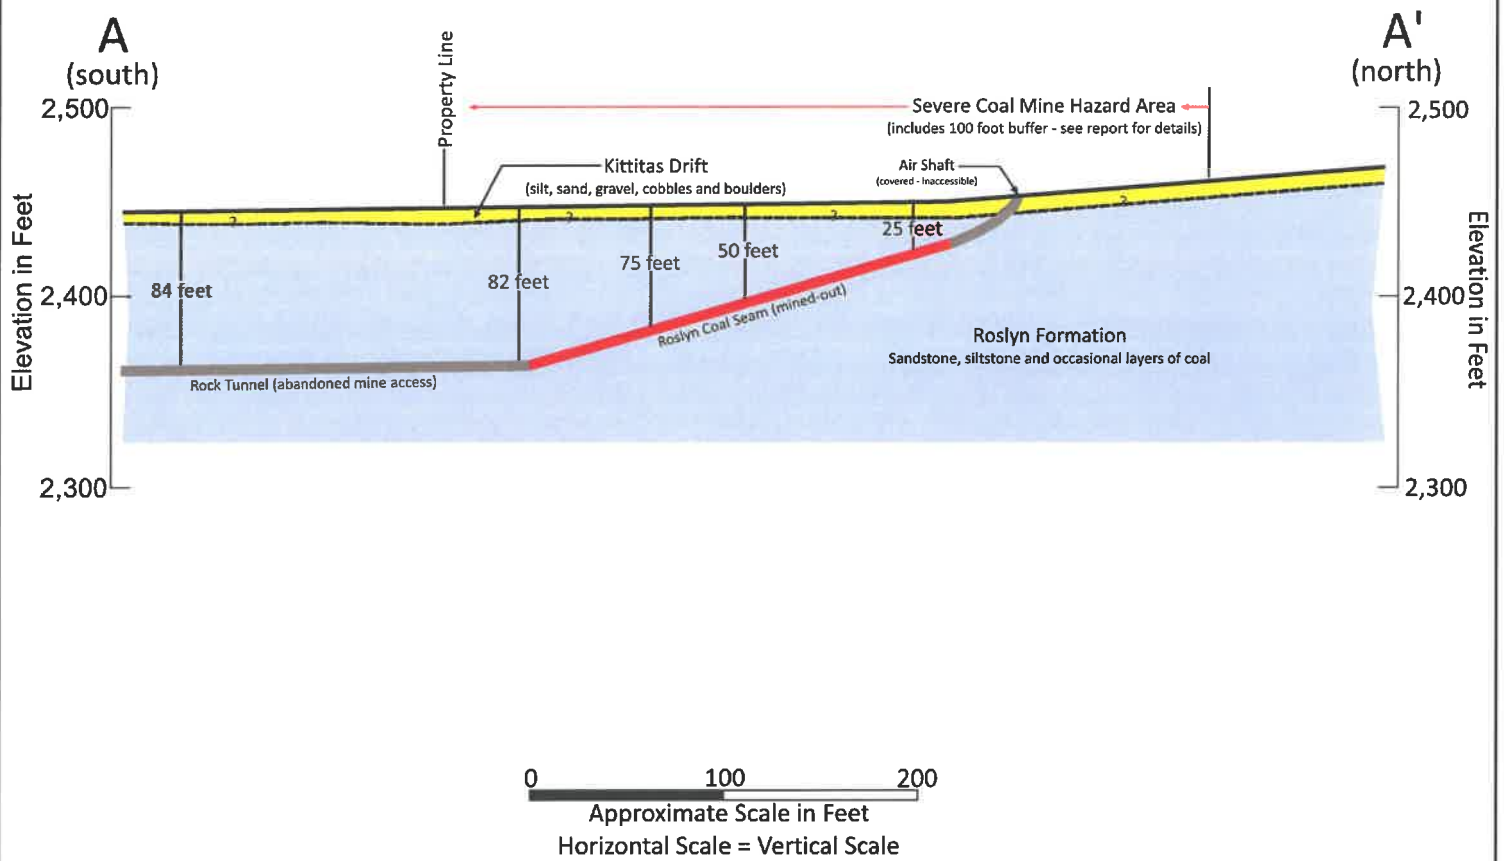
**GEOLOGIC CROSS-SECTION A-A'**

- Geologically Hazardous Areas within or adjacent to the Phase 1 area include Mine Hazards, Steep Slopes and Landslide Hazard Areas as shown on the Coal Mine Location Map, Geologic Cross-Section A-A’ and Geologically Hazardous Areas Map, Figures 5, 6 and 7, respectively. We expect that Mine Hazards and Landslide Hazards will be avoided and left as open space. Some of the Phase 1 area is bordered by Steep Slopes that will require a structure setback from the top of the Steep Slope. The purpose of the structure setback is to provide a buffer should a slope failure occur that will protect the structure from damage and to also allow for equipment access for slope repair/stabilization, if necessary.
