COOKE SCIENTIFIC

September 12, 2018

RE: Critical Areas Assessment for Potential Buffer Impacts Due to Past Septic Installation, Lake Cle Elum, Wa

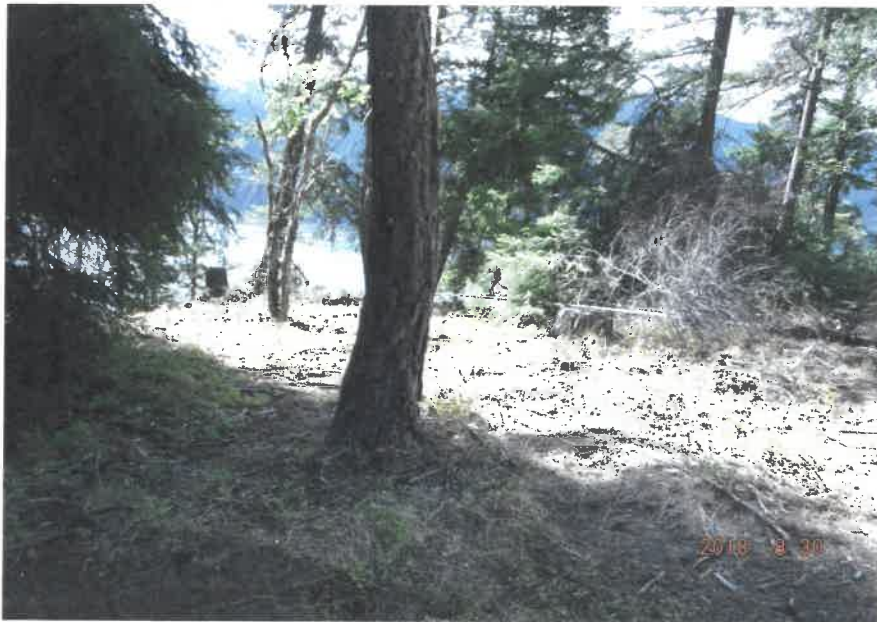
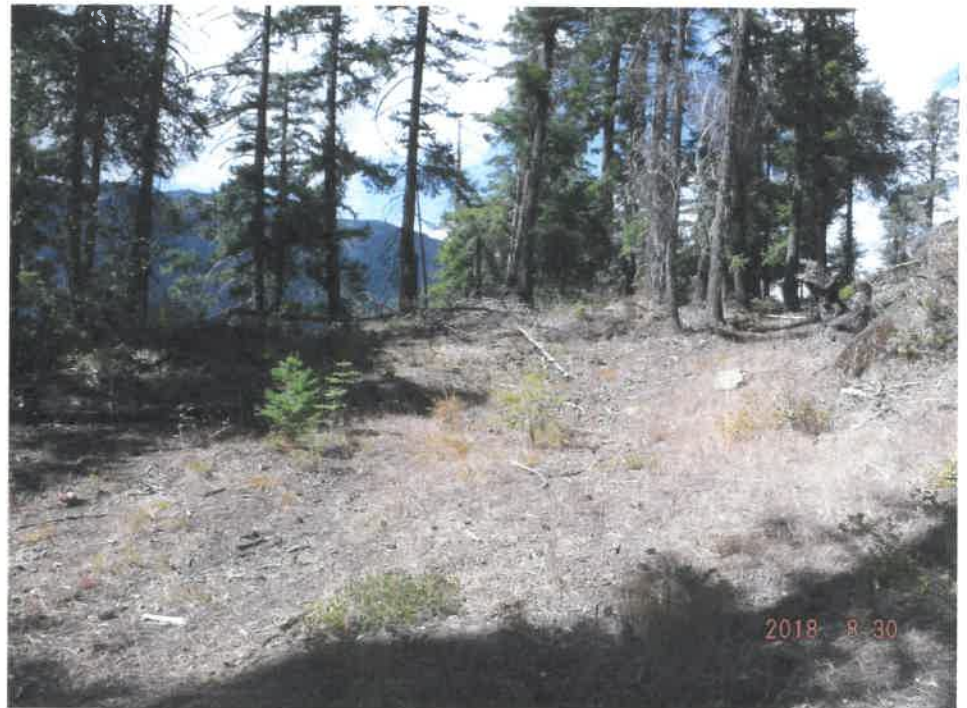
House Site

House site: Is currently somewhat open, as is typical with east-side forests. It is still vegetated with a few trees (mapped on Figure 3, photo on Photo page 2) and understory vegetation consisting of shrubs and forbs. As is the area to the north that will be set aside for mitigation (Figure 5).

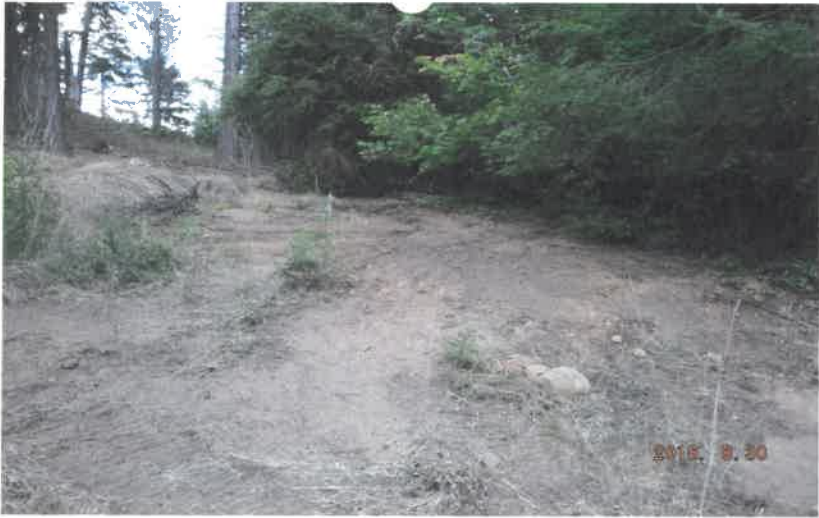
Leachfield area

Drainfield: The area where the drainfield was installed had recently been disturbed (Photo sheet 3). An area 12 feet x 32 feet was bare of plants, so this area will be replanted with shallowly rooted shrubs and forbs. No deeply rooted trees or shrubs will be planted there because of the potential to cause problems with the leachfield, but shallowly rooted species will be used. See the mitigation section below.

The leachfield is located outside of the buffer zone (Figures 2, 4, 5; and Photo Page 3) but this area will be replanted as compensation for the disturbance that occurred as a result of the recent disturbance in situ and the future construction of the house and driveway. The following will be planted:

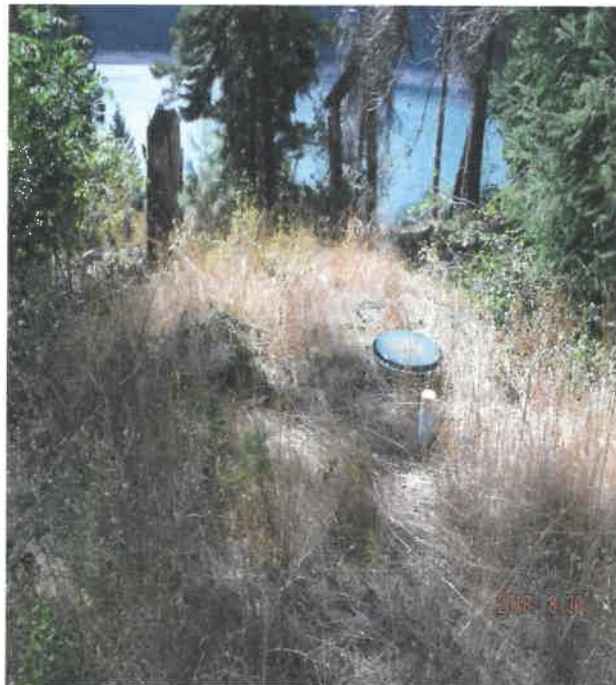
Septic tank area

Septic area: The septic tanks can be seen as three circular lids on the slope that grades down to the beach area. Their location can be seen on Figures 2, 3, 4, and 5, and Photo Sheet 3. All the area around the tanks consisted of installing tanks below the ground. It has been ten years since the installation and the area has since completely restored itself (except for the actual lids) to the same vegetation that is found elsewhere on the slope that grades down to the lake edge.

In exchange for the "impact" to the septic pit area 100-foot Shoreline buffer (which should be revisited as discussed above), - an equivalent area (28' x 28' = 784 FT²) will be set aside north of the house (Figure 5). This will be set aside as a permanent "no touch" buffer and will be recorded on the plat map on file with the County. Photo page 2, (lower photo) shows this area. The existing natural vegetation will be left untouched and no future activity will be planned that will affect this area. It is fully vegetated and so needs no additional plantings in-situ.

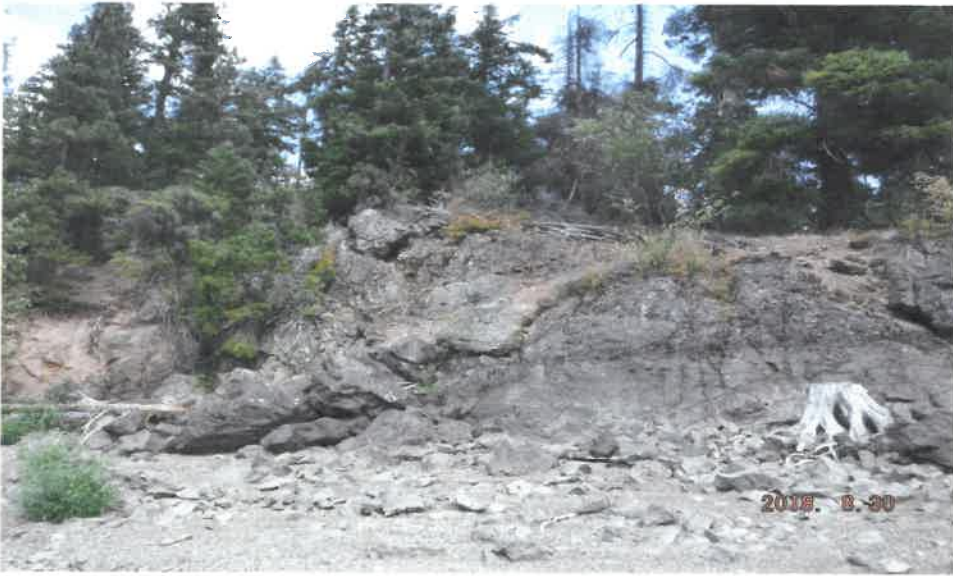
The area above the eroded line on the on the beach is above the area that commonly floods or there would be an erosive feature, vegetation, algal lines on the bedrock (Photo Page 4) at the toe of the slope. No such erosive feature exists there and the other indicators of vegetation, and soils, and indicators of hydrology are also missing. Although the aerial photograph seen in the photo section of this report (7/10/2012 and the aerial on the GPS mapping) show the water at a much higher elevation (right at the toe of the slope), there are two marks upon the beach visible in the other aerials and found during this summer's site investigation in August. The beach below the toe of slope is almost devoid of vegetation except for a few tufts of shore sedge (*Carex lenticularis* var. *lenticularis*) and Scouler willow (*Salix scouleriana*). In using the OHWM methodology, it was clear that the OHWM is where it is shown on the GPS map shown on Figure 4 and on the aerials from 7/15/2014 and 7/13/2017, where you can see the erosive lip shown on Photo Page 5.

Base of slope top of beach

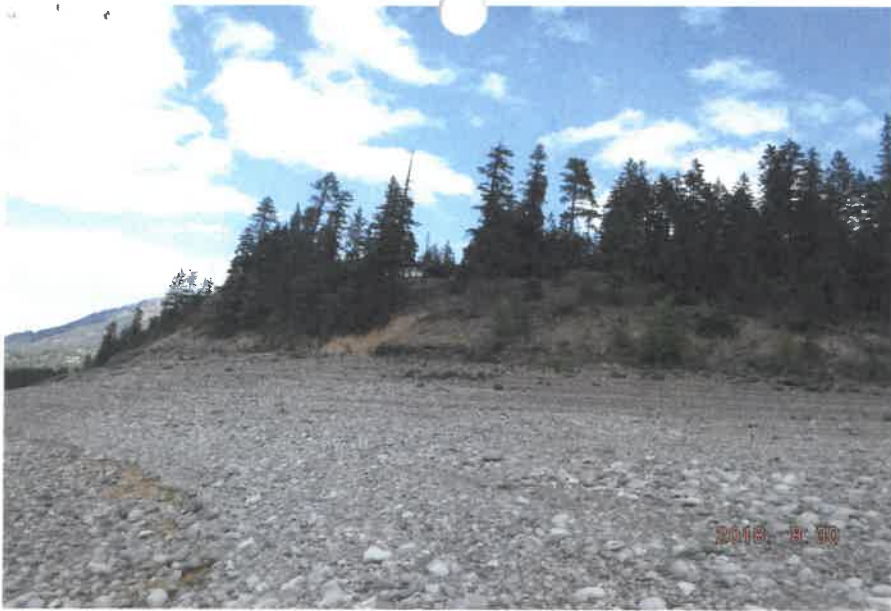
Eroded Ledge

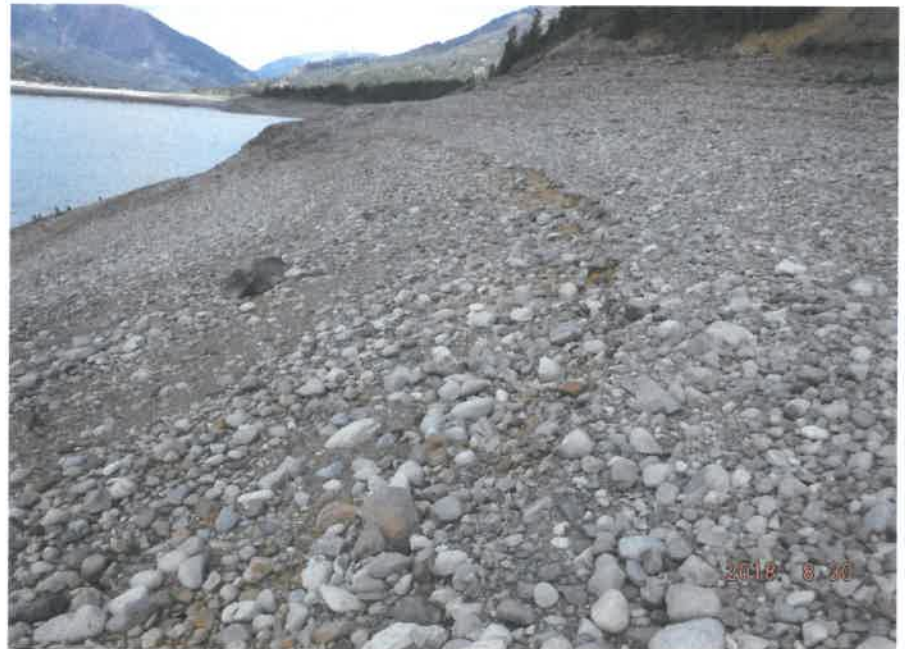
Eroded Ledge in front of property

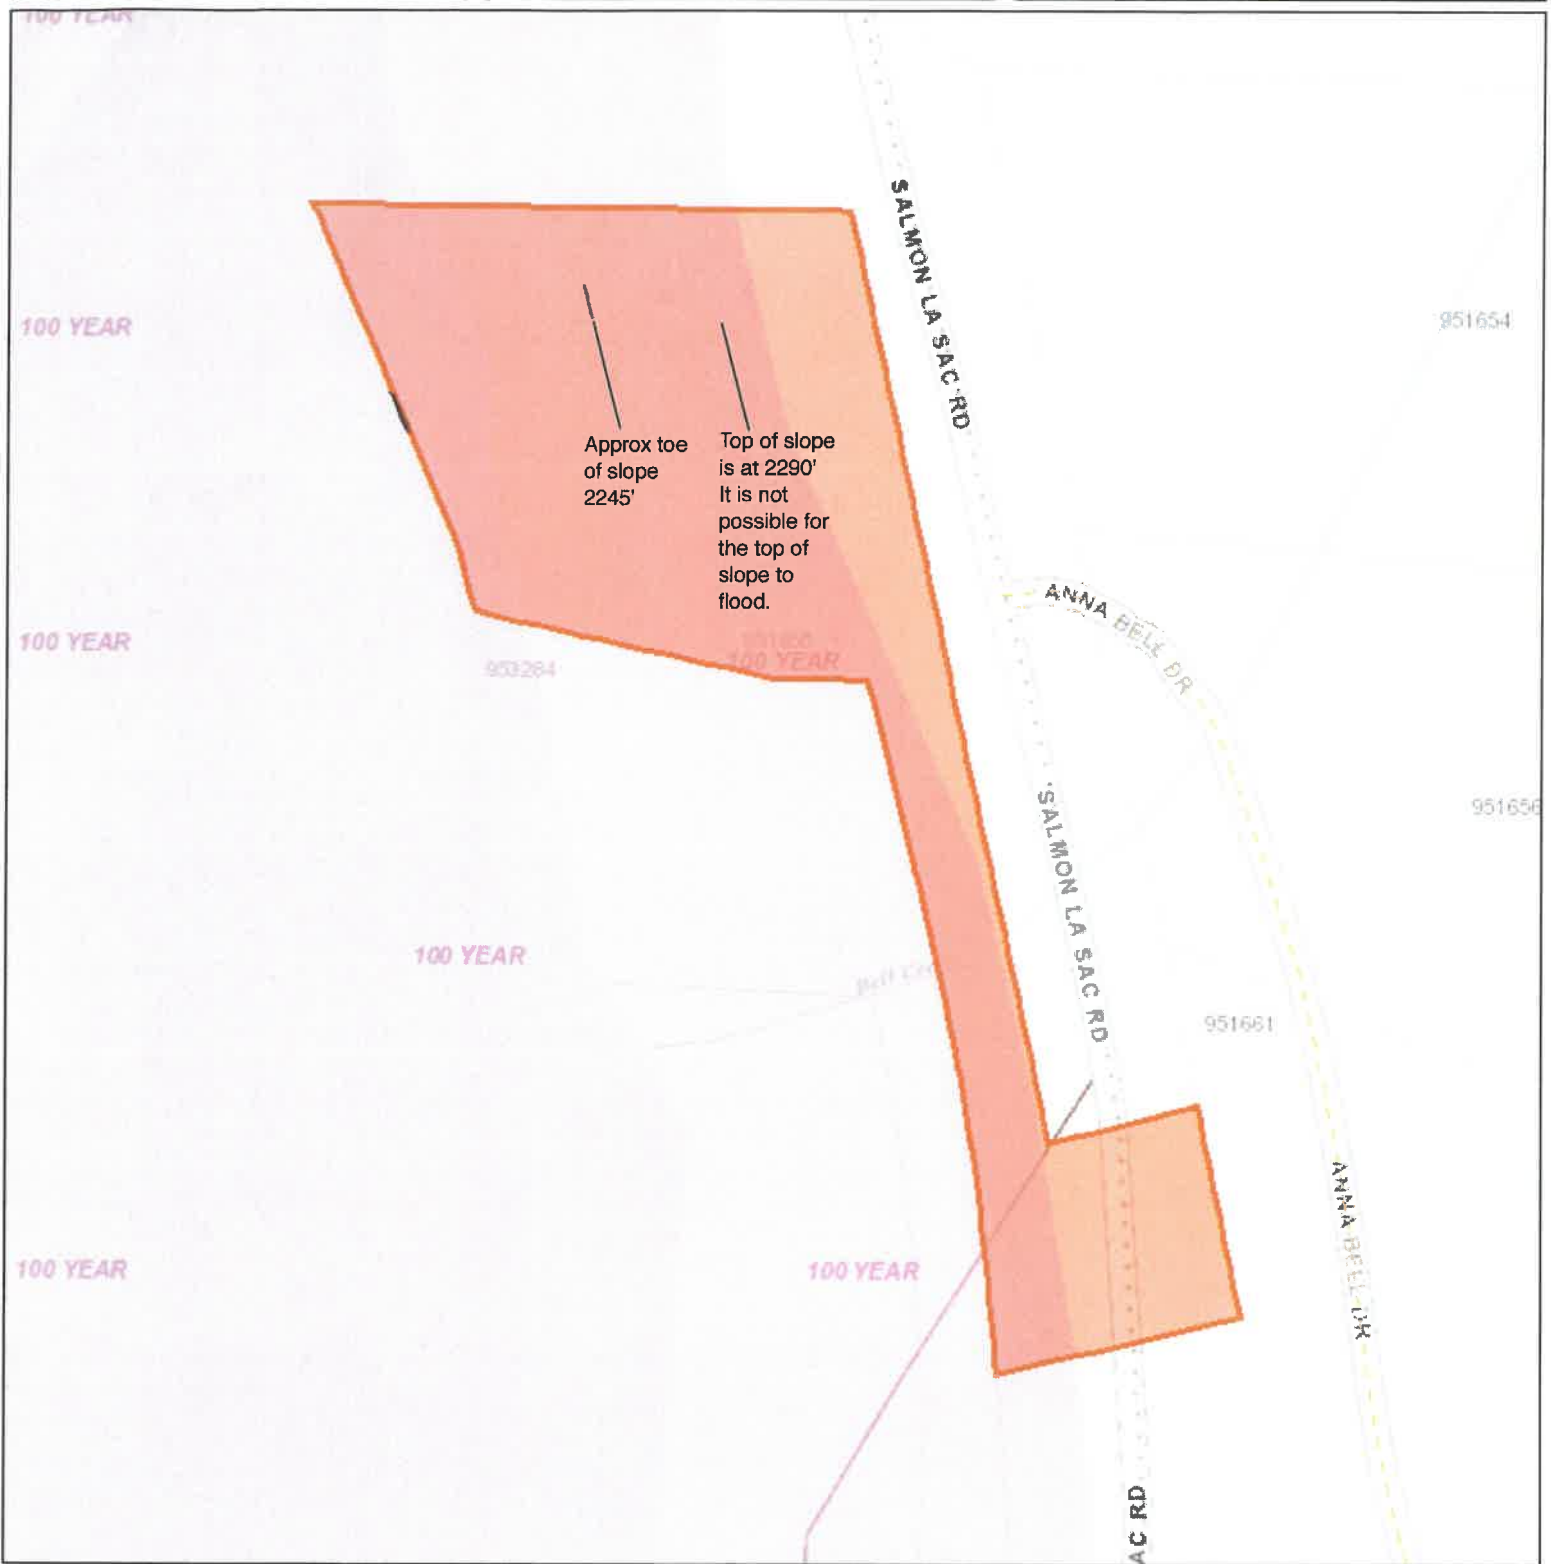
Figure 6. Ball Property, Inaccurate Floodmap

Lake edge: The Ordinary High Water Mark (OHWM) was evaluated using the methodology outlined by the Department of Ecology in their "*Determining the Ordinary High Water Mark for Shoreline Management Act Compliance in Washington State*, 2016 Publication # 16-06-029. As required, the "mark upon the landscape" down below the property at the toe of the slope (see topography Figures 3, 5, 6, and 7) would be identified at the eroded edge on the beach seen on Photo Page 4 and on Figure 4 the GPS map I produced during the field work. The aerial photograph Google selected as the base map for mapping the GPS data (Figure 4) was showing the lake during an obviously much higher water level than where the water level was on the day I visited the site (Photo Pages 4 and 5). As stated above in the Wetlands section, there was almost no vegetation (less than 5 percent aerial cover overall), the soils are sand and cobbles and the only obvious indicator was the eroded edge. The County has mapped the OHWM at the toe of the slope (Shown in Figures 6 and 7).

Obviously given the discrepancy between the County's mapping and my findings, the County has to make the final determination on this.

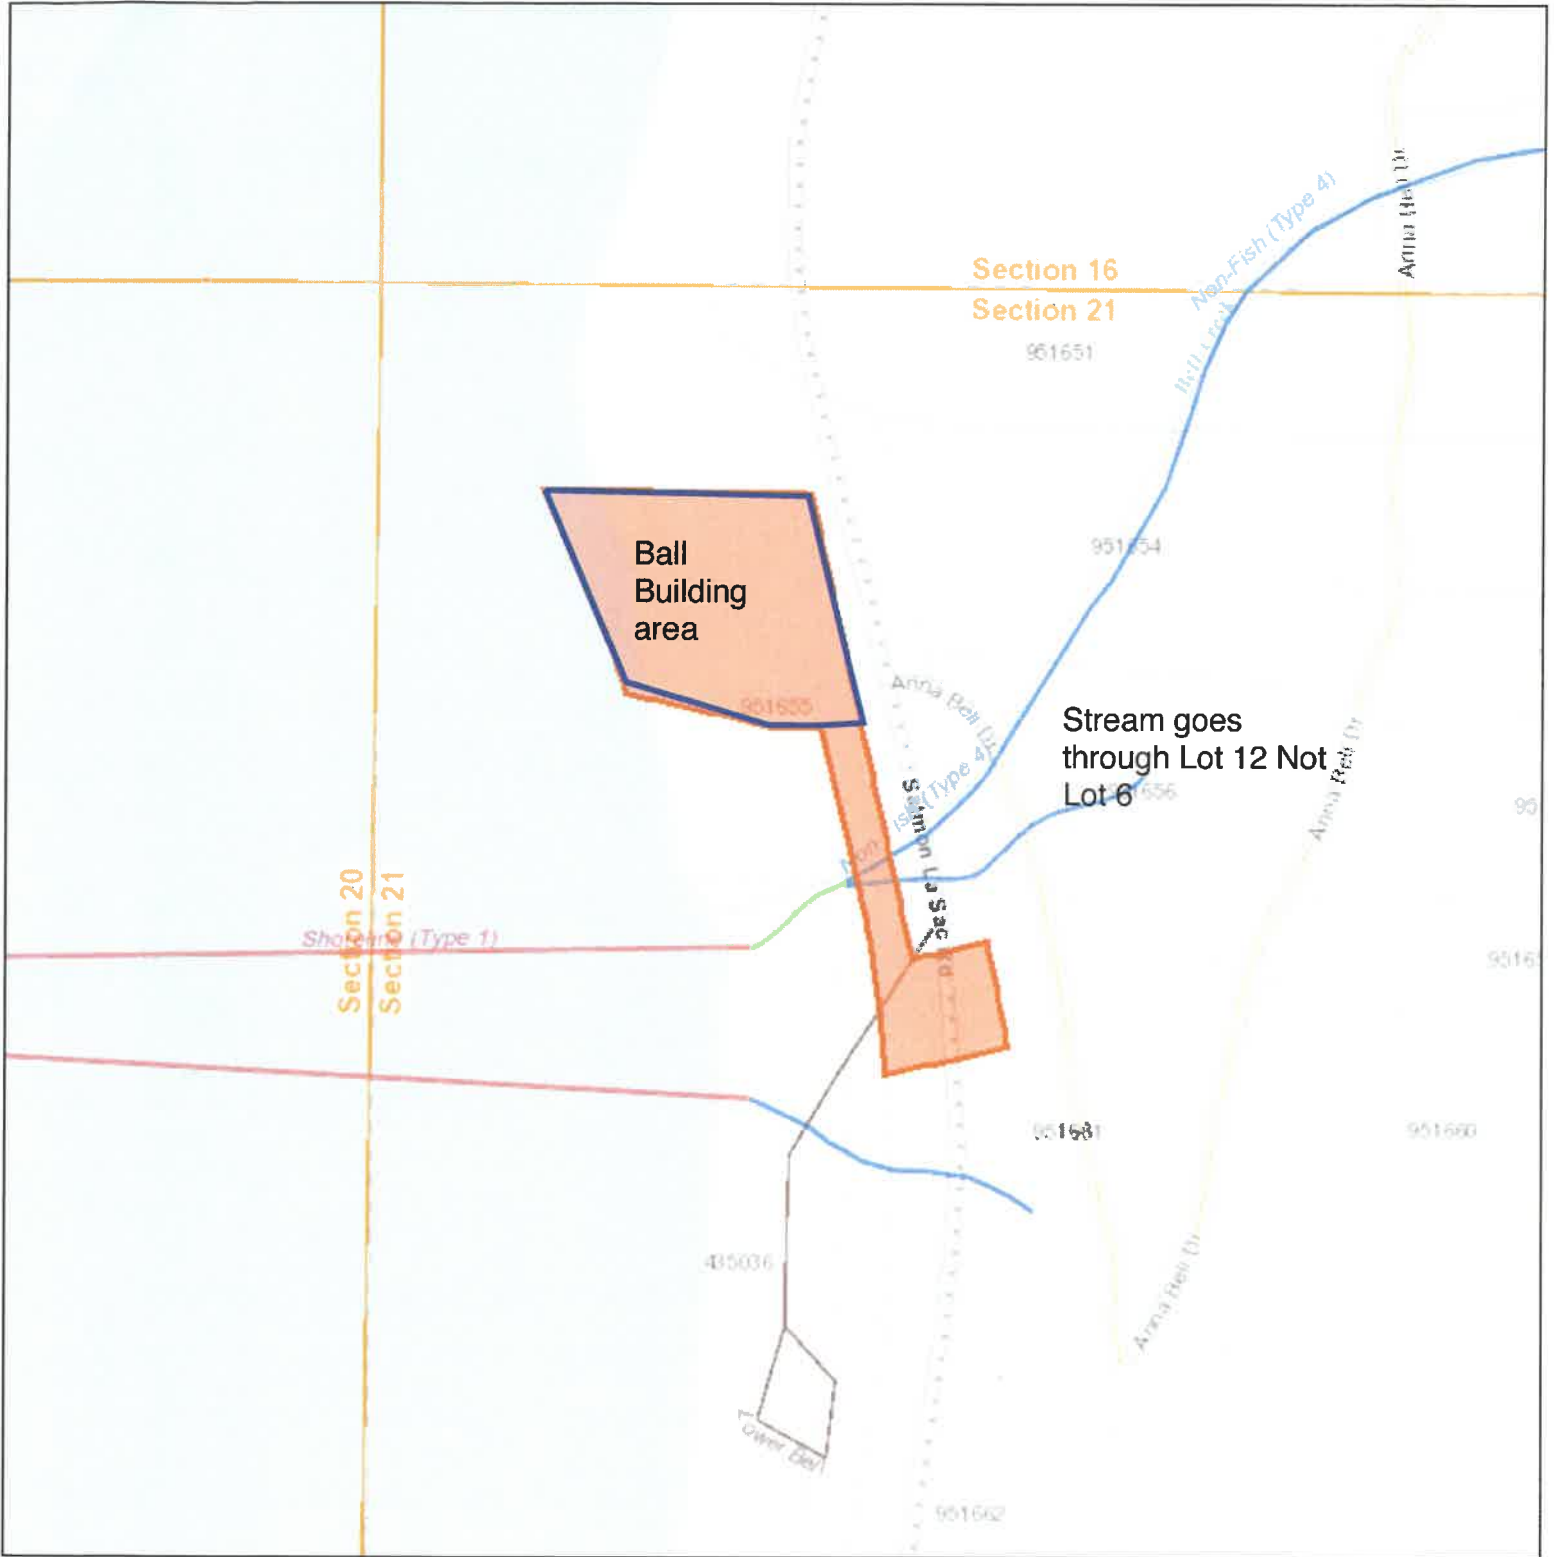
Figure 8. Ball Property, Stream Map

Stream: While the County's Critical areas mapping for streams shows Bell Creek on the property (Figure 8), it is actually east of Salmon La Sac Road and passes under the road – through the easement owned by the Ball family and there is no stream on the property that is to be developed west of Salmon La Sac Road. The stream (Bell Creek) comes from east of the road and it enters a culvert and passes under the road, well south of the Ball property where the house and other areas to be developed exist. This stream did not appear to affect the development of the lot (13) where it actually exists so there should be no issue of its presence on the lot the Ball family now want to develop.

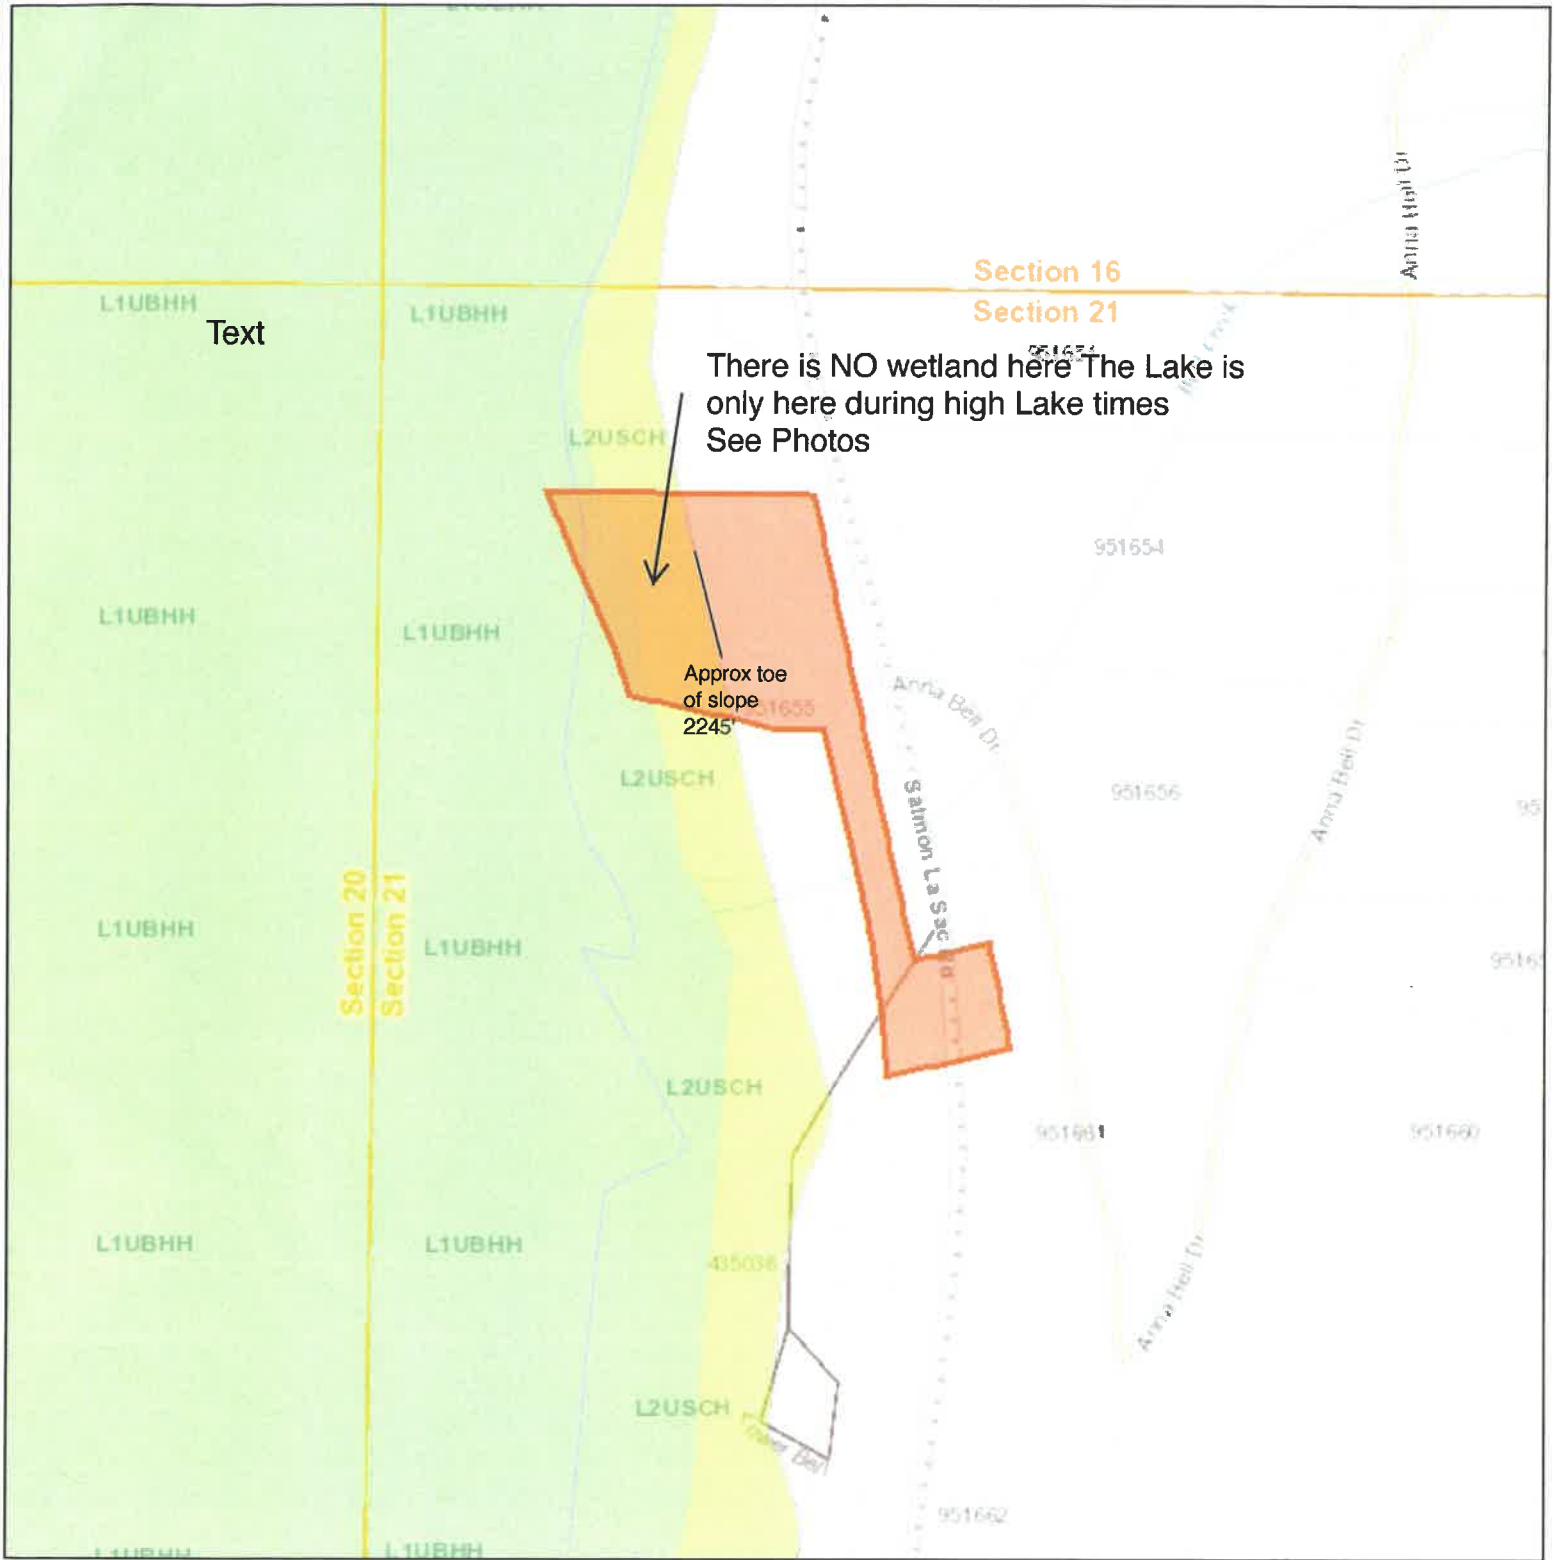
Figure 9. Ball Property, Incorrect Wetland Map

Wetland: The County shows a wetland on the property (Figure 9). They also mention a wetland on page 3 of the PSA #18-00194. ***There is no wetland anywhere on the property.*** I investigated the entire property off the Salmon La Sac Road and down below the cliff on the beach associated with Lake Cle Elum. There were no jurisdictional wetlands anywhere on the property. This is based on 35 years of wetland delineation expertise and using the criteria required under Section 17B.05.020F of the Kittitas County code and outlined in the US Army Corps of Engineers protocol "*The Regional Supplement to the Corps of Engineers Wetland Delineation Manual for Western Mountains, Valleys, and Coast Region* (May 2010) nor "*The Regional Supplement to the Corps of Engineers Wetland Delineation Manual for the Arid West* (Version 11-1-2006)". I examined for soils, hydrology, and vegetation indicators and they just did not exist, especially in the areas shown on the County's map on Figure 9. I have included photos of the property attached on Photo Sheets 1-4. The beach area identified on the County's wetland map are shown in their actual ground conditions on Photo Sheets 2, 3, and 4. As can be seen, the area identified as wetland is beach cobble with less than five percent vegetation. I found a few scattered clumps of shore sedge (*Carex lenticularis*, FACW) and a few clumps of newly germinated Scouler willow, (*Salix scouleriana*, FAC) and one very small lady's thumb (*Persicaria maculosa*, FACW). The soils were sand and cobbles.
