October 6, 2023

### 3. Inspection Methodology

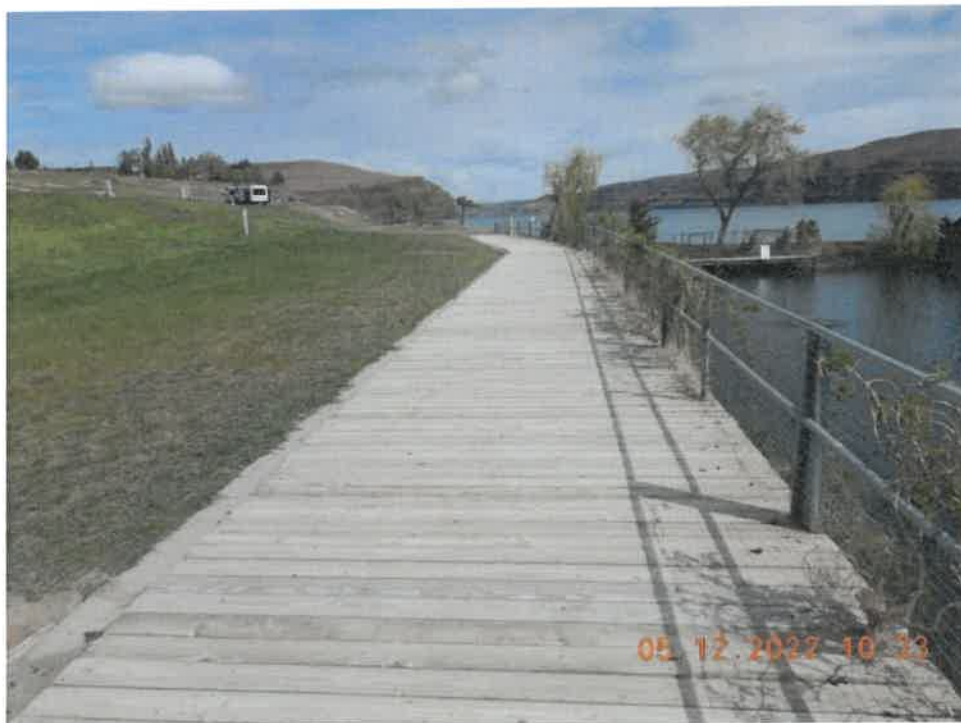
Generally, the upper boardwalk structure was observed to be in fair condition, with minor to moderate defects observed on various structural components. Localized areas of moderate deterioration are present but do not reduce the load bearing capacity of the structure. Photo 1 provides an overall view of the upper boardwalk.

*Photo 1: Overall View of Upper Boardwalk – Looking North*
