Subject: Casto Slope Landslide Investigation
561 Palouse Rd, Cle Elum, WA
QG Project No.: QG21-156

At your request, Quality Geo NW, PLLC (QG) has completed a limited evaluation of the existing slope failure within your property. We understand that following record rainfall, and apparent failure of surface drainage channels, that a large amount of soil was displaced and caused an unsupported, near-vertical portion of the hillside to fail and slide, translating portions of the slope as far as 40 feet in places. The general quality of the site and slope is in question. It has been requested that QG evaluate the slide and provide recommendations for improvements to reconstruct the slope and protect from future movement.

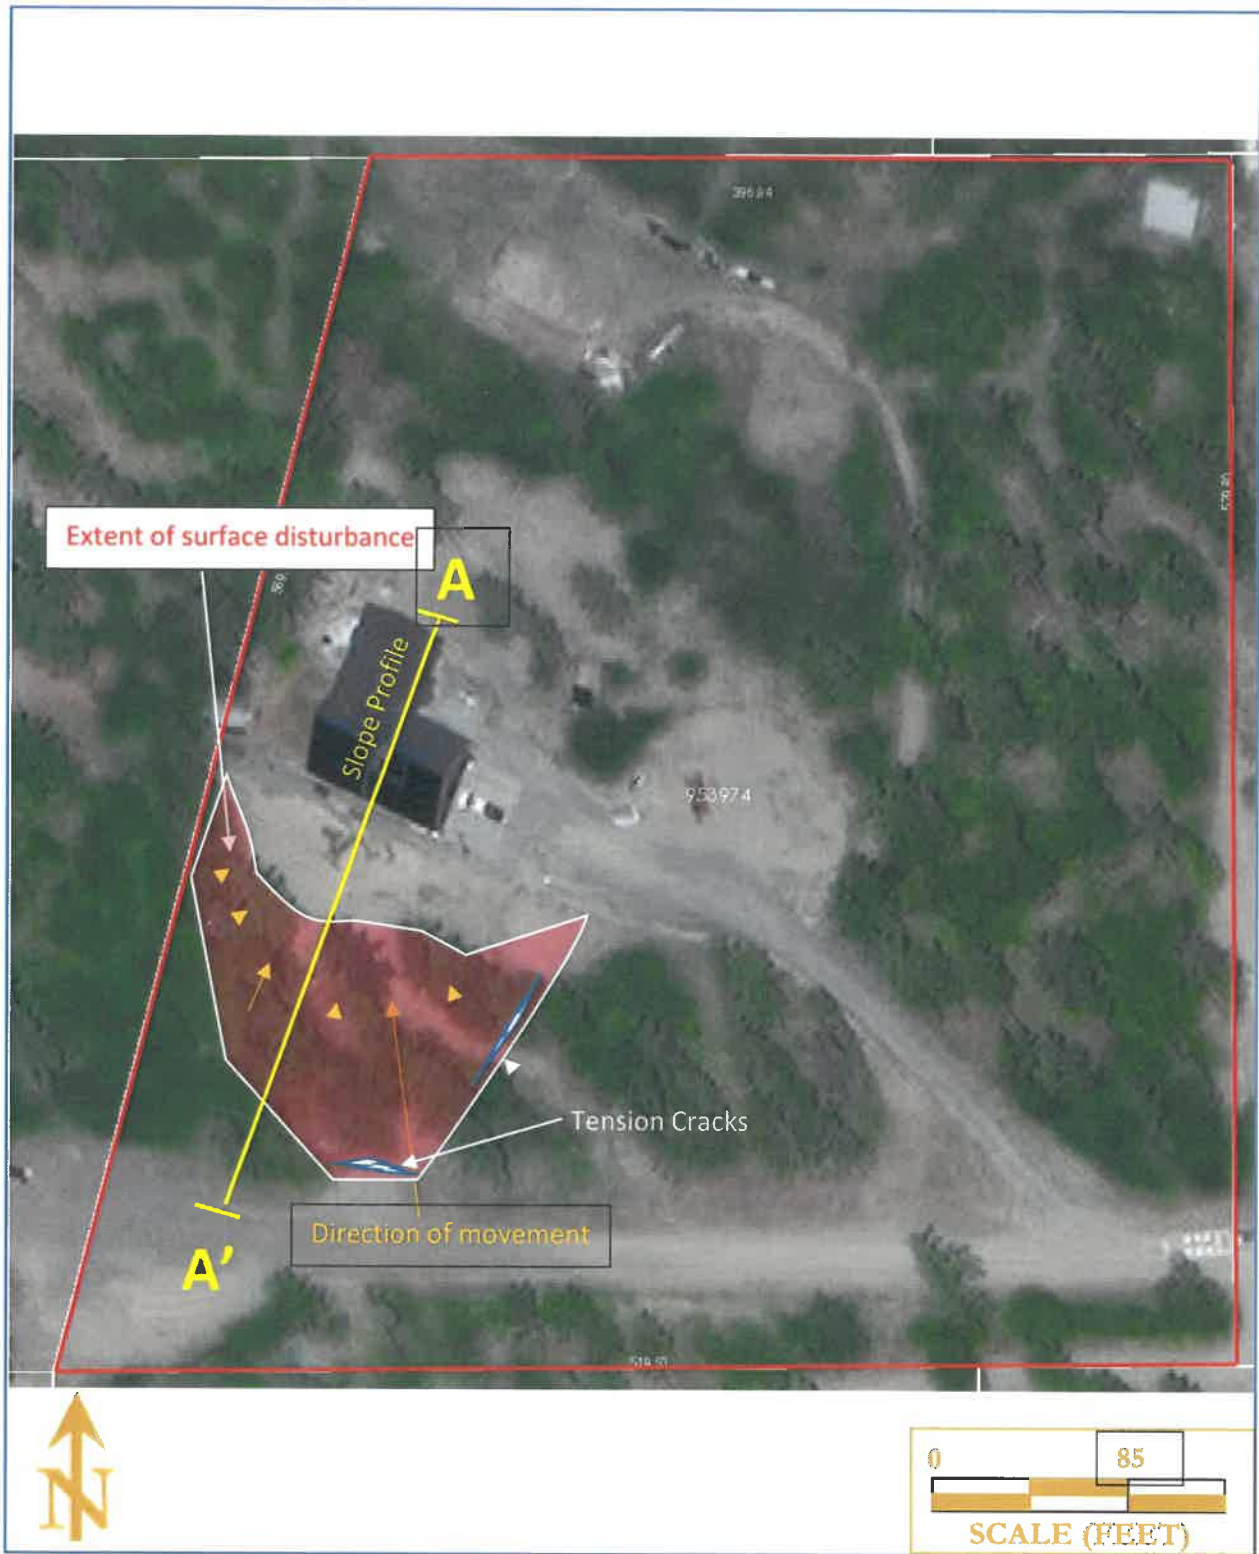
Figure 1

Proposed Drainage Map
Casto Property

The trench drain shall be installed along the farthest extent of disturbed ground (Appendix C) to intercept springs or seepage before they reach the slide area and infiltrate into the subsoils on the slope. Trench drains can be particularly effective in low gradient directional upland environments where permeable soils overlie relatively impermeable bedrock/hardpan conditions and groundwater is traveling from an upgradient source.

The trench drain shall be graded at an incline where there is no place for water to remain perched in the system, completely gravity flowing any intercepted water to the adjacent horizontal drains (described below) to completely contain the water and convey it downslope to an approved outfall at (or beyond) the quarry floor. A sturdy nonwoven geofabric material shall completely line the walls and base of the drain trench. A perforated or slotted rigid PVC pipe with minimum diameter of 6 inches (or alternative designed by the stormwater engineer) shall be placed near the base of the trench and be wrapped in filter fabric or a filter sock. Backfill with gravel drain rock meeting WSDOT Standard Specification 9-03-12(4) gravel Backfill for Drains or equivalent. The drain rock course shall be a minimum of 1 foot wide, and a minimum of 5 feet tall, extending the whole

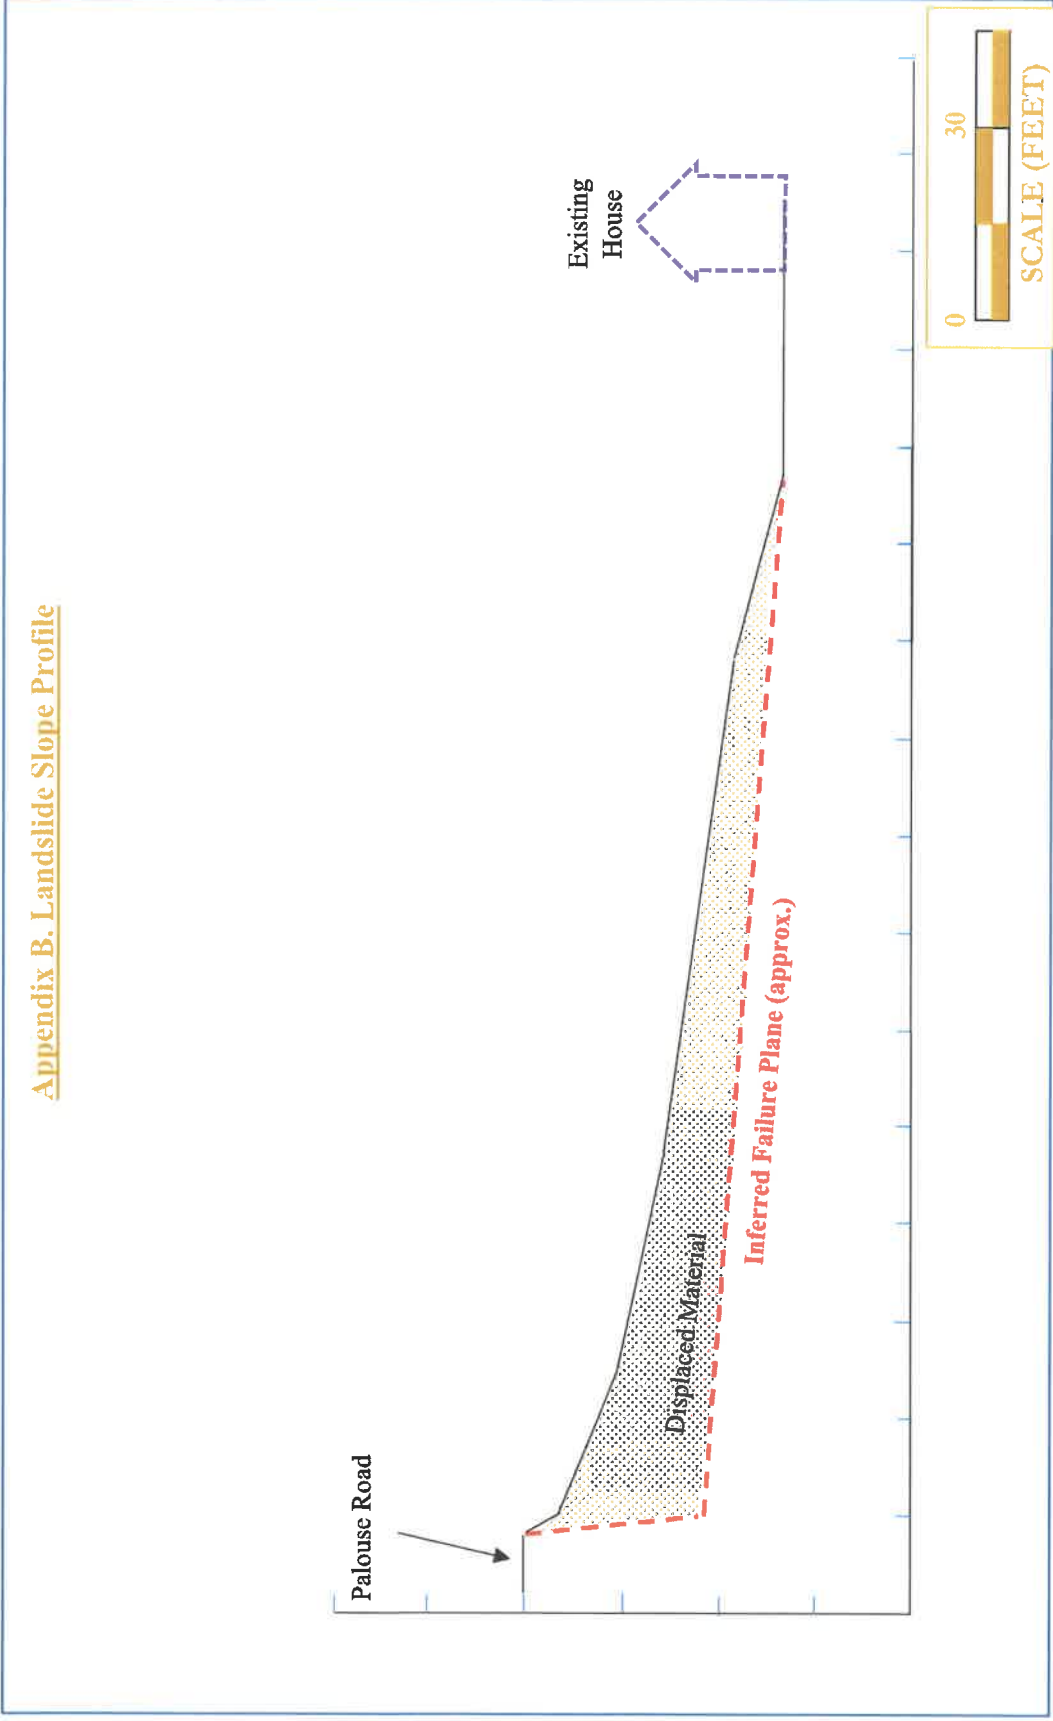
Figure 3

The original slope face (prior to the slide) was reported by the client to have been left as a near vertical and unsupported cut face, planned for further development around the residence. It is this near vertical face that experienced the most displacement. Based on our test pit explorations, and observations of the slide, the failure appears to have occurred across the plane where the weathered overburden soils interface with the un-weathered bedrock materials at depth. Sliding mechanisms appear to resemble a near-lateral translation slide (see Appendix C).

Landslide Profile
Alderbrook Quarry

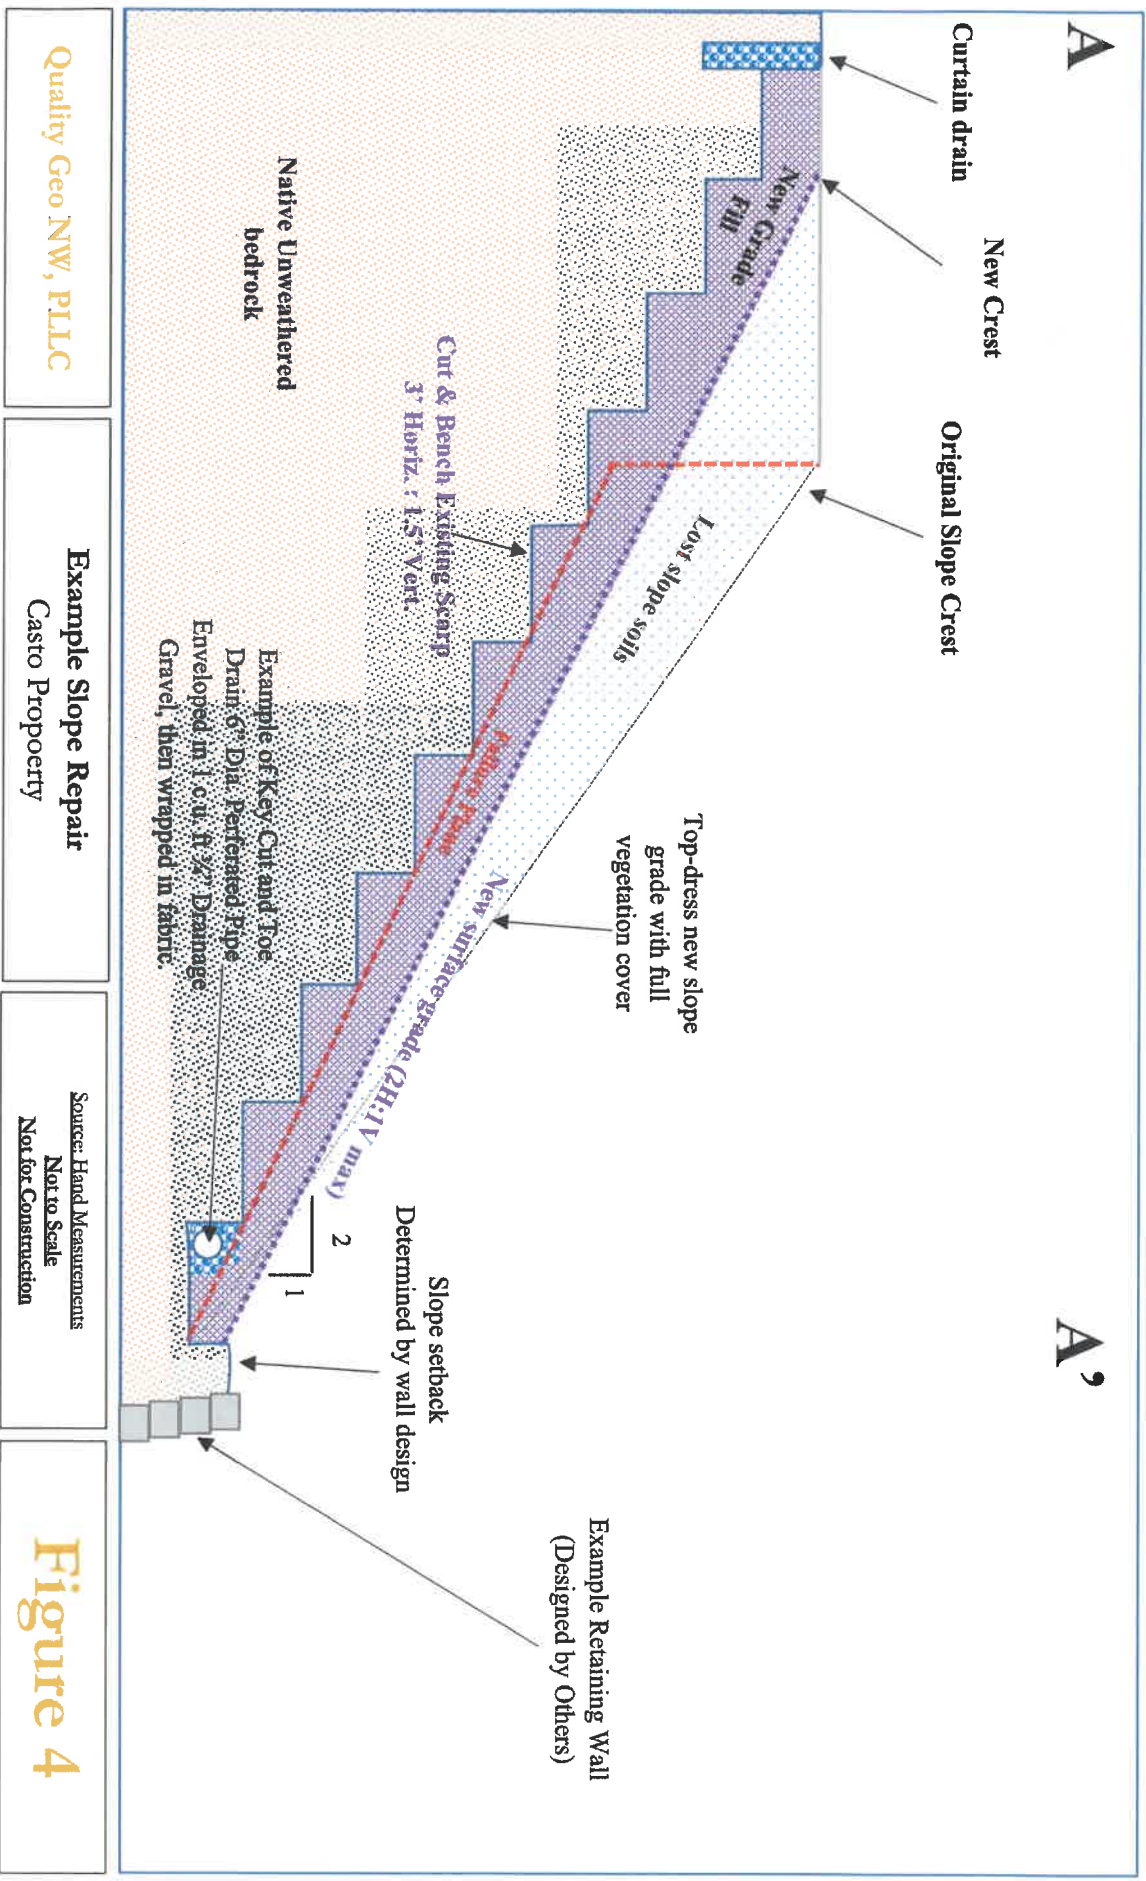
Figure 4

Example Slope Repair
Casto Property

Excavations can generally be performed with conventional earthmoving equipment such as bulldozers, scrapers, and excavators. QG recommends removing all organic topsoil, displaced landslide deposits, and weathered overburden, down to the less weathered sedimentary deposits, below where seepage extends, and benching the final bottom of subgrade elevation near flat. We recommend maximum vertical steps of 1.5 feet with horizontal spacing of at least 3.0 feet be constructed unless specified otherwise by the design engineer.

QG recommends that new areas of permanently graded and fill slopes be inclined no greater than 2H:1V, catching natural topography at the top and toe. We recommend that areas expected to receive imported fill be benched, placed, and compacted in accordance with WSDOT Standard Specifications: *Embankment Construction & Hillside Terraces*, sections 2-03.3(14) through 2-03.3(14)D. Fill slopes may be inclined no greater than 2H:1V. All site slopes should be permanently stabilized from erosion.
