SUBJECT: ENG – Trip Report  
Beloukas EWP – Teanaway River  
Kittitas County, WA

On May 11, 2026, we visited the Beloukas EWP site to visually inspect site conditions for bank stabilization along the Teanaway River following flooding in December 2025. The flooding caused extensive bank erosion and continues to pose a significant hazard to the foundation of a house on the property. The site is located at 220 Seaton Road, Cle Elum, WA.

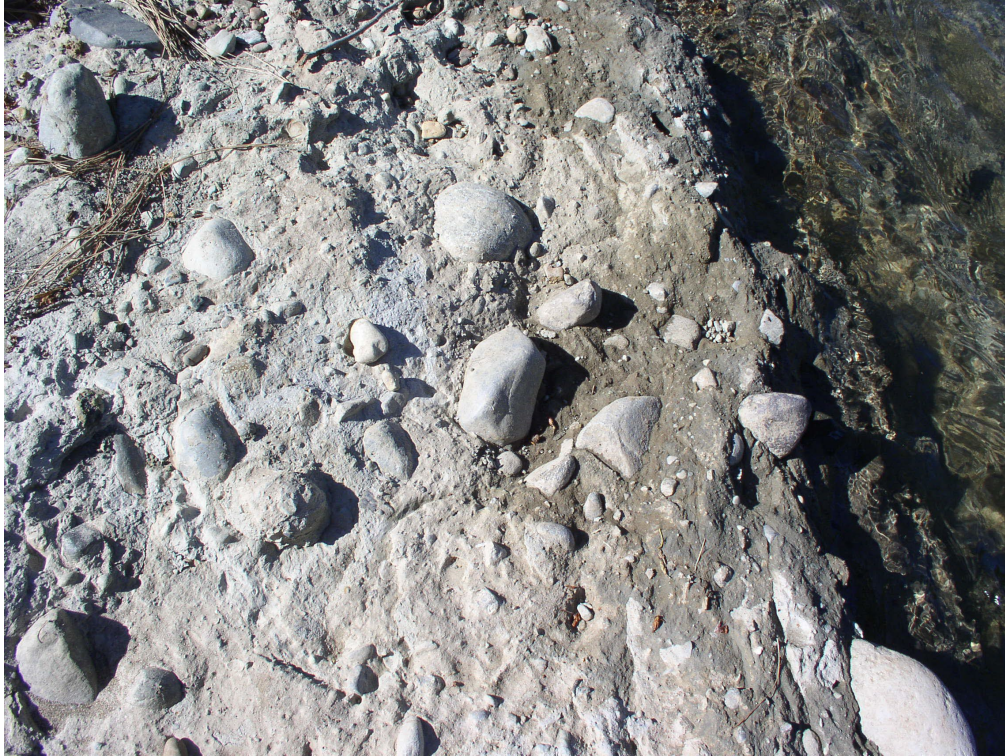
The foundation soils consist of Pleistocene age alpine glacial drift composed mostly of cobbles and gravel with a silt matrix. These soils are susceptible to slope failure when the toe of the slope is undercut through stream erosion and when saturated from heavy rain or rain on snow events (Figures 2 to 5).

Figure 2. Image of the cobble gravel material of the alpine glacial drift which comprises the hillslope.

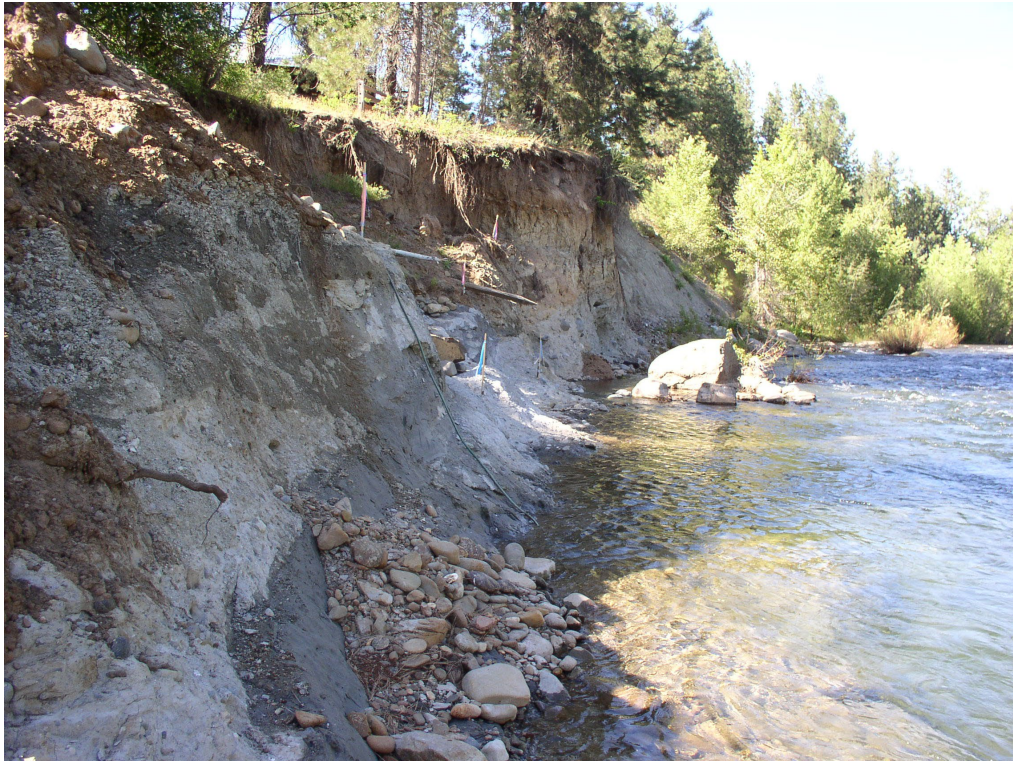
The streambank in this reach of channel remains unstable and will continue to collapse through topple, slump, or rotational failure modes when saturated or eroded at the toe by the Teanaway River. The structure at the top of bank will be undermined by ongoing bank failure unless action is taken to stabilize the toe of the slope from further erosion and drainage is provided to protect the embankment from excessive saturation. The structure is in imminent threat of failure if the streambank is not stabilized.

Figure 3. Near vertical streambank with cracks and wet surface from bank saturation.

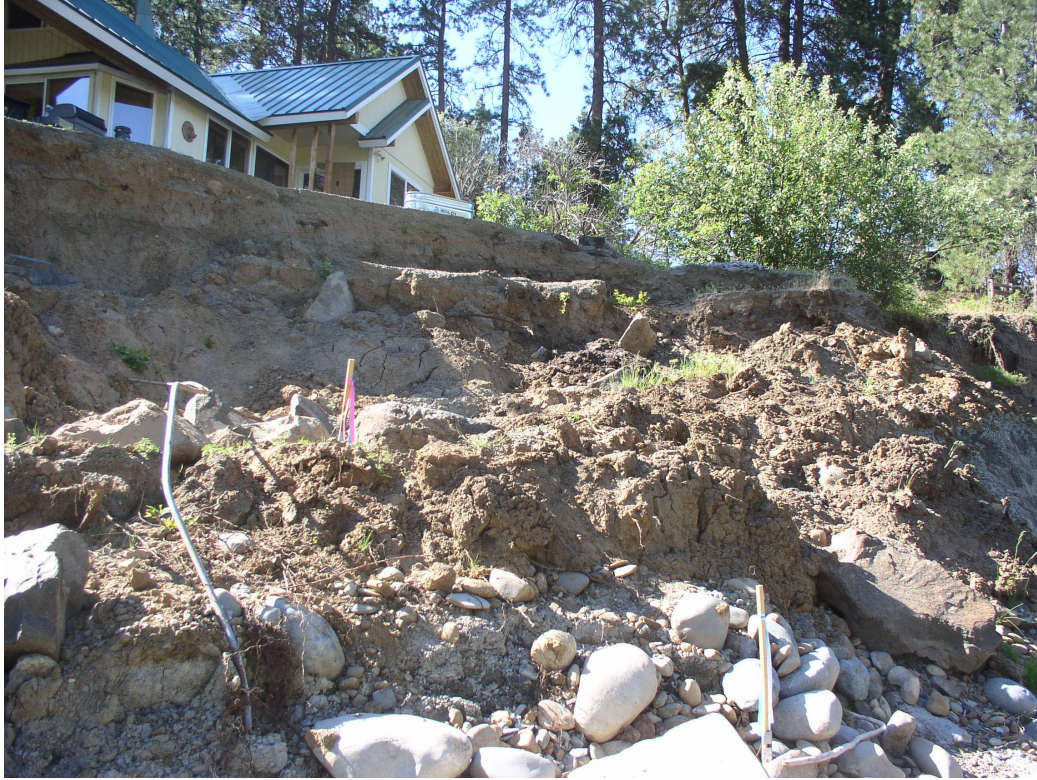
Figure 4. Image of structure at top of bank with topple, slump, and rotational failure of slope along with active cracking.

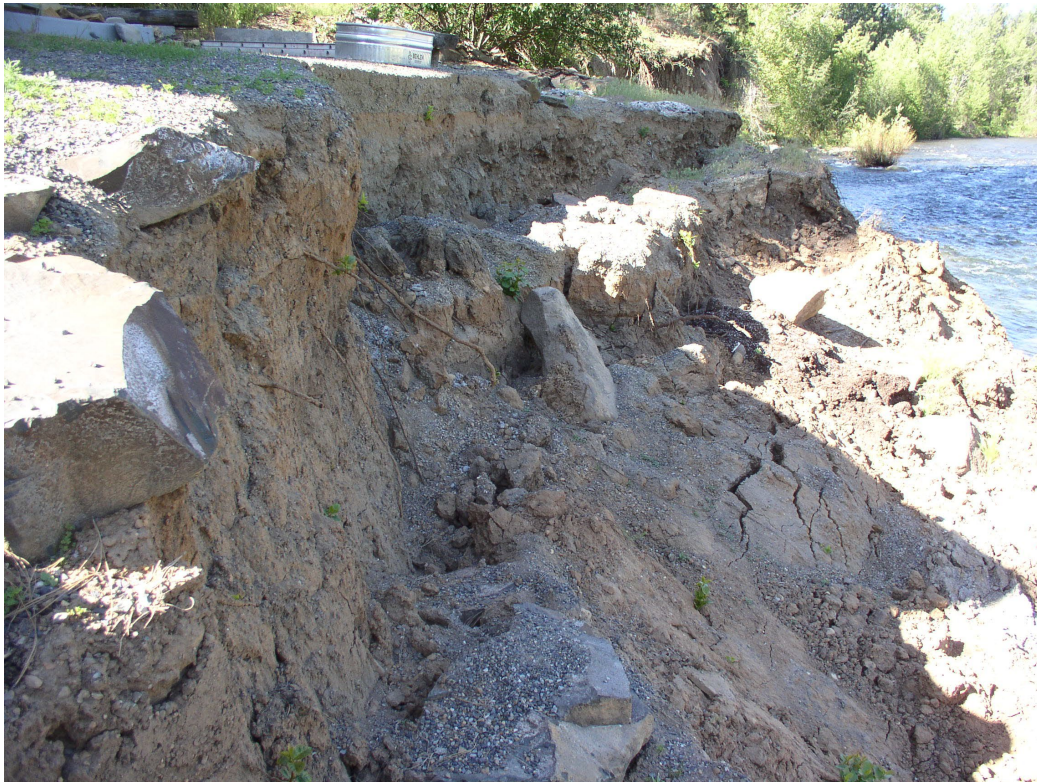
Figure 5. Image showing impacts of progressive slope failure.
