APPENDIX A Site Photographs

Geotechnical Summary Memo Johnson Property Manastash Creek Channel Migration Zone Study 11810 Manastash Road, Ellensburg, Washington

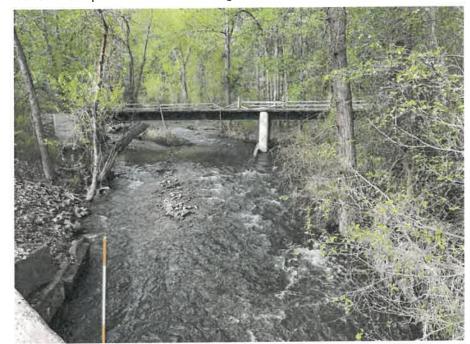
PHOTO 1: Upstream area from bridge, view to the west

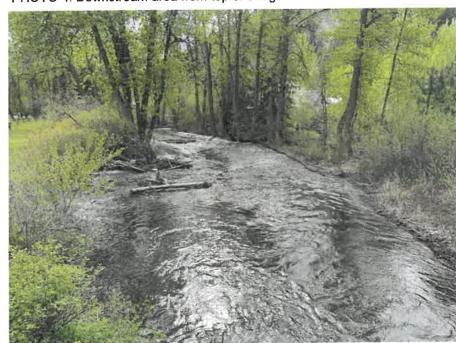
PHOTO 4: Downstream area from top of bridge at the Site

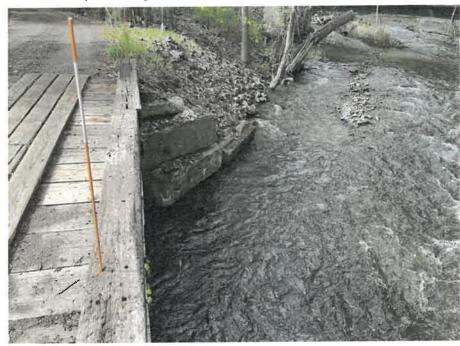
PHOTO 2: Upstream right bank

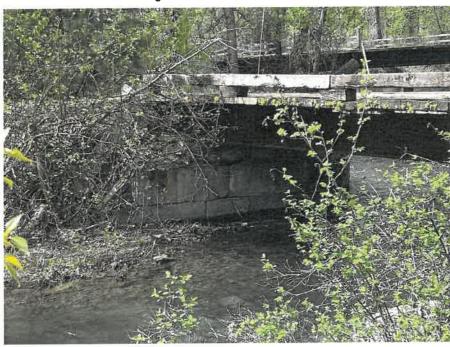
PHOTO 5: Downstream right bank

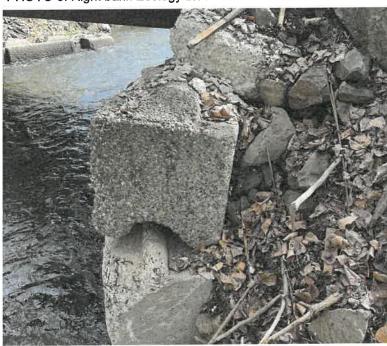
PHOTO 3: Right bank Ecology block abutment view downstream

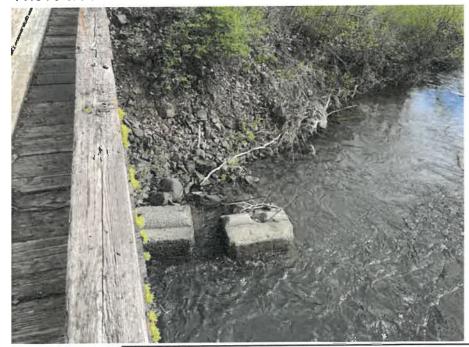
PHOTO 6: Downstream left bank

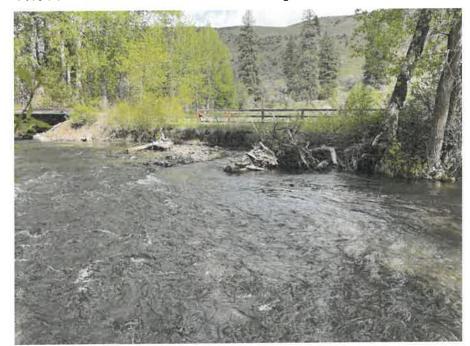
PHOTO 7: Creek left bank downstream of bridge, view to the northwest

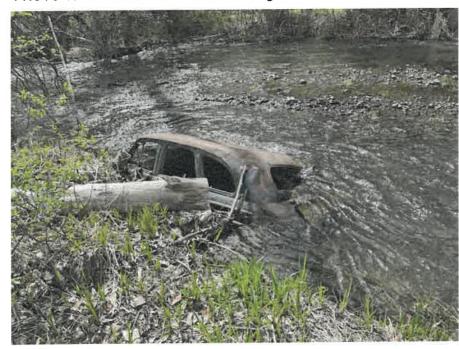
PHOTO 10: Abandoned automobile armoring creek left bank

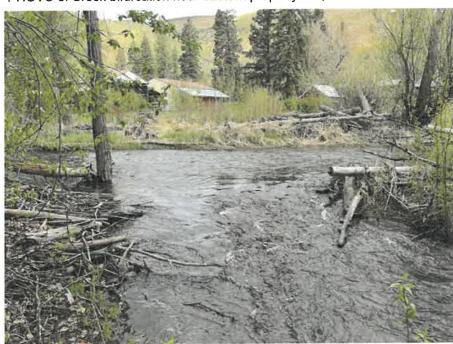
PHOTO 8: Creek bifurcation near eastern property line, view to the north

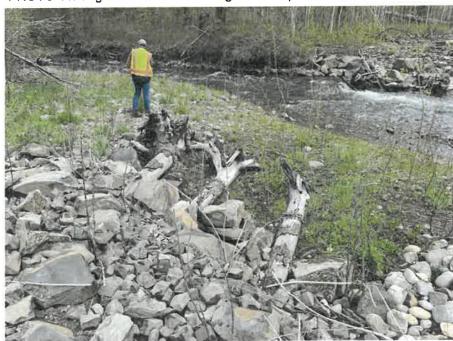
PHOTO 11: Engineered bank armoring 3 miles upstream of Site

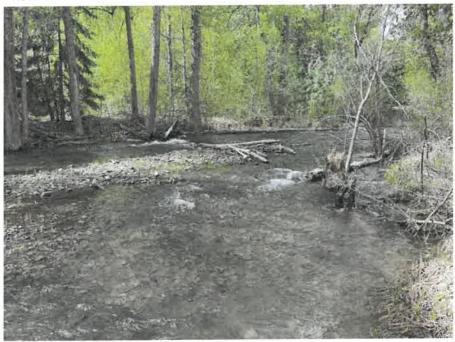
PHOTO 9: Gravel bar and woody in creek near east property line, view to the west

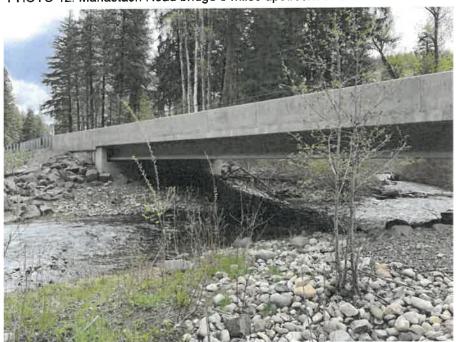
PHOTO 12: Manastash Road bridge 3 miles upstream of Site

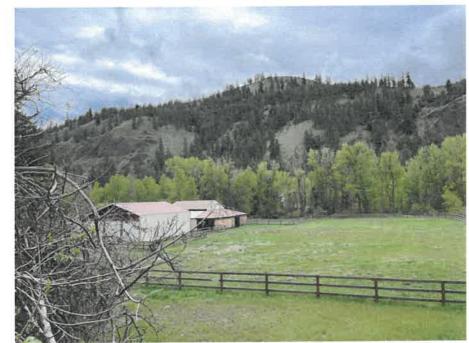
PHOTO 13: View towards subject property from Manastash Road

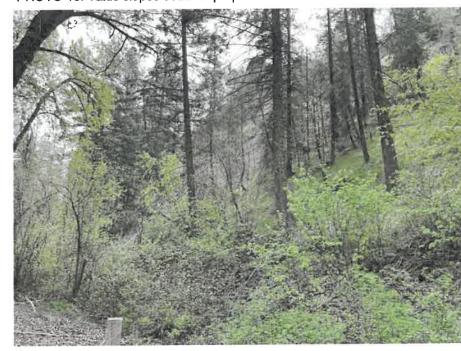
PHOTO 16: Talus slopes south of proposed new structure

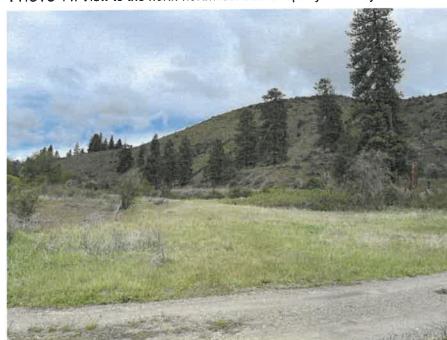
PHOTO 14: View to the north-northwest from Property driveway

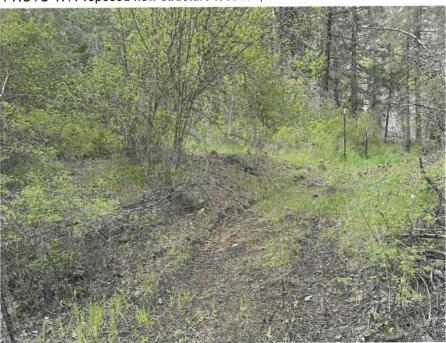
PHOTO 17: Proposed new structure location, view to the south

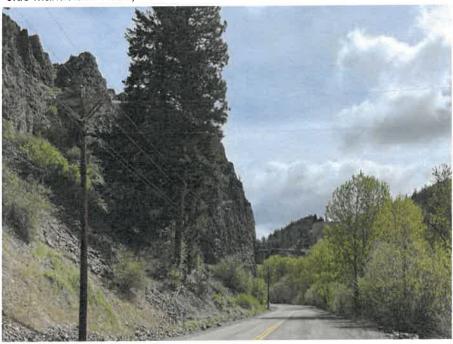
PHOTO 15: Basalt bedrock cliffs and talus slopes above north side Manastash Road, view to the east

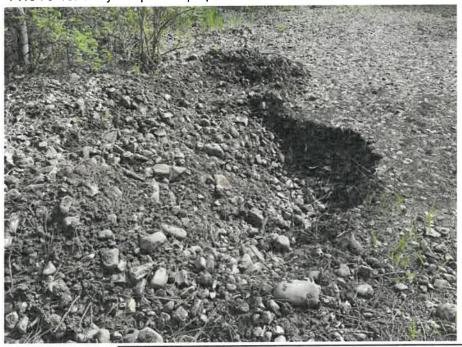
PHOTO 18: Utility test pit near proposed new structure location
