Caseo Residence  
561 Palouse Dr. Cle Elum, WA  
Kittitas County Parcel # 953974

4/6/2021

Slope Failure

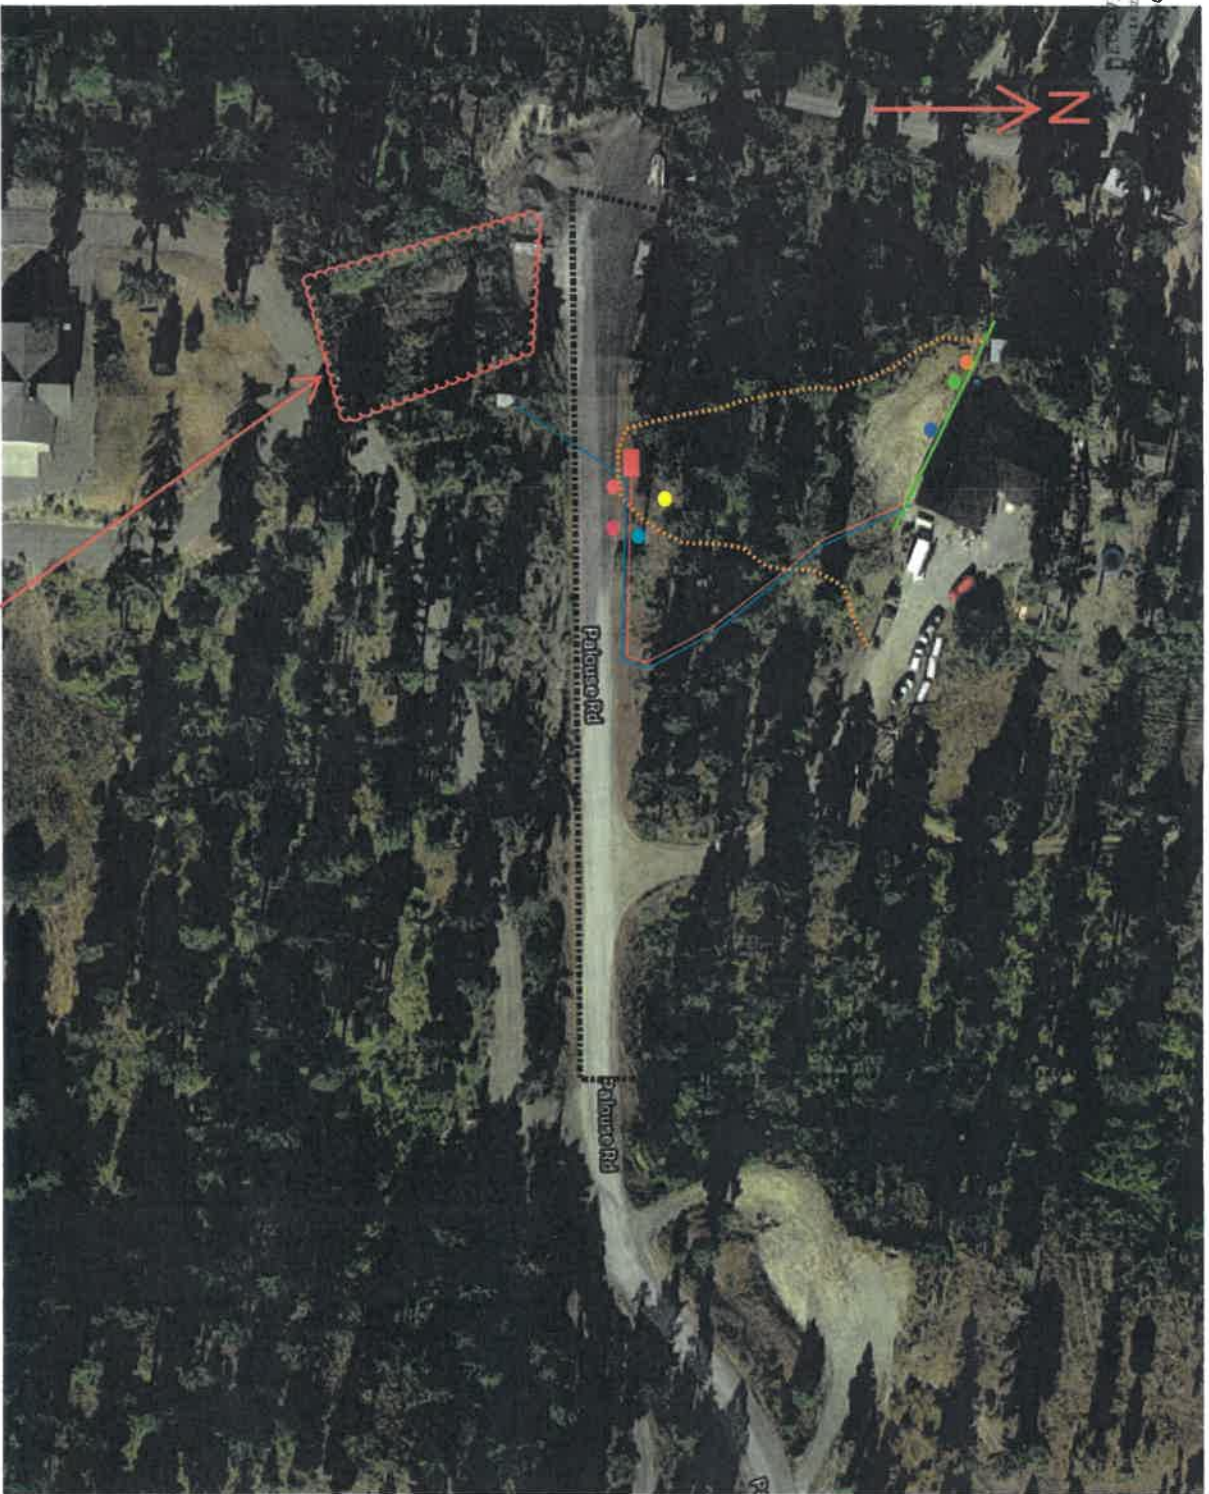
Approximate location of previous slope mitigation work. Mitigation involved drains and grading to drain water from slope. Water drains into roadside swale on South side of Cul-de-Sac.

Approximate Extent of Landslide and Location of Cracking

Photo 1, @ Vault looking North to House

Photo 2, East of Vault looking West Along Road and along road showing head scarp of slide

Photo 4, North of Vault showing top of slide and vault settlement

Photo 5, @ Toe of Slope looking up and east at cut slope failure

Photo 6, @ Toe of Slope looking east along toe

Photo 5, @ Toe of Slope near mid point of cut showing local cut failure and small slide zone causing heave of existing grade near house
