JENSEN
ENGINEERING
INC.

Project Number 16049-100

August 16, 2016

This letter is in regard to on-site sewage disposal feasibility study done by Jensen Engineering Inc. for the proposed development of Marian Meadows east of Easton, Kittitas County, Washington. The following will summarize the findings of our site visit.

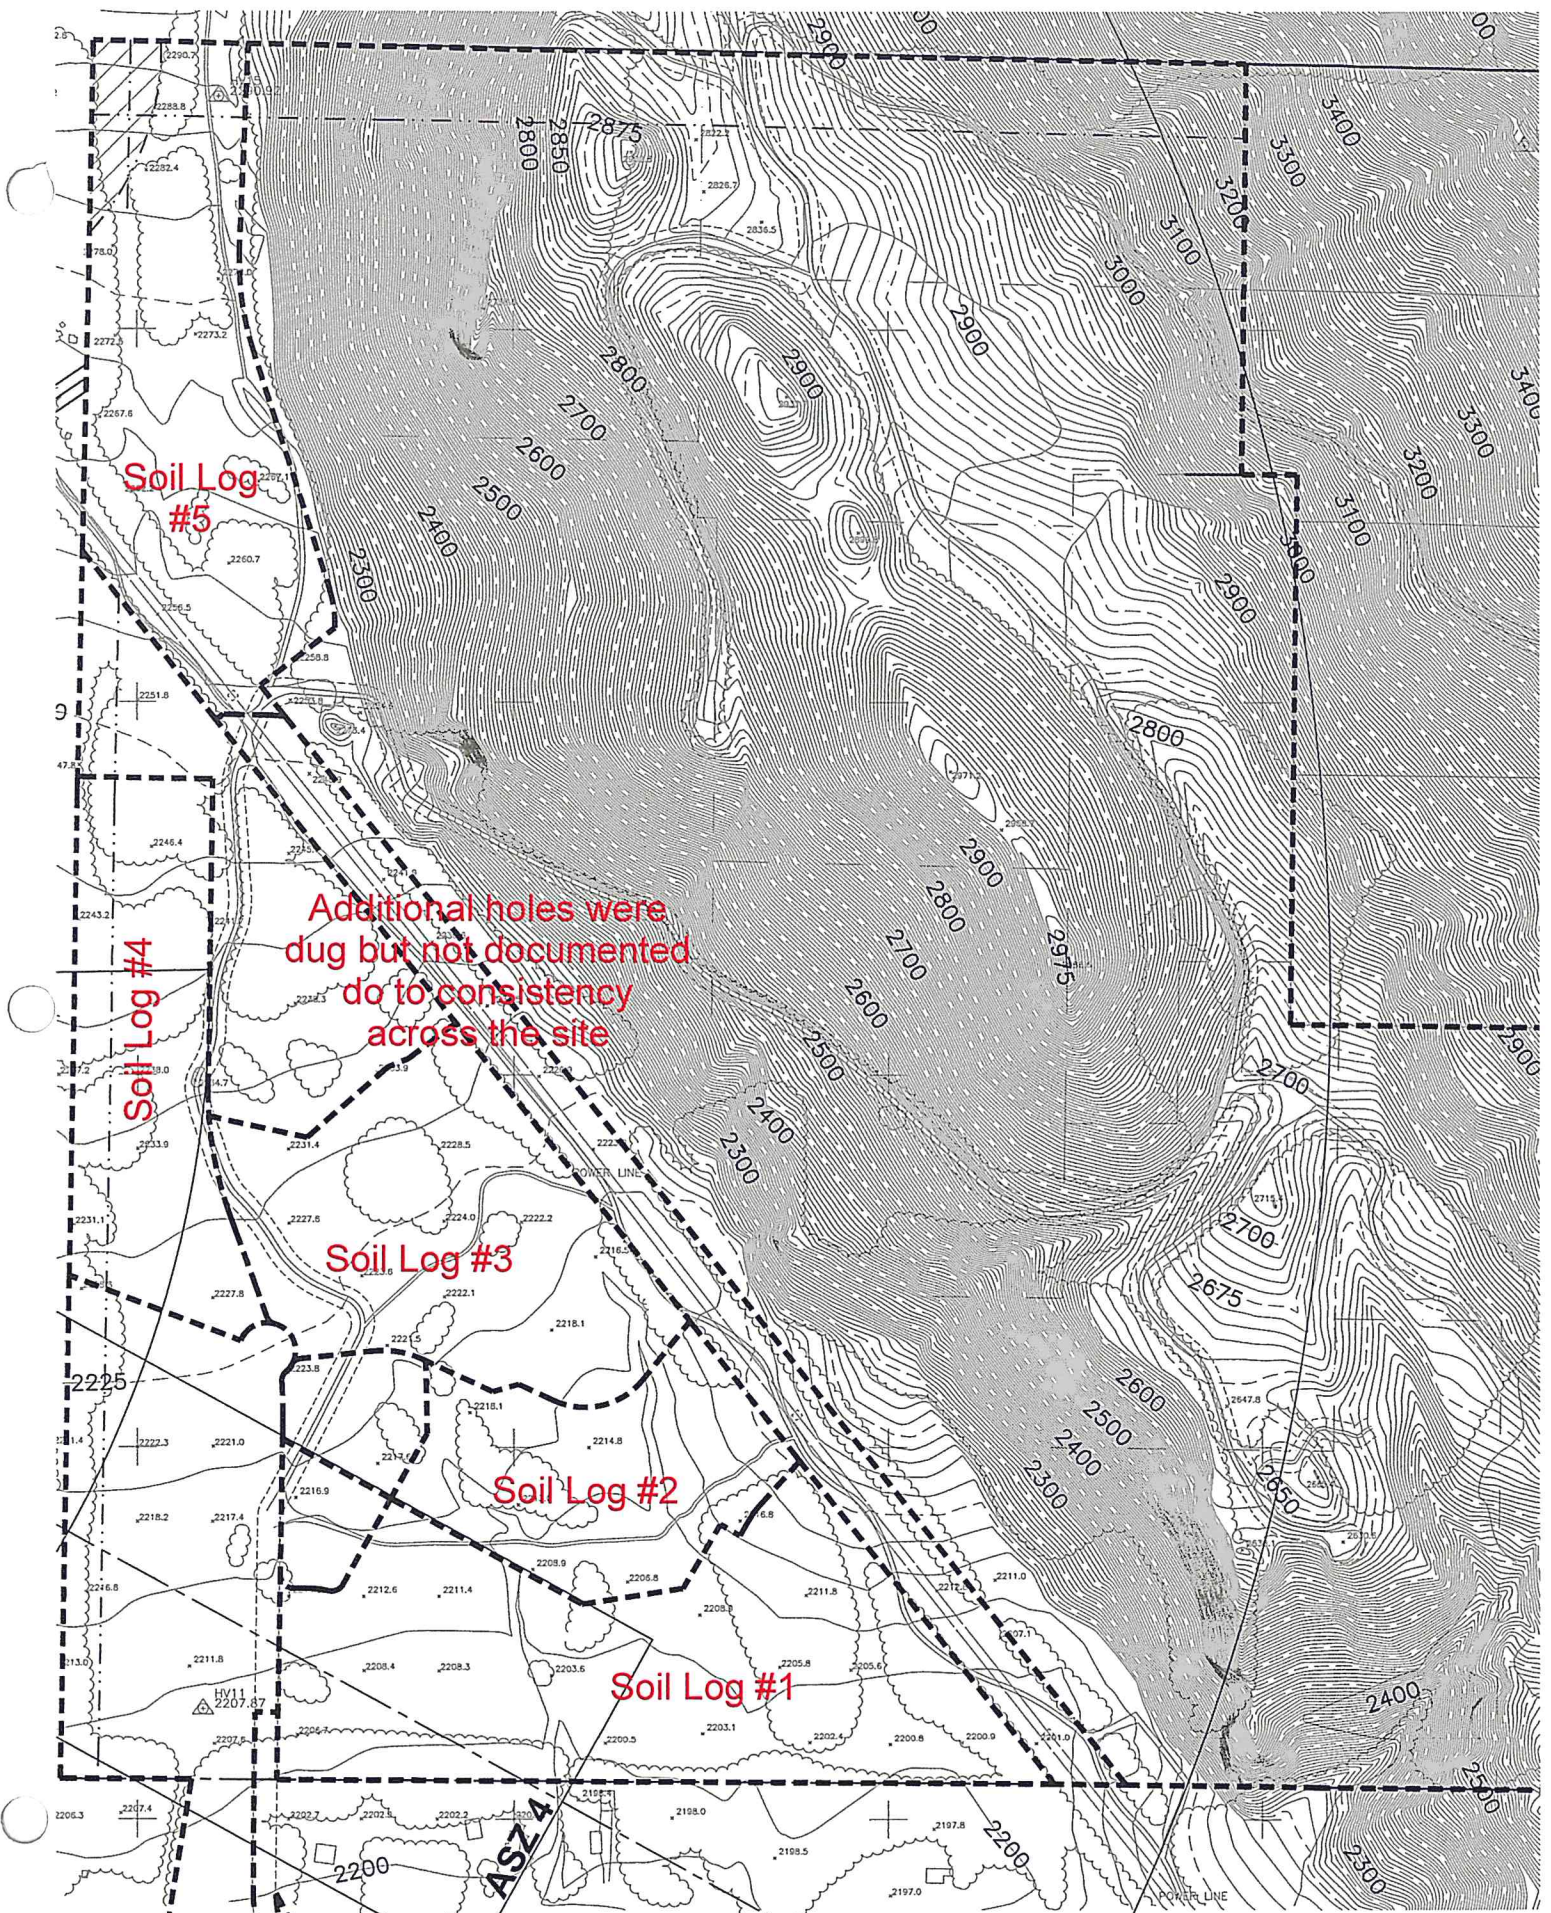
Septic Exhibit

Additional holes were dug but not documented do to consistency across the site

Septic pot hole locations
