Technical Memorandum

To:	John Woods
From:	John Knutson, PE URS Corporation 3810 Kern Rd., Suite A Yakima, WA 98902 (509) 469-0163
Copies:	File
Date:	July 29, 2014
Subject:	Review and Comments on Flood Study for Black Horse
Project:	33764776—Bender Road Flood Review

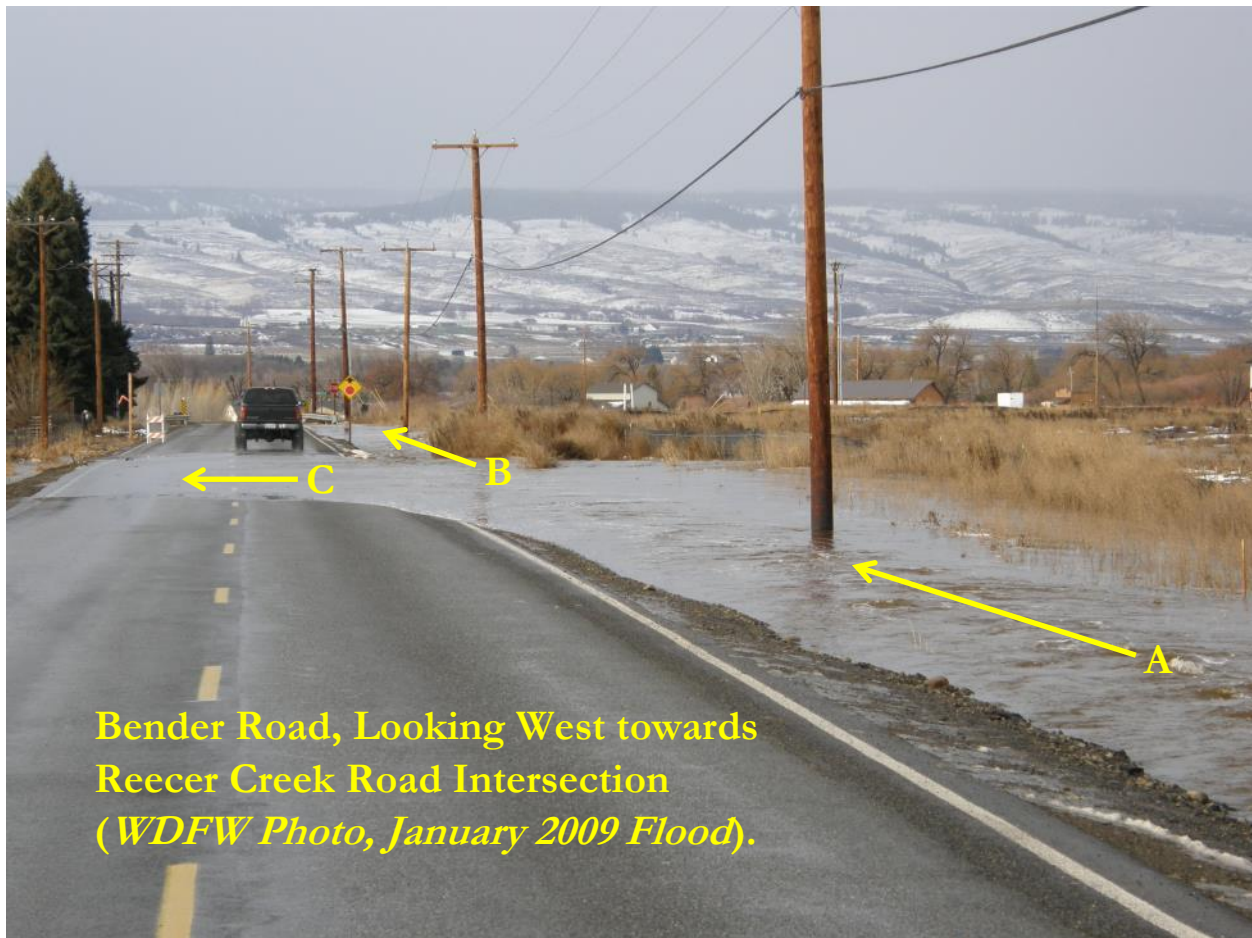
- A. Anchor's model accurately shows that under existing conditions a substantial amount of flood water cannot pass through the existing Bender Road culvert, and instead is diverted to the west along the upstream side of Bender Road where a portion of it overtops Bender Road and a portion overtops the Town Canal banks near intersection of Bender Road and Reecer Creek Road (**Figures 1 and 2**).

Figure 1. Whiskey Creek floodwaters flowing west away from the creek along Bender Road. **A.** Based on Anchor's model using the estimated 1996 flood flow, the diverted flow would be approximately 283 cfs for a Whiskey Creek flood flow of 378 cfs (*likely greater than the 2009 flood flow shown here*). **B.** The majority of diverted flow overtops the Town Canal banks and leaves the area. **C.** A smaller portion of the diverted flow overtops Bender Road (shallow enough to still see road stripes in 2009) and enters the roadside ditch where it flows into the Town Canal on the south side of the road. In 1996 the flow overtopping Bender Road was great enough to overwhelm the capacity of the south side ditch and enter Woods field.

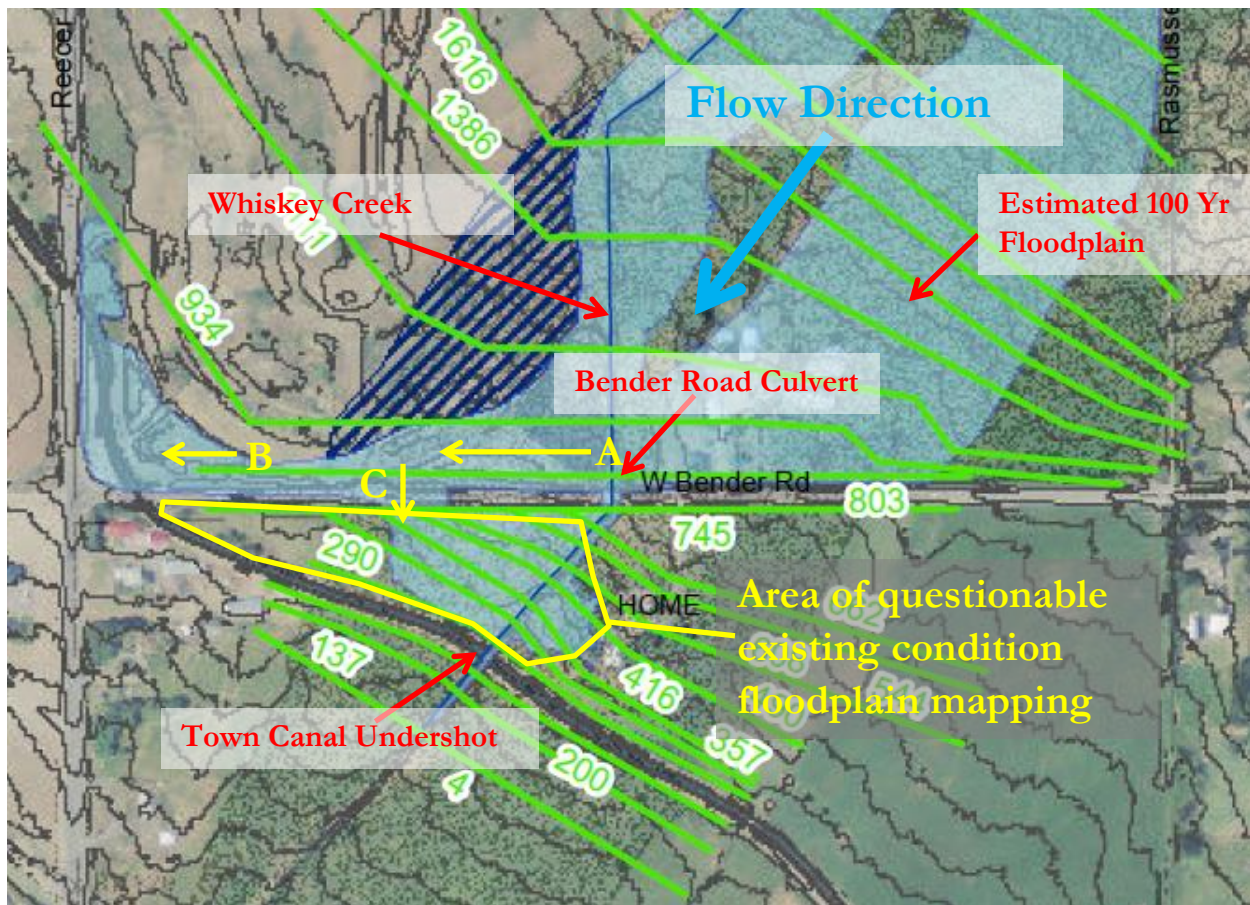
Figure 2 (Edited from Anchor Floodplain Analysis, Sept. 28, 2012). Anchor model shows Whiskey Creek floodwaters flowing west away from the creek along Bender Road. **A.** Based on Anchor’s model, the diverted flow would be approximately 283 cfs for a Whiskey Creek flood flow of 378 cfs. **B.** The model shows the Town Canal being over-topped. **C.** A portion of the diverted flow is shown crossing Bender Road and entering John Woods field.

- B. While the diversion of flow along Bender Road and the overtopping of the road and the Town Canal appear correct, the floodplain mapping on the south side of Bender Road does not appear to be correct (**Figure 2**). Nor does it match Mr. Woods’ observations over the last 30 years, during which several floods have occurred with the largest occurring in 1996. The floodplain mapping does not match the Anchor HEC-RAS model output either. There are several inconsistencies:

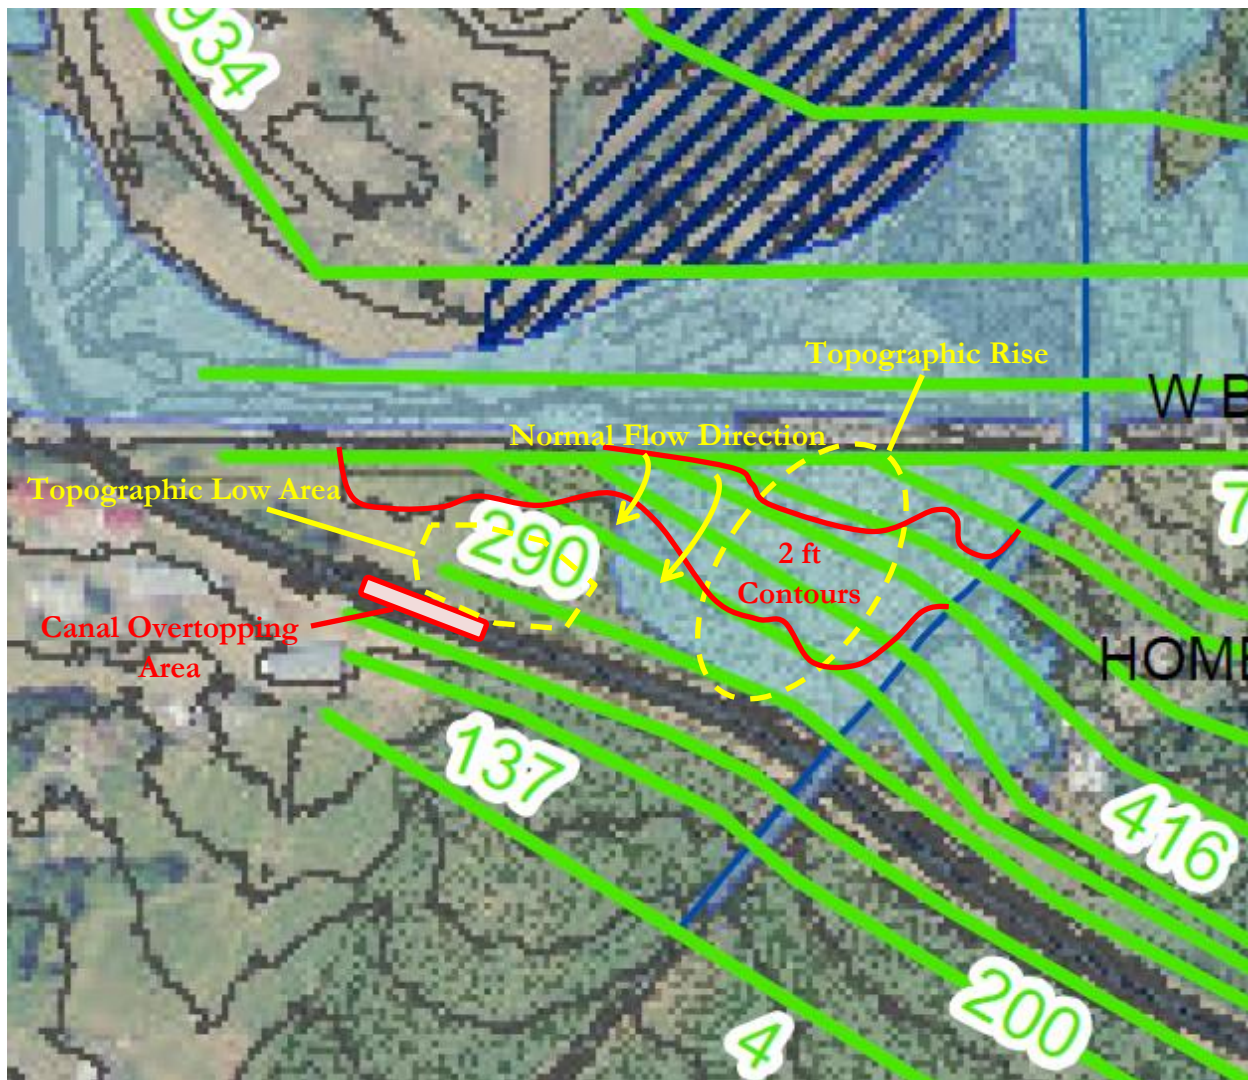
- i. Once the diverted floodwater overtops Bender Road, based on the 2 ft contours the Anchor mapping essentially has it flowing up-hill, across a low topographic rise, and back down to Whiskey Creek. While it may be slight, the topographic rise can be observed in the field and is also shown in the 2 ft contours. The 2 ft contours (presumably derived from LiDAR data) show that, once overtopping Bender Road, the floodwater should: (a) flow down the south side ditch and into the canal on the south side of Bender Road; and (b) when over topping flows are great enough (such as in 1996), flow downhill (perpendicular to the contour lines) in the field and pool in the low spot in the vicinity of the “290” location (**Figure 3**). There appears to be no reason to map as floodplain the entire area between the road overtopping location and the creek/canal undershot.

Once pooled near the “290” location, there is no topographic reason the floodwater will not overtop the Town Canal bank and enter the canal rather than return to Whiskey Creek (which is what Mr. Woods has observed). In fact, prior to 1996 Mr. Woods and the Ellensburg Water Company installed a “cut-out” on the side of the canal at the low spot in the field to drain excess irrigation water from the Woods field – this is how floodwaters from the field entered the canal in 1996. This flooding pattern is also validated by a video of the 1996 flood provided by Mr. Woods. The video (1:12:46) shows the road being overtopped (deeper than 2009), yet the field between the overtopping location and the creek channel is still covered with snow (1:12:34) - not inundated with floodwater as shown by the Anchor floodplain map (see **Figure 4**). The video shows Bender Road being overtopped in the same location as in 2009, and shows floodwater entering the Town Canal near the intersection of Bender Road and Reecer Creek Road (1:13:27).

Figure 3 (Edited from Anchor Floodplain Analysis, Sept. 28, 2012). Shows 2 ft contours, low topographic rise, the direction that floodwaters that overtop Bender Road should flow, the low area along the canal, and the zone where overtopping and flow into the canal occurs.

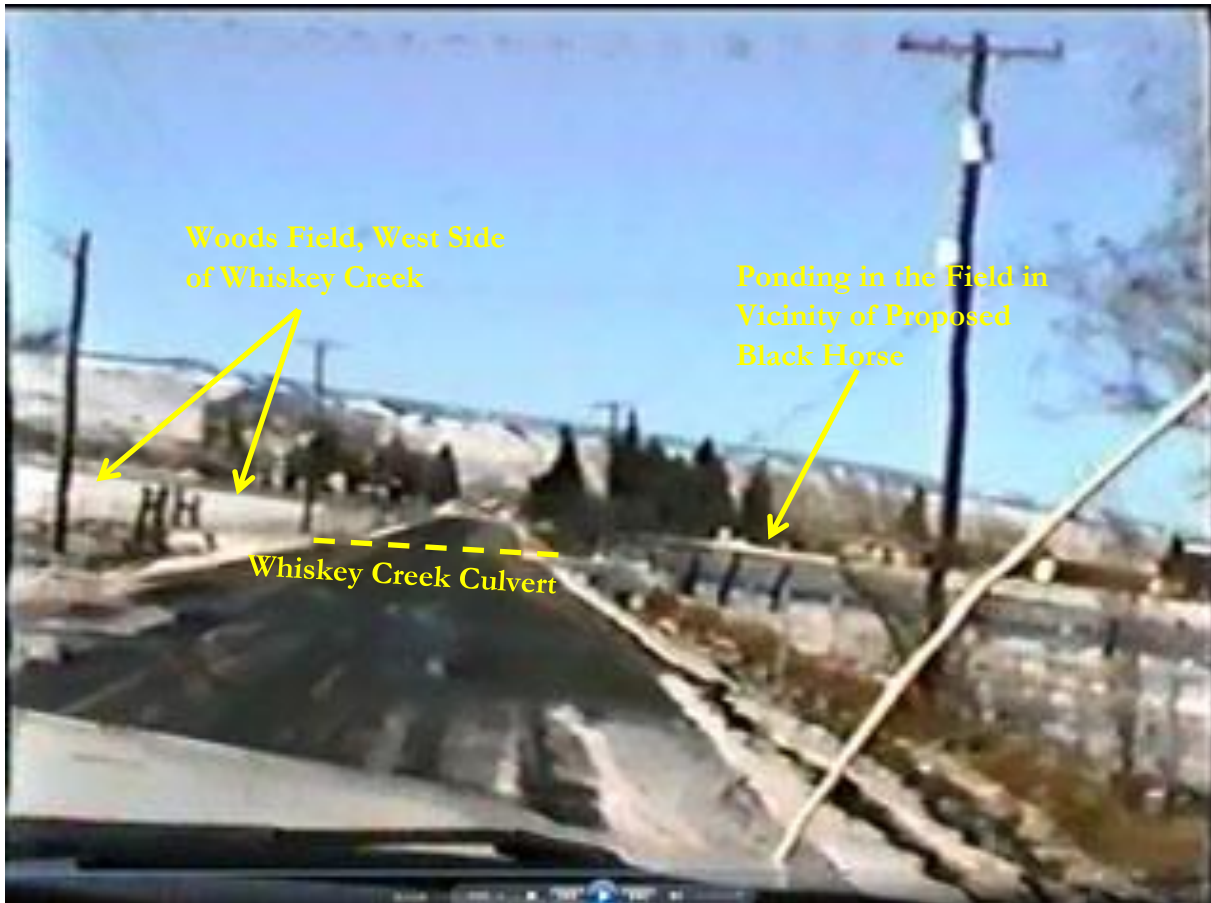
Figure 4. Screen shot (1:12:34) of 1996 flood video (Video by the Lebo Family) showing the Woods field still covered in snow (not being flooded) during the 1996 flood. The video also shows Bender Road being overtopped shortly after this (1:12:46).

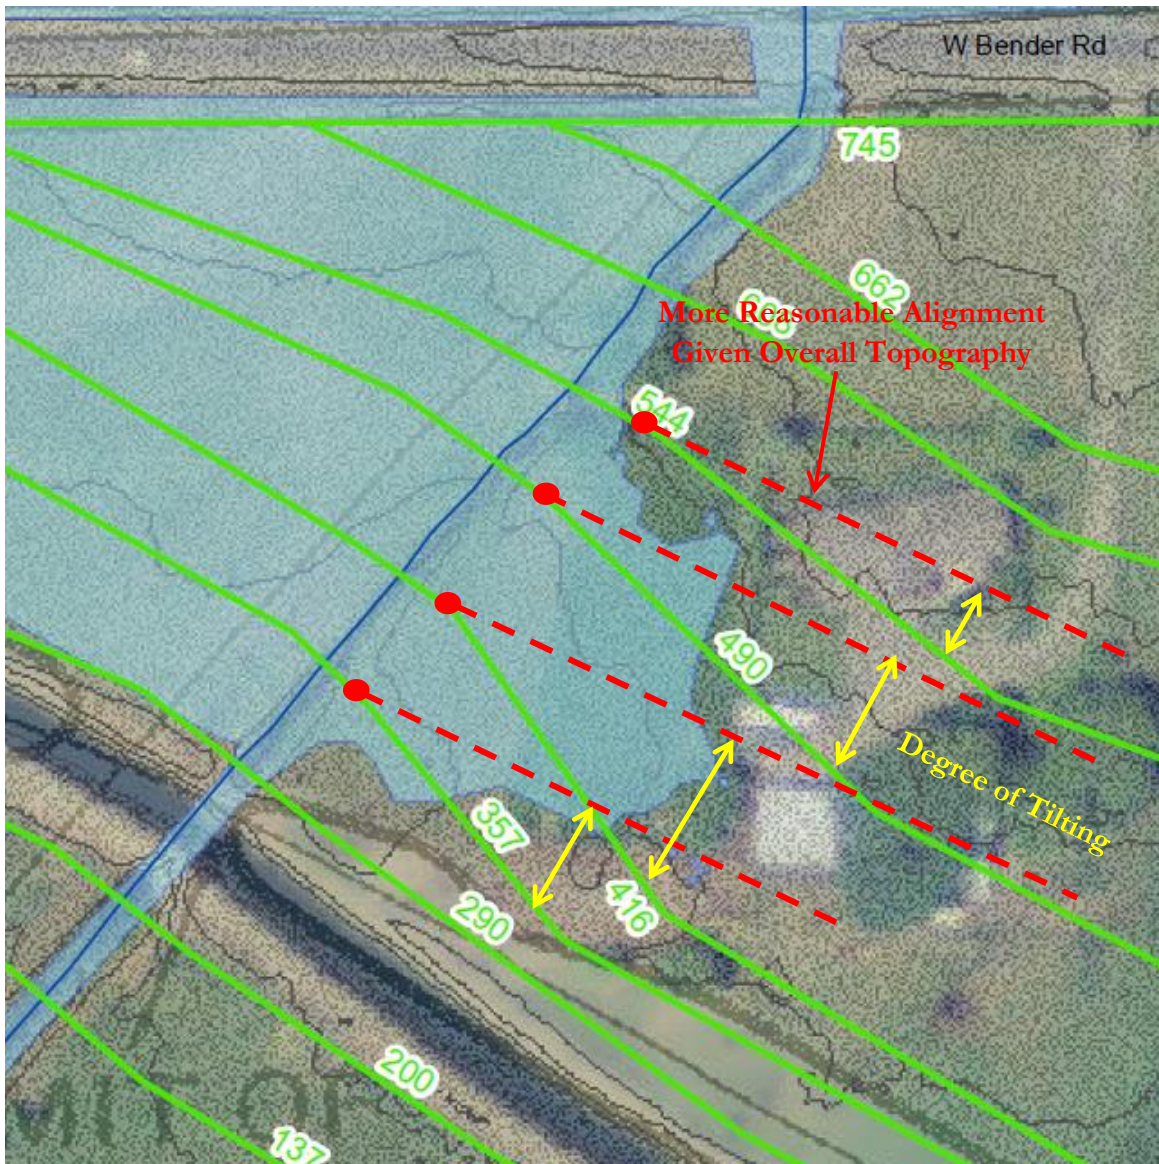
One possible reason some width-of-flow estimates are wider than observed may be the x-section data. It appears that portions of x-sections 490-357 are aligned in a downhill direction on the east side of the creek, which would increase the estimated extent of inundation (**Figure 5**). For instance, if not aligned downhill, x-section 490 (flow width of 95 ft) would intersect with a 2 ft contour line about 150 ft from the creek. With its somewhat downhill orientation, it does not intersect the 2 ft contour even after 400 ft. X-section 416 appears to be aligned in an even more downhill direction but its width-of-flow is estimated at 12 ft.

Figure 5. Tilting of the HEC-RAS model x-sections in what appears to be a downhill direction, which can lead to overestimation of floodplain limits.

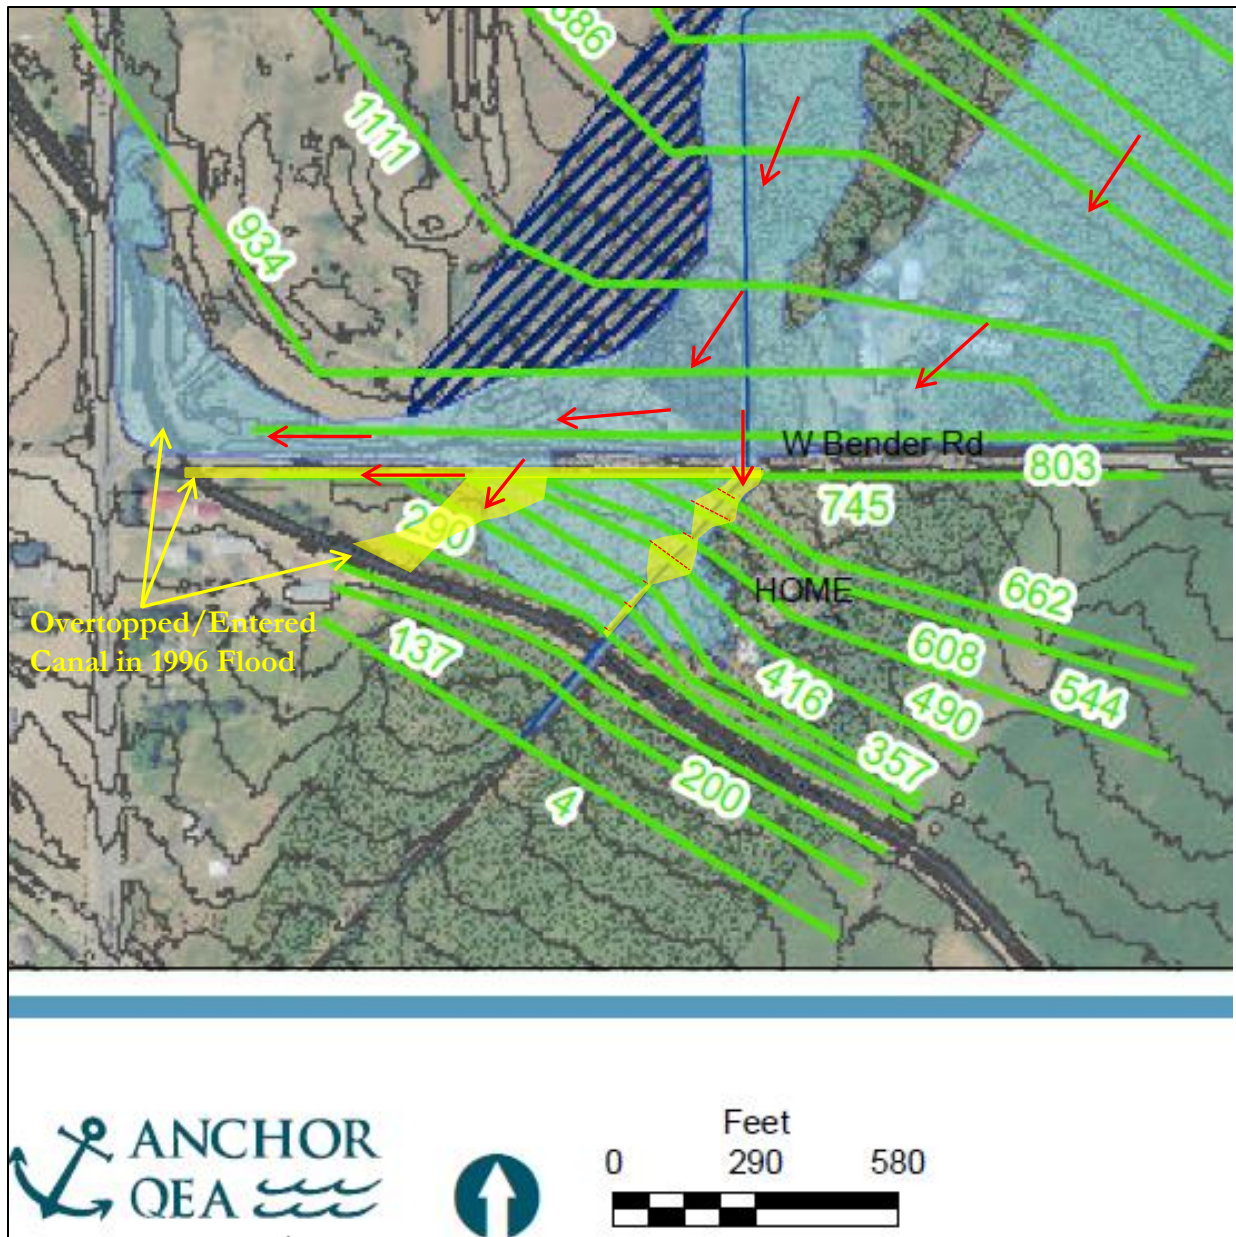
While there are still some inconsistencies between the model output and the Woods observations, Anchor's HEC-RAS model output (Table 1 from Anchor Sept. 28, 2013 Memo) can be used to develop a better estimate of the existing condition floodplain along Whiskey Creek through the Woods property. URS has prepared a mock-up of the existing condition floodplain map using Anchor's width-of-flow information for the reach of Whiskey Creek crossing the Woods property (**Figure 6**).

Figure 6. URS mock-up of more correct floodplain on John Woods property (yellow shading) based on Anchor’s Table 1 (X-Section/Width-of Flow): 745/899.62 ft, 662/38.62 ft, 608/89.66 ft, 544/22.21 ft, 490/94.71 ft, 416/11.83 ft, 357/19.66 ft, 290/12.77 ft.

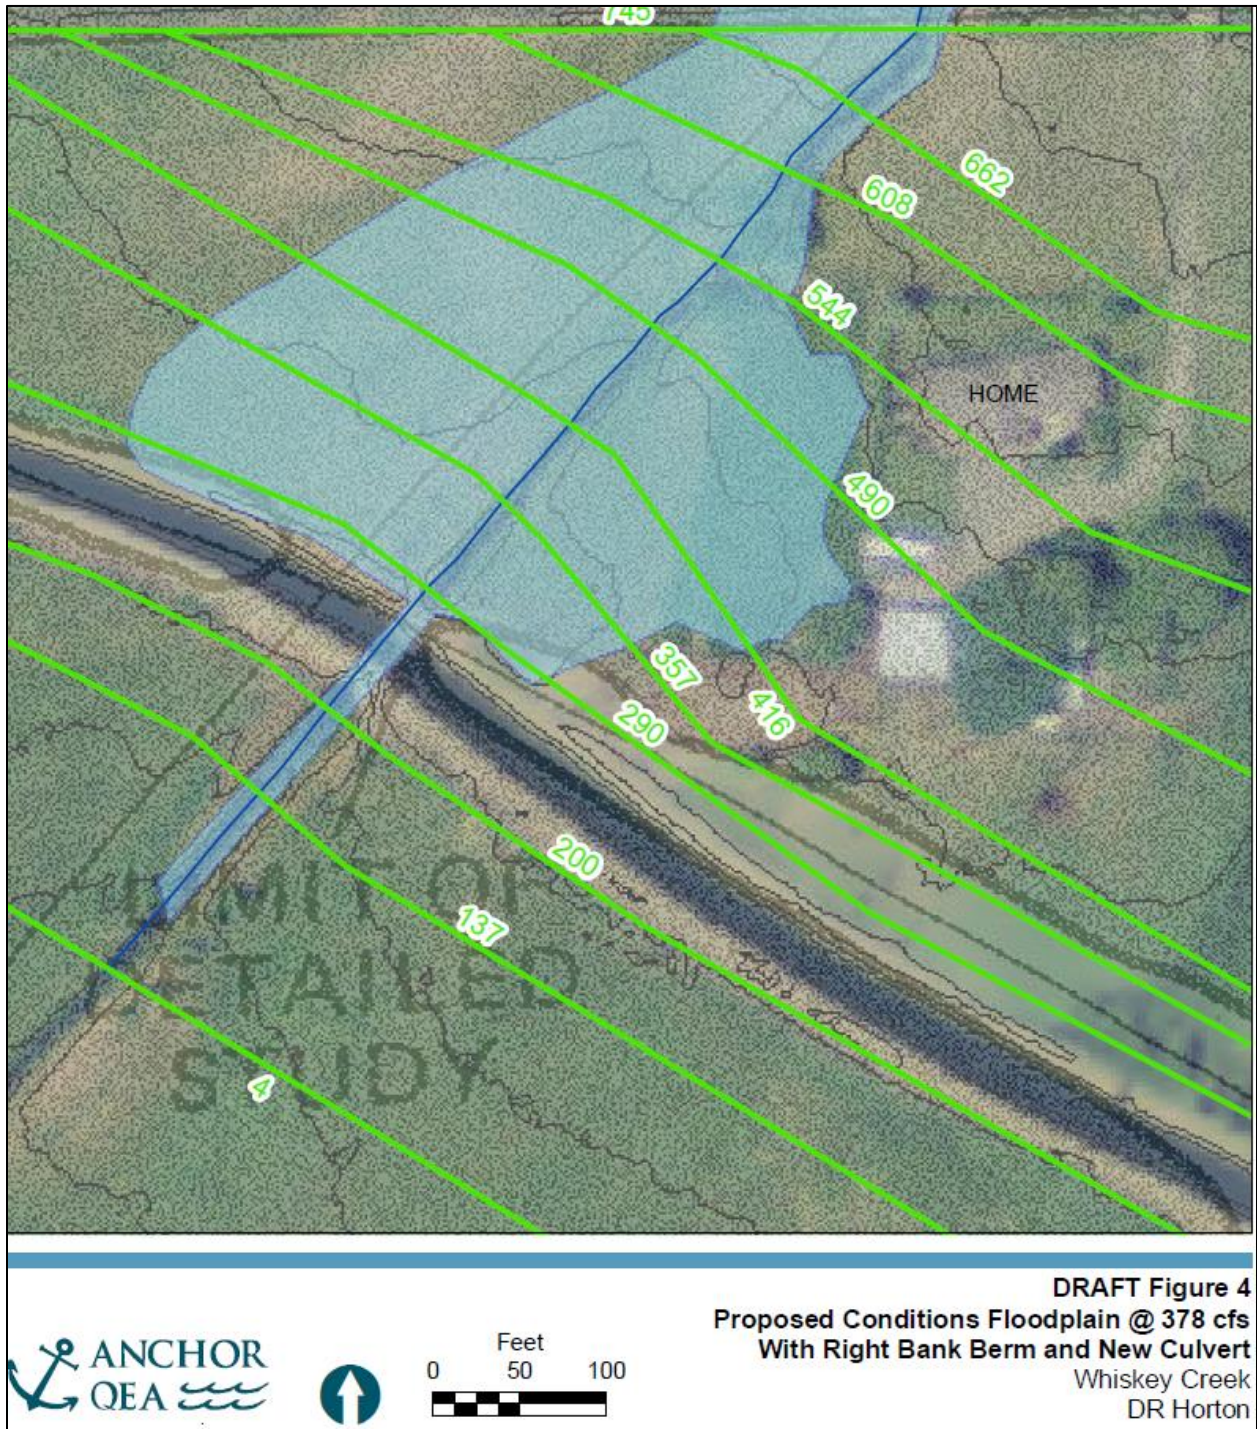
Therefore the reach is estimated to have a 400% increase in flow compared to existing conditions (378 cfs vs. 94.5 cfs). The proposed floodplain on the Woods property is shown in **Figure 7**. In addition to the increase in peak flow rate, there is a corresponding increase in channel velocity, depth, and width-of-flow.

Figure 7. Anchor’s estimated floodplain limits on the Woods property under the proposed conditions (Anchor Sept. 28, 2012 Memo). *The accuracy of the proposed condition mapping should be carefully reviewed for some of the same reasons discussed above.*

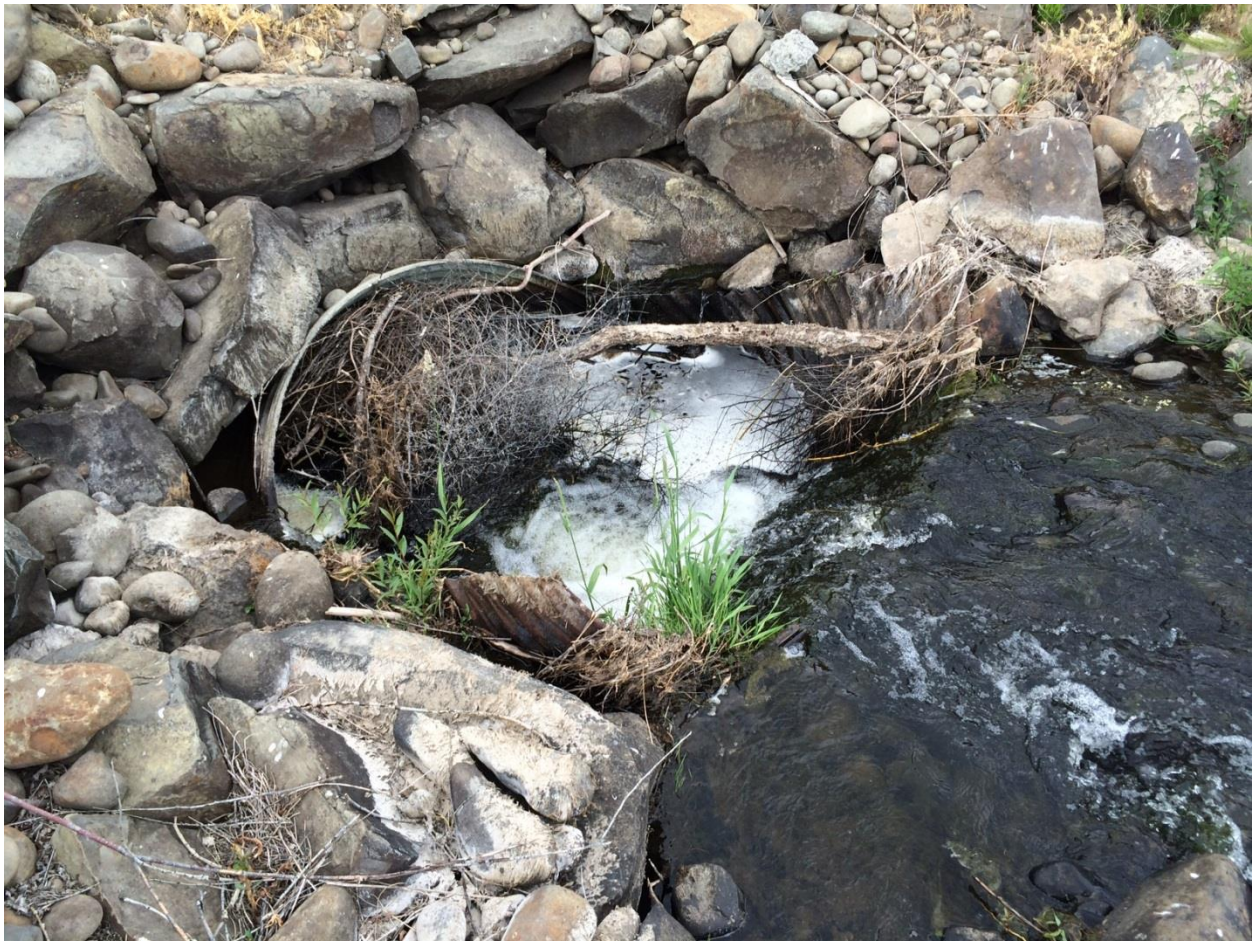
The proposed flooding changes in the vicinity of the Woods home, landscaping, out-buildings, barn, and corral are illustrated in Tables 1 and 2 below. URS notes that impacts of the proposed condition could be increased greatly depending on the ability of the Town Canal undershot to pass the flood discharge. The Ellensburg Water Company estimated the maximum capacity of the undershot at 320 cfs, while the estimated 1996 rain-on-snow flood peak discharge is estimated at 378 cfs – a large discrepancy. Flow not able to pass through the undershot will pool on the Woods property and increase the depth of flooding. The undershot appears susceptible to plugging due to debris accumulation (**Figure 8**).

Figure 8. The entrance to the Town Canal undershot appears susceptible to plugging due to debris or ice however its performance is will be a key factor in controlling the level of flooding on the Woods property. The ability to perform maintenance on the entrance during a large flood is questionable.
