**Ball Property Wetland Reconnaissance, OHWM
Determination and Mitigation Plan
Ronald, Washington**

Submitted to:
The Ball family
18401 Salmon La Sac Road
Ronald, Wa, 98940

COOKE SCIENTIFIC
4231 NE 110th Street
Seattle, WA 98125
(206) 695-2267

BALL PROPERTY OHWM DELINEATION WETLAND RECONNAISSANCE AND MITIGATION PLAN

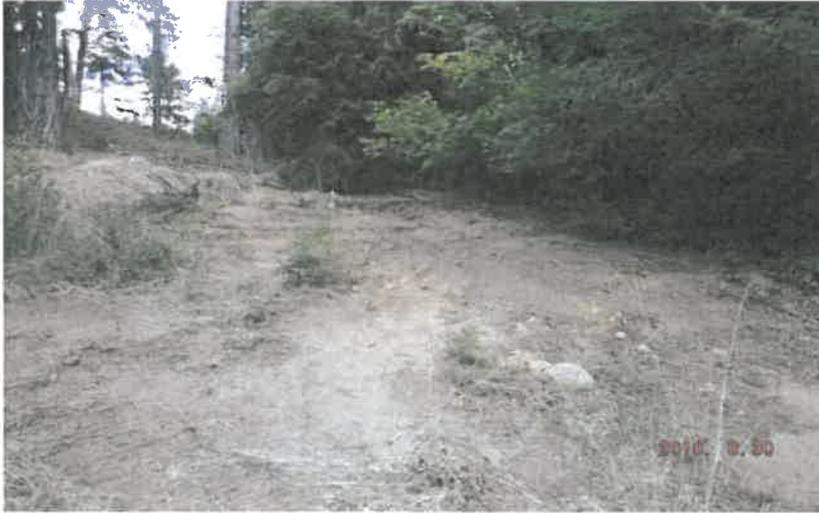
The area where the drainfield was installed had recently been disturbed (Photo sheet 3). An area 12 feet x 32 feet was bare of plants, so this area will be replanted with shallowly rooted shrubs and forbs. No deeply rooted trees or shrubs will be planted there because of the potential to cause problems with the leachfield, but shallowly rooted shrubs should not cause a problem. See the mitigation section below.

Leachfield area

The leachfield is located outside of the buffer zone (Figures 2, 4, 5; and Photo Page 3) but this area will be replanted as compensation for the disturbance that occurred as a result of the recent disturbance in situ and the future construction of the house and driveway. The rest of the site minus where the house is to be built and the existing driveway is fully vegetated and so there is really nowhere else to plant. The following will be planted: (in the rectangle identified on Figure 5b)

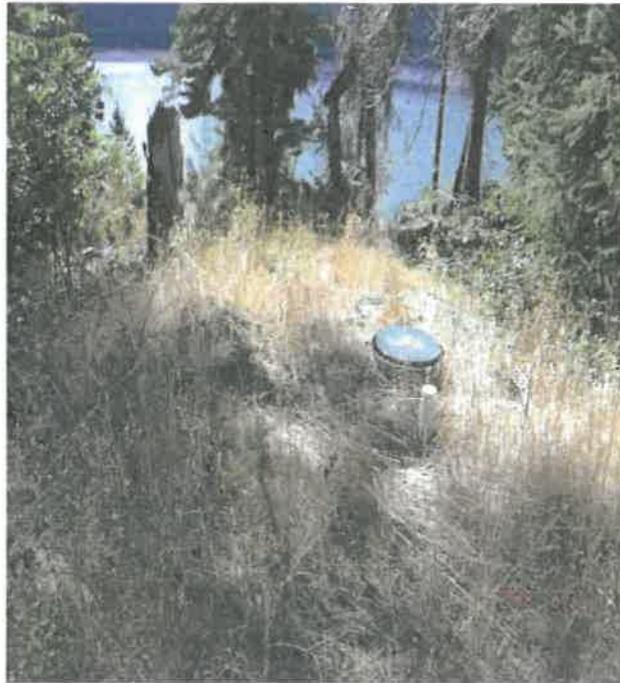
The septic tanks can be seen as three circular lids on the slope that grades down to the beach area. Their location can be seen on Figures 2, 3, 4, and 5, and Photo Sheet 3. All the area around the tanks consisted of installing tanks below the ground. It has been ten years since the installation and the area has since completely restored itself (except for the actual lids) to the same vegetation that is found elsewhere on the slope that grades down to the lake edge.

Septic tank area

In exchange for the "impact" to the septic pit area 100-foot Shoreline buffer, an equivalent area (28' x 28' = 784 FT²) will be set aside north of the house (as shown on Figures 5a and 5ba and 5b) that will not be developed, nor cleared and left in a "natural" state with native trees and shrubs and forbs). This will be set aside as a permanent "no touch" buffer and will be recorded on the plat map on file with the County. Photo page 2, (lower photo) shows this area. The existing natural vegetation will be left untouched and no future activity will be planned that will affect this area. As shown on the photo, the septic area is after 10 years, fully vegetated and so needs no additional plantings in-situ.

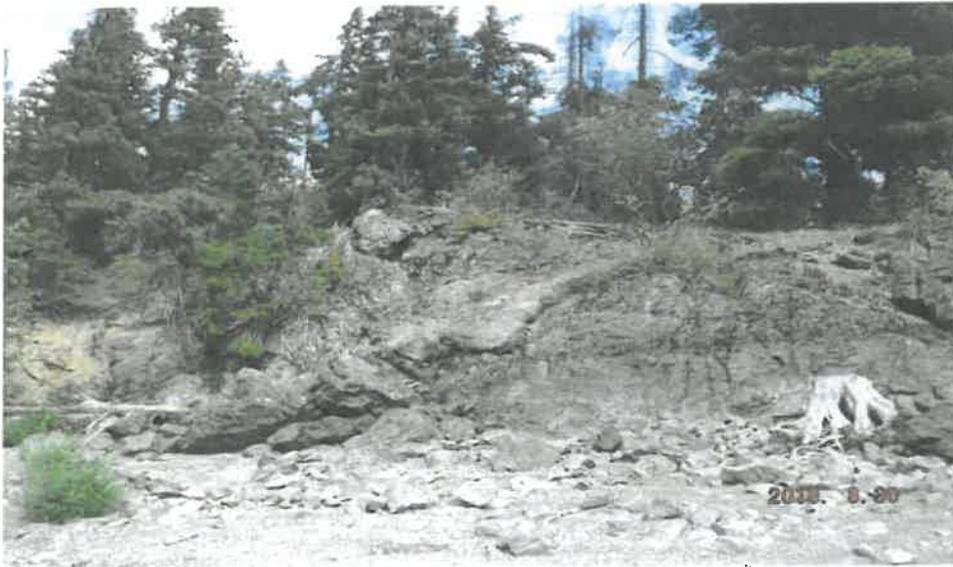
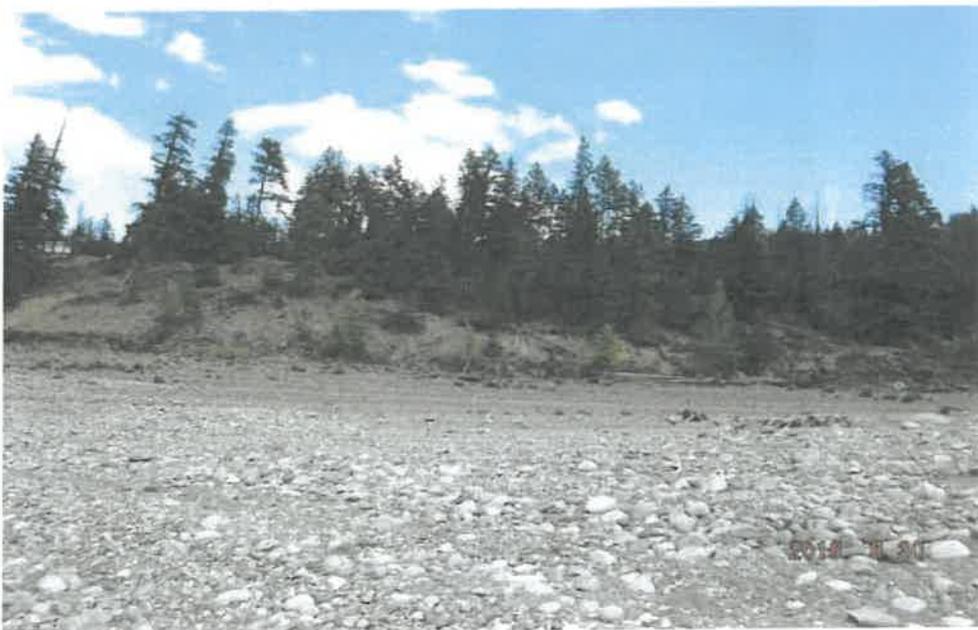
**Photo Page 4. Ball Property,
Anna Bell Plat, Kittitas
County, Wa**

The area above the eroded line on the on the beach (Photo Page 5, is above the area that commonly floods or there would be an erosive feature, vegetation, algal lines on the bedrock (Photo Page 4) at the toe of the slope. No such erosive feature exists there and the other indicators of vegetation, and soils, and indicators of hydrology are also missing. Although the aerial photograph seen in the photo section of this report (7/10/2012 and the aerial on the GPS mapping) show the water at a much higher elevation (right at the toe of the slope), there are two marks upon the beach visible in the other aerials and found during this summer's site investigation in August indicating that the water is more commonly lower down on the beach. The beach below the toe of slope is almost devoid of vegetation except for a few tufts of shore sedge (*Carex lenticularis* var. *lenticularis*) and *Scouler willow* (*Salix scouleriana*). In using the OHWM methodology, it was not clear that the OHWM is where it is shown on the 2012 aerial because of the lack of vegetation and eroded features see on Figure 4 and on the aerials from 7/15/2014 and 7/13/2017, where you can see the erosive lip shown on Photo Page 5.

Base of slope top of beach

Beach lacking veg

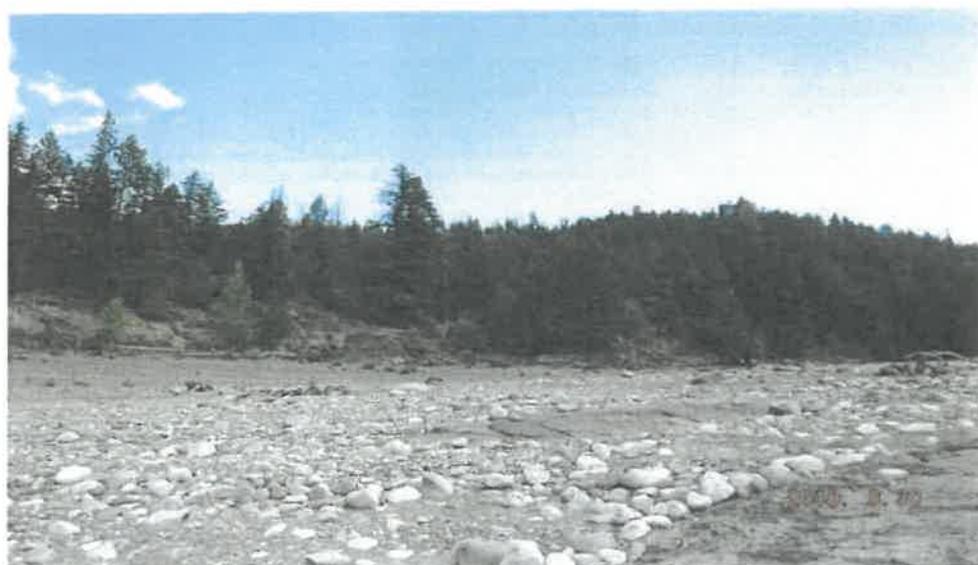
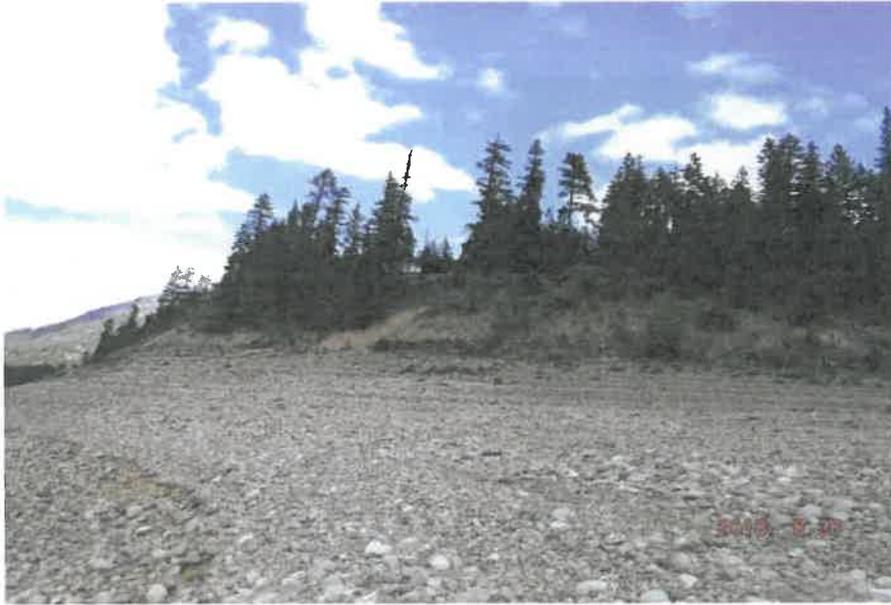
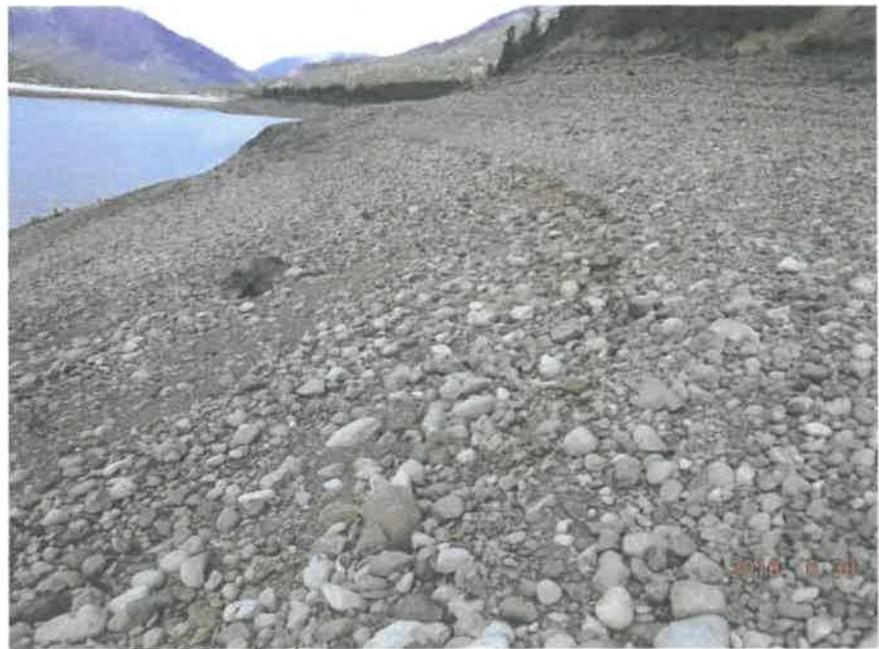
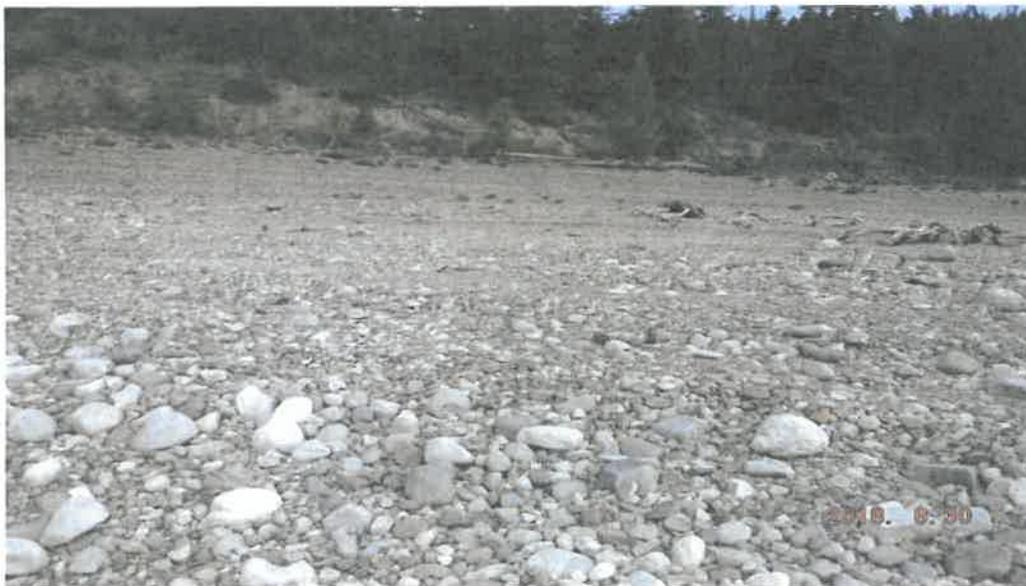
Photo Page 5. Ball Prope Plat, Kittitas County, Wa

Beach looking back at
Ball property

Eroded Ledge

Eroded Ledge in front of property

very little veg on beach

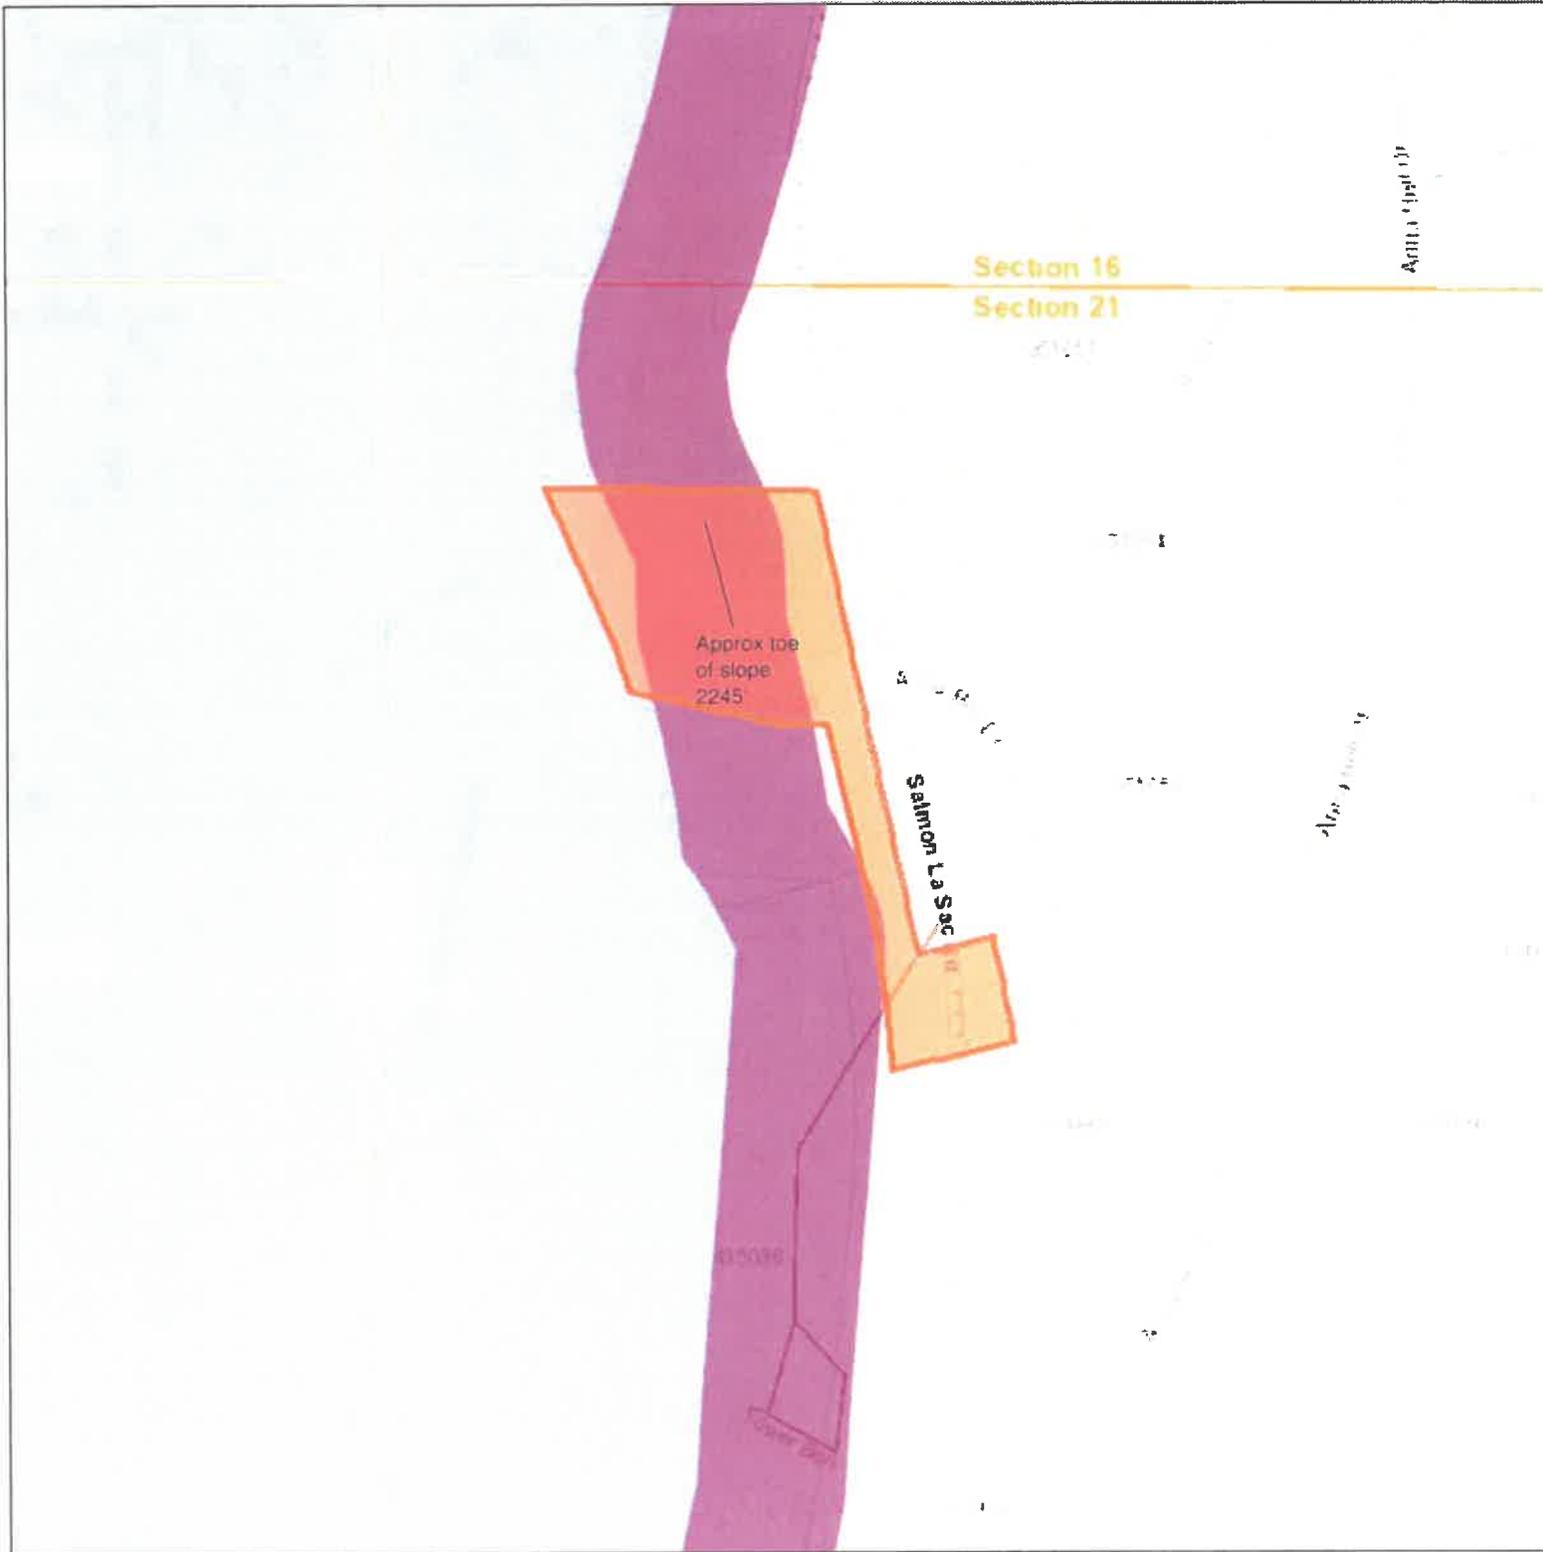
Figure 7. Ball Property, Inaccurate Shoreline Map

The Ordinary High-Water Mark (OHWM) was evaluated using the methodology outlined by the Department of Ecology in their "*Determining the Ordinary High Water Mark for Shoreline Management Act Compliance in Washington State*, 2016 Publication # 16-06-029. As required, the "mark upon the landscape" down below the property at the toe of the slope (see topography Figures 3, 5, 6, and 7) would be identified at the eroded edge on the beach seen on Photo Page 4 and on Figure 4 the GPS map I produced during the field work. The aerial photograph Google selected as the base map for mapping the GPS data (Figure 4) was showing the lake during an obviously much higher water level than where the water level was on the day that I visited the site (Photo Pages 4 and 5). As stated above in the Wetlands section, there was almost no vegetation (less than 5 percent aerial cover overall), the soils are sandy with cobbles and the only obvious indicator was the eroded edge. The County has mapped the OHWM on top of the slope (Shown in Figures 6 and 7), and clearly that is not correct.

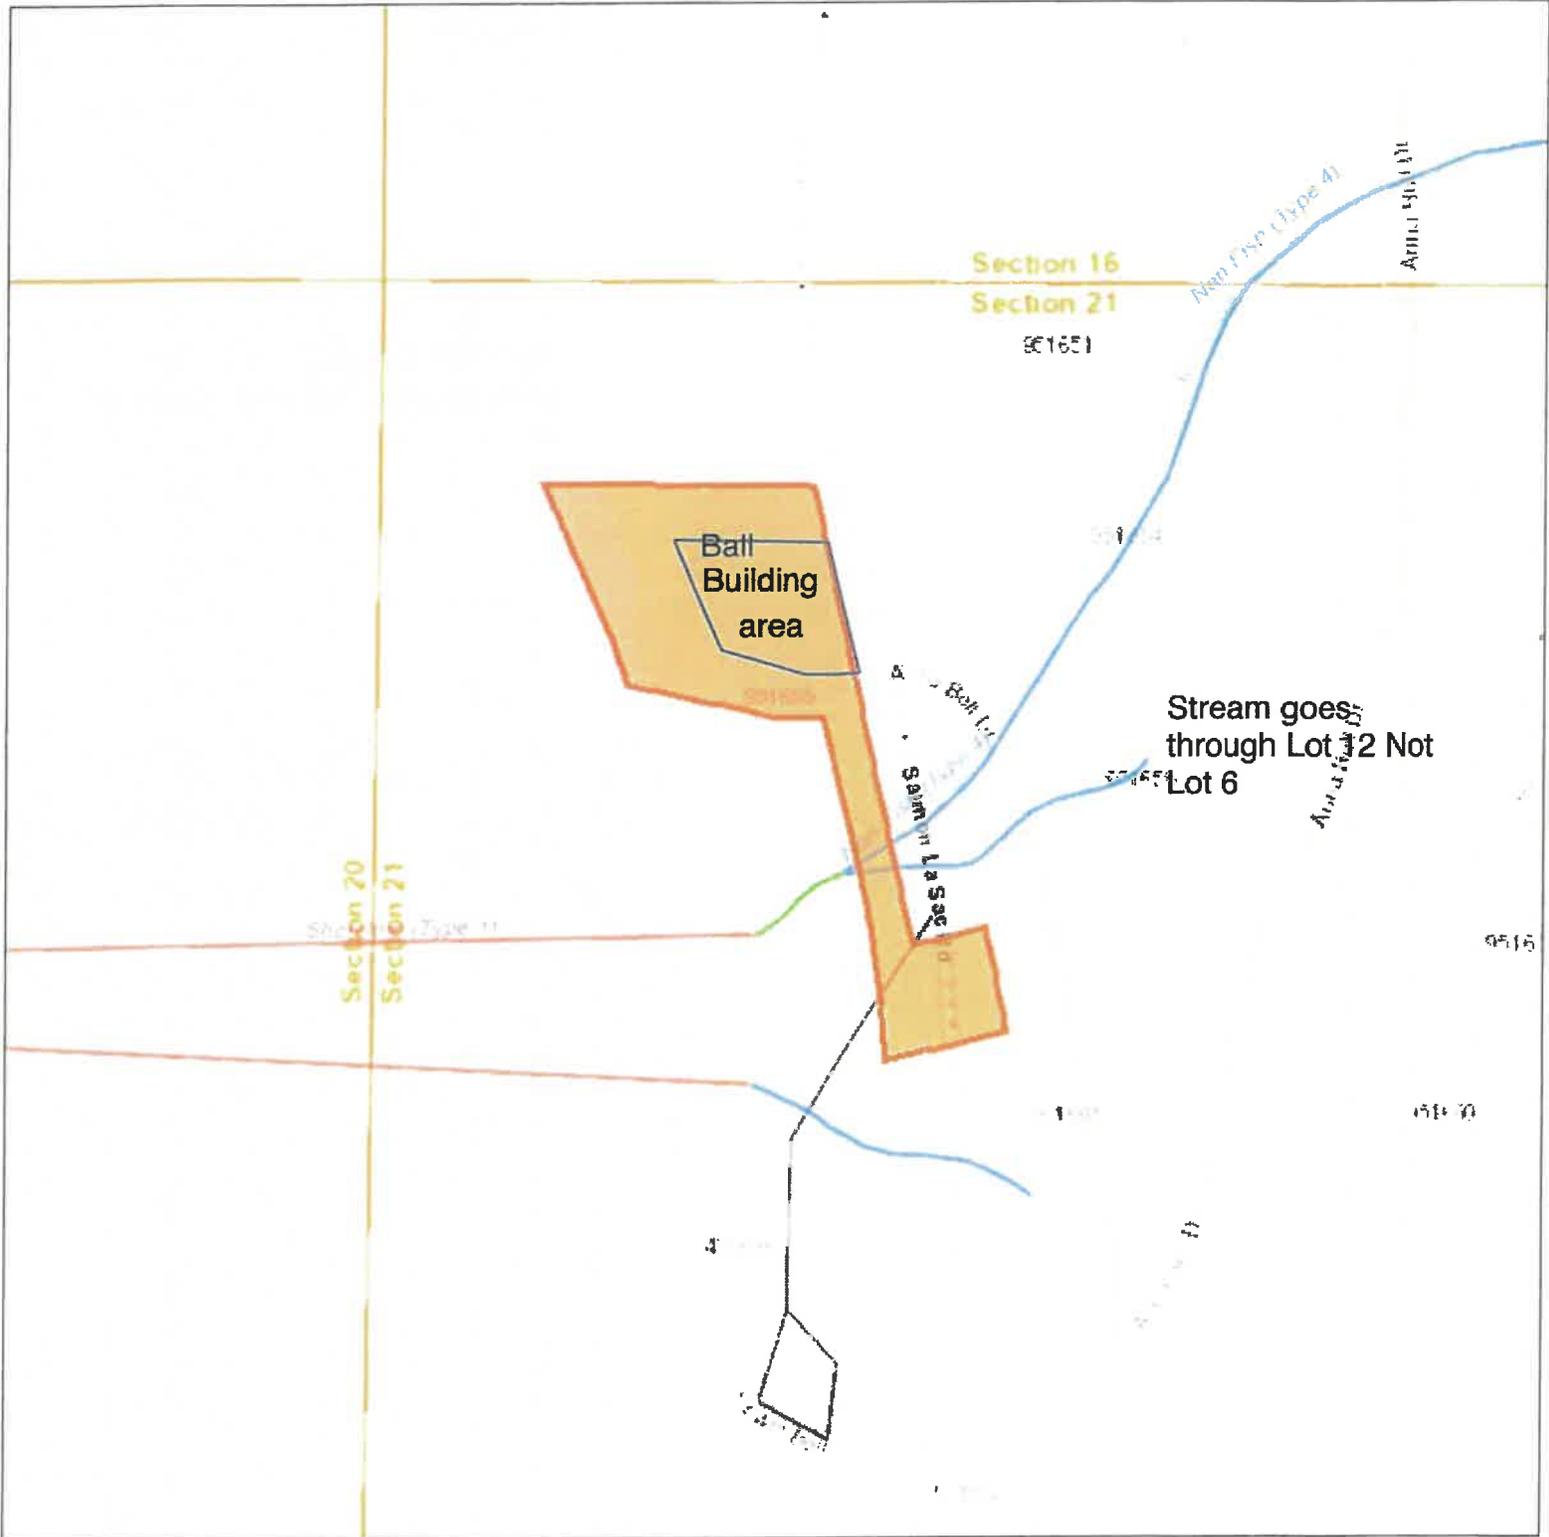
Figure 8. Ball Property, Stream Map

While the County's Critical areas mapping for streams shows Bell Creek on the property (Figure 8), it is actually east of Salmon La Sac Road and passes under the road – through the easement owned by the Ball family and there is no stream on the property that is to be developed west of Salmon La Sac Road. The stream (Bell Creek) comes from east of the road and it enters a culvert and passes under the road, well south of the Ball property where the house and other areas to be developed exist. This stream did not appear to affect the development of the lot (13) where it actually exists so there should be no issue of its presence on the lot the Ball family now want to develop.

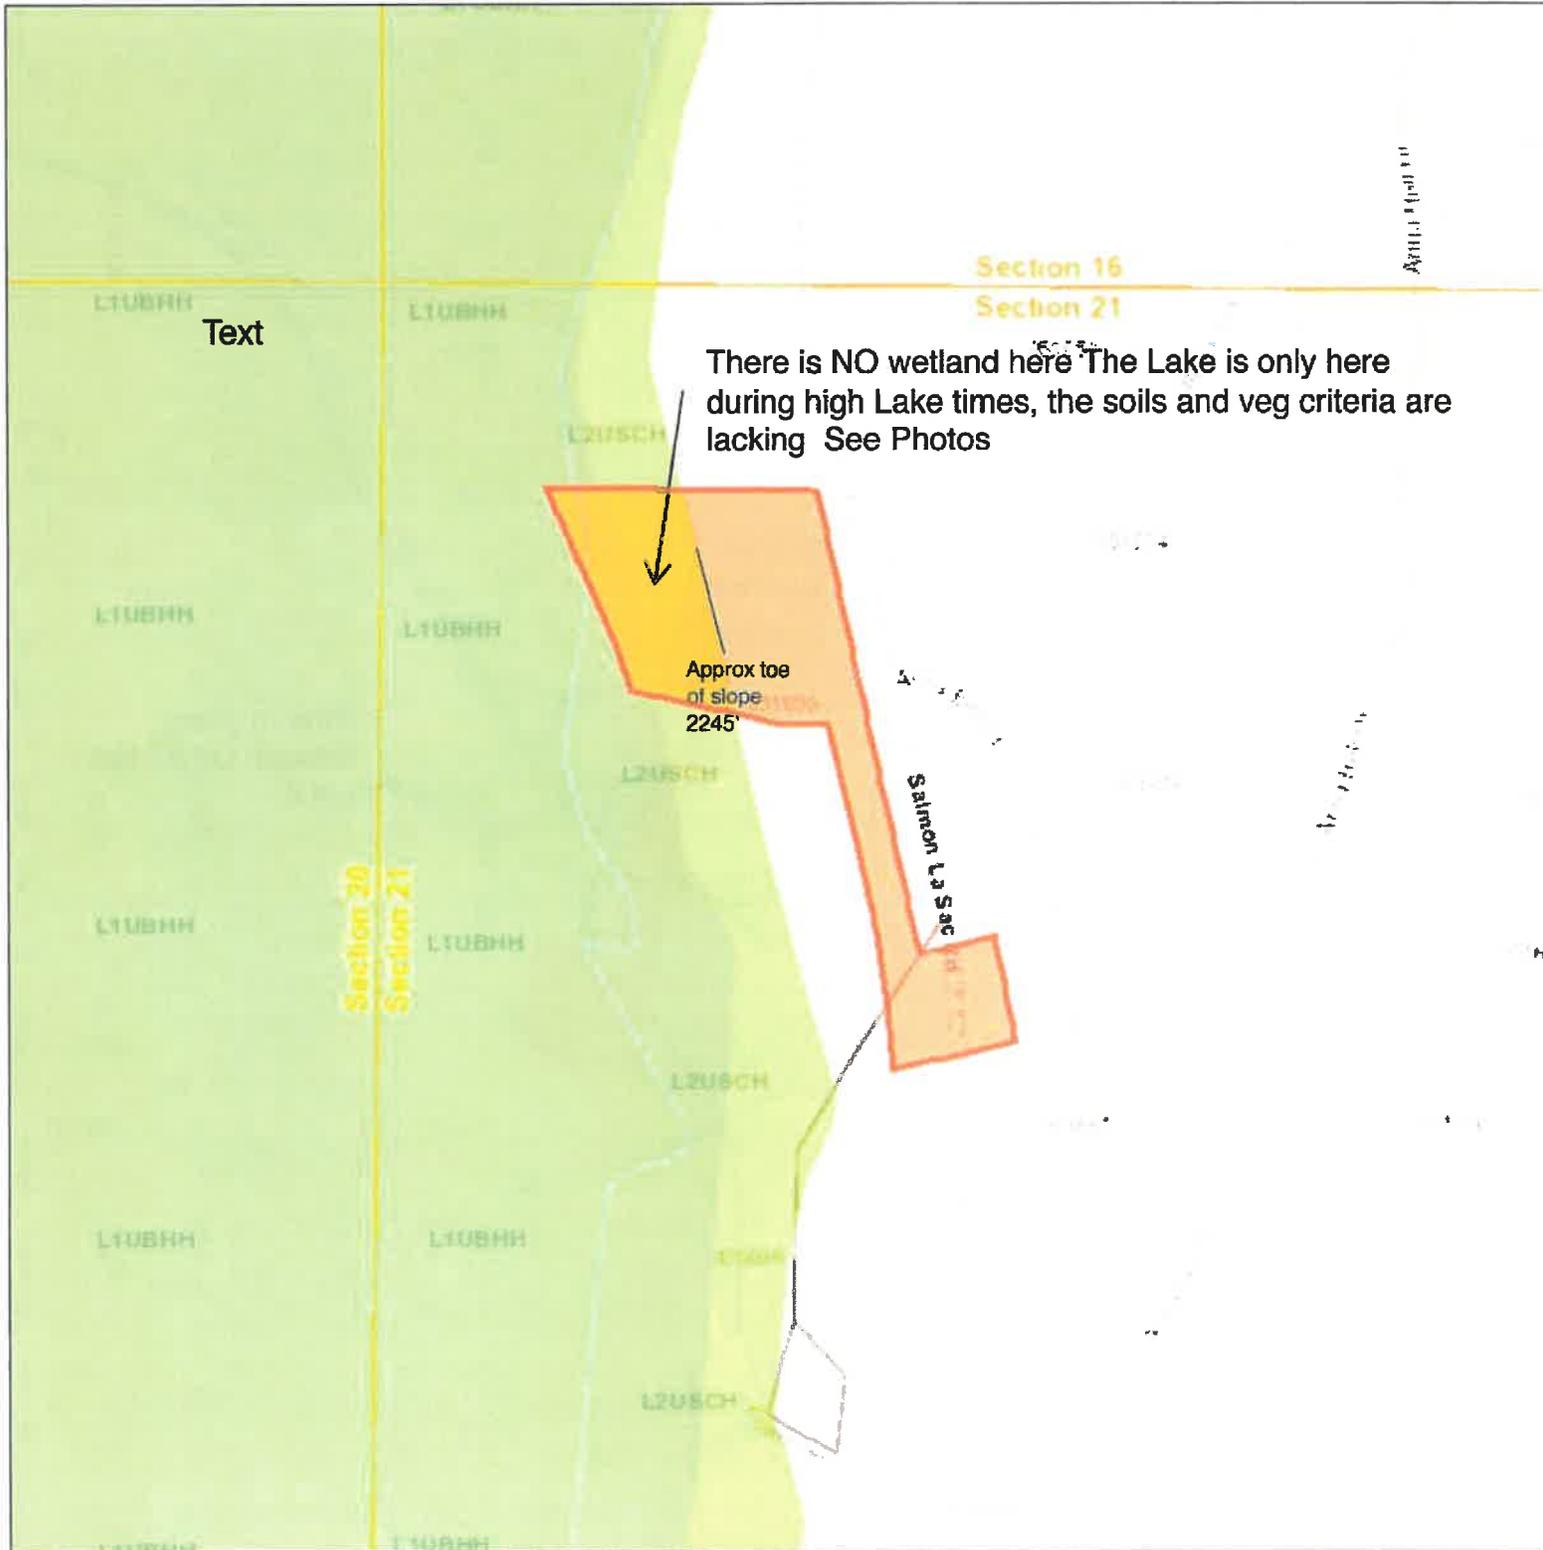
Figure 9. Ball Property, Inaccurate Wetland Map

Wetland: The County shows a wetland on the property (Figure 9). They also mention a wetland on page 3 of the PSA #18-00194. ***There is no wetland area anywhere on the property.*** I investigated the entire property off the Salmon La Sac Road and down below the cliff on the beach associated with Lake Cle Elum. There were no jurisdictional wetlands anywhere on the property. This is based on 35 years of wetland delineation expertise and using the criteria required under Section 17B.05.020F of the Kittitas County code and outlined in the US Army Corps of Engineers protocol "*The Regional Supplement to the Corps of Engineers Wetland Delineation Manual for Western Mountains, Valleys, and Coast Region* (May 2010) nor "*The Regional Supplement to the Corps of Engineers Wetland Delineation Manual for the Arid West* (Version 11-1-2006)". I examined for soils, hydrology, and vegetation indicators and they just did not exist, especially in the areas shown on the County's map on Figure 9. I have included photos of the property attached on Photo Sheets 1-4. The beach area identified on the County's wetland map are shown in their actual ground conditions on Photo Sheets 2, 3, and 4. As can be seen, the area identified as wetland is beach cobble with less than five percent vegetation. I found a few scattered clumps of shore sedge (*Carex lenticularis*, FACW) and a few clumps of newly germinated Scouler willow, (*Salix scouleriana*, FAC) and one very small lady's thumb (*Persicaria maculosa*, FACW). The soils were a coarse sand and cobbles.

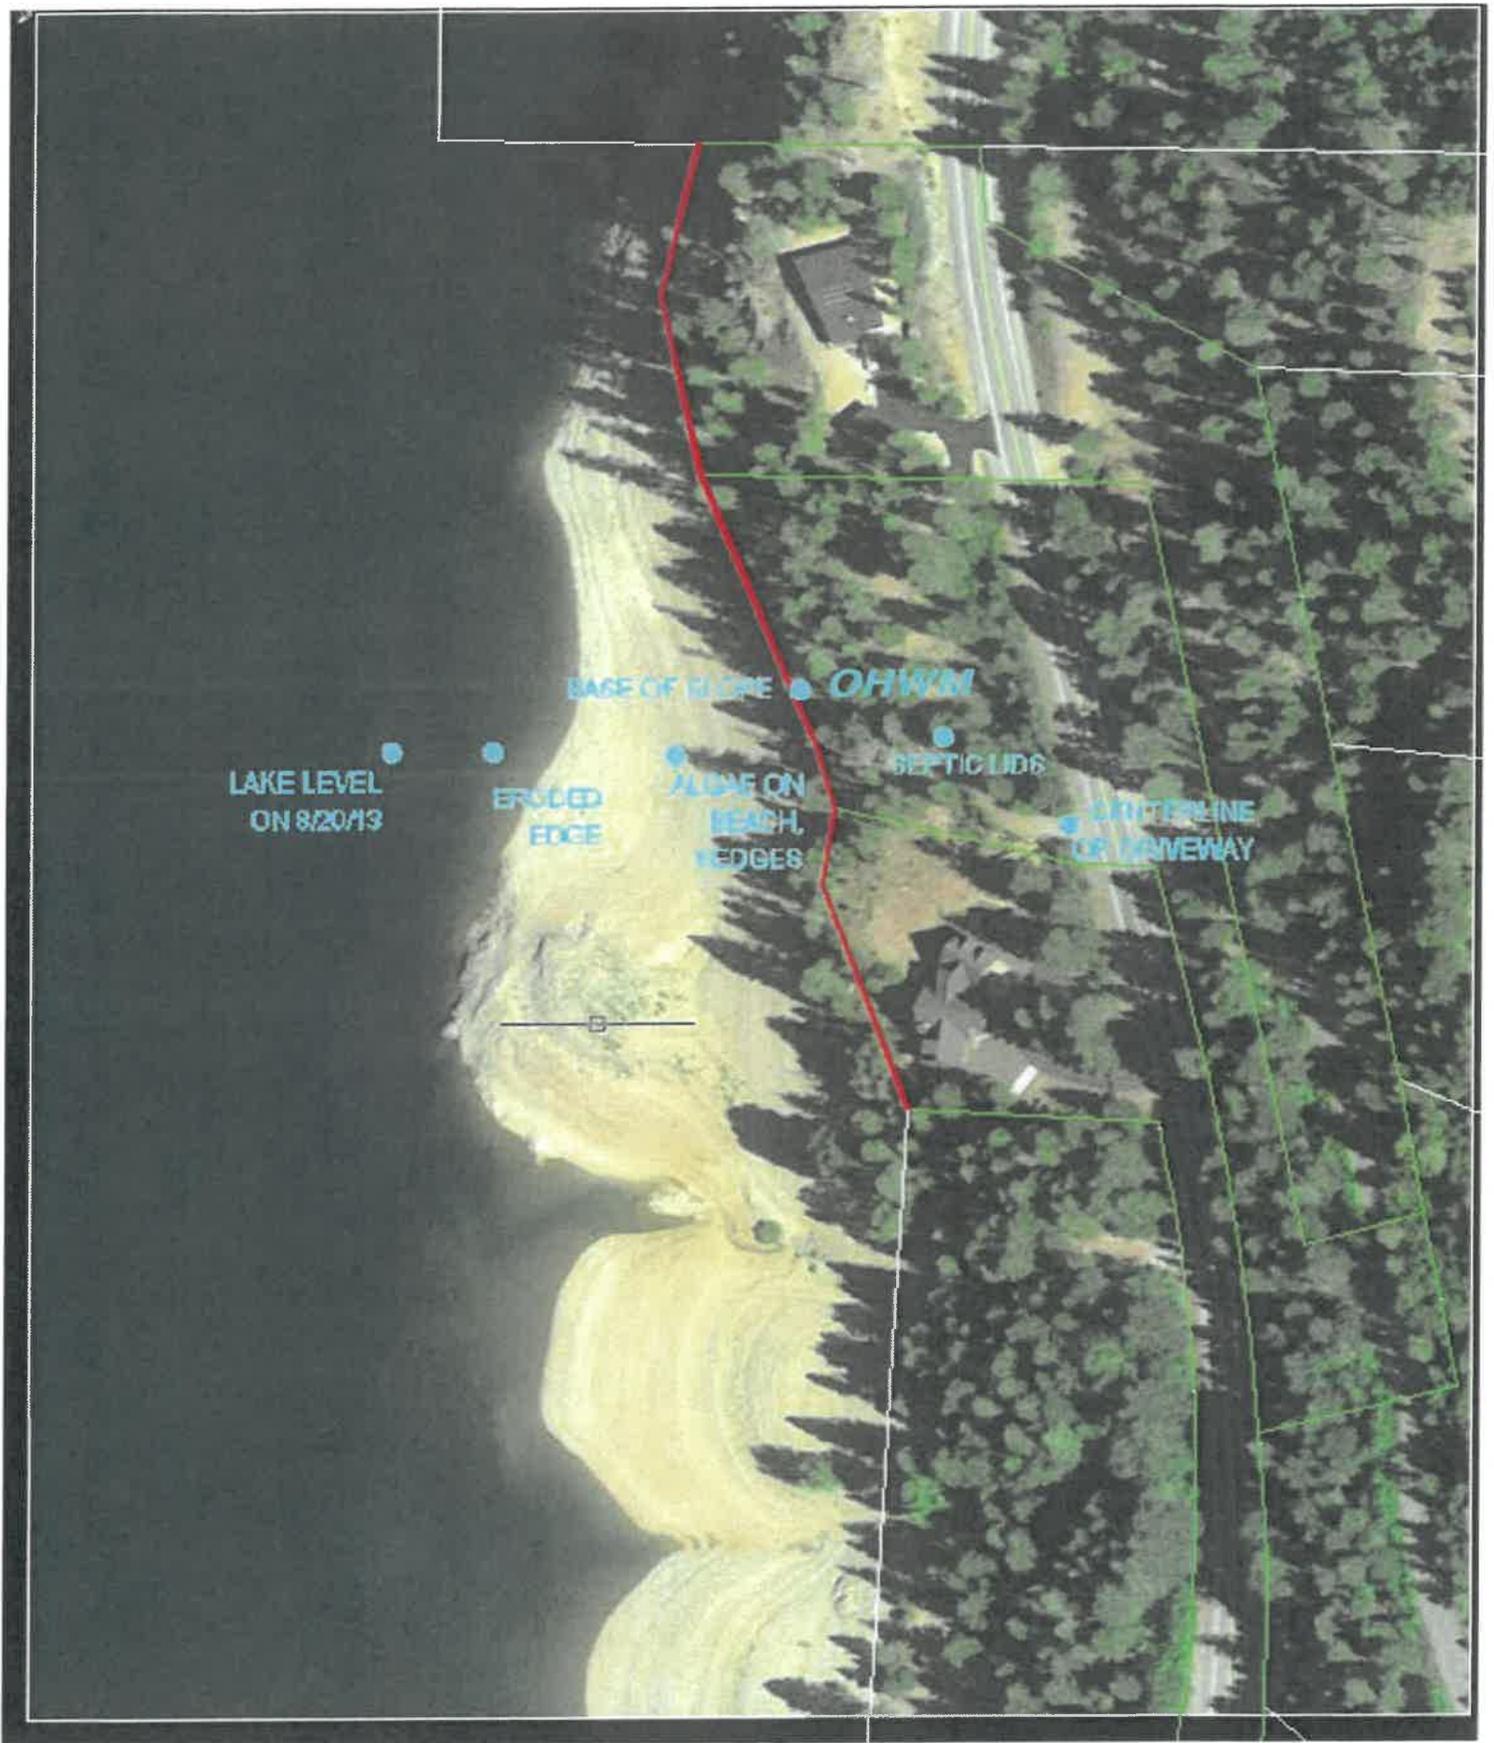
Figure 10. Ball Property, Final OHWM Location on Aerial as seen on Figure 5.

The Washington State Department of Ecology has determined the OHWM is at the toe of slope. They state that this is because the Lake levels are for a short time every year at that elevation. As stated in the manual, "Common misunderstandings in determining lake OHWMs include: (1) assuming that the OHWM is limited to the area of open water and not following the continuous and contiguous water surface elevation to its landward limit within fringing wetlands and, (2) in lakes with a significant groundwater input, not accounting for a seasonal lag time in the highest water levels; high water does not necessarily occur at the wettest time of year. In those rare circumstances on lakes (and streams) where the OHWM cannot be determined from field indicators, the SMA directs that the OHWM shall be the line of mean high water (RCW 90.58.030(2)(c))." The area lacks vegetation and soils to fulfill the criteria as outlined in the State's OHWM manual, **but I defer to the DOE and we have placed the line where they have indicated** per RCW 90.58.030(2)(c).
