KITTITAS COUNTY DEPARTMENT OF PUBLIC WORKS

TO: Neil Caulkins, DPA
FROM: Douglas D'Hondt, County Engineer, Public Works
DATE: February 17, 2011
SUBJECT: Hancock Flood Claim

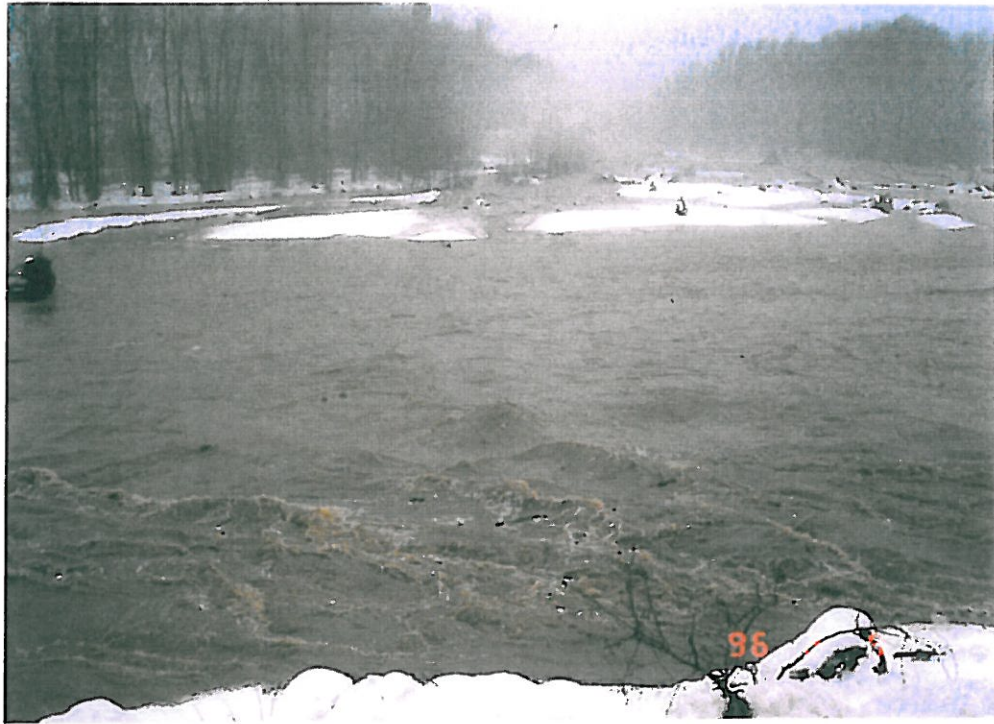
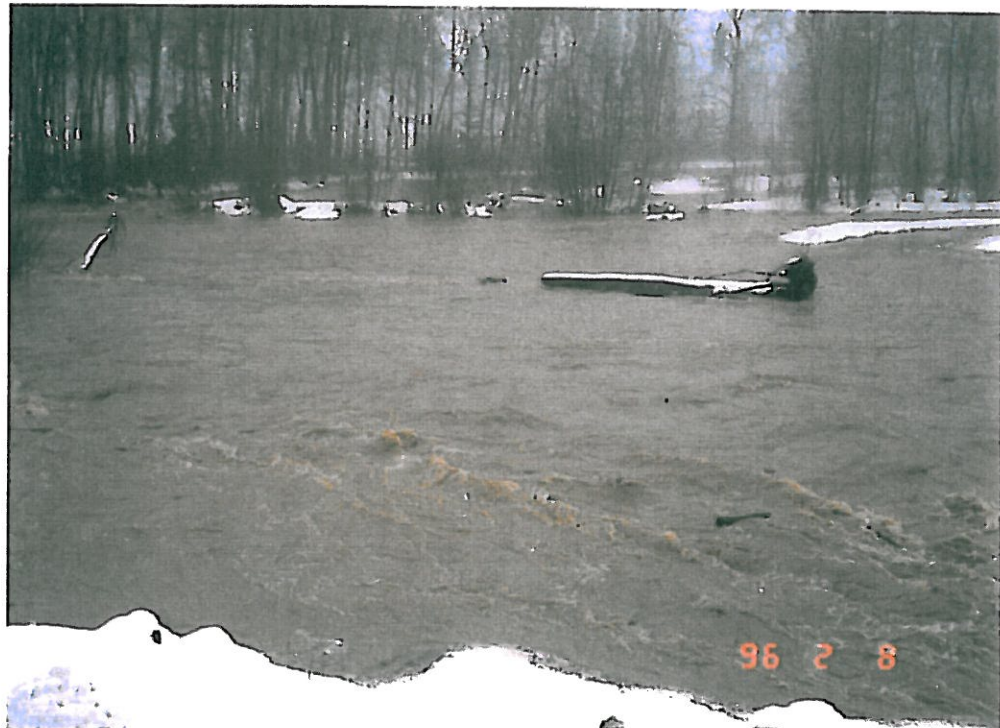
Looking @ Levee To West

Kittitas County does not retain ownership of the levees and never have. Kittitas County worked with the US Army Corps of Engineers after the January 2009 flood event to reconstruct the one levee for protection of Quail Valley and Lambert Roads.
