RE: Critical Areas Report & Reasonable Use Justification
Parcel #767835
Kittitas County, Washington
SWC Job #22-192

This report describes our observations and delineation of any jurisdictional wetlands or streams on Parcel #448135, located 601 Yellowstone Road in the Snoqualmie Pass area of unincorporated Kittitas County, Washington (the "site").

PROJECT: HARMON ADDITION
OWNER: DONALD & TIFFANY HARMON
PROJECT ADDRESS: 601 YELLOWSTONE RD
PARCEL: 767835, 22-11-090011-0007
ACRES: 0.43
ZONE: PUD LAMRID TYPE 1 RESIDENTIAL
GROUND
SNOW LOAD Pg: 252
SEISMIC ZONE: D1
WUI ZONE: IR 1
SETBACKS:
FRONT: 15'
SIDE: 5'
REAR: 15'

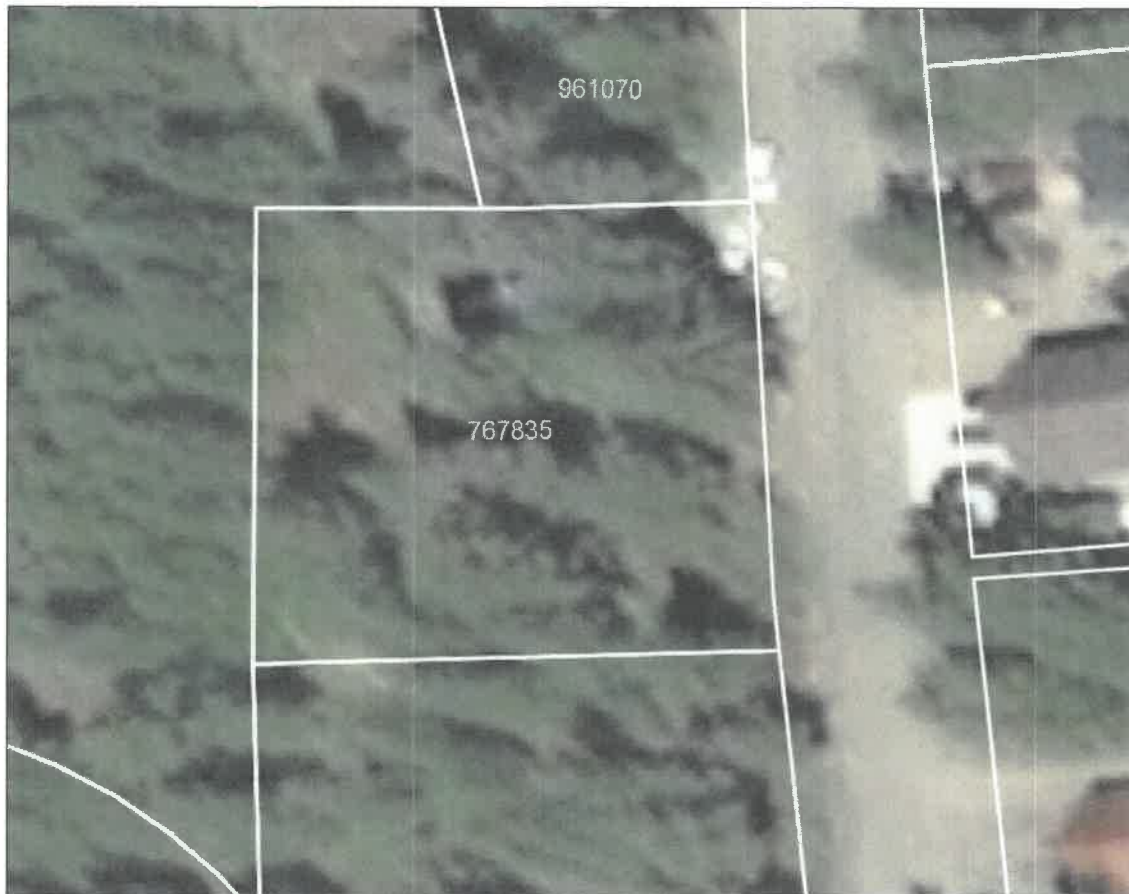
The site consists of a 0.43 acre rectangular shaped parcel located within NE ¼ of Section 9, Township 22 North, Range 11 East of the W.M.

Above: Kittitas County TaxSifter aerial image of the site.

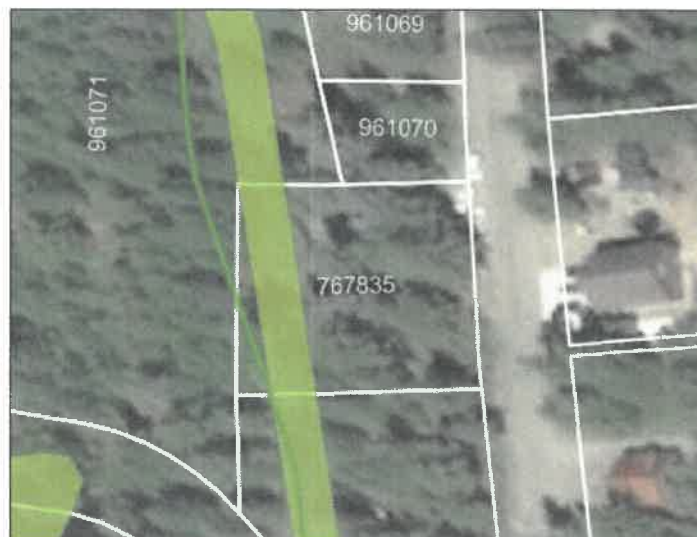
The Kittitas Taxsifter website with streams and wetland layers activated depicts a linear emergent wetland as well as a Type F stream on the west side of the site. This layer is taken from the NWI map which has had no ground verification.

Above: Kittitas County Taxsifter with wetland and stream layers activated.

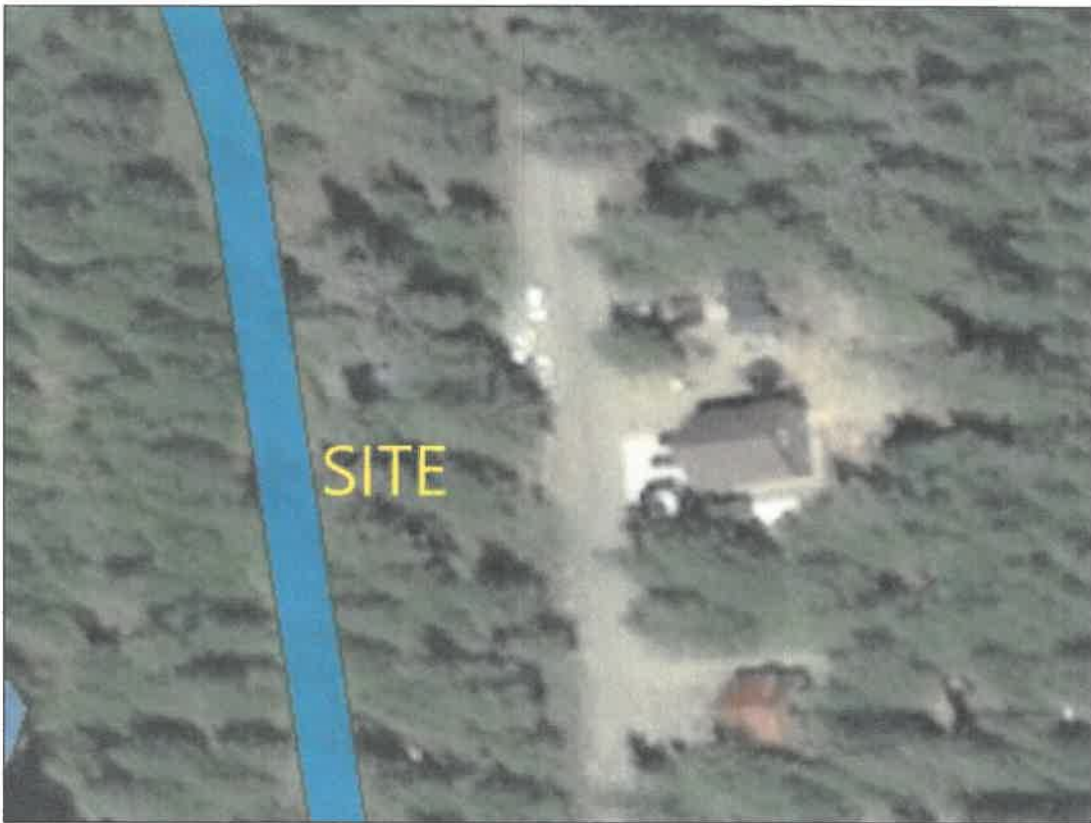
The NWI map depicts a stream on the west side of the site. These areas were interpreted from aerial photographs by the US Fish and Wildlife Service using 2017 aerial photographs with no ground-truthing.

Above: NWI map of the area of the site

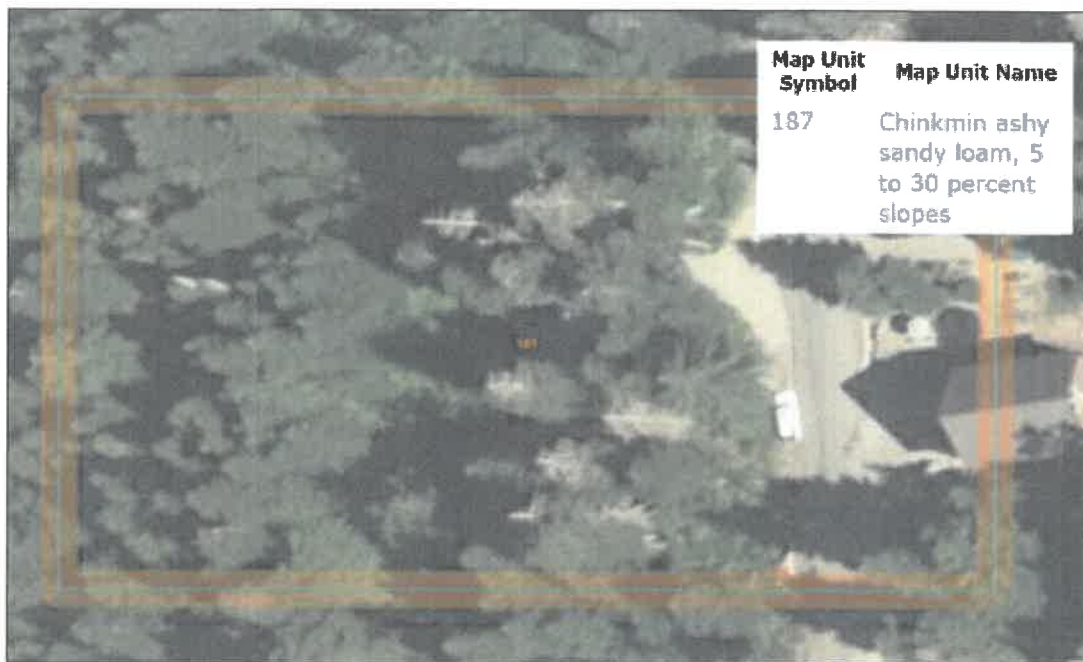
According to the NRCS Soil Mapper website, the site is mapped as containing moderately well drained Chinkman ashy sandy loam. Chinkman soils are formed in colluvium from glacial till, volcanic ash, and pumice overlying dense glacial till. Chinkman soils are not considered "hydric" or wetland soils according to the publication Hydric Soils of the United States (USDA NTCHS Pub No.1491, 1991).

Above: NRCS soil map of the site.

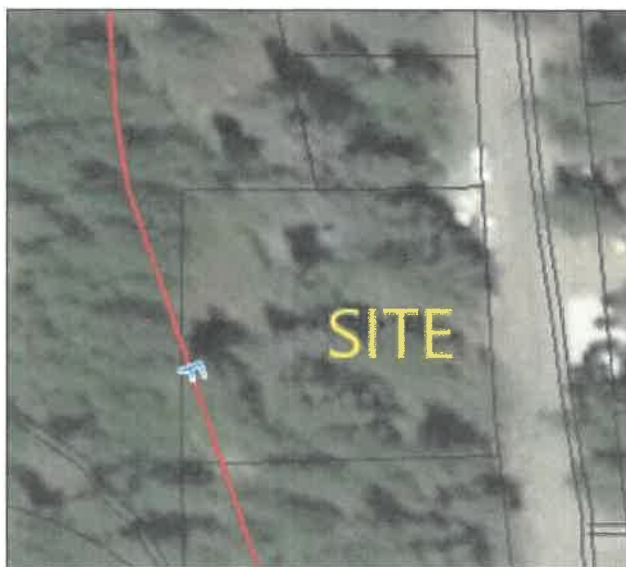
According to the WADNR FPARS website with stream types layers activated there is a Type F (fish bearing) stream mapped on the west side of the site.

Above: WDNR Fpars Stream Mapping of the area of the site.

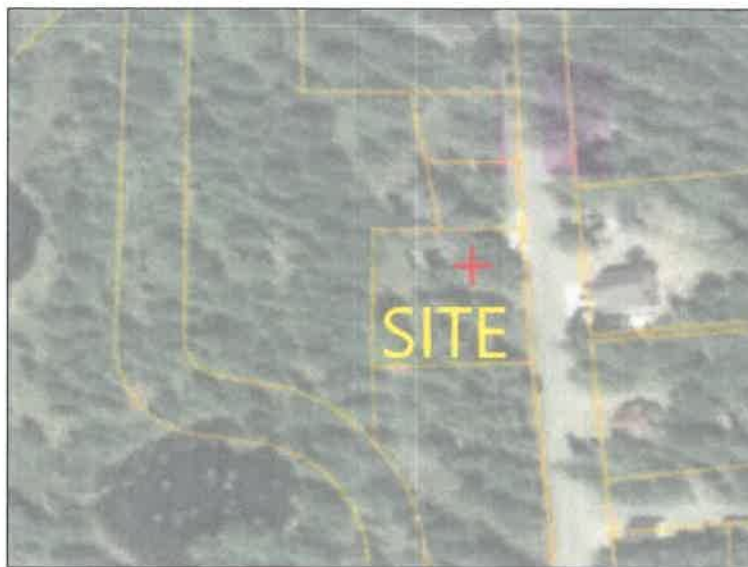
According to the WDFW Priority Habitat Website with Public access layers activated, the site is located within the Township in which the northern spotted owl and grey wolf, both federally listed, are known to exist.

Above: WDFW Priority Habitats Map of the site.
