**GG Environmental, LLC**

December 6, 2022

**RE: Critical areas evaluation for an existing propane tank installation.**

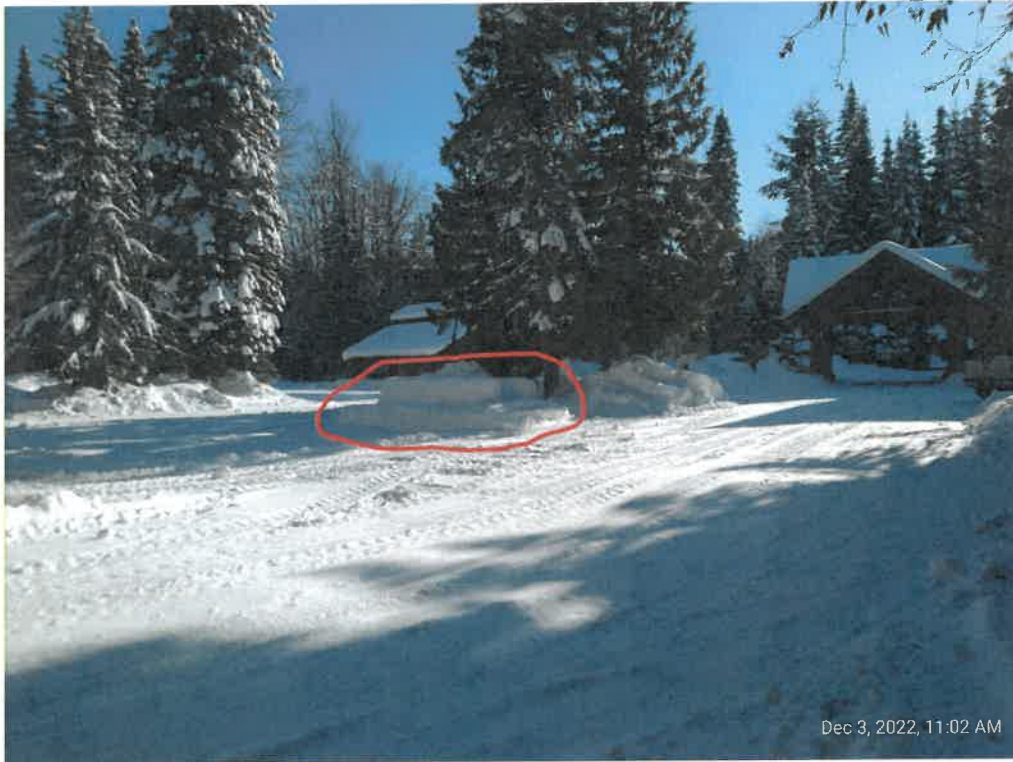
**Figure 2. Propane tanks in the middle of the parking lot.**

A field visit was conducted on December 3, 2022 by GG Environmental, LLC (Geoffrey Gray, MA, PWS). It had recently snowed approximately 24 inches prior to the site visit, and the soils surface/herbaceous vegetation was obscured (**Figure 2**). Features documented in the field were geospatially surveyed with a Motorola G Stylus mobile phone, running the Mapit Spatial GIS application paired via Bluetooth® with a Juniper Systems Geode™ Multi-Global Navigation Satellite System (Multi-GNSS) receiver capable of sub-meter horizontal accuracy.

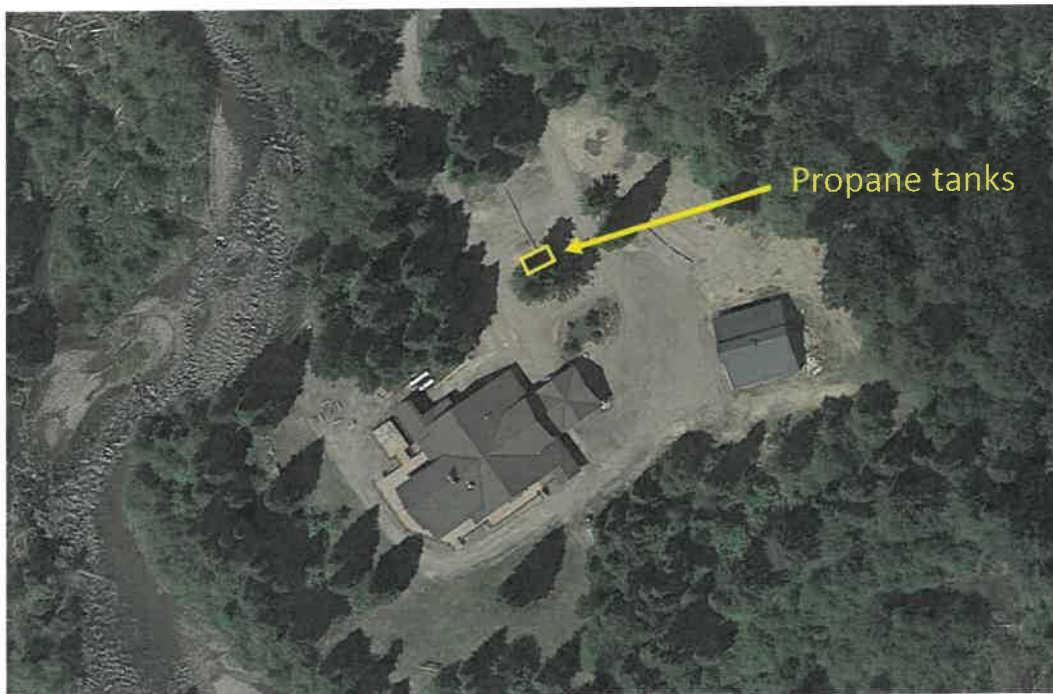
**Figure 3.** Satellite image from 2021<sup>6</sup>

No wetlands or streams are present within the project footprint because the propane tanks were constructed within a legally-established, maintained, and active parking lot. The area is leveled and xeric as evidenced in historic satellite imagery (**Figure 3**).

The parking area surrounding the project footprint serves to interrupt any potential adverse effect of the propane tank installation on any adjacent critical areas, including wetlands, streams or their respective regulatory buffers, consistent with KCC 17B.05.050.B.3. As such, it is determined that the project has not resulted in any measurable adverse effect to critical areas or loss of shoreline functions.
