Sewall Wetland Consulting, Inc.

November 15, 2021

RE: Critical Area Report – Parcel #761133
Kittitas County, Washington
SWC Job #21-175

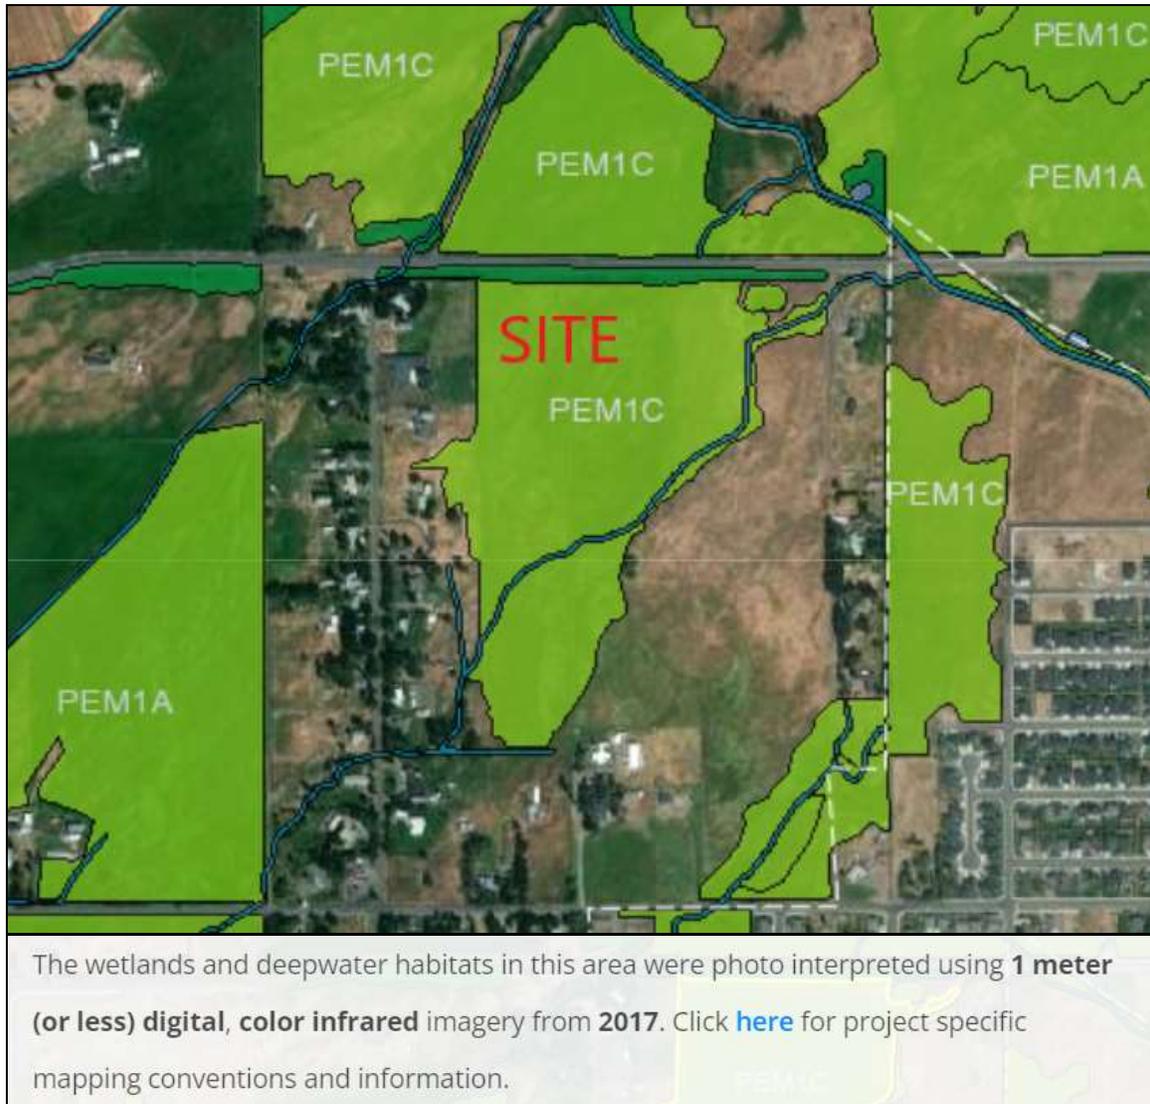
The NWI map depicts a large emergent wetland on the site which matches historic flood irrigation patterns on the site. The main irrigation channel is depicted as a stream crossing south of the site. This inventory

was done from interpretation of a 2017 aerial photographs with no field verification of the mapping.

Above: NWI map of the area of the site

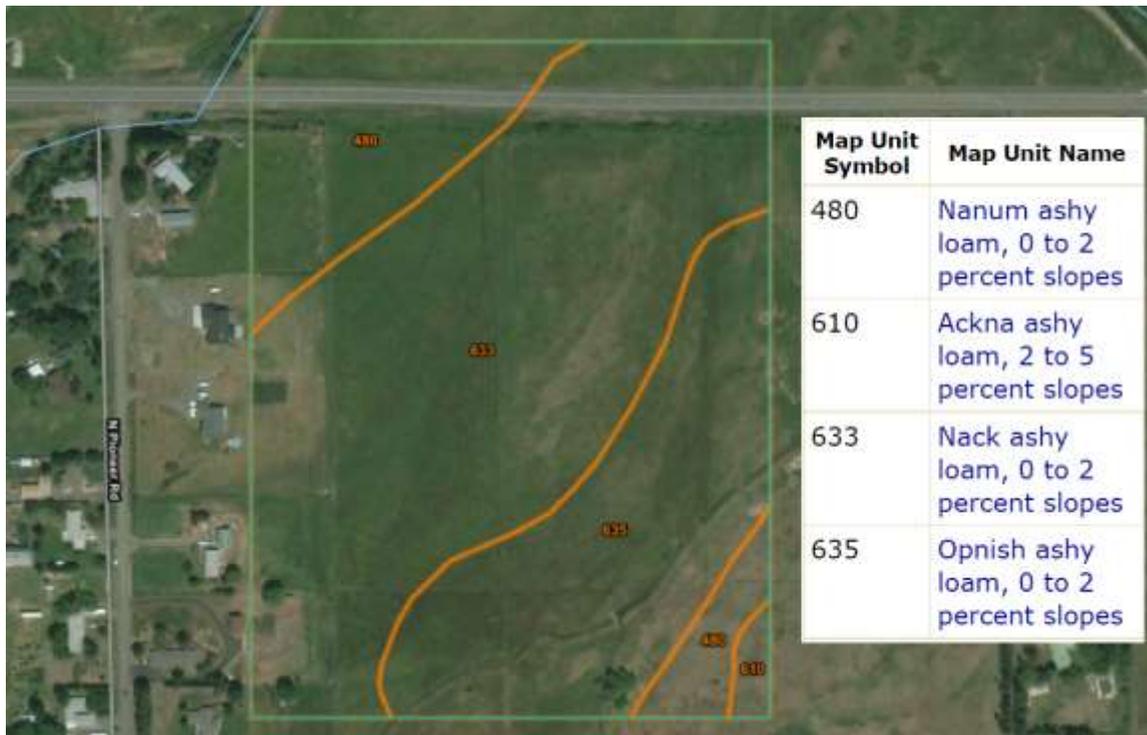
According to the NRCS Soil Mapper website, the site is mapped as containing 5 soil types; Nanum Ashy loam (Map unit 480), Ackna ashly loam (Map Unit 610), Mitta ashly silt loam (Map Unit #621), Nack ashly

loam (Map unit #633) and Opnish ashy loam (Map unit #635). These soils range from somewhat poorly drained to well drained.

None of these soil series are considered "hydric" or wetland soils according to the publication Hydric Soils of the United States (USDA NTCHS Pub No.1491, 1991).

Above: NRCS soil map of the site.

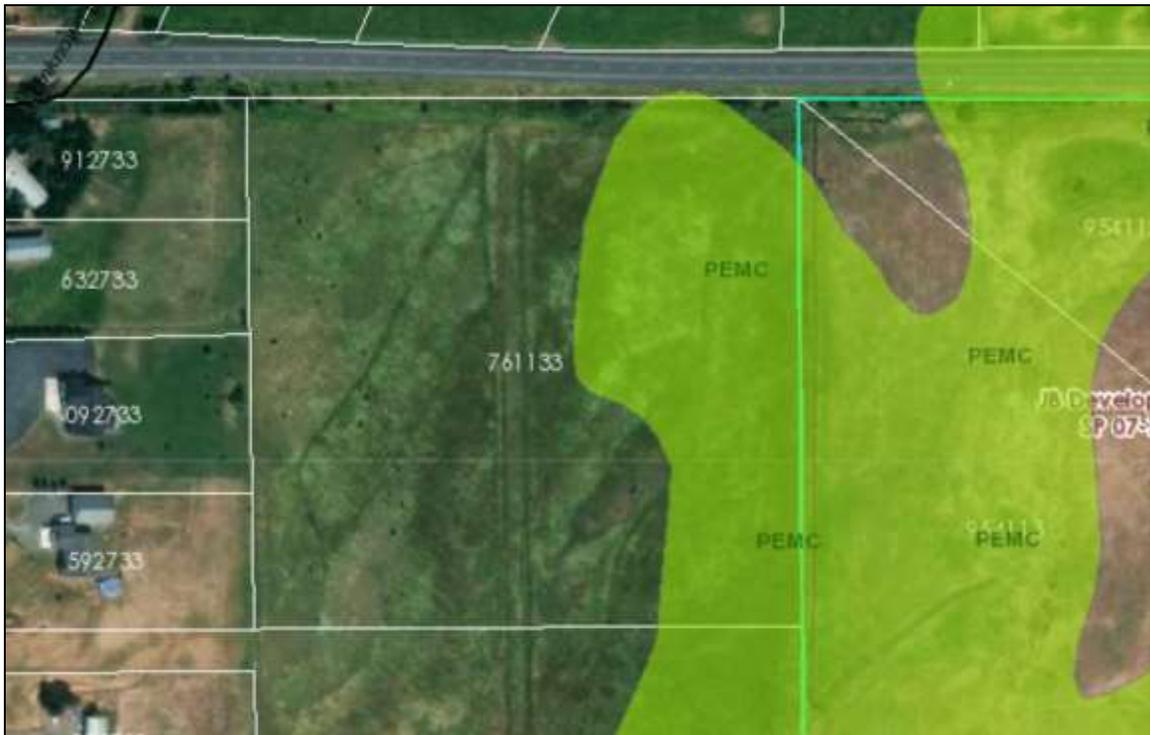
The Kittitas County Mapsifter website depicts a portion of an emergent wetland extending onto the eastern side of the site. As with the NWI inventory, this mapping represents an aerial photograph interpretation of the site with no field verification.

Above: Kittitas County wetland and stream mapping of the site.

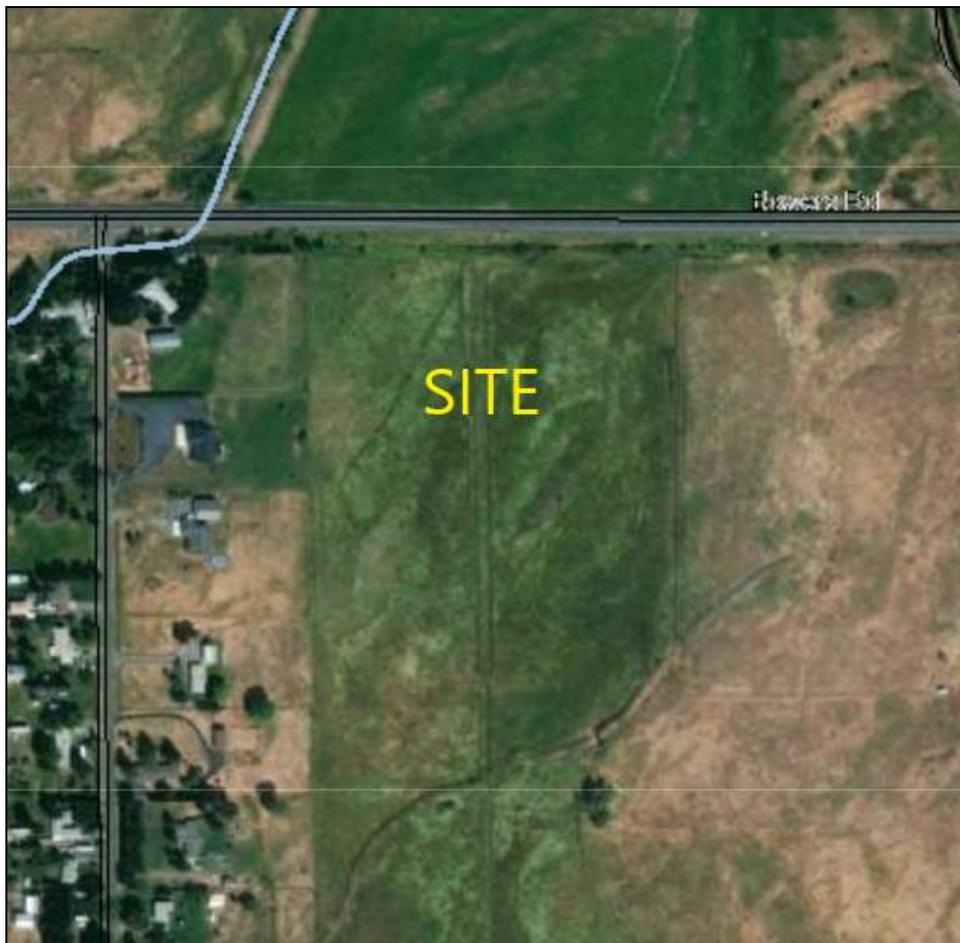
According to the WDNR Fpars stream mapping website, there are no streams on or near the site.

Above: WADNR Fpars stream mapping of the site

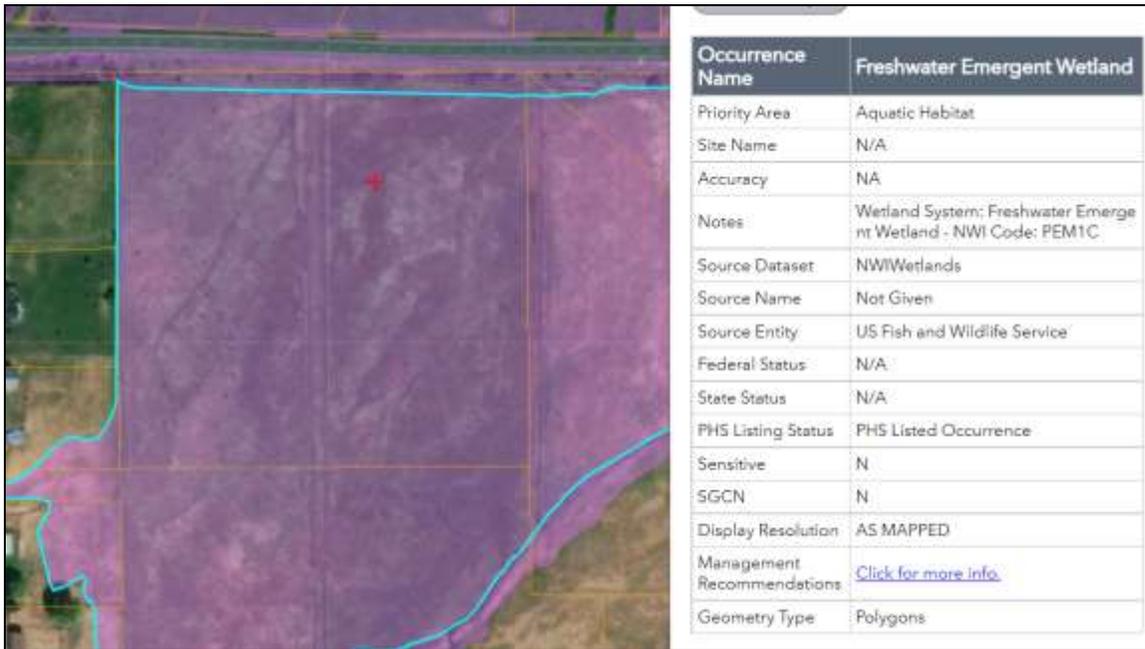
The WDFW Priority Habitats and Species mapping for the site depicts the same wetland carried over from the NWI mapping.

Above: WDFW Priority habitat mapping of the area of the site.

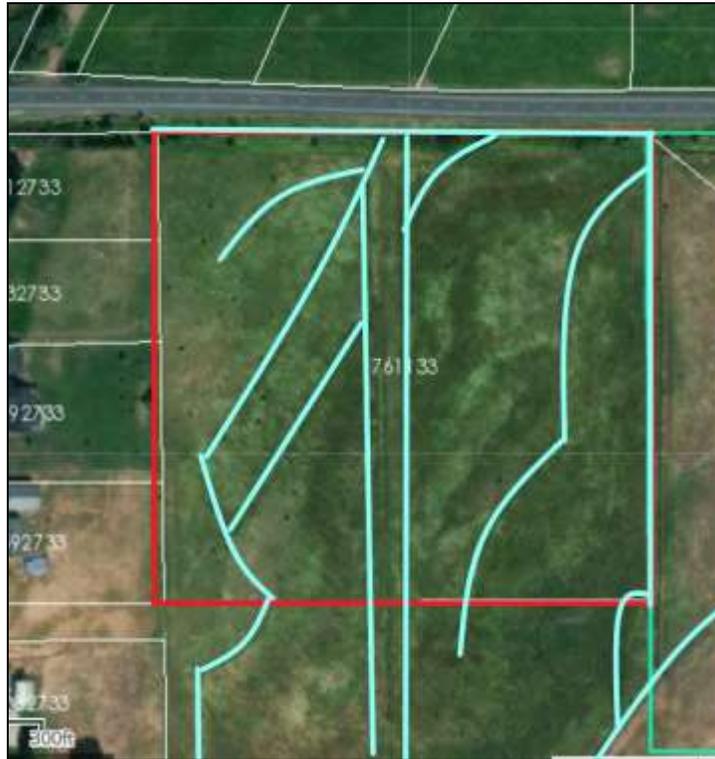
The site is used for grazing livestock and consists of a historically flood irrigated pasture. Flood irrigation over most of the site was ceased several years ago. The main irrigation channel that had supplied irrigation water to the site runs along the north edge of the site and at the toe of the south side of the road prism of Bowers Road. Water within this ditch originates in the KRD system to the north. Water was dispersed onto the site through a series of irrigation ditches which then dispersed water across the site using typical flood irrigation practices. Water that passed through the site drained into a large irrigation ditch just south of the site.

An old roadbed type feature passes through the center of the site from north to south. Several large cobble piles are present from past agricultural work on the site.

Above: Approximate location of irrigation ditches across the site (light blue lines).

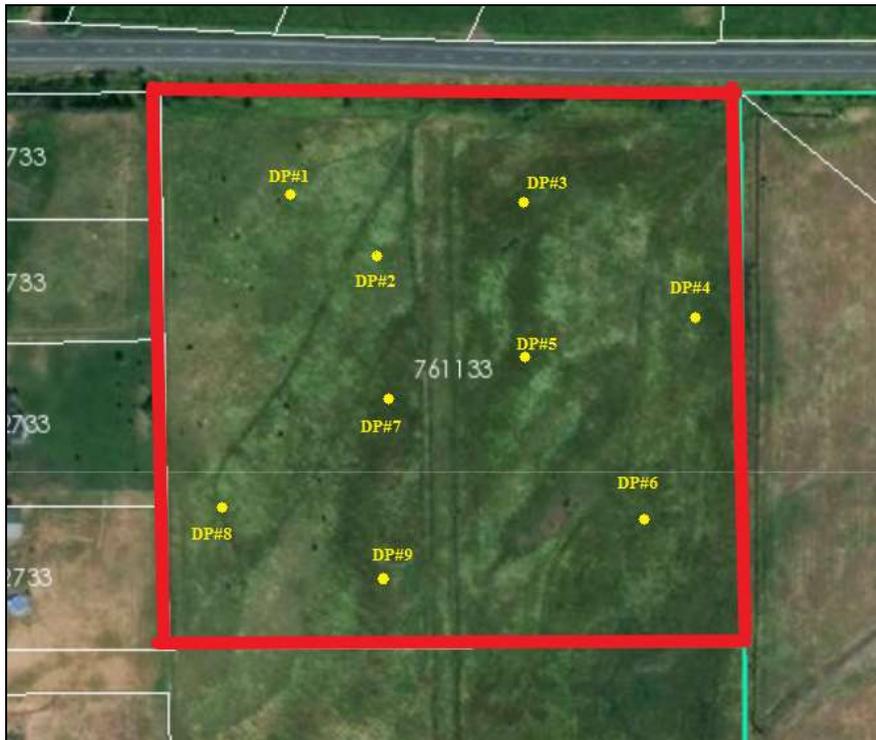
A series of 9 soil pits/data points were excavated on the site to characterize the plant, soil and hydrology conditions.

In general the soils on the site are cobbly loams with soil chroma colors of 3 or 2 without any redoximorphic features. Portions of the site include cobbly sandy loams with similar soil colors.

Areas within the old irrigation channels and flood irrigation flow paths have some wetland species and relic hydric soil indicators. However, none of these areas contained any evidence of wetland hydrology even in the late September period when groundwater levels are at their highest in the valley.

Above: Data point locations.

There are no wetlands, streams or buffers on the site.
