**GEOTECHNICAL AND PAVEMENT
ENGINEERING REPORT**
Thorp Prairie Road Evaluation and Design
Kittitas County, Washington
HWA Project No. 2012-105-21
Prepared for
PacifiClean Environmental LLC
February 1, 2013

**SUBJECT: Geotechnical and Pavement Engineering Report
Thorp Prairie Road Evaluation and Design
Kittitas County, Washington**

GEOTECHNICAL AND PAVEMENT ENGINEERING REPORT THORP PRAIRIE ROAD EVALUATION AND DESIGN KITITAS COUNTY, WASHINGTON

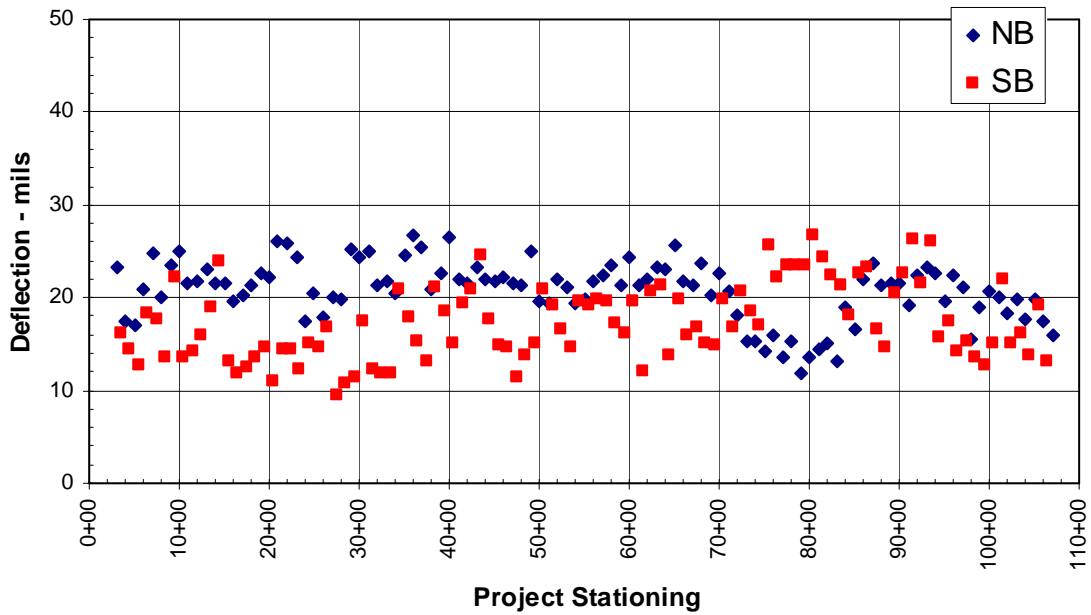
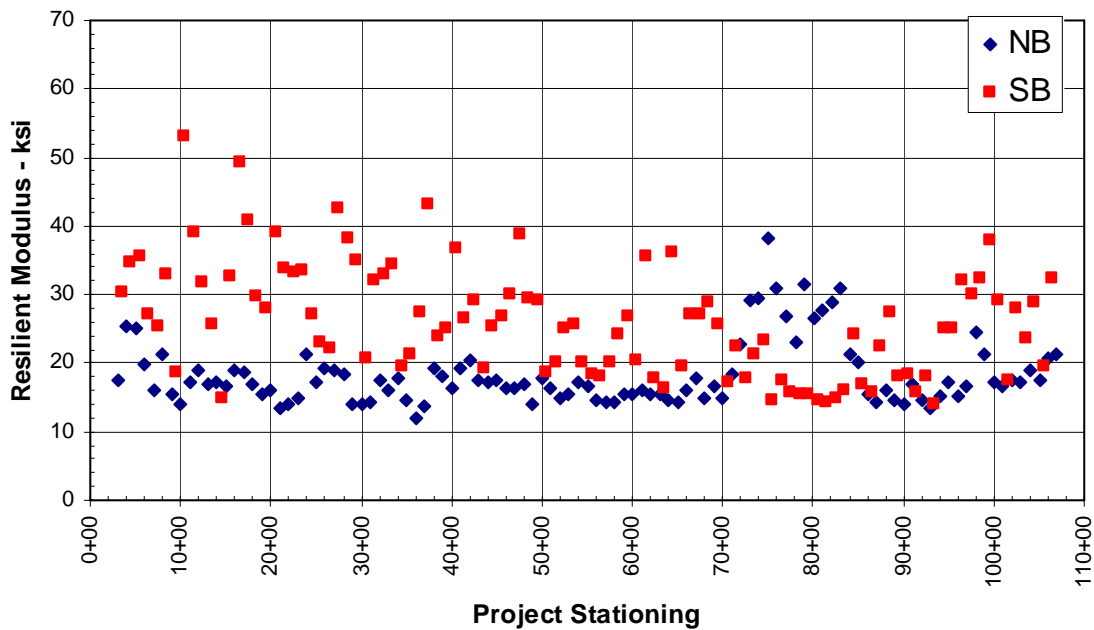
FWD TEST RESULTS

a. Maximum Deflection Normalized for 9,000 lb Load

b. Resilient Modulus of Subgrade

Falling Weight Deflectometer (FWD) testing was conducted on November 16, 2012, in both directions, at intervals of approximately 100 feet. The FWD testing was undertaken using a Dynatest Model 8081 Heavy Falling Weight Deflectometer. This FWD allows the pavement to be tested under a wide range of loading conditions (6,500 to 54,000 pounds) to simulate a variety of traffic loads. For this investigation, the FWD was programmed to apply controlled pulse loads of approximately 6,000, 9,000 and 12,000 pounds to the pavement surface. The corresponding pavement surface deflections were measured with velocity transducers located directly under the loaded area, and at 12, 24, 36, 48, 60 and 72 inches from the center of the loaded area. The measured deflections were normalized to a 9,000-pound load for comparison purposes. The load-deflection relationships were then used along with the measured thicknesses of each pavement layer to back-calculate the resilient modulus (M_r) of the subgrade soil.

The deflection basins for each of the test locations, normalized to a 9,000-pound load, are presented in Appendix C. Deflection readings closest to the applied load reflect the strength of the near-surface layers, whereas, deflection readings further from the applied load reflect deeper soil conditions.

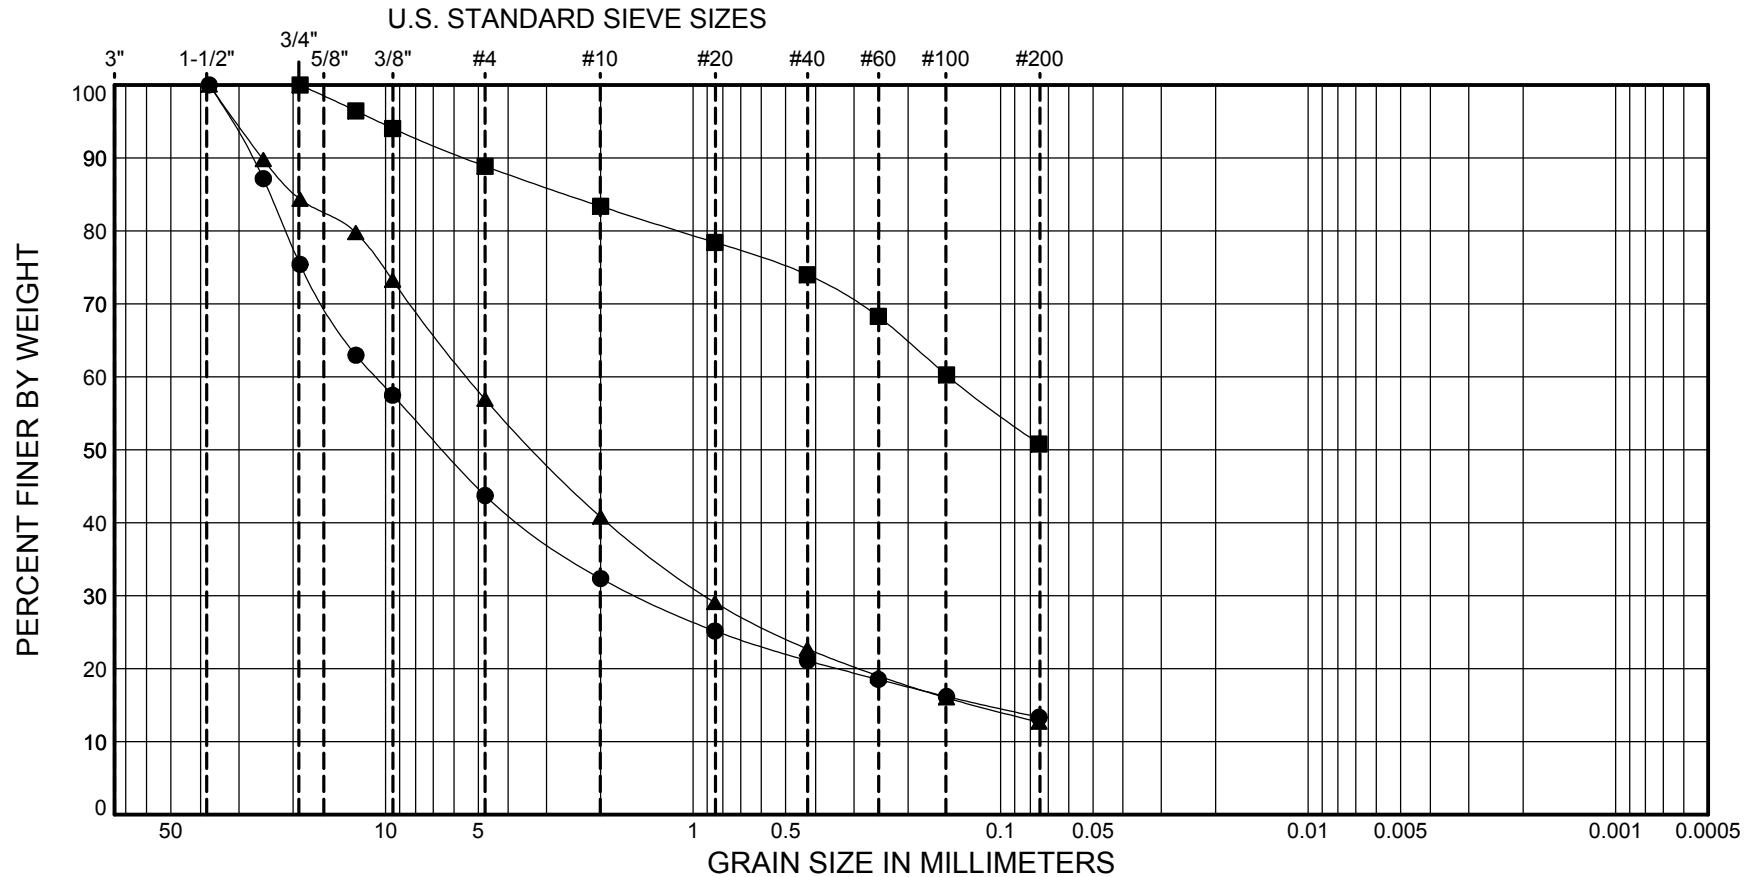
SYMBOL	SAMPLE		DEPTH (ft)	CLASSIFICATION OF SOIL- ASTM D2487 Group Symbol and Name	% MC	LL	PL	PI	Gravel %	Sand %	Fines %
●	Core-1	S-2	0.3 - 0.7	(GM) Very dark brown, silty GRAVEL with sand	7				56.3	30.4	13.3
■	Core-1	S-4	1.5 - 1.8	(ML) Dark brown, sandy SILT	15				11.1	38.1	50.8
▲	Core-4	S-1	0.3 - 0.5	(GM) Black, silty GRAVEL with sand	5				43.1	44.3	12.7

Particle Size Analysis of Soils: Selected granular samples were tested to determine the particle size distribution of material in accordance with ASTM D 422. The results are summarized on the attached Particle-Size Analysis report (Figure B-1, in Appendix B), which also provides information regarding the classification of the samples and the moisture content at the time of testing.

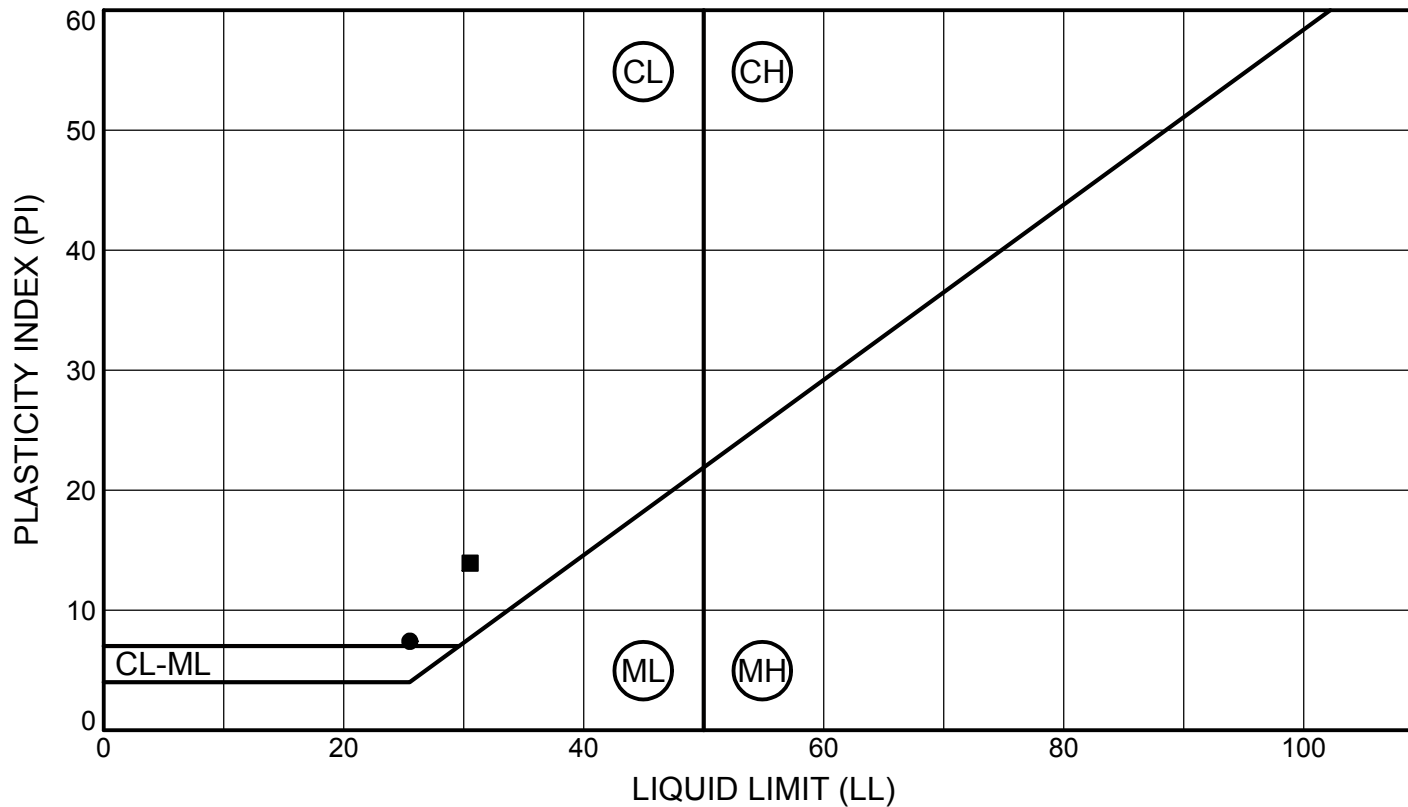
PERCENT OF MATERIAL PASSING
 #200 SIEVE
 METHOD ASTM D1140

SYMBOL	SAMPLE		DEPTH (ft)	CLASSIFICATION	% MC	LL	PL	PI	% Fines
●	Core-4	S-2	1.5 - 1.9	(CL) Very dark brown, sandy lean CLAY	19	26	18	8	54.9
■	Core-5	S-3	2.0 - 2.2	(GC) Dark yellowish brown, clayey GRAVEL	13	31	17	14	31.1

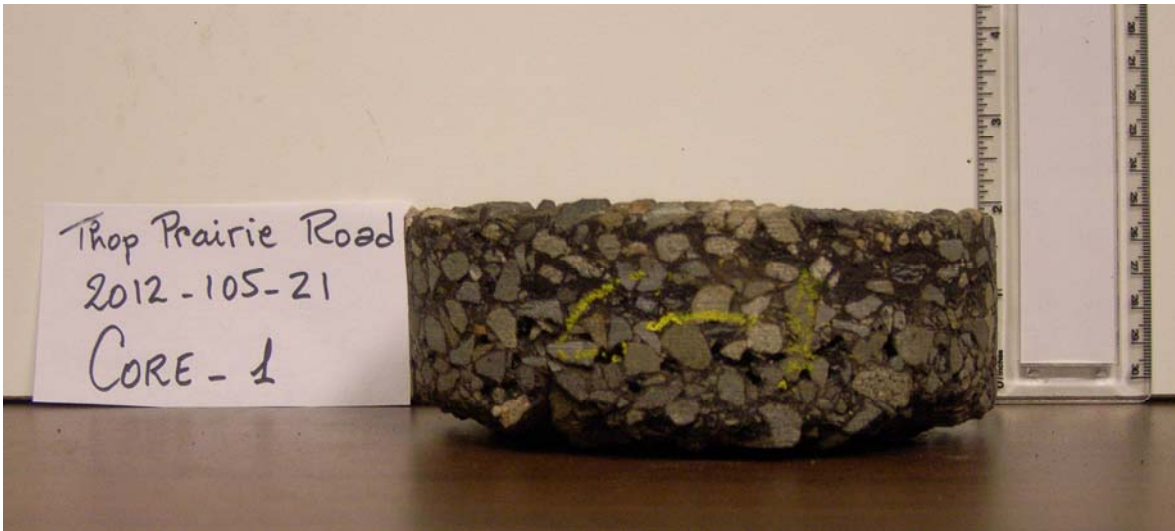
Core Designation: Core-1

Sample Location: Thorp Prairie Road Station 15+00 Southbound Lane

Total Wearing Surface Depth: 2 inches

Thickness (inches)	Description of Material	Lifts (inches)	Condition
2	Bituminous Surface Treatment (BST)	1,1	Fair
1.5	Crushed Surfacing Top Course	-	Dense
14.5	Reddish brown silty GRAVEL with sand	-	Very dense

The BST wearing surface samples, obtained from the pavement cores along Thorp Prairie Road, had an approximate thickness of 2 inches and were generally in good to fair condition. Five cores were taken in the southbound lane and one pavement core (Core-5) was taken in the northbound lane. Crushed base course was encountered in pavement cores Core-1, Core-3, Core-4 and Core-6. The thickness of the crushed base layer was approximately 5 inches in Core-6, and it ranged from 1 inch to 1.5 in the other pavement cores. In the remaining pavement cores (Core-2 and Core-5), fill soils were encountered directly underneath the BST layer. The subgrade soils in all pavement cores were fill materials consisting of very dense silty gravel with sand or silty sand with gravel, and were likely placed as a subbase course during construction.

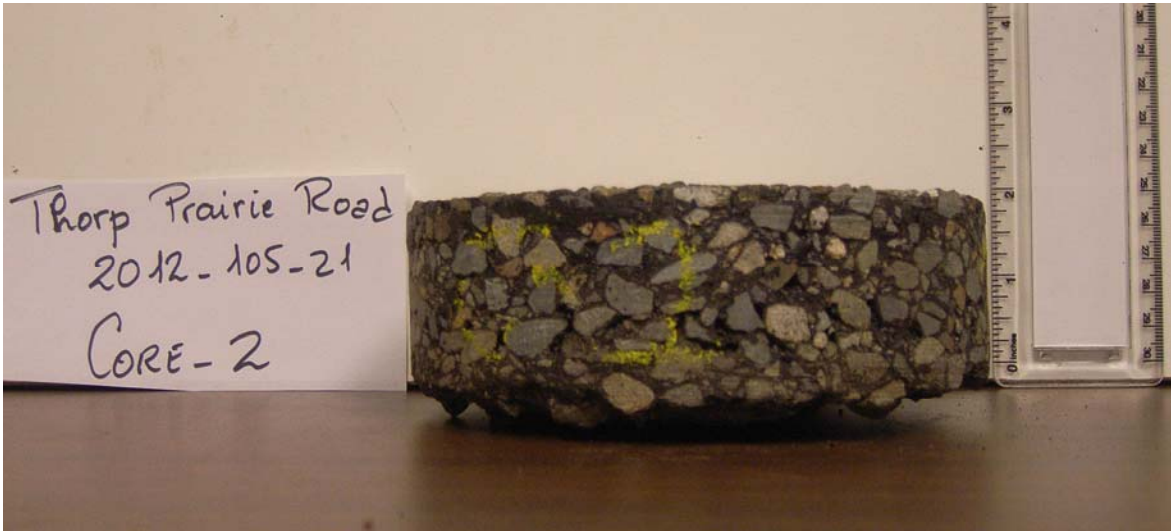
Core Designation: Core-2

Sample Location: Thorp Prairie Road Station 30+50 Southbound Lane

Total Wearing Surface Depth: 1.75 inches

Thickness (inches)	Description of Material	Lifts (inches)	Condition
1.75	BST	1, 0.75	Fair
-	Brown, silty GRAVEL with sand	-	Very dense

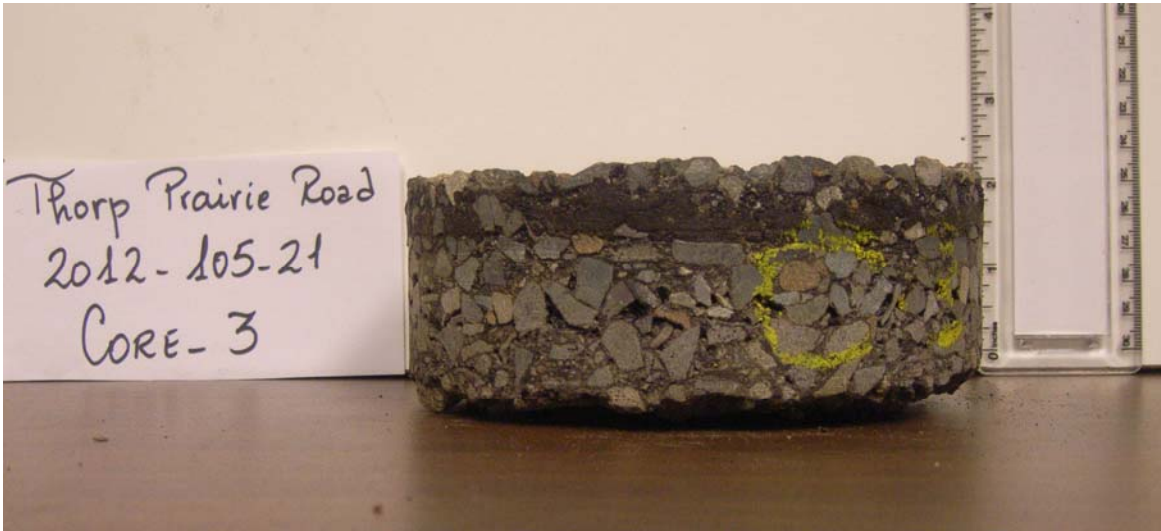
Core Designation: Core-3

Sample Location: Thorp Prairie Road Station 45+00 Southbound Lane

Total Wearing Surface Depth: 2 inches

Thickness (inches)	Description of Material	Lifts (inches)	Condition
2	BST	0.5, 1.5	Fair
1	Crushed Surfacing Top Course	-	Dense
-	Brown, silty GRAVEL with sand	-	Very dense

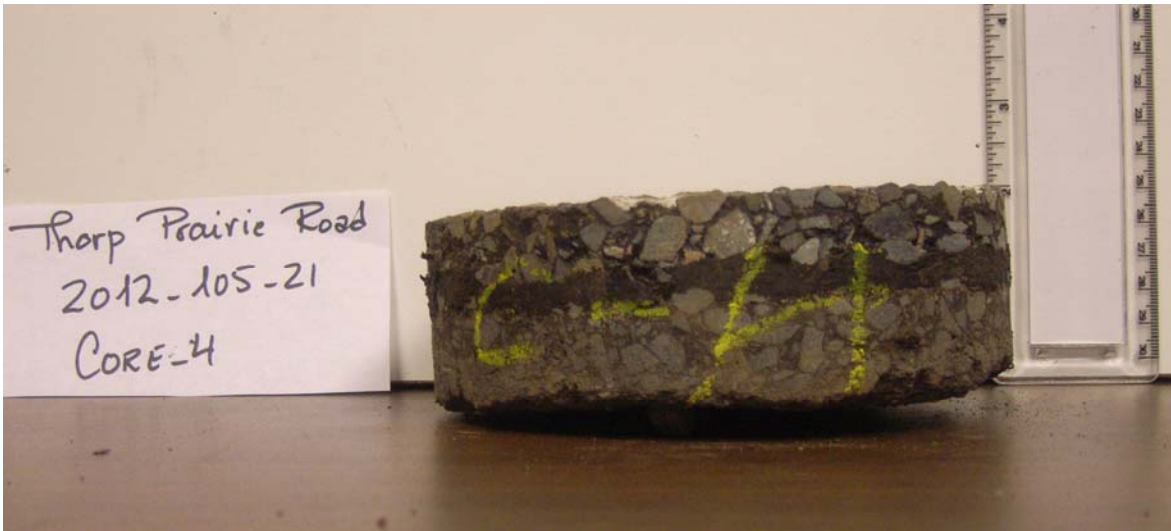
Core Designation: Core-4

Sample Location: Thorp Prairie Road Station 60+50 Southbound Lane

Total Wearing Surface Depth: 1.75 inches

Thickness (inches)	Description of Material	Lifts (inches)	Condition
1.75	BST	0.75, 1	Fair
1.25	Crushed Surfacing Top Course	-	Dense
-	Dark grayish brown silty Gravel with sand	-	Very dense

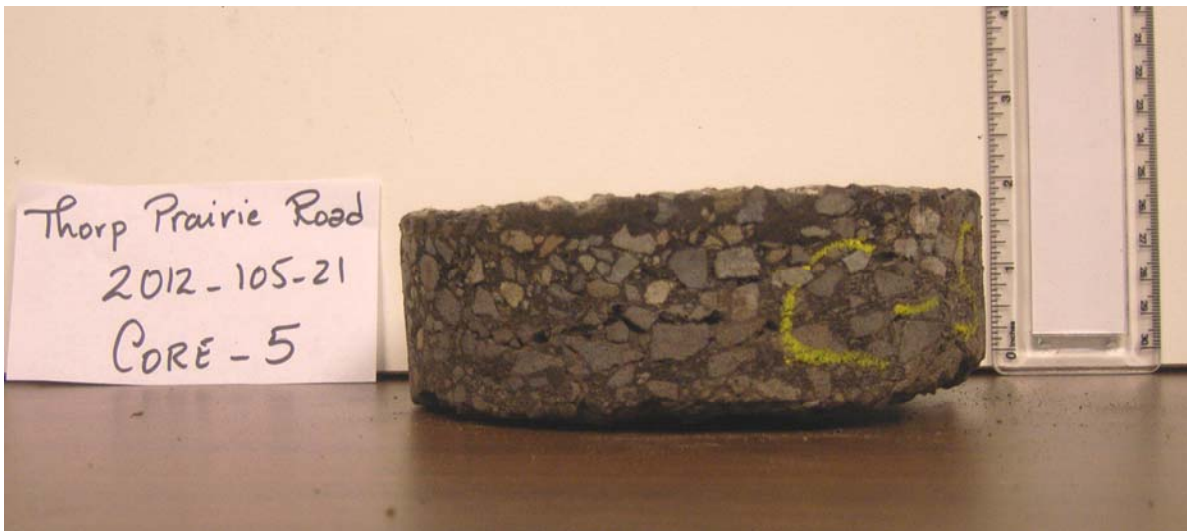
Core Designation: Core-5

Sample Location: Thorp Prairie Road Station 75+00 Northbound Lane

Total Wearing Surface Depth: 1.75 inches

Thickness (inches)	Description of Material	Lifts (inches)	Condition
1.75	BST	1, 0.75	Fair
21	Silty SAND with gravel	-	Very dense

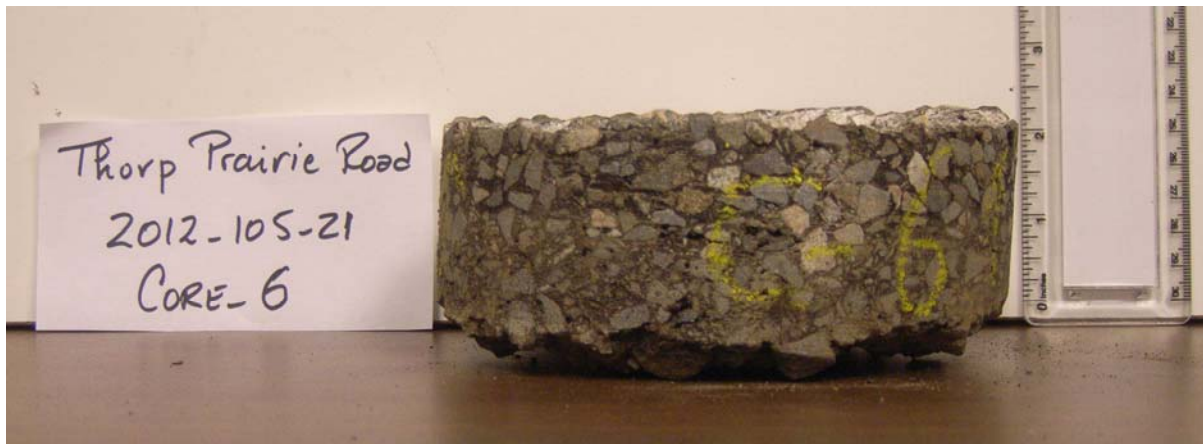
Core Designation: Core-6

Sample Location: Thorp Prairie Road Station 92+50 Southbound Lane

Total Wearing Surface Depth: 2 inches

Thickness (inches)	Description of Material	Lifts (inches)	Condition
2	BST	1, 1	Fair
5	Crushed Rock Base Course	-	Dense
-	Reddish brown clayey GRAVEL with sand	-	Very dense
