RE: Revised Critical Area Report – Parcels #707835
Kittitas County, Washington
SWC Job #21-151

INTRODUCTION

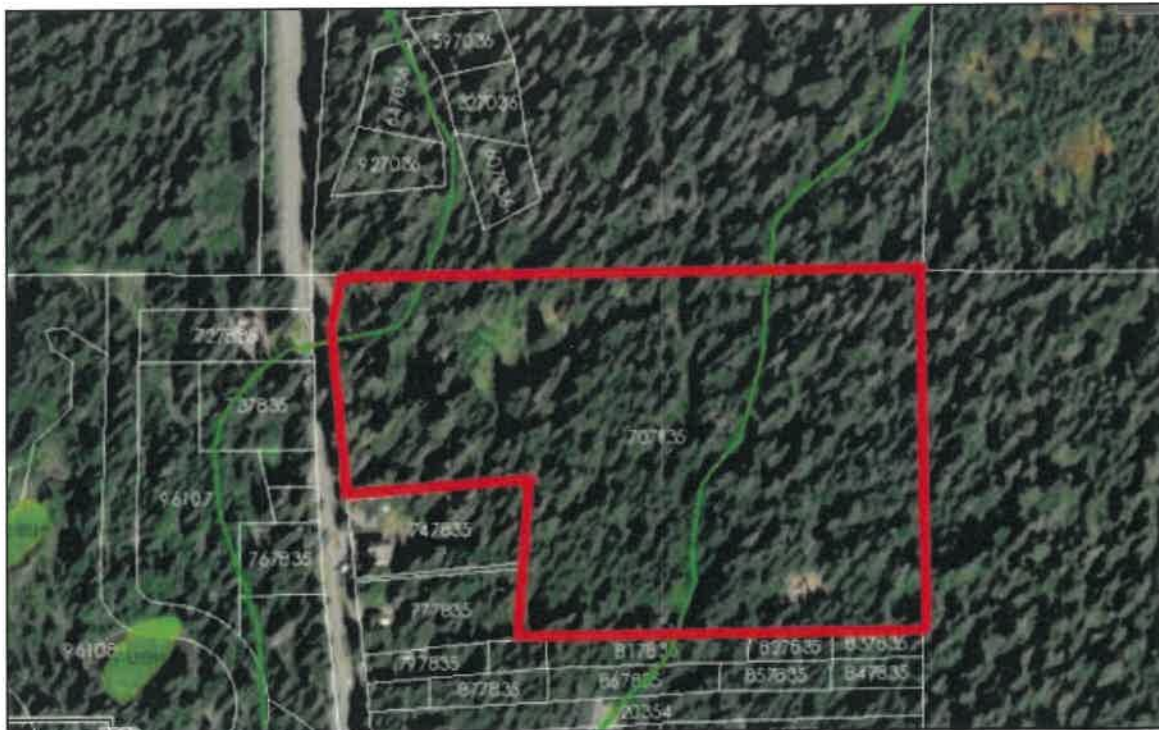
Above: Kittitas County TaxsiFTER aerial photograph of the site with wetland and stream layers activated.

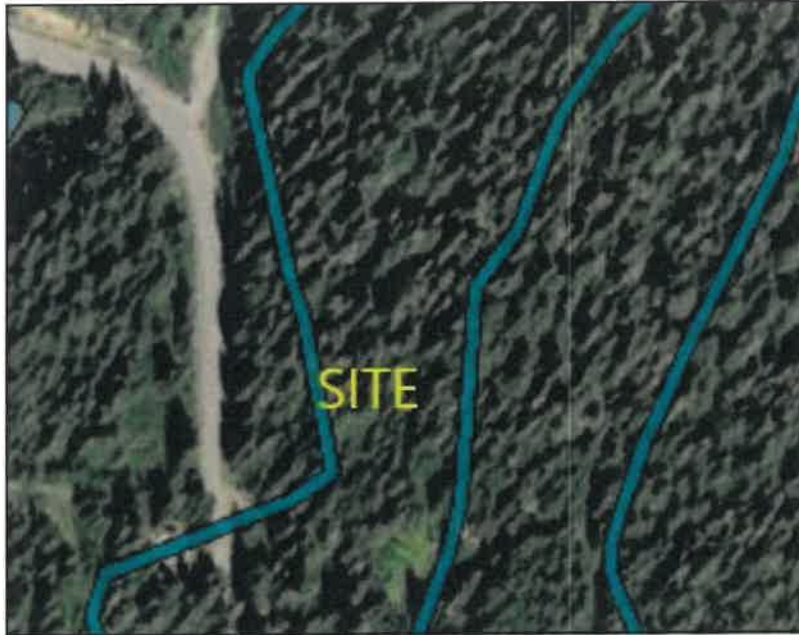
The NWI map depicts no wetlands on the site. Several streams are depicted on the site, one across the northwest corner, and one across the eastern side of the site.

Above: NWI Map of the study area

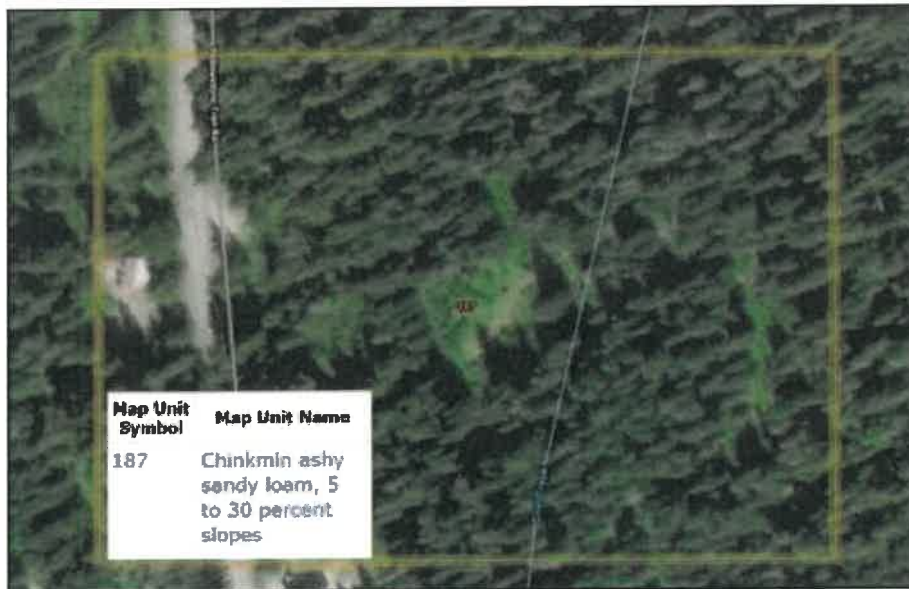
According to the NRCS Soil Mapper website, the entire site is mapped as Chinkmin ashy, sandy loam. The Chinkmin series consists of moderately deep to cemented glacial till, moderately well drained soil formed in colluvium from glacial till, volcanic ash, and pumice overlying dense glacial till. Chinkmin soils are in cirques, valleys, on lateral moraines and

drift plains in mountains. Slopes are 0 to 70 percent. Chinkmin soils are not considered a "hydric" soils according to the publication Hydric Soils of the United States (USDA NTCHS Pub No.1491, 1991).

Above: NRCS Soil map of the study area.

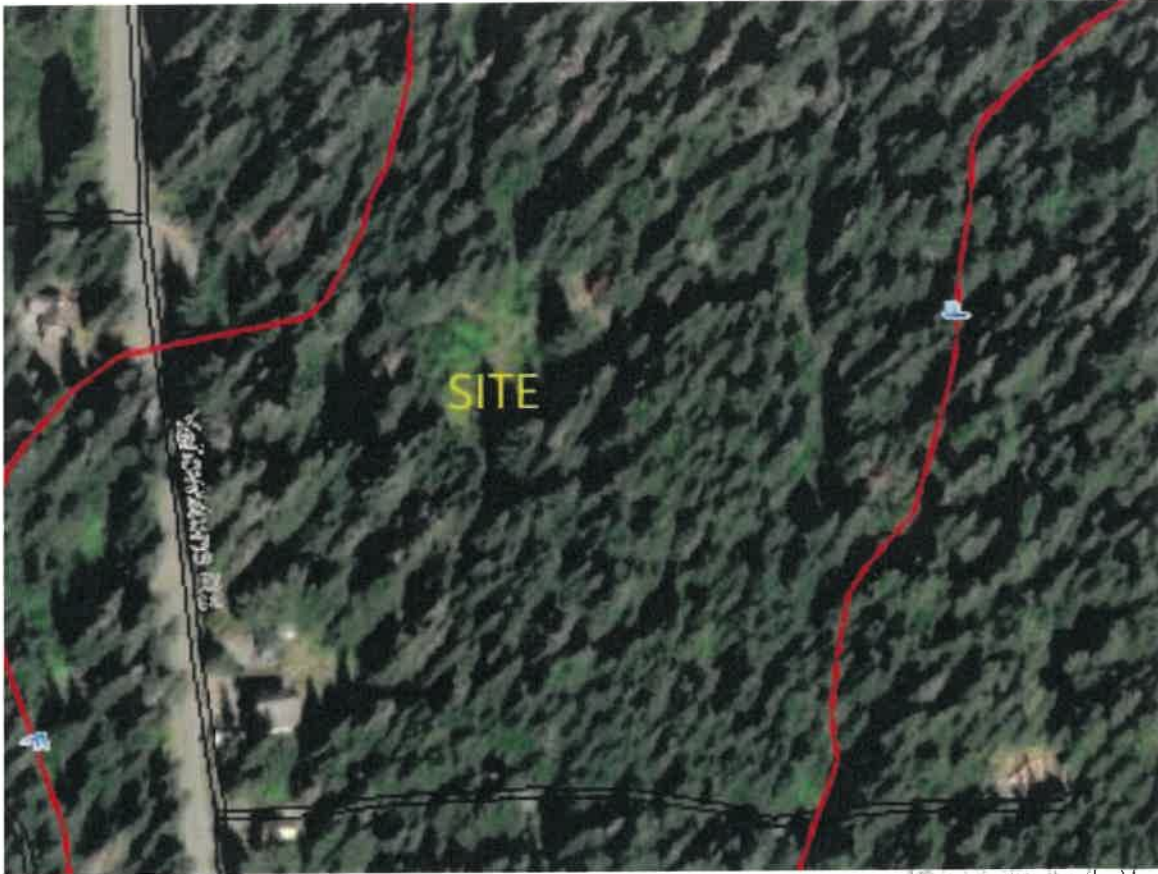
The WADNR Fpars stream mapping website depicts a Type F water crossing the northwest corner of the site and a Type F stream across the eastern side of the site.

Above WDNR Fpars Stream Map

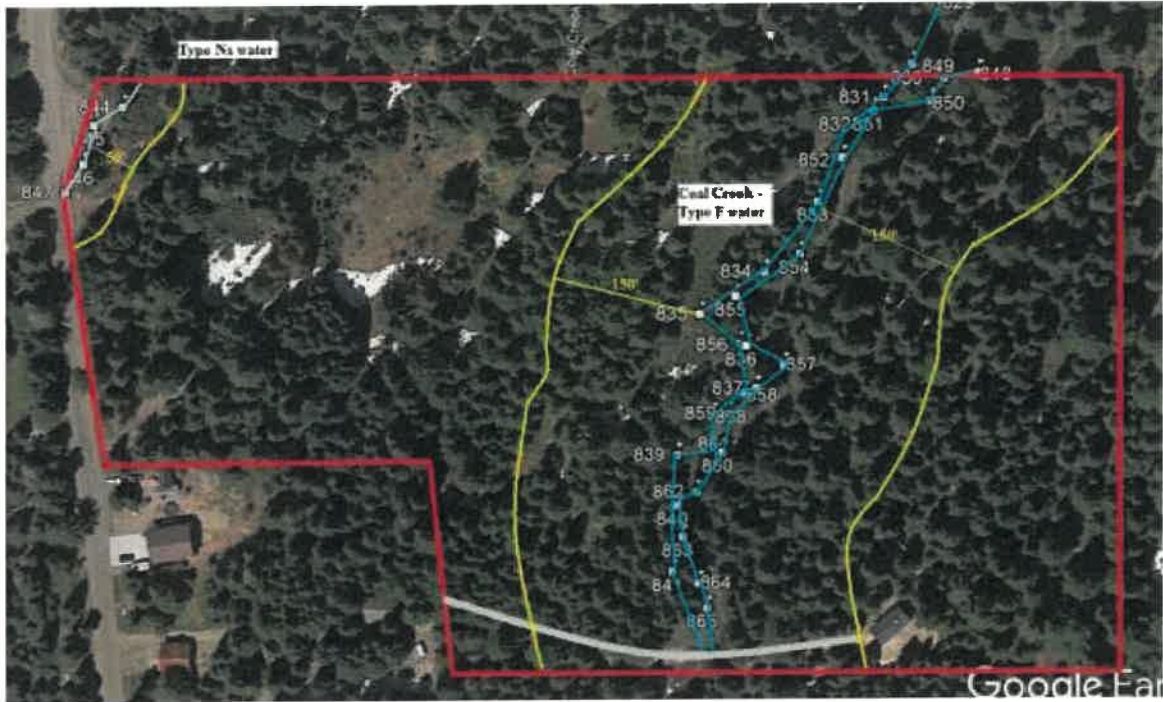
Coal Creek in the area of the site is a large, boulder and cobble bed stream approximately 15' wide on average with steep, eroded banks from wither flood flows. Large woody debris is present throughout the stream channel and the channel was flowing up to 18" deep during our summer, dry season site visit. An existing bridge and gravel road crosses over this stream on the south side of the site.

The ordinary high water mark of this stream was flagged with flags E1-E18 (east edge) and S1-S18 (west edge).

This stream is mapped as a fish bearing stream and best meets the criteria of a Type F water.

Above: GPS mapping of streams on the site.

According to Kittitas County Municipal Code 17.A.04.030-4, Type F streams in the Cascade Ecoregion have a 150' buffer measured from the OHWM of the stream. In addition, a 15' Building Setback line is required from the edge of the buffer.

This stream appears to meet the criteria of a Type Ns due to lack of fish use and seasonal flow. According to Kittitas County Municipal Code 17.A.04.030-4, Type Ns streams in the Cascade Ecoregion have a 50' buffer measured from the OHWM of the stream. In addition, a 15' Building Setback line is required from the edge of the buffer.
