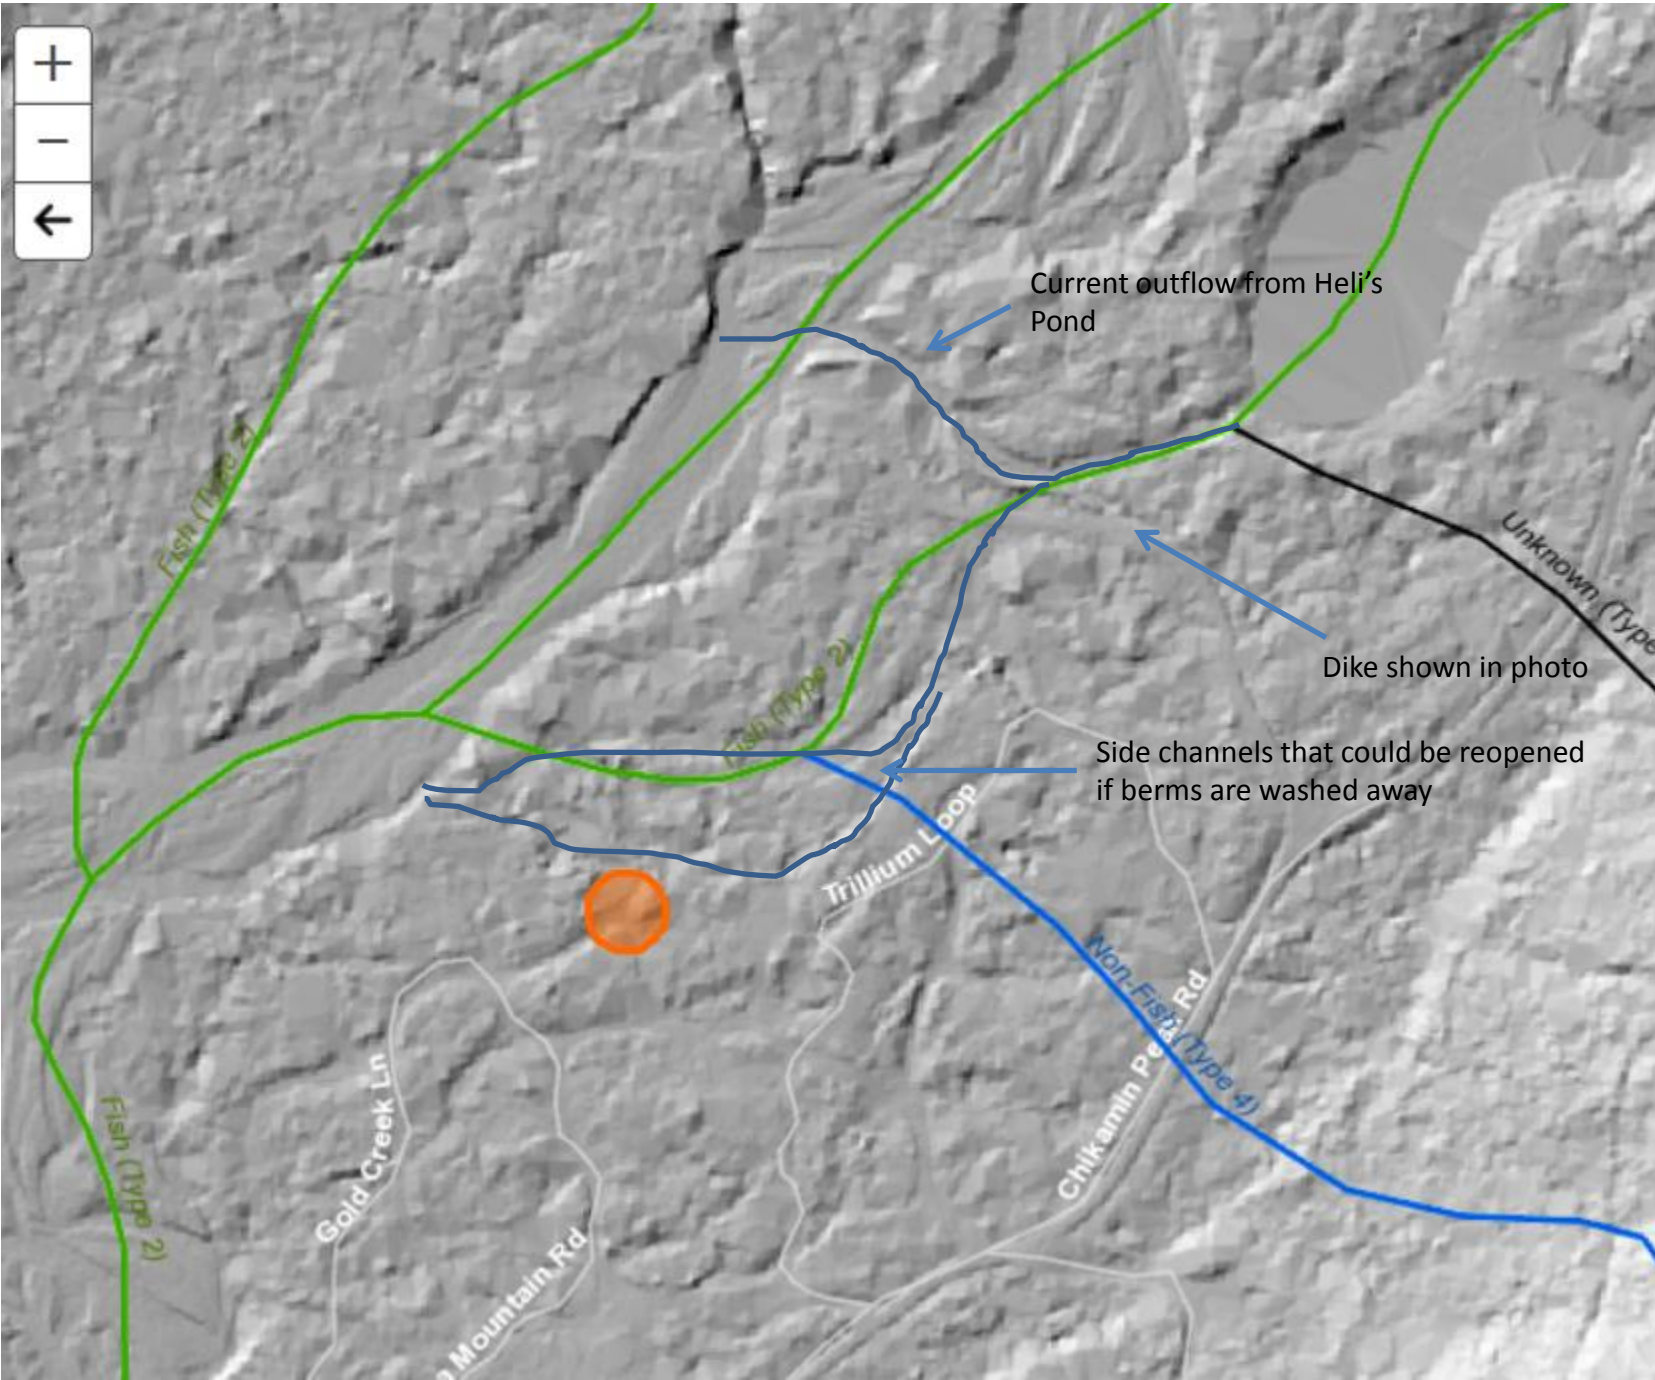
Current outflow from Heli's Pond

Dike shown in photo

Side channels that could be reopened if berms are washed away

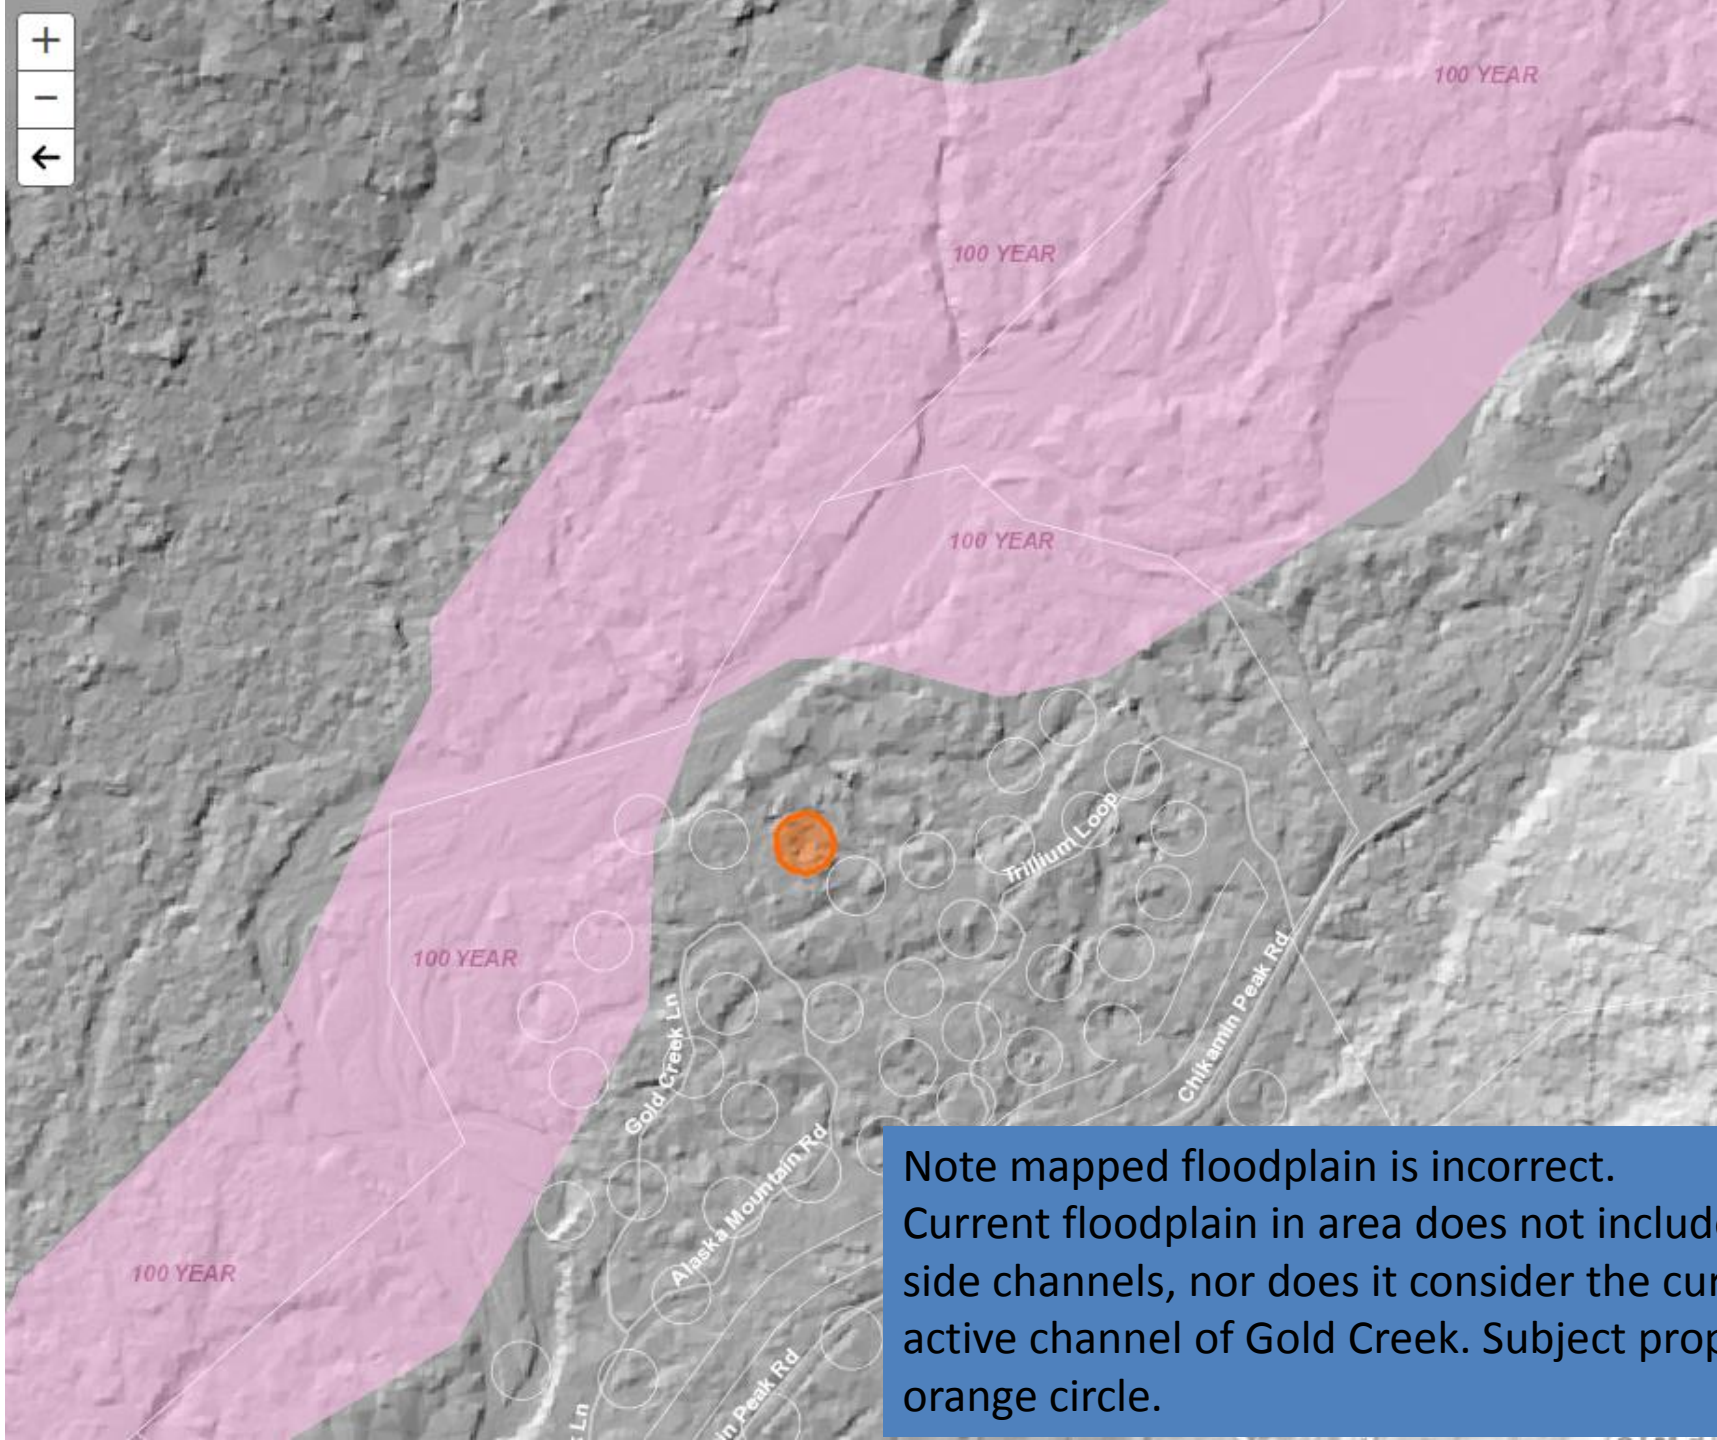
Note mapped floodplain is incorrect. Current floodplain in area does not include side channels, nor does it consider the current active channel of Gold Creek. Subject property is orange circle.

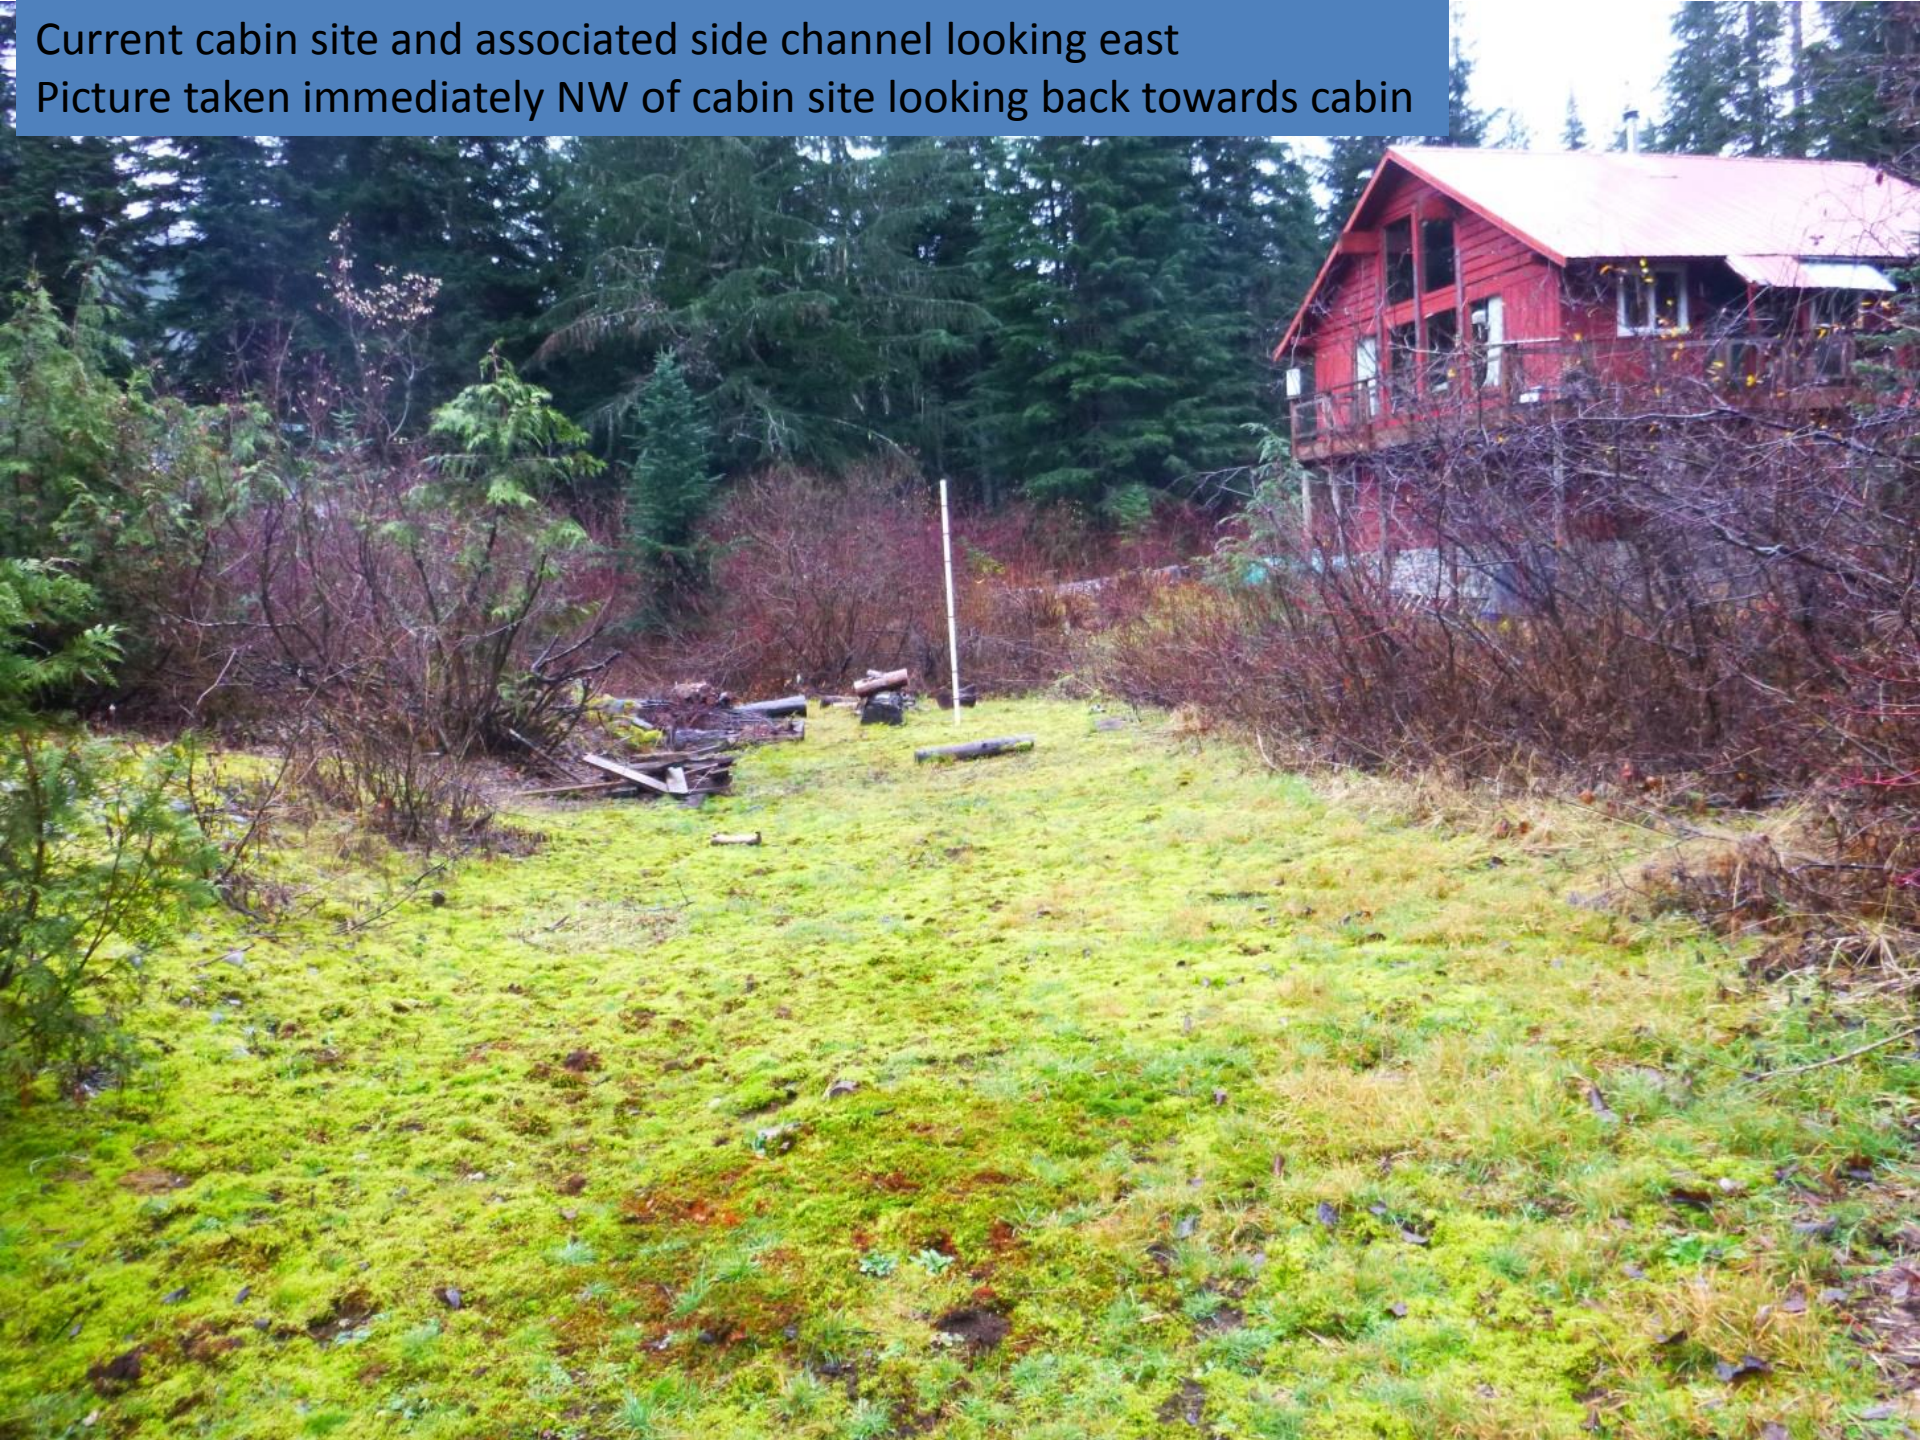
Current cabin site and associated side channel looking east
Picture taken immediately NW of cabin site looking back towards cabin

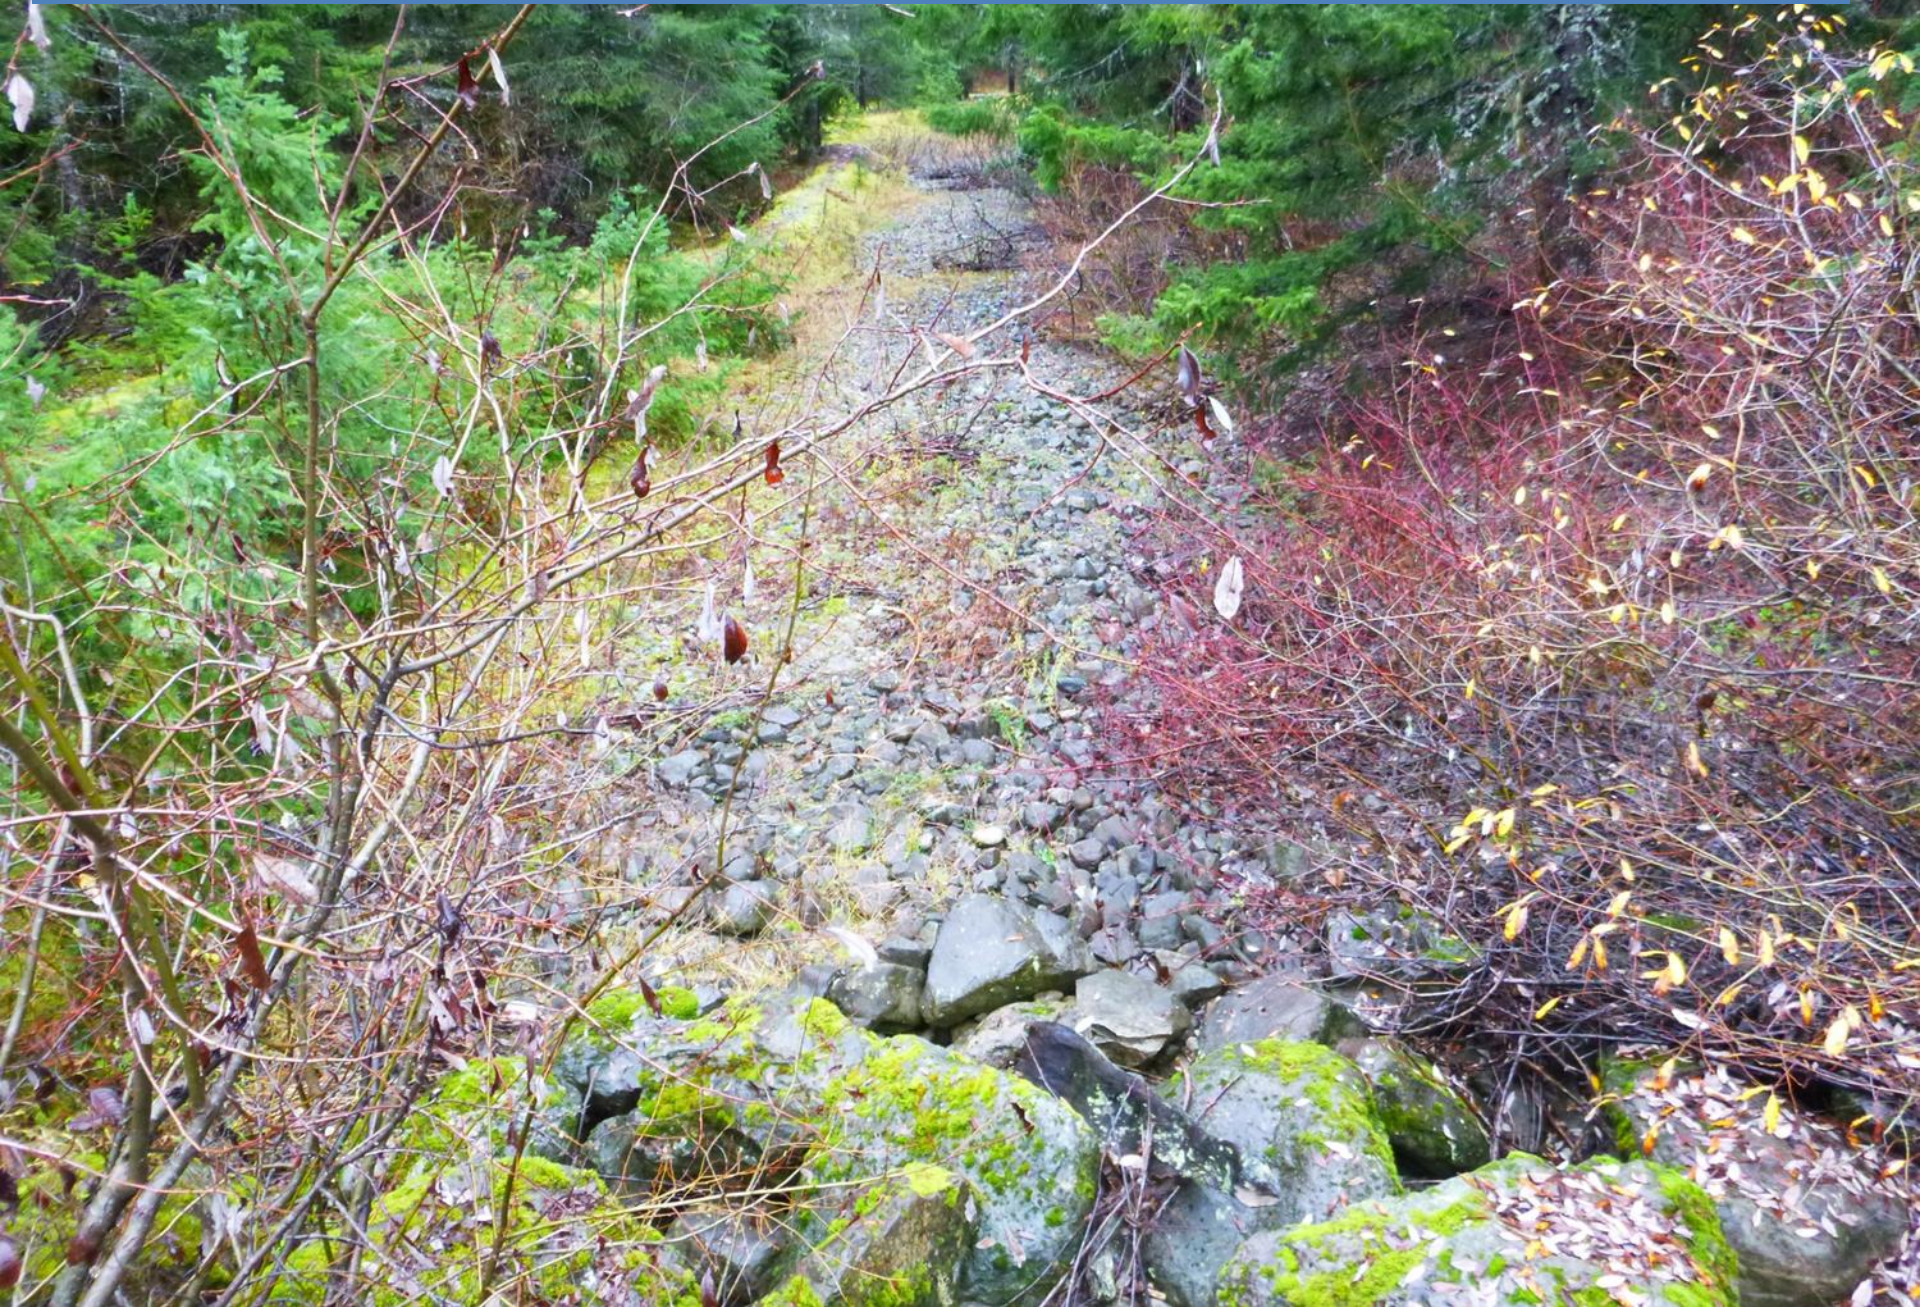
Dike, just south of Heli's Pond that currently diverts most of the water away from Cabins to the south. If this dike were to break, the cabin site would get annual spring flows.
