<table><tr> <th colspan="2">Channel Maintenance</th> </tr></table>

PROJECT DESCRIPTION:  
BAR 14 RD BRIDGE REMOVAL - EX. PLAN

<b>JACOBS</b> APPLICANT: KITTITAS RECLAMATION DISTRICT REFERENCE:	LAT/LONG   TRS: SW/NW 04 09 18N 19E	DATE: 10/26/2017	PAGE: 8 OF 8
	PROJECT DESCRIPTION: NANEUM CREEK CHANNEL MAINTENANCE	IN: NANEUM CREEK	NEAR/AT: ELLENSBURG
	ADJACENT PROPERTY OWNERS: SEE JARPA	COUNTY: KITTITAS	STATE: WA

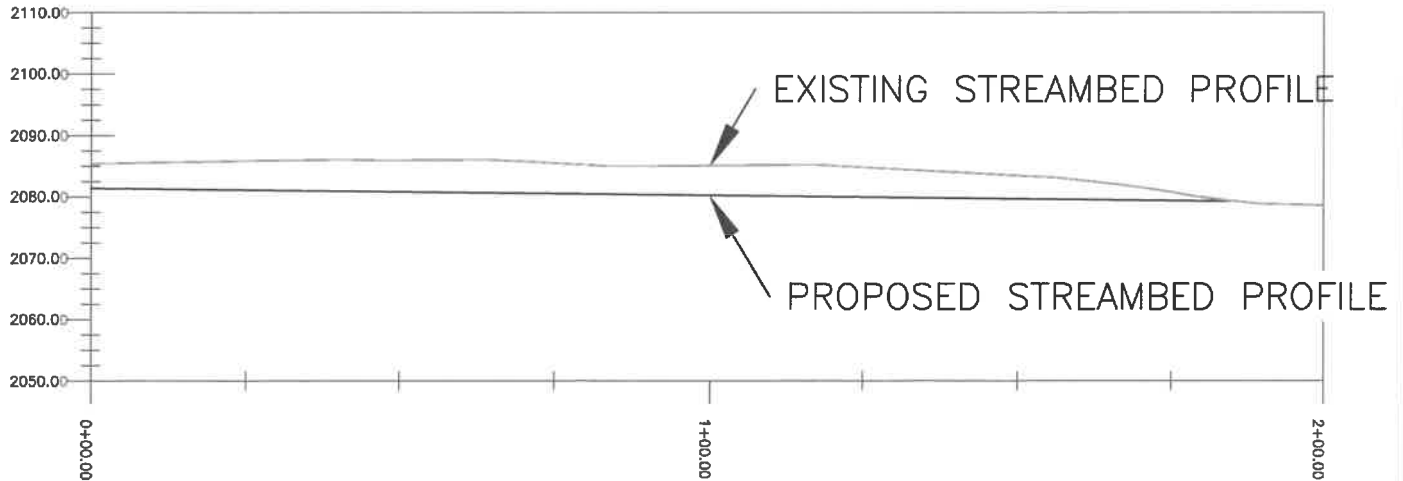
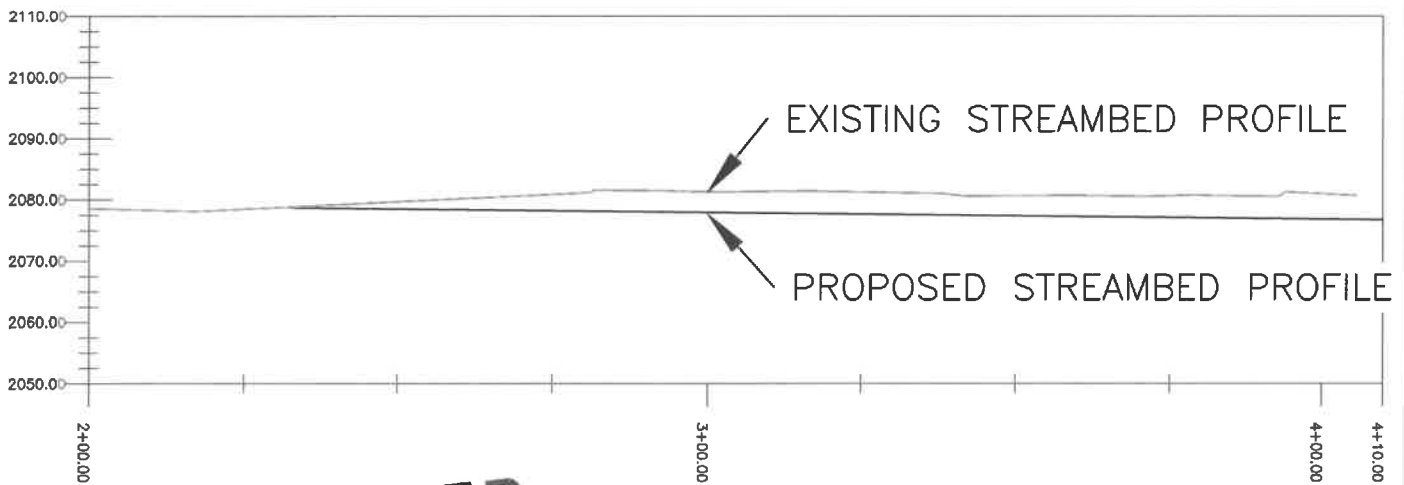
PROFILE — STREAMBED

CHANNEL MAINTENANCE	
ELEMENT	VALUE
LENGTH OF CHANNEL MAINTENANCE	425 LF
EXCAVATION VOLUME WITHIN CHANNEL	950 CY
EXCAVATION AREA WITHIN CHANNEL	10,945 SF

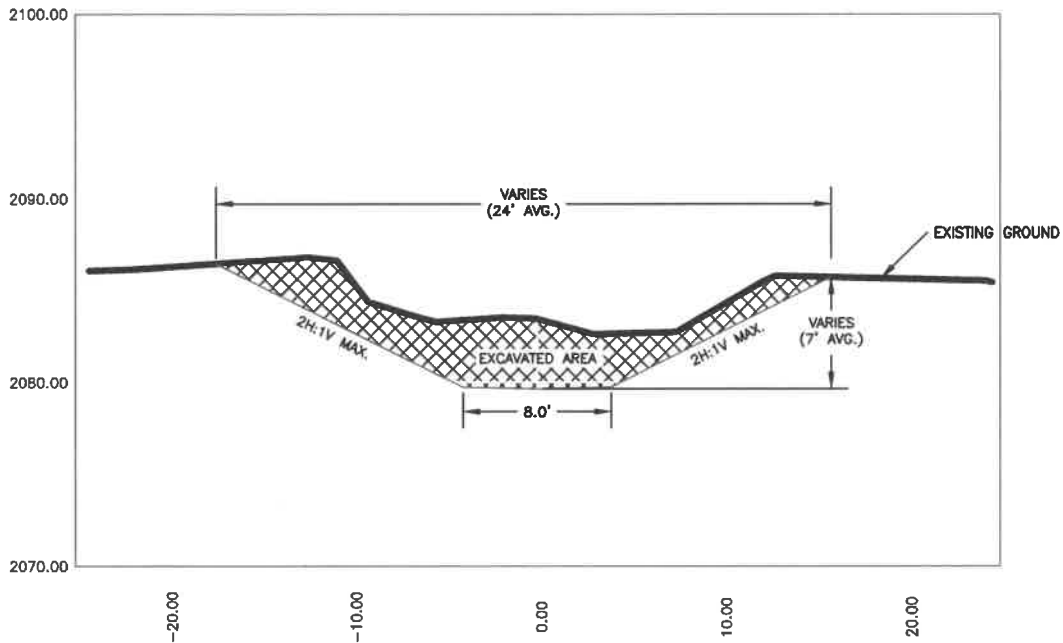
### CROSS SECTION 1-1

CHANNEL MAINTENANCE	
ELEMENT	VALUE
LENGTH OF CHANNEL MAINTENANCE	425 LF
EXCAVATION VOLUME WITHIN CHANNEL	950 CY
EXCAVATION AREA WITHIN CHANNEL	10,945 SF

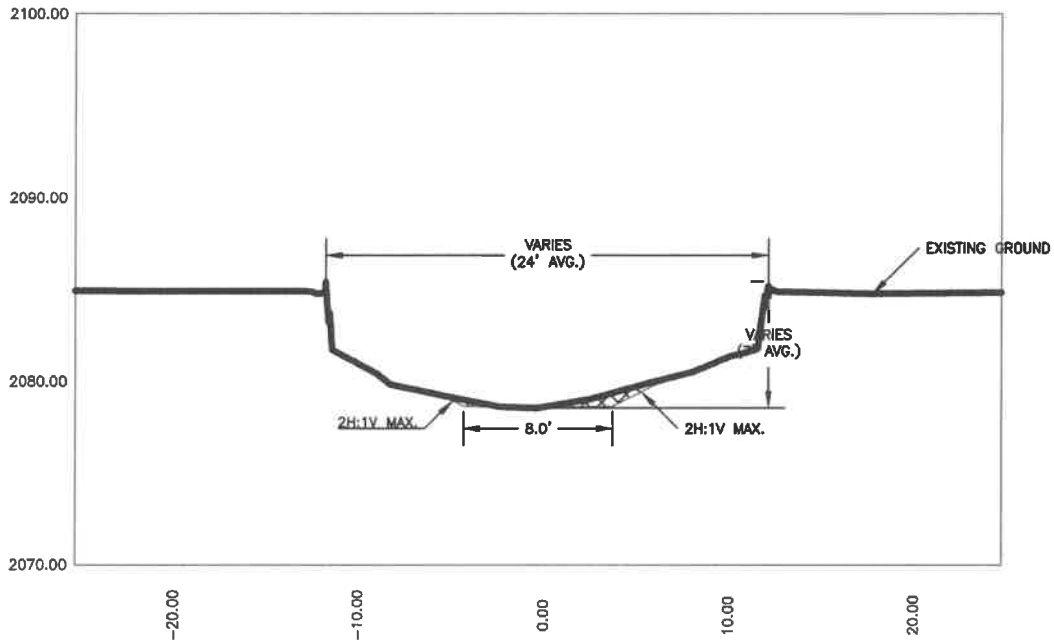
## CROSS SECTION 2-2

CHANNEL MAINTENANCE	
ELEMENT	VALUE
LENGTH OF CHANNEL MAINTENANCE	425 LF
EXCAVATION VOLUME WITHIN CHANNEL	950 CY
EXCAVATION AREA WITHIN CHANNEL	10,945 SF

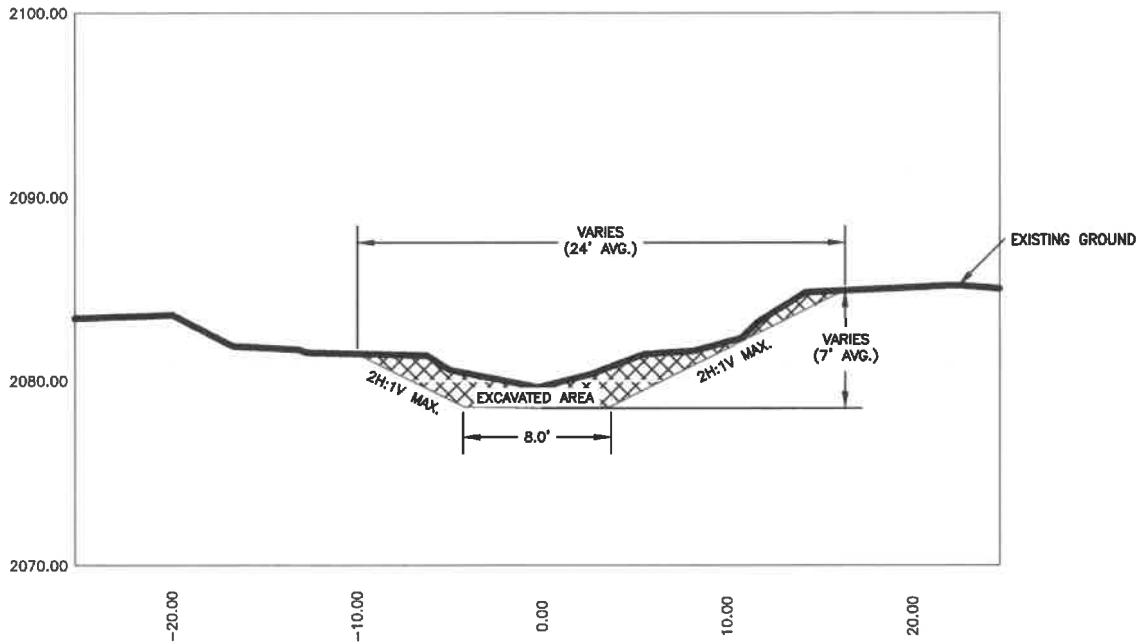
### CROSS SECTION 3-3

CHANNEL MAINTENANCE	
ELEMENT	VALUE
LENGTH OF CHANNEL MAINTENANCE	425 LF
EXCAVATION VOLUME WITHIN CHANNEL	950 CY
EXCAVATION AREA WITHIN CHANNEL	10,945 SF

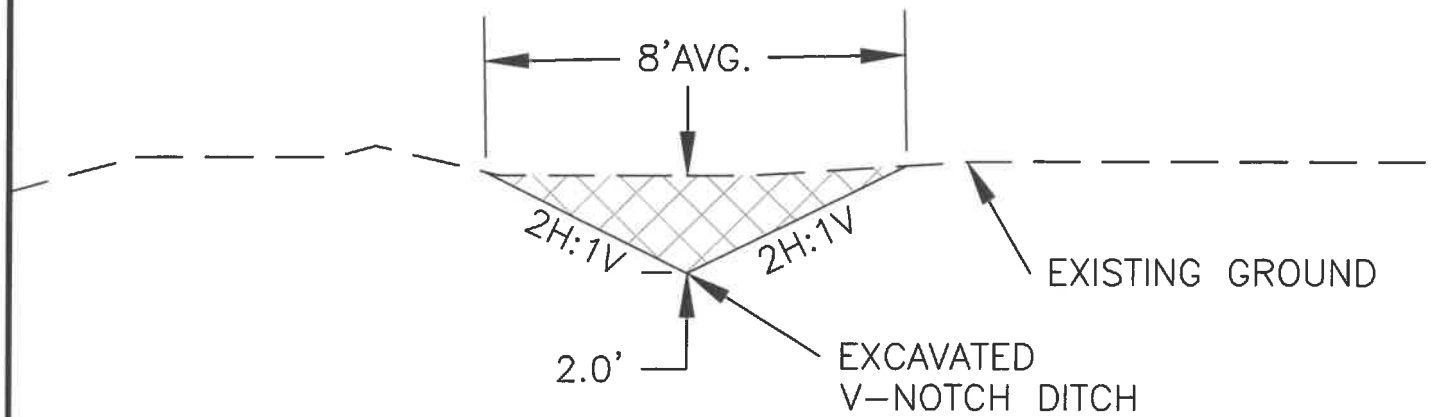
DIVERSION DITCH CROSS SECTION

DIVERSION DITCH	
ELEMENT	VALUE
LENGTH OF DIVERSION DITCH	650 LF
EXCAVATION VOLUME WITHIN DITCH	195 CY
EXCAVATION AREA WITHIN DITCH	5,200 SF

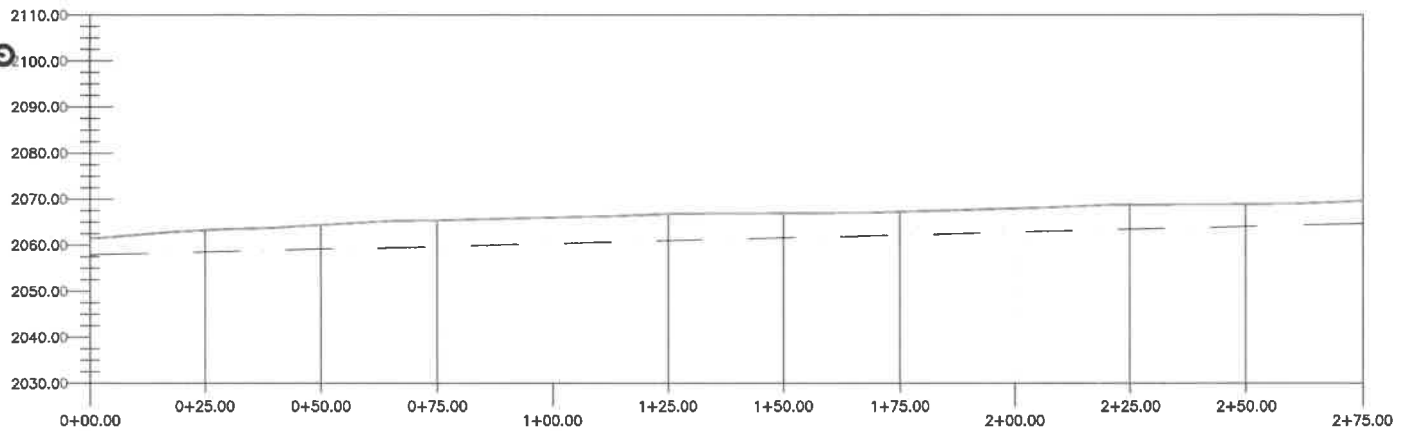
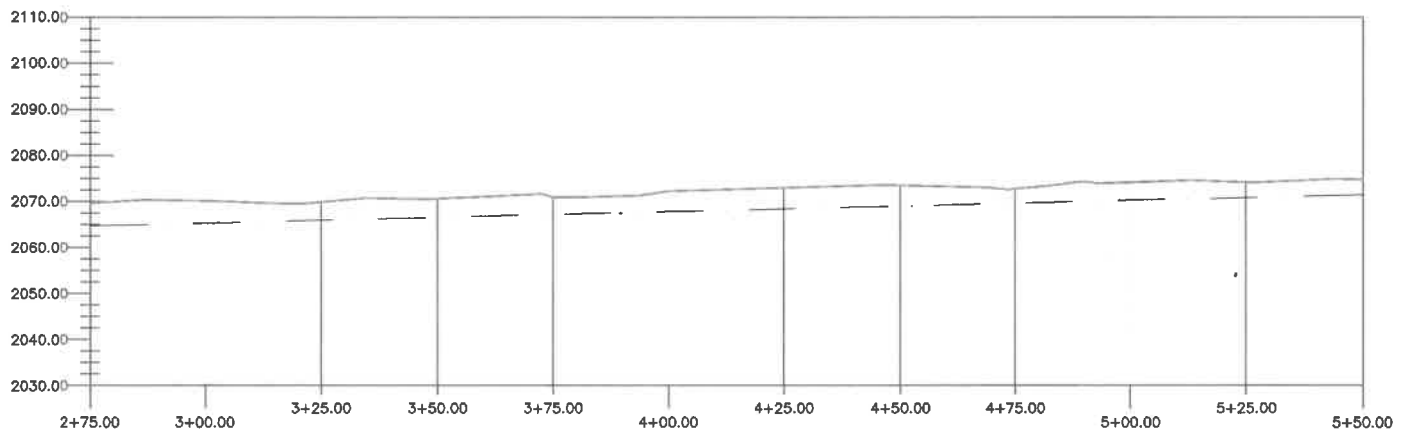
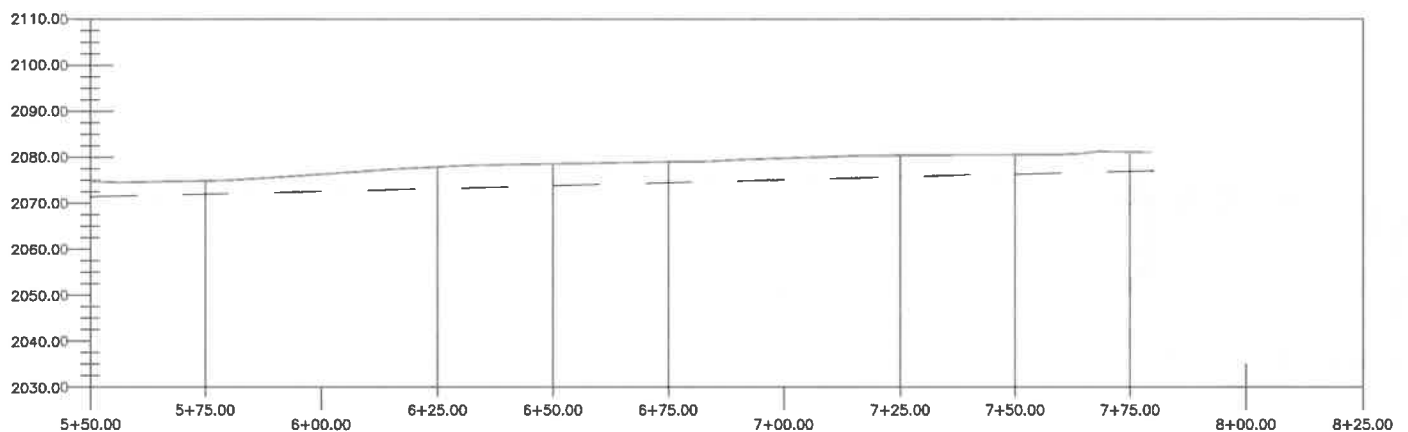
## PROFILE — STREAMBED

CHANNEL MAINTENANCE	
ELEMENT	VALUE
LENGTH OF CHANNEL MAINTENANCE	780 LF
EXCAVATION VOLUME WITHIN CHANNEL	2,250 CY
EXCAVATION AREA WITHIN CHANNEL	19,175 SF

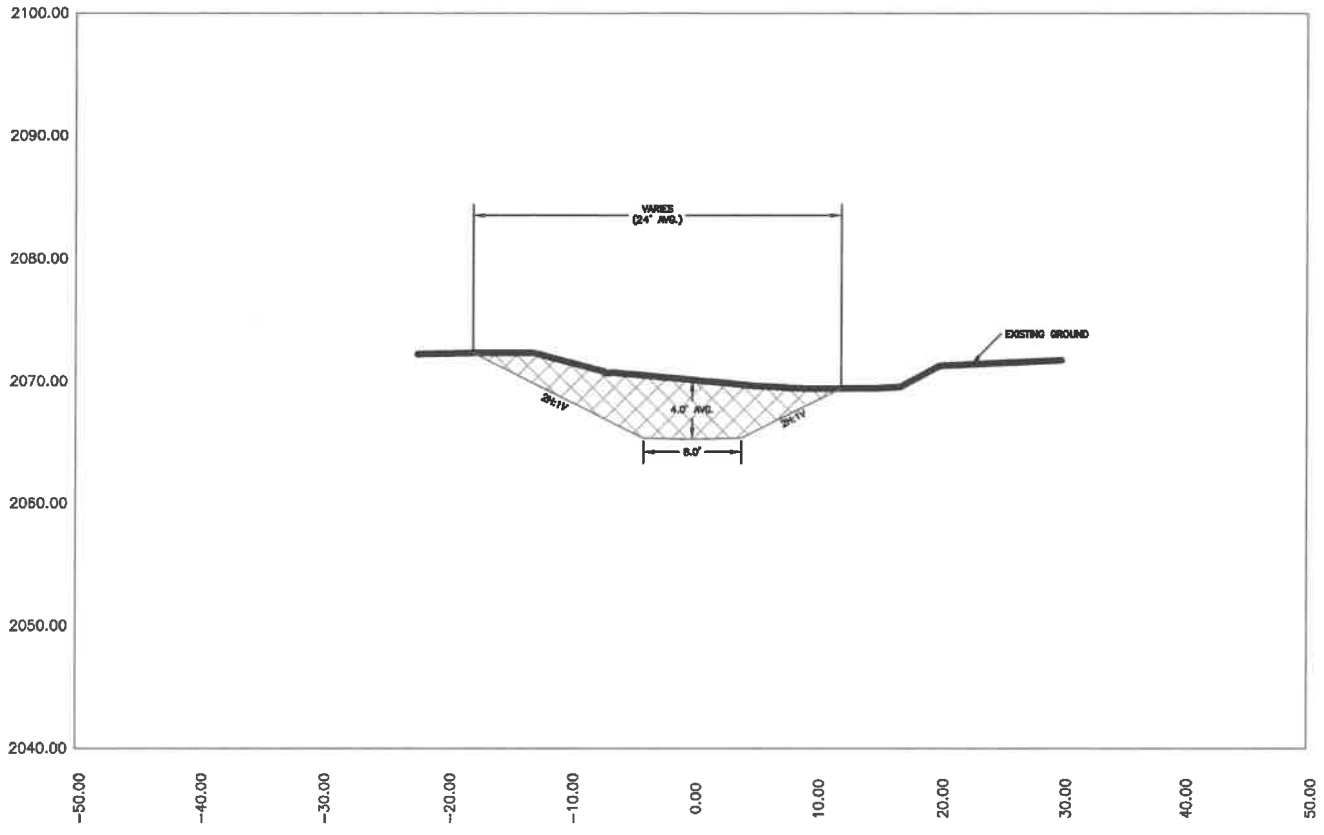
CROSS SECTION 1-1

CHANNEL MAINTENANCE	
ELEMENT	VALUE
LENGTH OF CHANNEL MAINTENANCE	780 LF
EXCAVATION VOLUME WITHIN CHANNEL	2,250 CY
EXCAVATION AREA WITHIN CHANNEL	19,175 SF

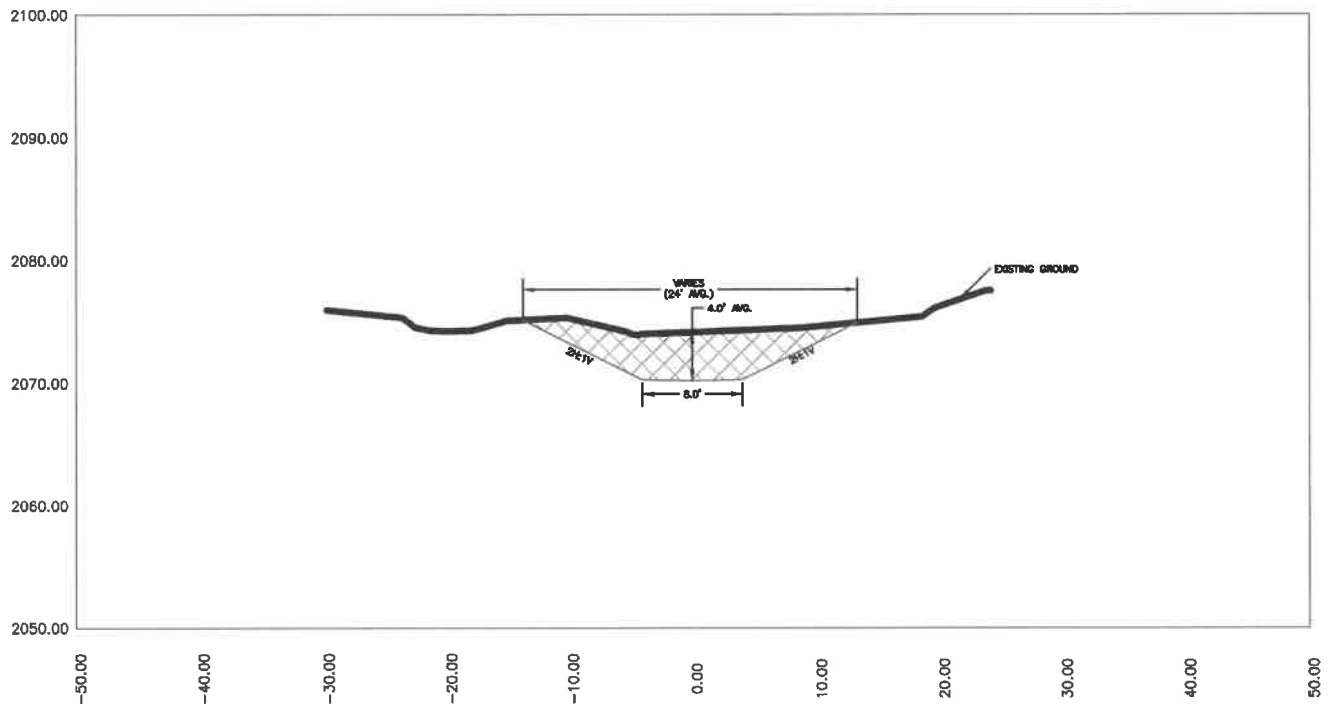
## CROSS SECTION 2-2

CHANNEL MAINTENANCE	
ELEMENT	VALUE
LENGTH OF CHANNEL MAINTENANCE	780 LF
EXCAVATION VOLUME WITHIN CHANNEL	2,250 CY
EXCAVATION AREA WITHIN CHANNEL	19,175 SF

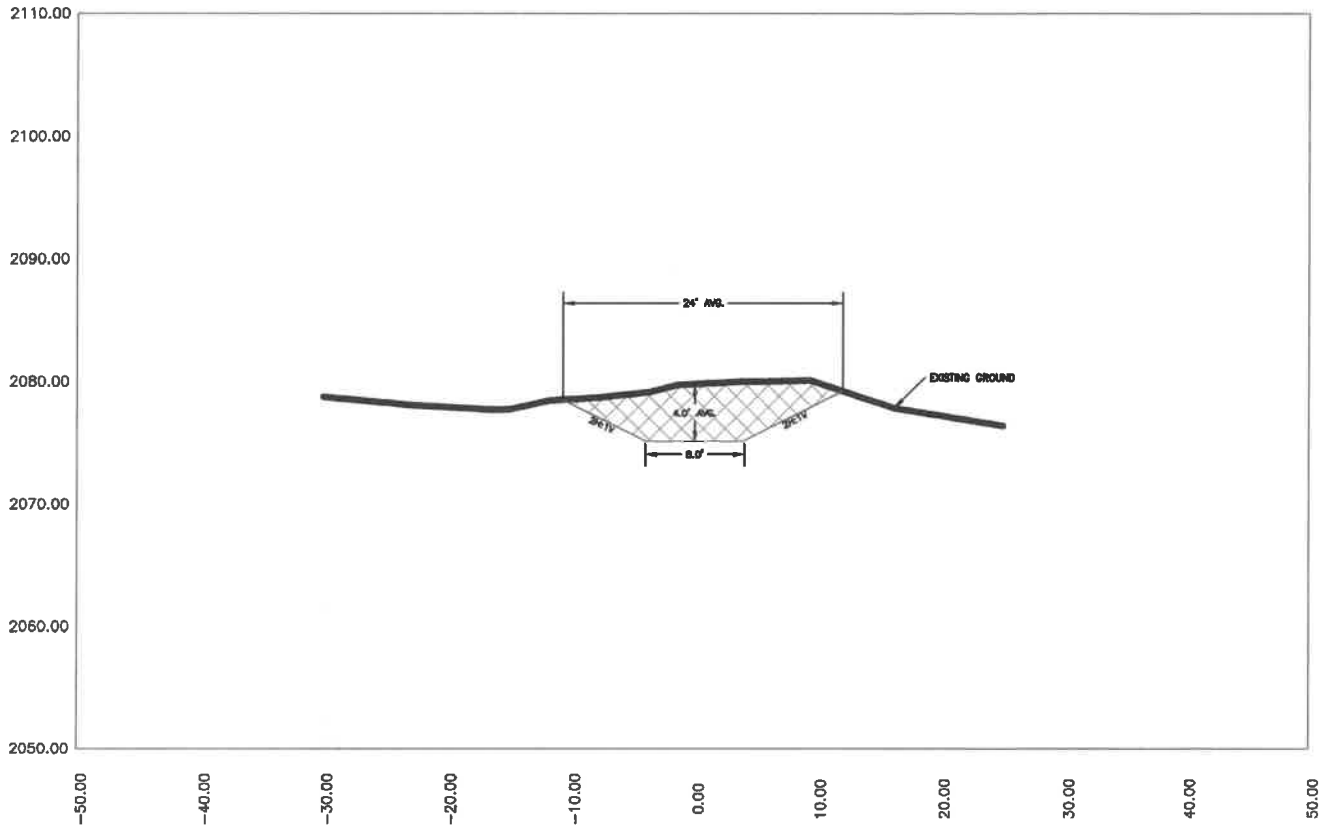
### CROSS SECTION 3-3

CHANNEL MAINTENANCE	
ELEMENT	VALUE
LENGTH OF CHANNEL MAINTENANCE	780 LF
EXCAVATION VOLUME WITHIN CHANNEL	2,250 CY
EXCAVATION AREA WITHIN CHANNEL	19,175 SF

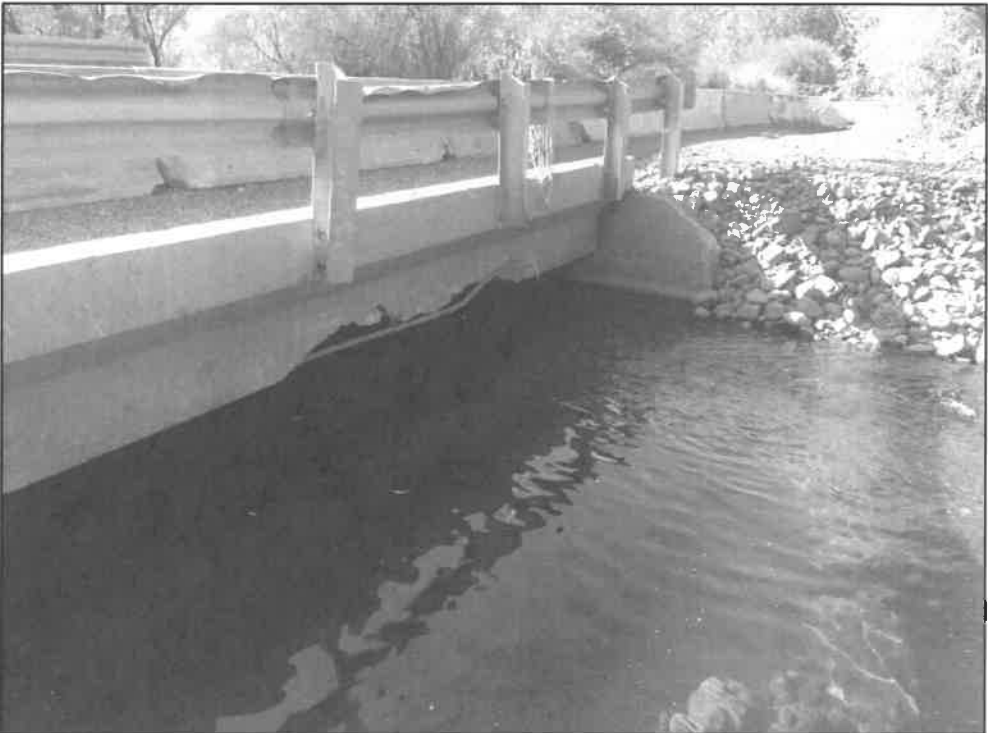
Photo 4. Damage to Bar 14 Road Bridge.

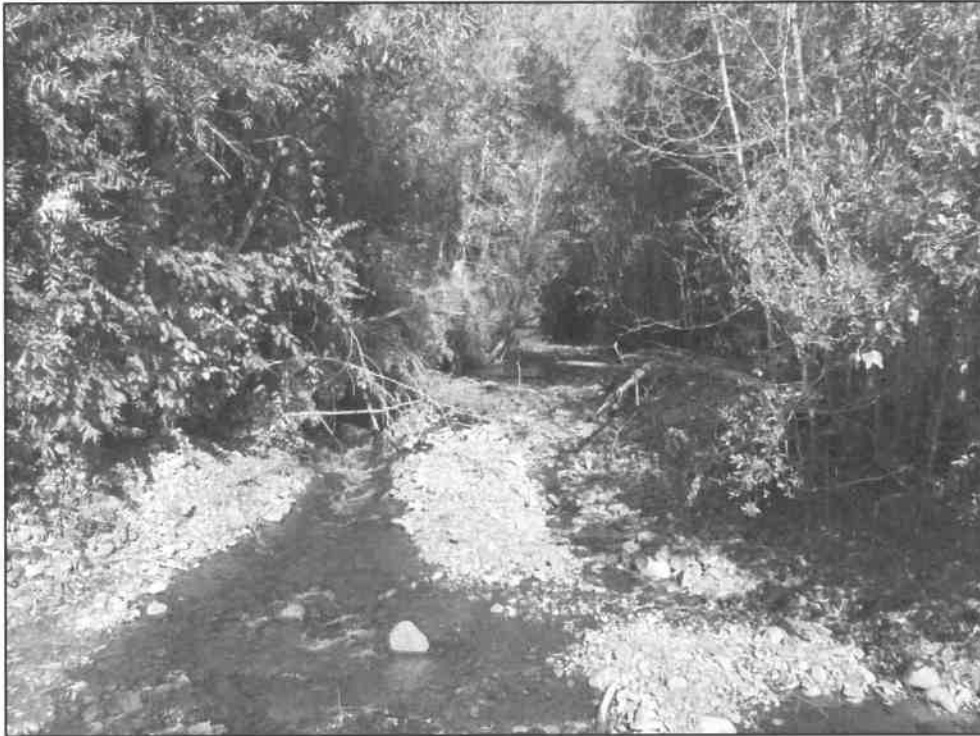
Photo 5. Aggraded sediment and cobbles upstream of the bridge.

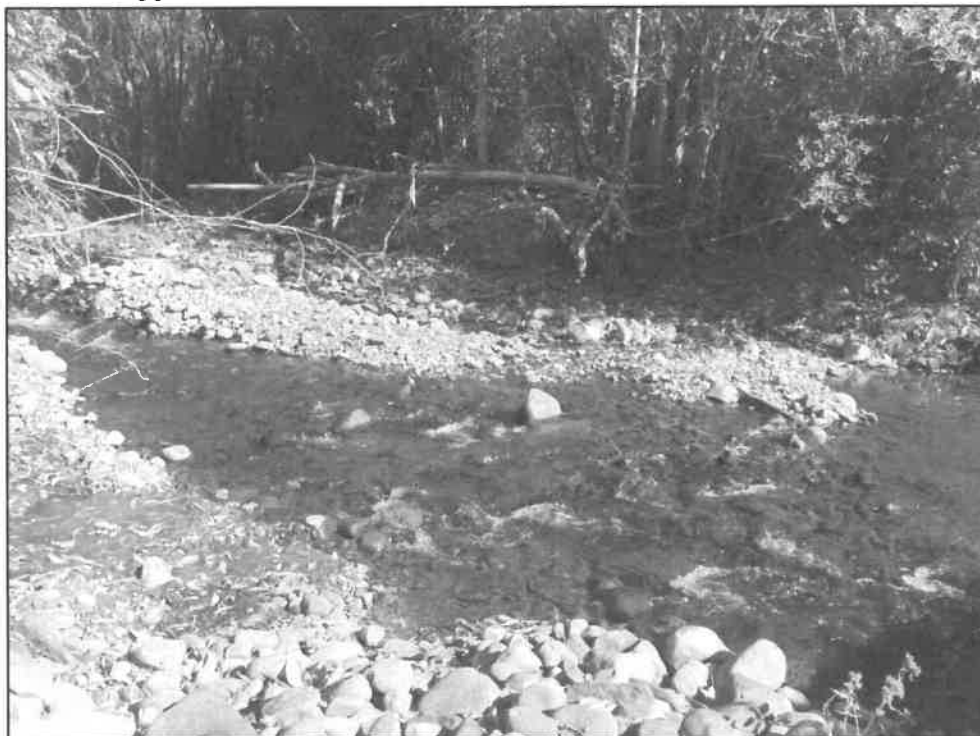
Photo 6. Aggraded sediment and cobbles upstream of the bridge.

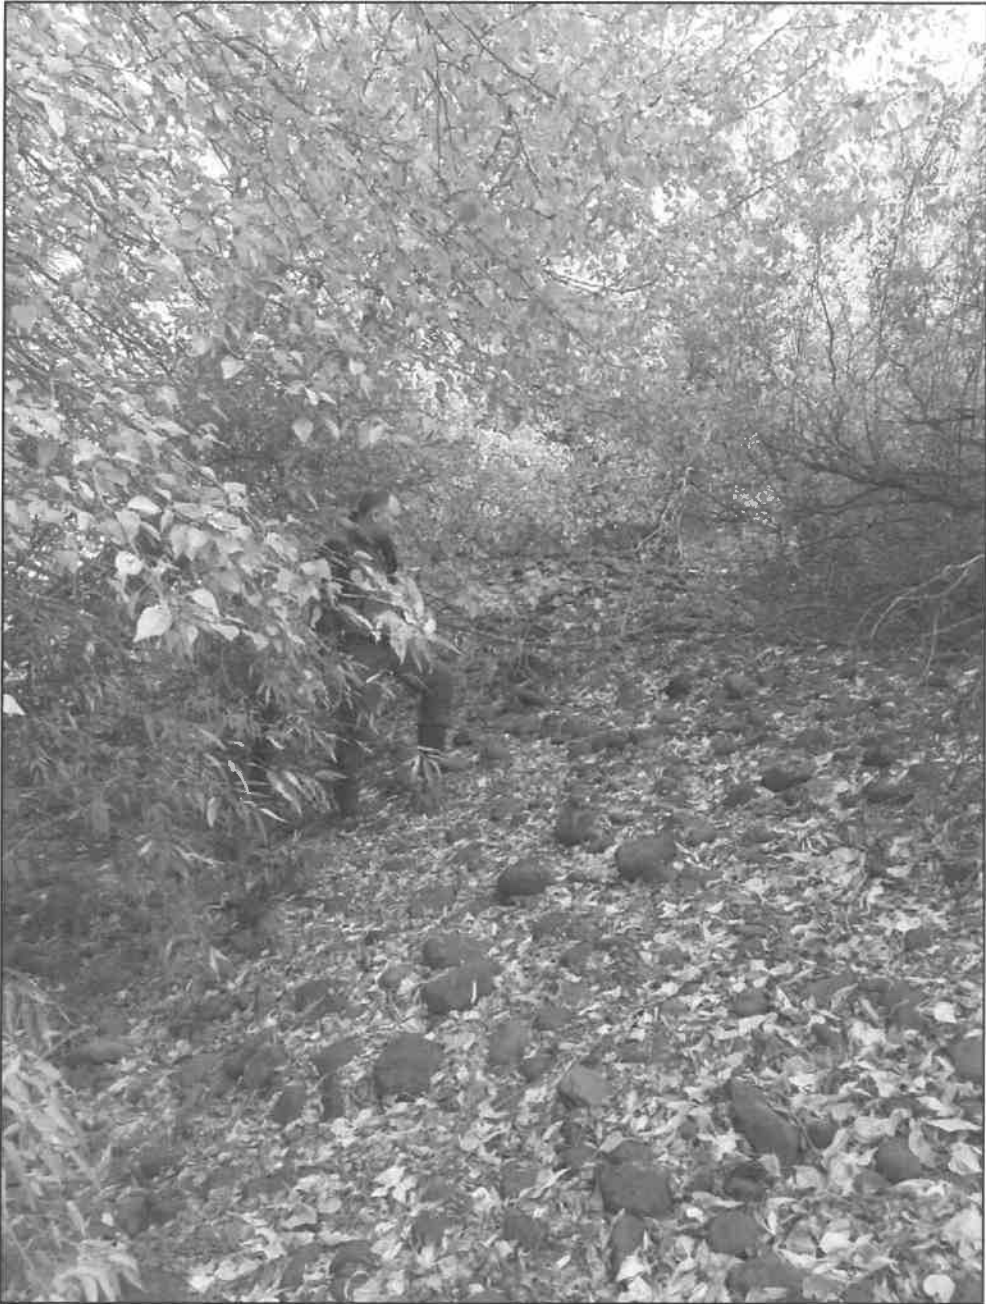
Photo 7. Sidecast material from historic channel maintenance.

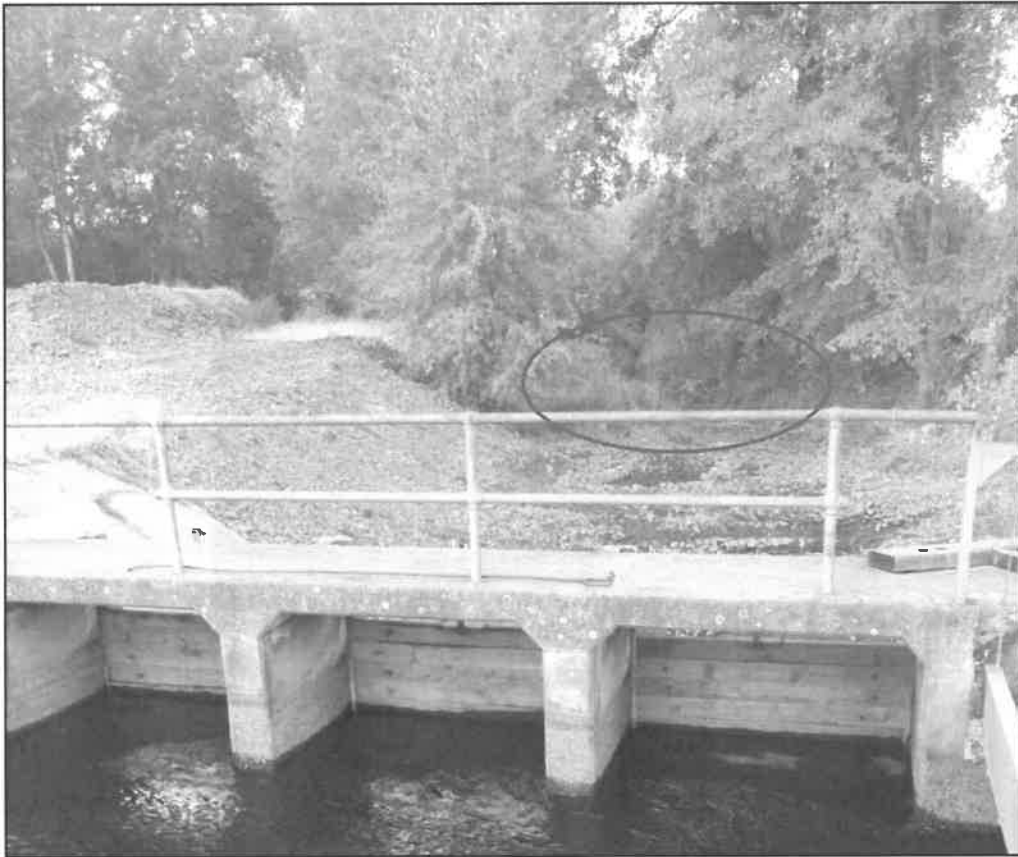
Photo 1. KRD intake looking upstream at Naneum Creek channel. Note chronic bedload on the left that is removed from the intake structure. Circle shows perched bedload.

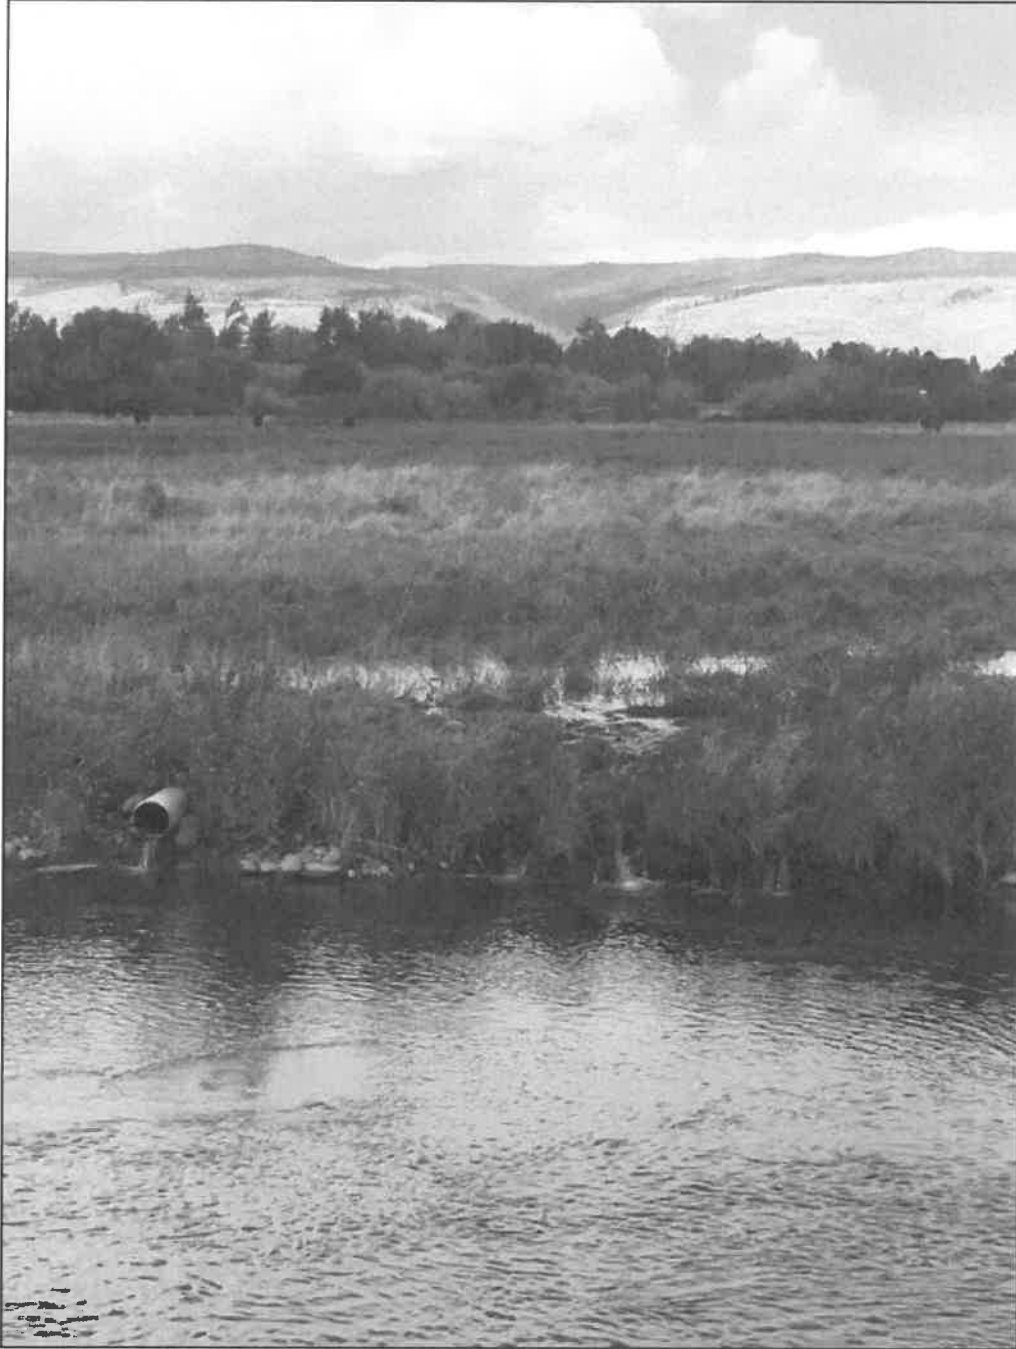
Photo 2. KRD canal with Naneum Creek overflow. Note bank scour.
