# SHORELINE BUFFER PLANTING PLAN

**Parcel #893234  
Kittitas County, Washington**

**GG Environmental**

July 28, 2021  
**RECEIVED**  
AUG 10 2021

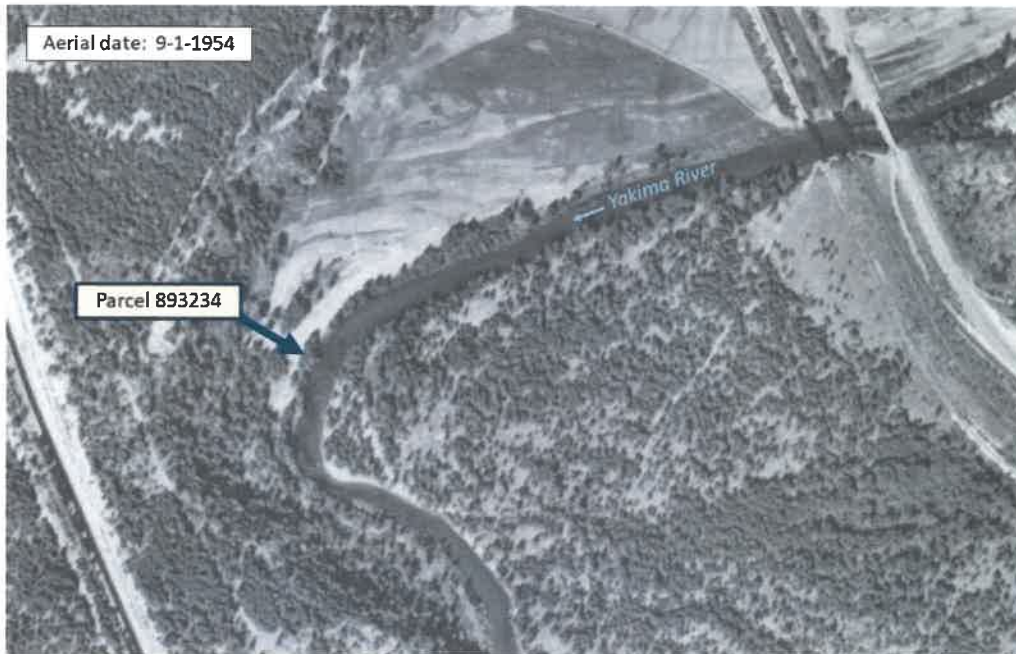
Figure 2. Aerial image from 1954

The flow path of the local Yakima River reach<sup>4</sup> has remained relatively stable over time, showing little variation in its meander since at least 1954 (CWU 2021). At that time, riparian vegetation along the north (right) bank of the river was limited to a narrow band of trees and shrubs, presumably due to clearing for adjacent agricultural management (**Figure 2**).

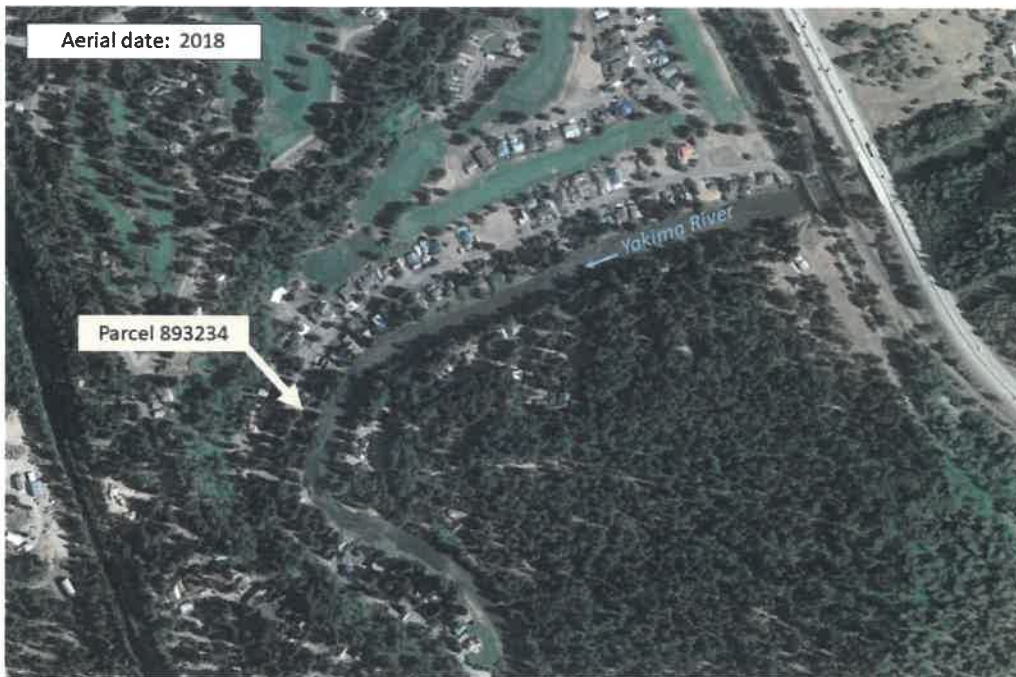
Figure 3. Aerial image from 2018

Historic aerial imagery shows high-density residential development on the right bank of the river since at least 1998 (Google 2021) (**Figure 3**). For at least the past two decades, vegetation along the bank has been limited to that which spatially conforms to the aggregate layout of residential structures. Each residence has a uniquely-managed shoreline exposure with diverse plant densities and communities.

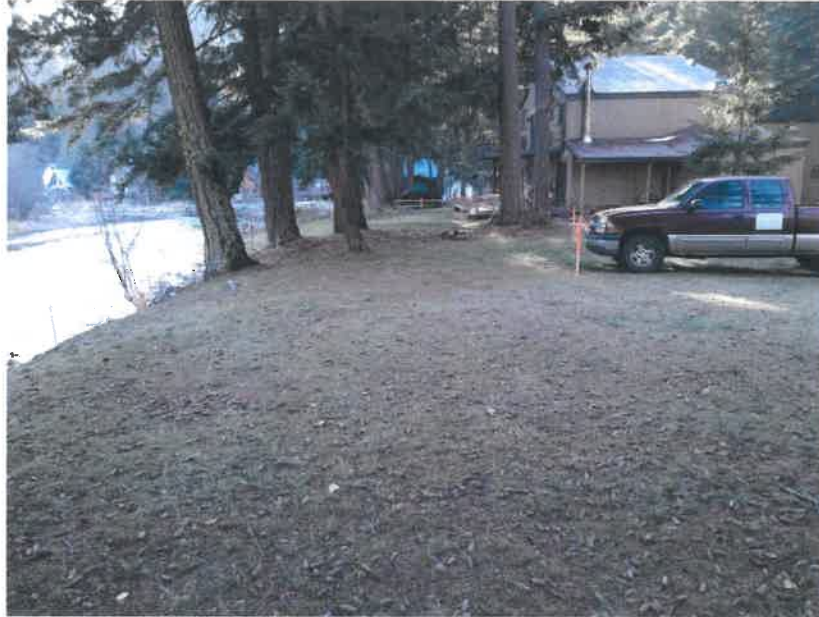
**Photo 1. East end of the parcel at the river. Viewed downstream on 12-5-2020.**

The riverbank along the parcel is sparsely vegetated, limited to a small alder, several snowberry shrubs, a single Oregon grape, and reed canarygrass. The upstream section of the bank includes rock reinforcement. Several mature Douglas fir trees are present at the top of the riverbank in the parcels' southeast corner. The rest of the parcel is largely devoid of woody vegetation, excepting two small shrub clusters near Pebble Beach Drive, consisting of vine maple, elderberry, snowberry, and Oregon grape. No bird nests were observed in the shrubs. Wildlife observations in the vicinity were limited to deer on the golf course and a single instance of beaver gnaw near the parcel. No sign of pooled water or surface runoff was observed on the parcel. As such, it is inferred that infiltration is rapid and no surface flow enters the river. No wetlands were observed within the parcel boundary. Photos of the parcel are included in **Attachment 1 – Site Photos**.

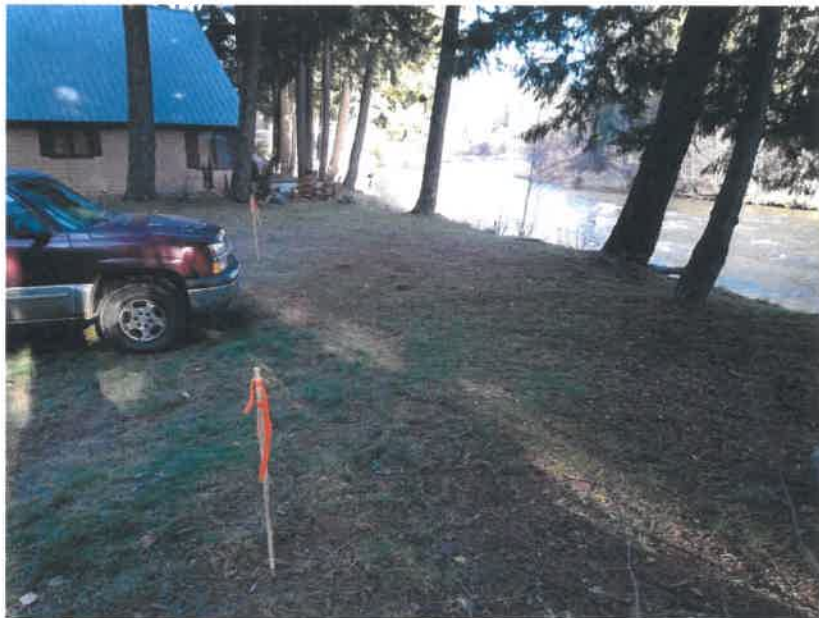
**Photo 2. East end of the parcel at the river. Viewed upstream on 12-5-2020.**

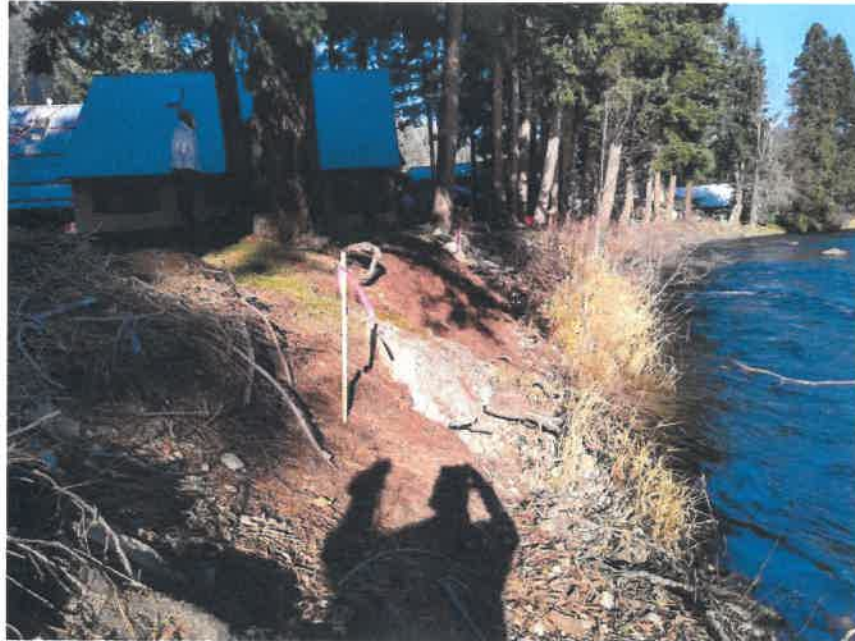
**Photo 3. Existing vegetation on the riverbank. Viewed upstream on 12-5-2020.**
