RE: Conceptual Block Wall at 280 Wilderness Lane Easton, WA

We propose installing a gravity type block wall such as the Redi Rock product. The wall is initially estimated to be 70-ft long and 15-ft high maximum. See Figure 1 Site Plan with conceptual wall location.

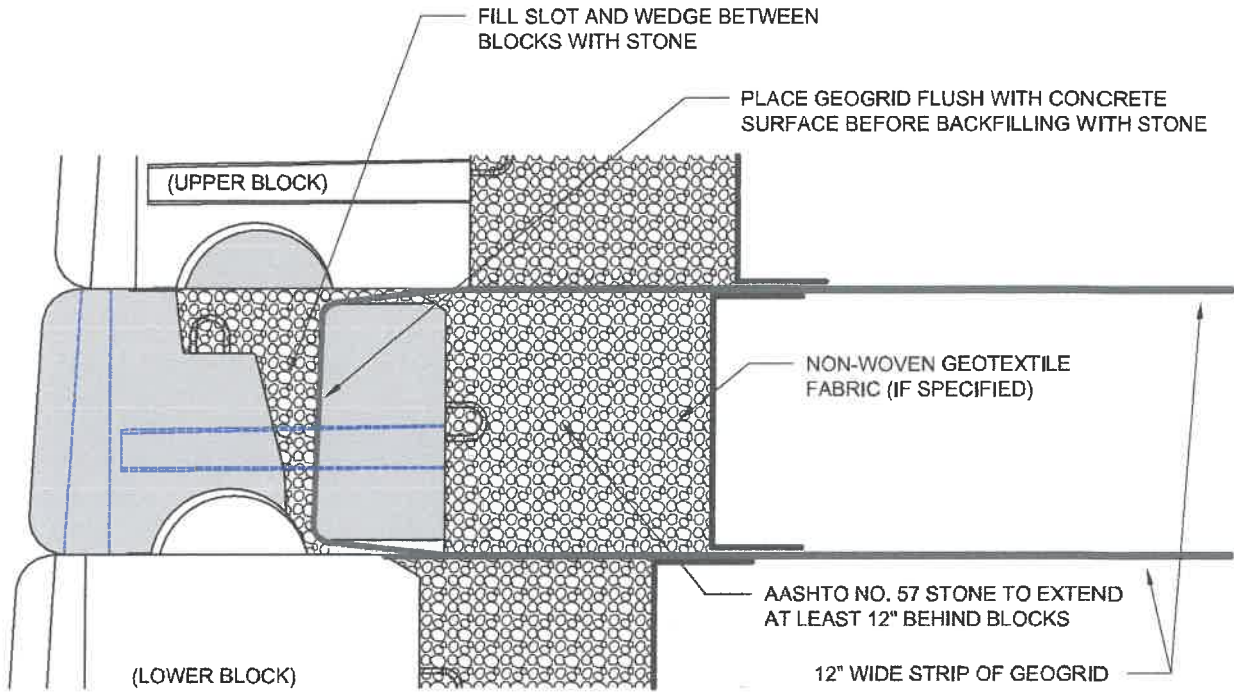
SECTION VIEW THROUGH BLOCKS

GEOGRID STRIP WRAPS THROUGH BLOCK AND EXTENDS FULL LENGTH (L) INTO REINFORCED FILL ZONE (TYPICAL)

We recommend a positive connection wall with geogrid reinforcement geogrid.
See Figure 2 Block wall reinforced design.

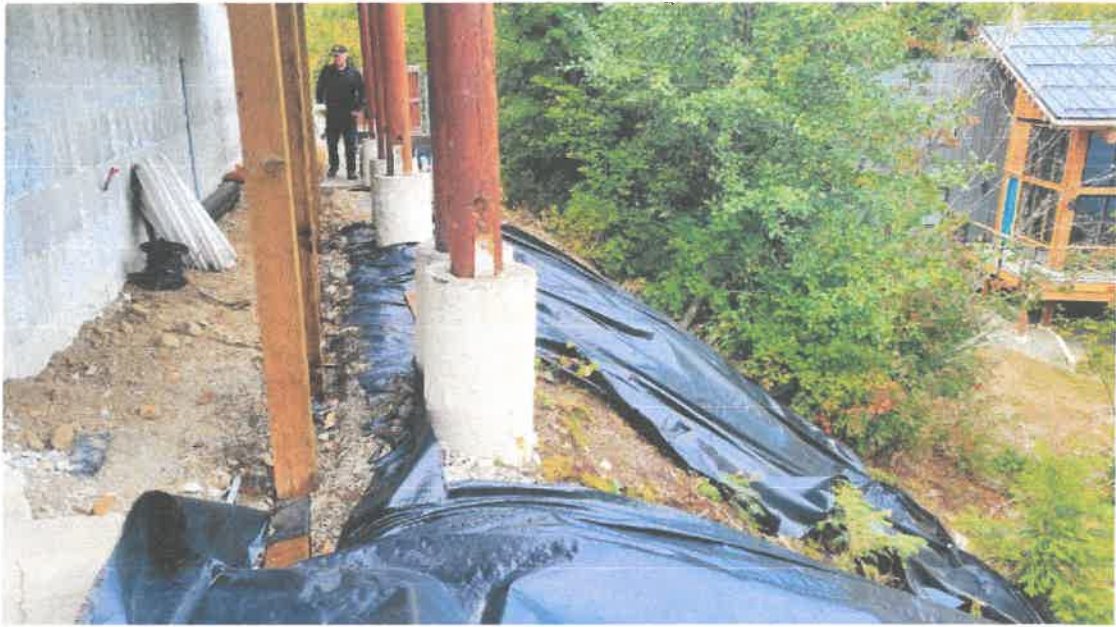
Looking west along north wall, demolition work continues and protecting slope with plastic.

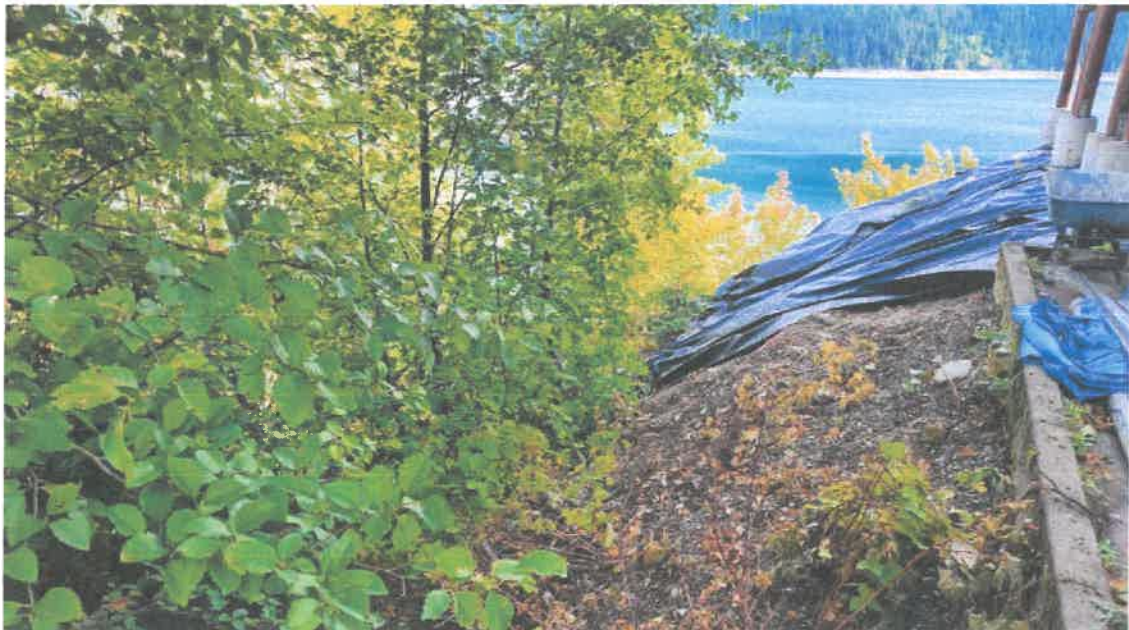
Looking east along north side of property where steep slope exists. Block wall would extend east into middle area of photo depending on soil/rock conditions.

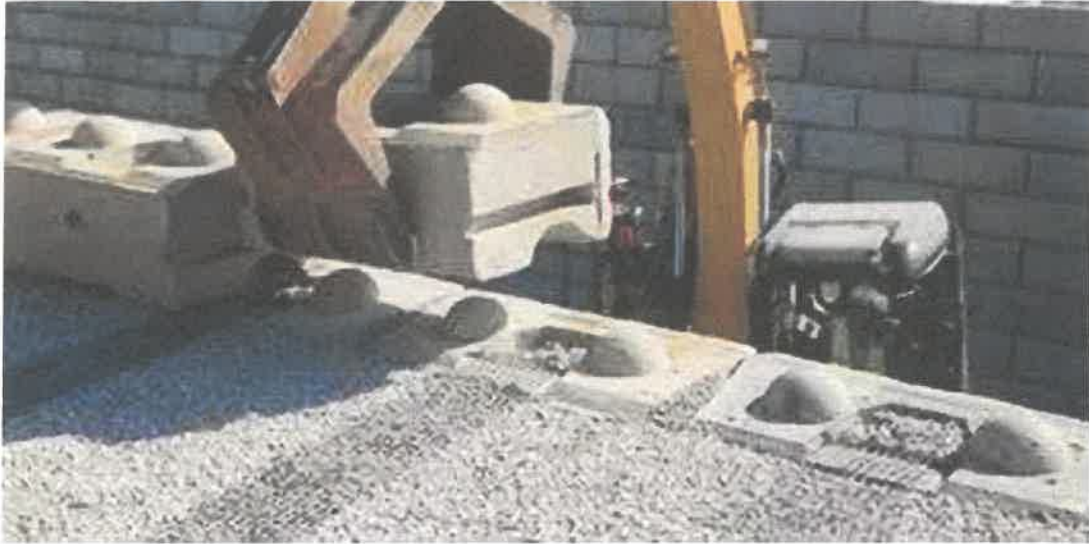
Example of placing Redi Rock block wall

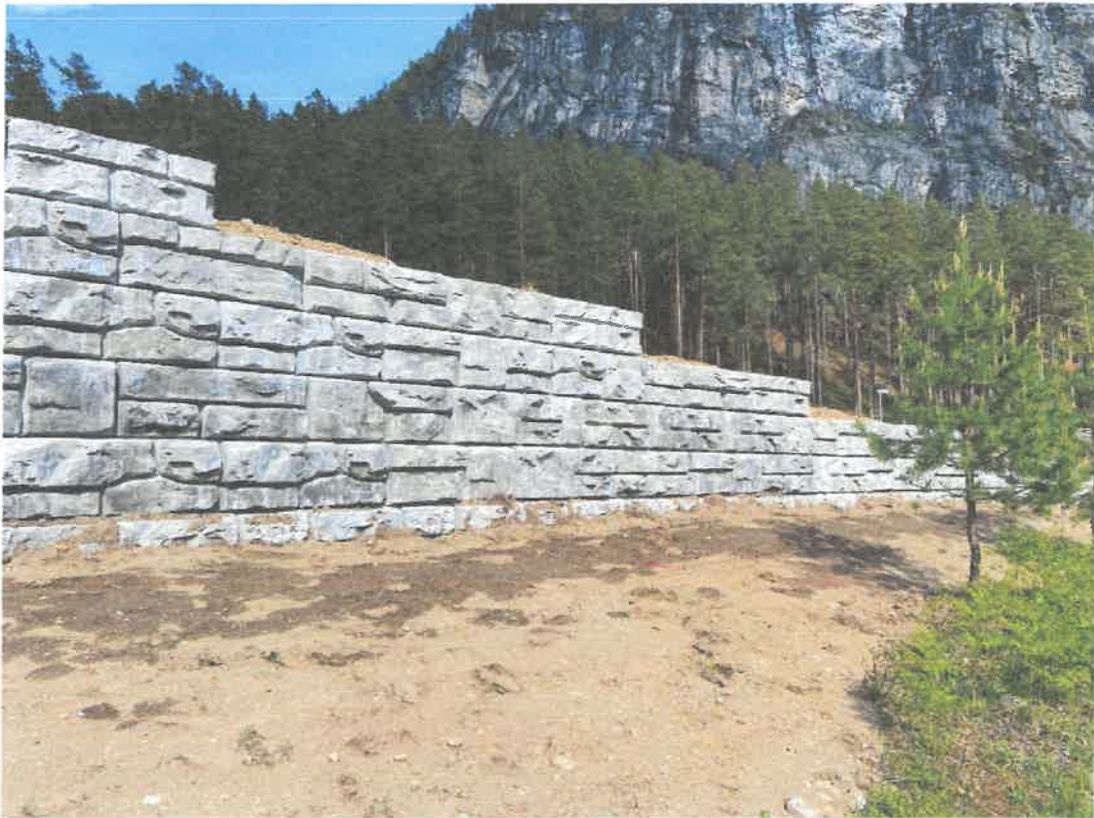
Example of Redi Rock block wall in alpine environment
