Sparks Road: DRAINAGE REPORT

Prepared by:
Encompass Engineering & Surveying
407 Swiftwater Blvd
Cle Elum, WA 98922

**SPARKS ROAD
LEVEL 1 DOWNSTREAM ANALYSIS**

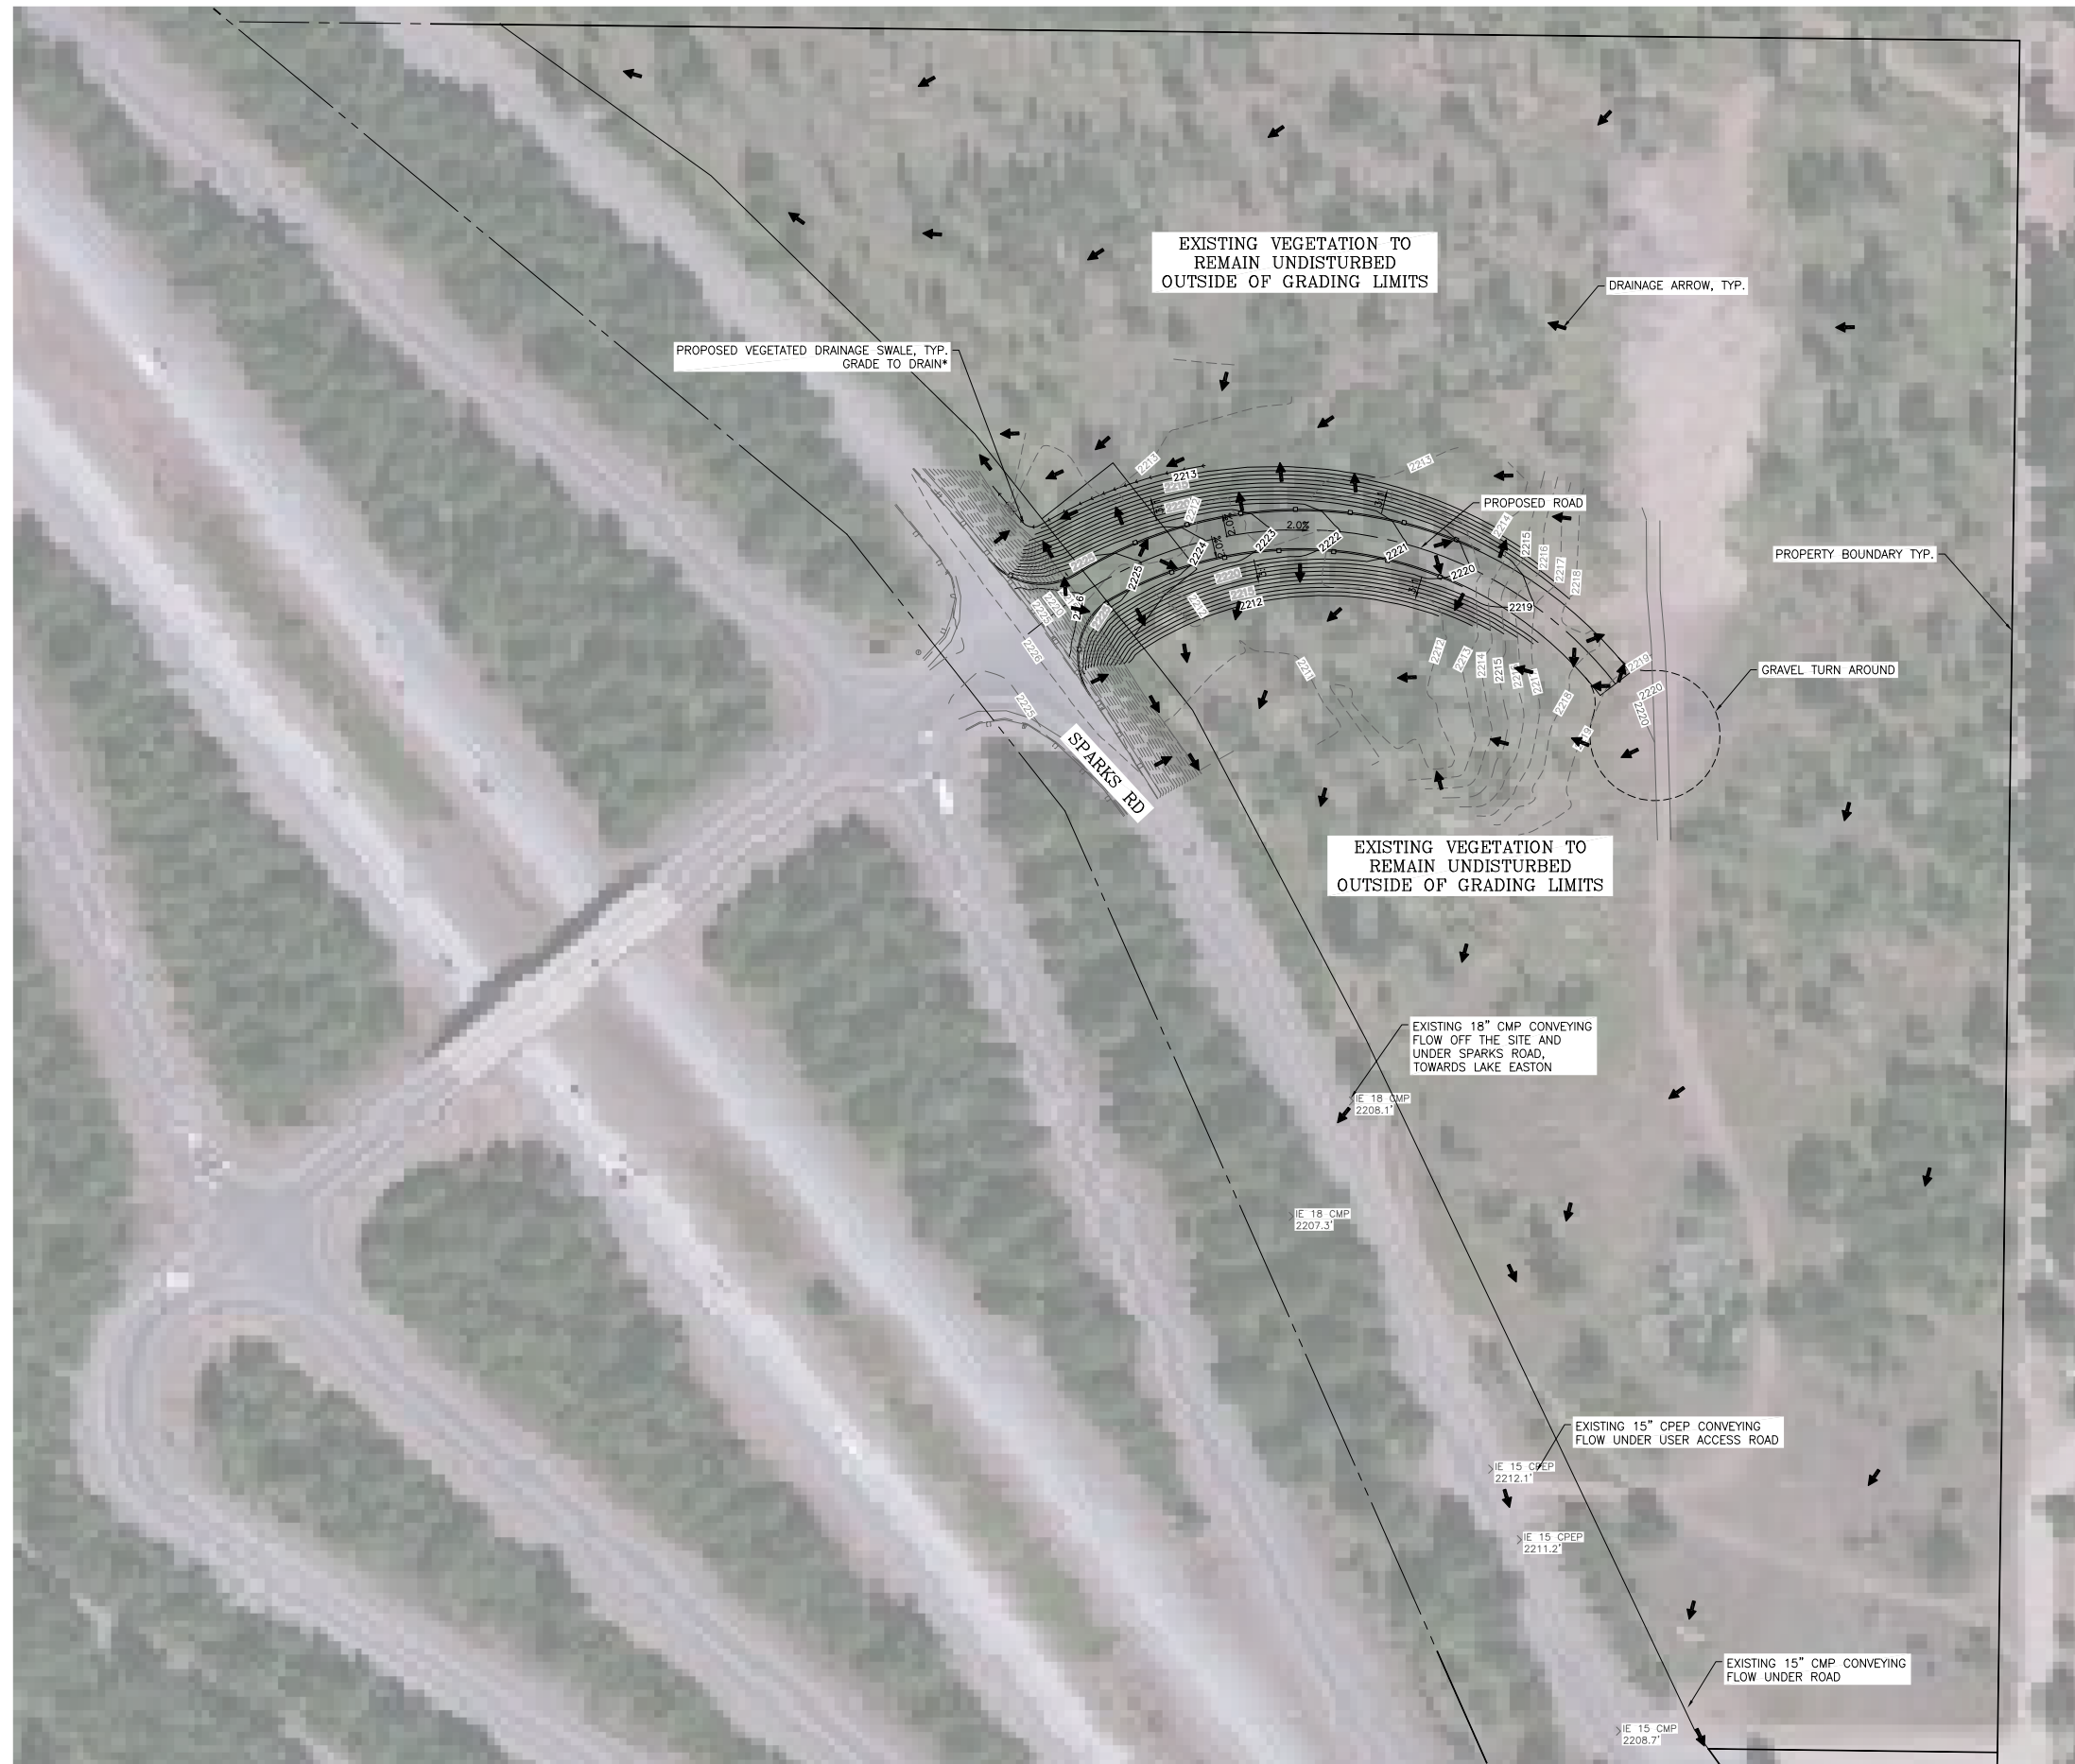
SPARKS ROAD
 NATHAN WEIS
 PROPOSED DRAINAGE CONDITIONS EXHIBIT

The only grading and ground disturbance resulting from this project will be in relation to the proposed access road. Aside from the access road, the drainage basin will remain relatively undisturbed, with similar drainage patterns. Proposed conditions can be seen in Figure 1.

1. Preparation of a Stormwater Site Plan:
 - This can be seen in Figure 1- Proposed Drainage Basin Map, and will be included in the civil plans.
2. Construction Stormwater Pollution Prevention:

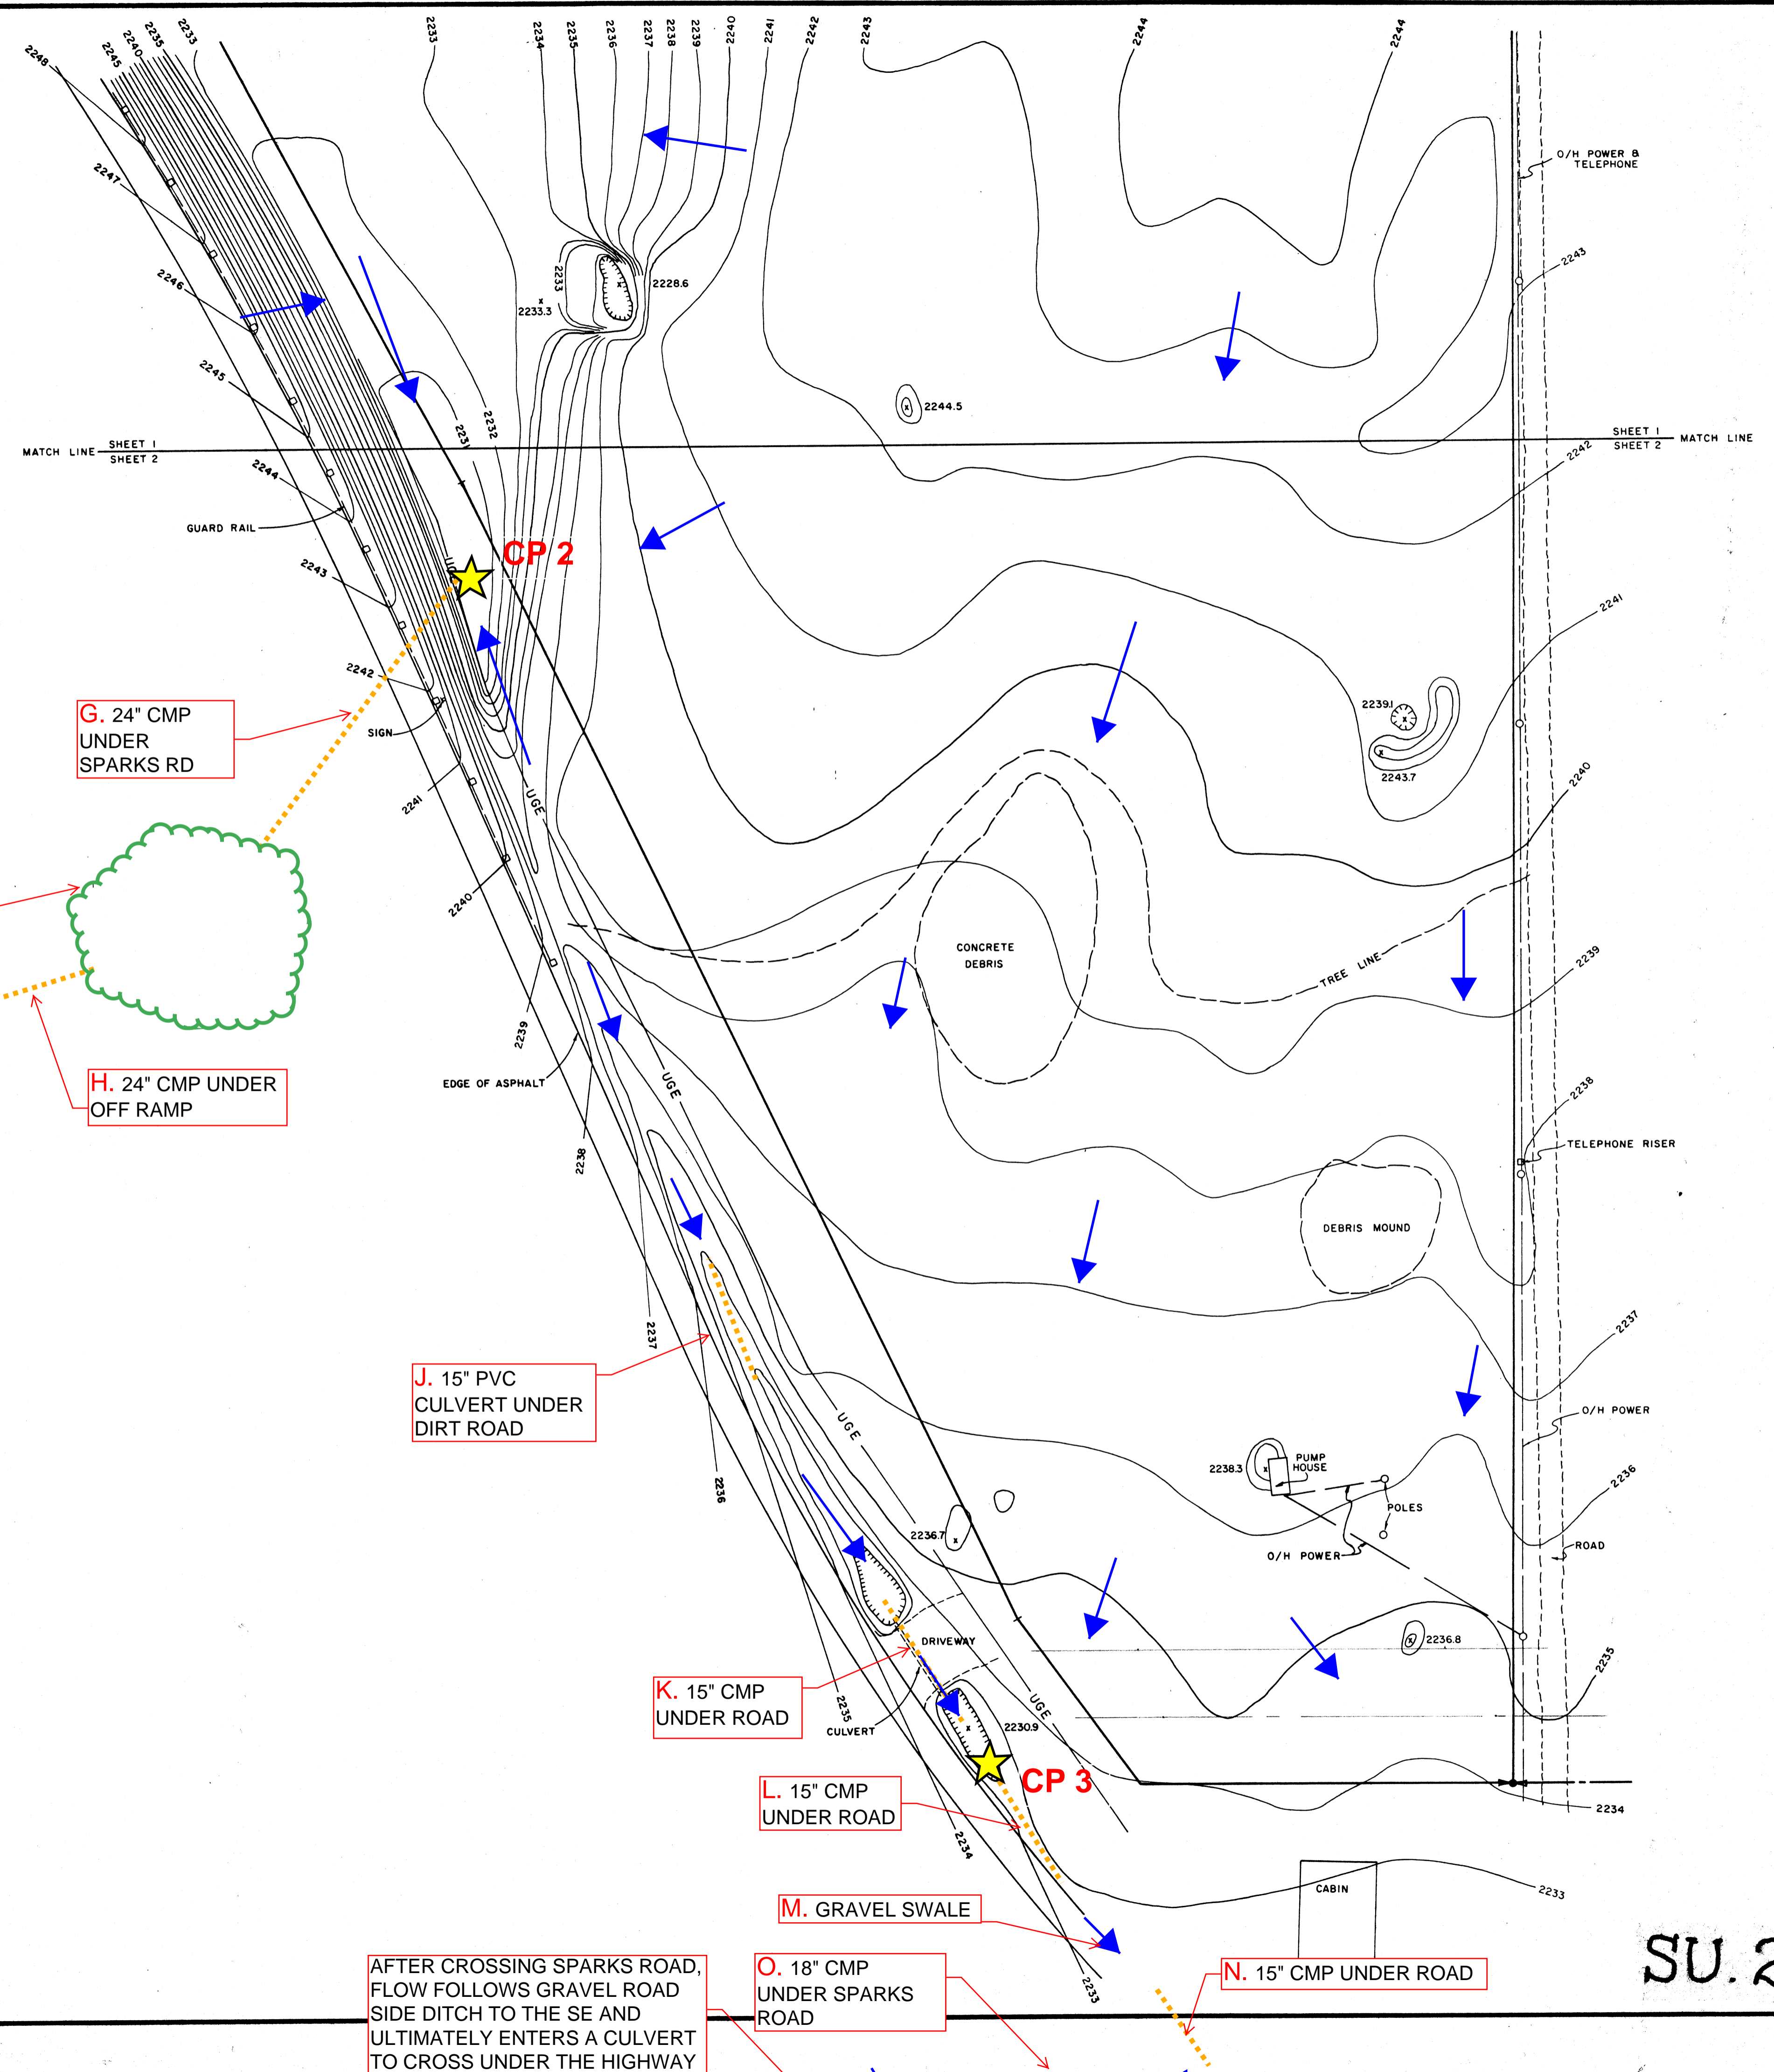
**EXHIBIT A2
STUDY AREA MAP
SPARKS ROAD DOWNSTREAM ANALYSIS**

G. 24" CMP UNDER SPARKS RD

FLAT SHRUBBED AREA WITH NO DISTINCT CHANNELS

H. 24" CMP UNDER OFF RAMP

I. 15" CONCRETE CULVERT UNDER I-90

J. 15" PVC CULVERT UNDER DIRT ROAD

K. 15" CMP UNDER ROAD

L. 15" CMP UNDER ROAD

M. GRAVEL SWALE

O. 18" CMP UNDER SPARKS ROAD

N. 15" CMP UNDER ROAD

AFTER CROSSING SPARKS ROAD, FLOW FOLLOWS GRAVEL ROAD SIDE DITCH TO THE SE AND ULTIMATELY ENTERS A CULVERT TO CROSS UNDER THE HIGHWAY

CP2 is located midway along the site’s southwestern border, see Exhibit A. There is an existing 24” CMP at this point that diverts water from the site to the southwest under Sparks Rd. This culvert outlets to a relatively flat, shrubbed area with no distinct channel. It gently slopes to the west, where the runoff enters a 24” CMP and travels under the I-90 off ramp. After exiting the culvert, it continues traveling west before entering a 15” concrete culvert that conveys the stormwater underneath I-90, towards Lake Easton.

CP3 marks the southeast corner of the project site. It sits at the end of the gravel channel that runs southeast along the southwestern border. The flow leaving the site at CP3 passes through at 15” CMP underneath a gravel road. The flow follows Sparks Rd to the south through a gravel ditch, towards another 15” CMP. Upon exiting the CMP, the flow continues south in a gravel roadside ditch, before entering an 18” CMP that crosses under Sparks Rd to the West. The runoff then follows a gravel roadside ditch on the west side of Sparks Rd. It travels south before ultimately entering a culvert to cross under I-90, towards Lake Easton.

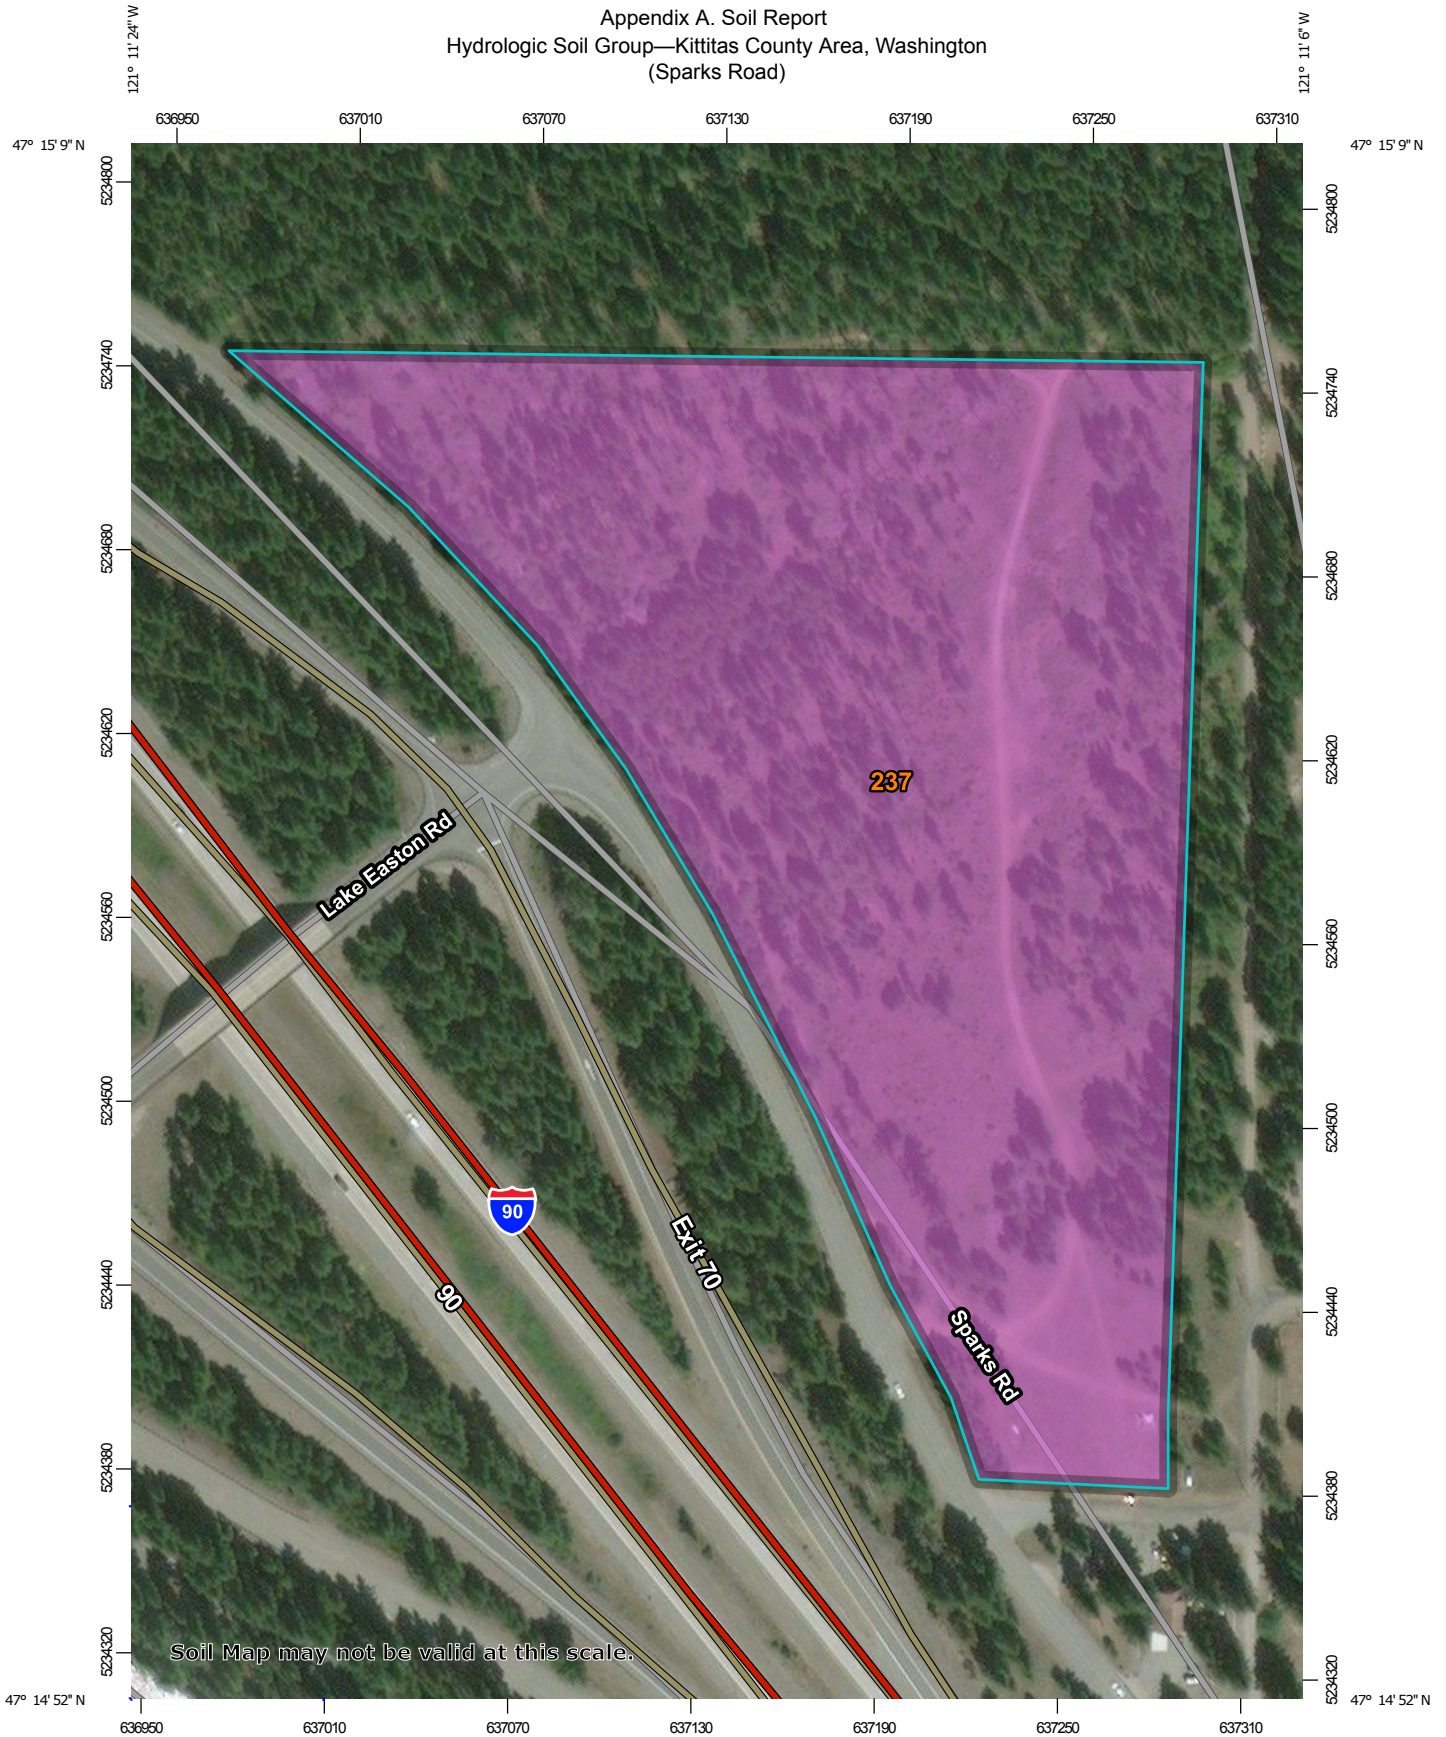
Appendix A. Soil Report
Hydrologic Soil Group—Kittitas County Area, Washington
(Sparks Road)

An NRCS Web Soil Survey was performed for the site in order to obtain onsite soil types. The results of the report give descriptions of the soils found in the project area and the corresponding hydrologic soil groups. The results can be seen in Appendix A of the Downstream Analysis (Appendix A). The site is composed entirely of Kladnick, ashy sandy loam with 0 to 3% slopes. This soil type belongs to Hydrologic Soil Group A, meaning it is well drained and has a high infiltration rate.

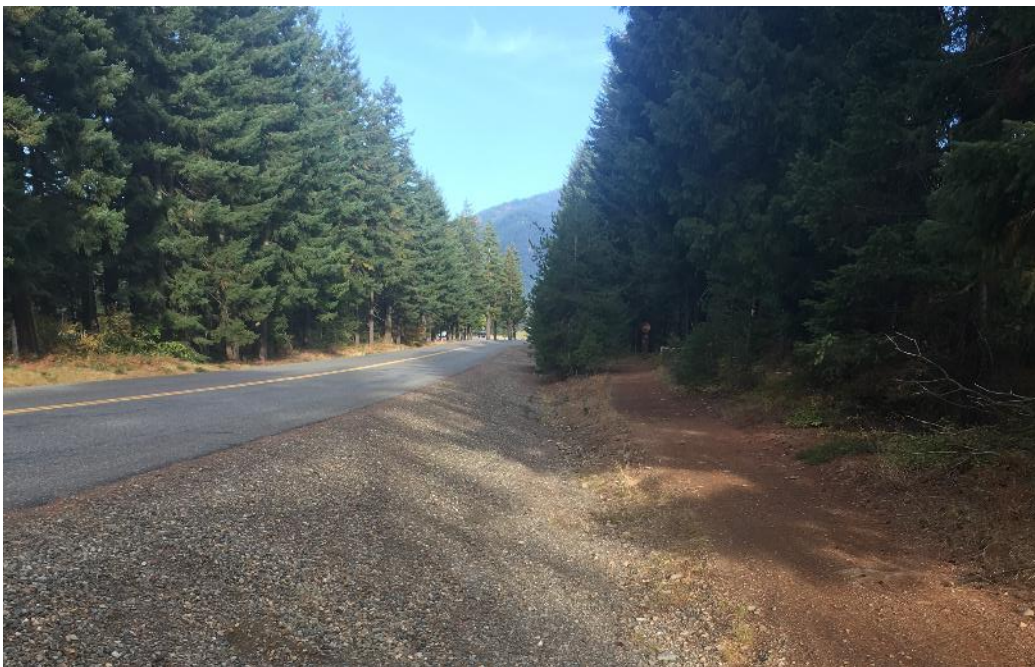
Figure 2: Feature A- Gravel swale, looking northwest from site

| OFF-SITE ANALYSIS DRAINAGE SYSTEM TABLE SURFACE WATER DESIGN MANUAL, CORE REQUIREMENT #2 | | | | | | |
|---|--|--|---|---|--|---|
| A | Existing Gravel Swale, 2 ft wide bottom, 3 ft deep 3:1 side slopes | relatively maintained | CP1 | immediately downstream | None | Along Sparks Rd, adequately sized |

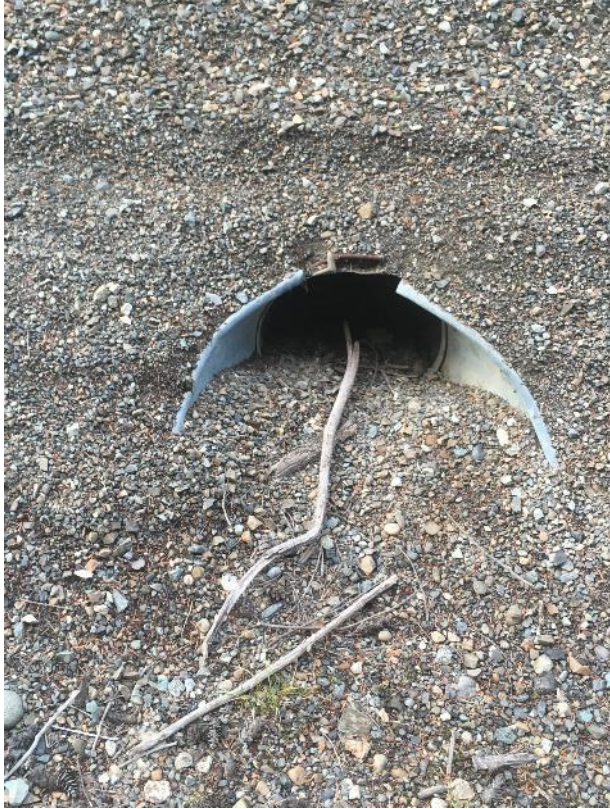
Figure 3: Feature C- 18" CMP entrance

| OFF-SITE ANALYSIS DRAINAGE SYSTEM TABLE SURFACE WATER DESIGN MANUAL, CORE REQUIREMENT #2 | | | | | | |
|---|--|--|---|---|--|---|
| C | 18" CMP | 2-3 ft of cover, approx. 50 ft long | CP1 | 100 ft downstream | Gravel buildup in pipes and near entrance/exit. | Conveys flow under Sparks Rd |

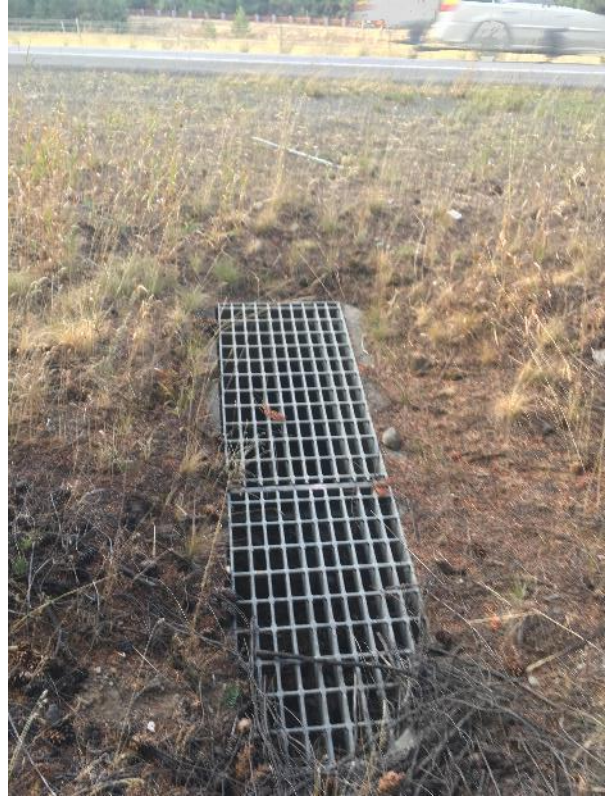
Figure 4: Feature F- Grate inlet prior to I-90

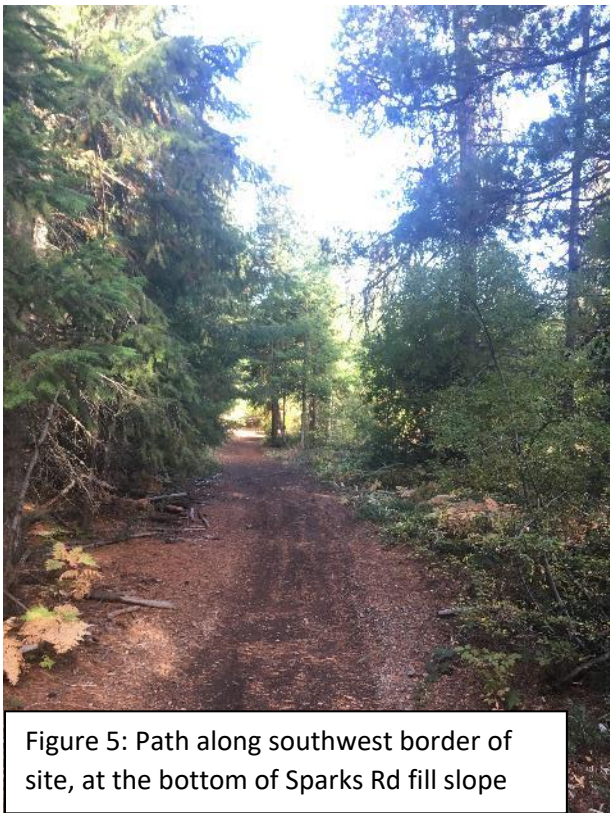
Figure 5: Path along southwest border of site, at the bottom of Sparks Rd fill slope

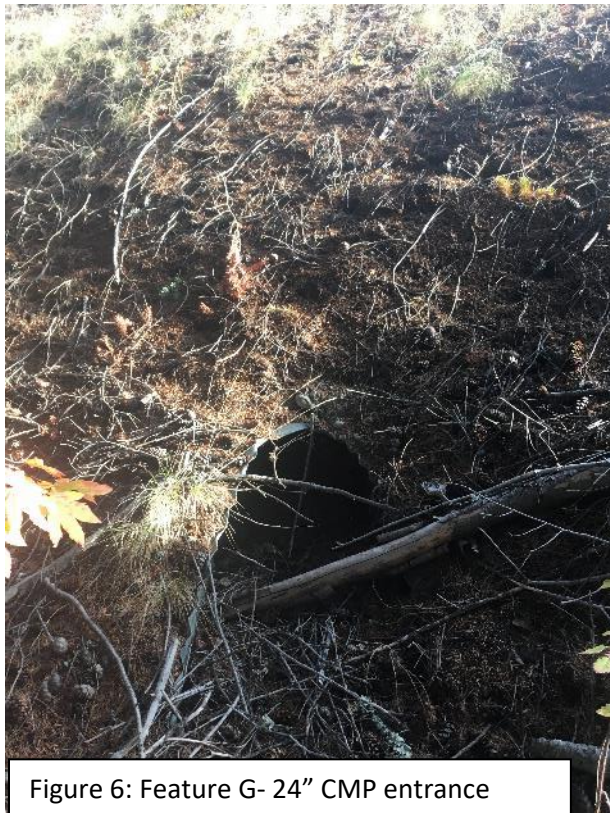
Figure 6: Feature G- 24" CMP entrance

An analysis of the runoff path has determined that there are a few minor problems with drainage features along the existing flow path. The culverts under Sparks Rd at CP2 and downstream of CP3 (Exhibit B, Features G and O) have the greatest obstructions at the entrances and exits. See Appendix B, Figures 6 and 12 for photos. Although this does not pose a large issue, it is recommended to clear any debris in and around the culvert when the project occurs. All swales and roadside ditches are in working condition and sufficiently sized to convey runoff. No erosion or sloughing was noted. The culverts along the flow paths appeared adequately sized to handle the runoff, as there were no signs of previous overtopping. Although there is some debris buildup at the entrances and exits of a few culverts, it is not enough to significantly impede the flow of water. The

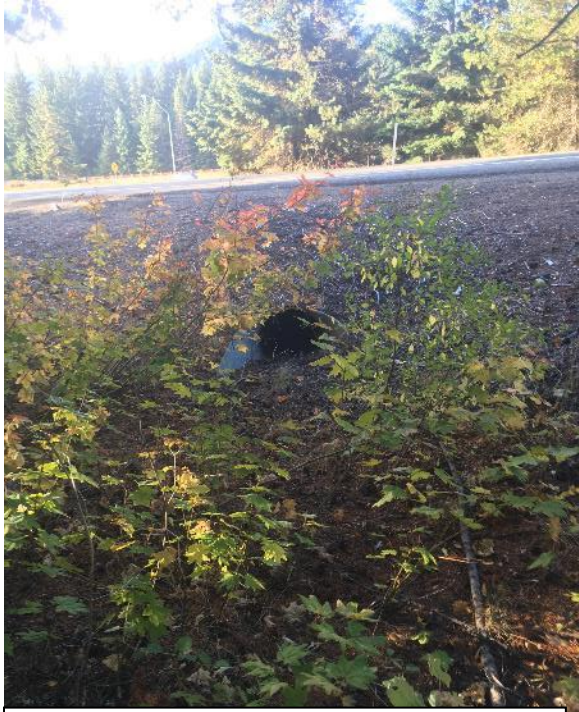
Figure 7: Feature H- 24" CMP entrance

| OFF-SITE ANALYSIS DRAINAGE SYSTEM TABLE SURFACE WATER DESIGN MANUAL, CORE REQUIREMENT #2 | | | | | | |
|---|--|--|---|---|--|---|
| H | 24" CMP | Approx 2-3 ft cover, 65 ft long | CP2 | 450 ft downstream | None | Conveys flow under I-90 off ramp |

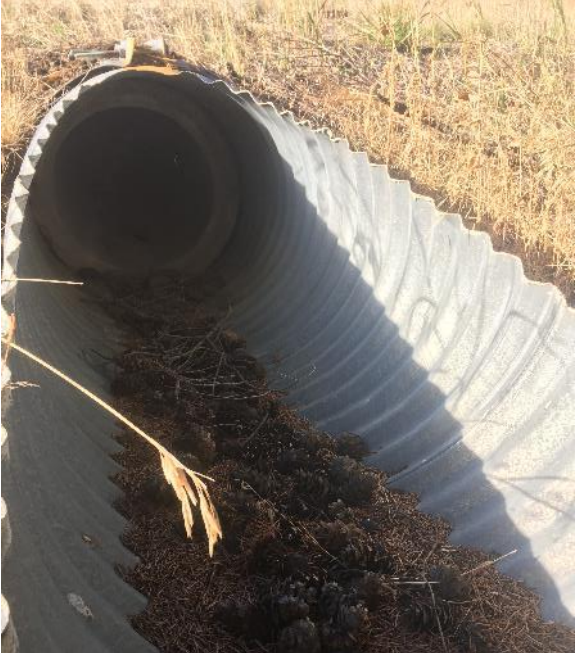
Figure 8: Feature I- 15" Concrete culvert entrance

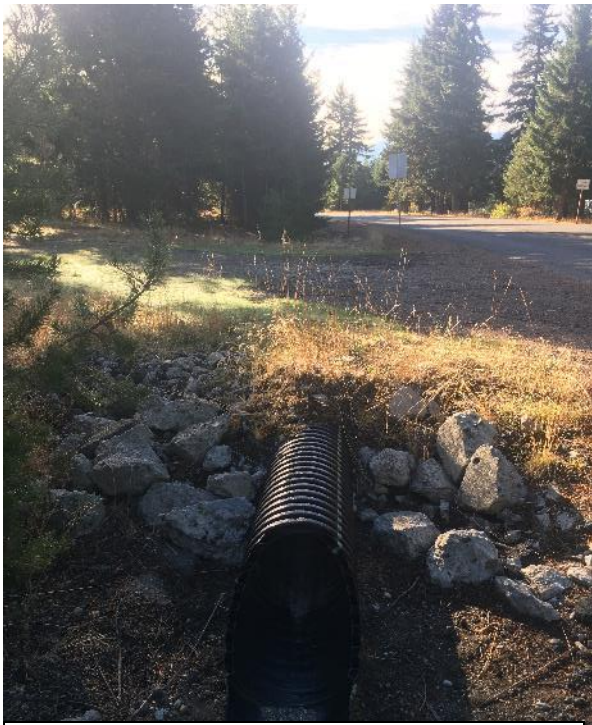
Figure 9: Feature J- 15" PVC culvert entrance

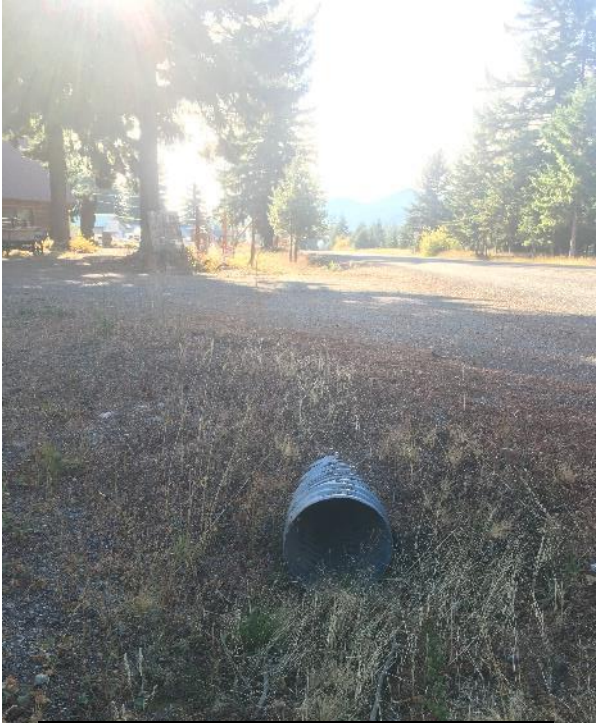
Figure 10: Feature L- 15" CMP entrance

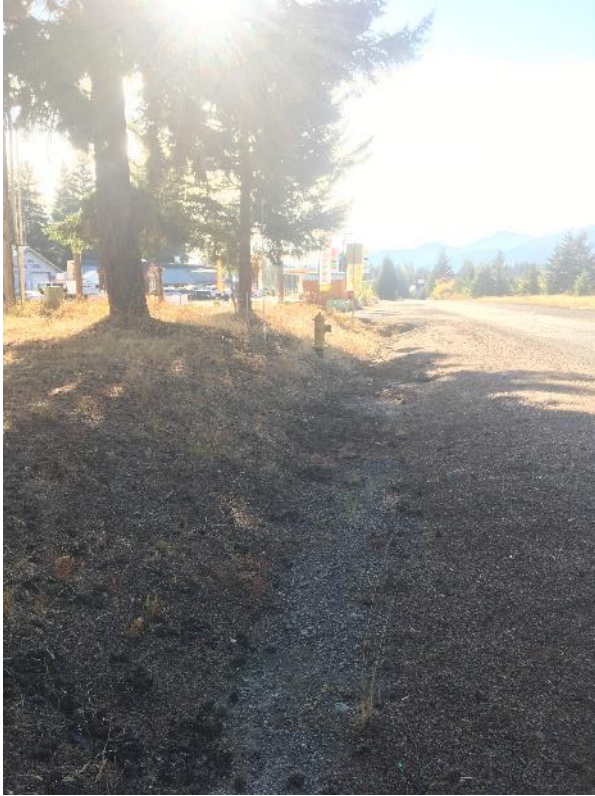
Figure 11: Feature M- Gravel Swale, looking southeast along Sparks Rd

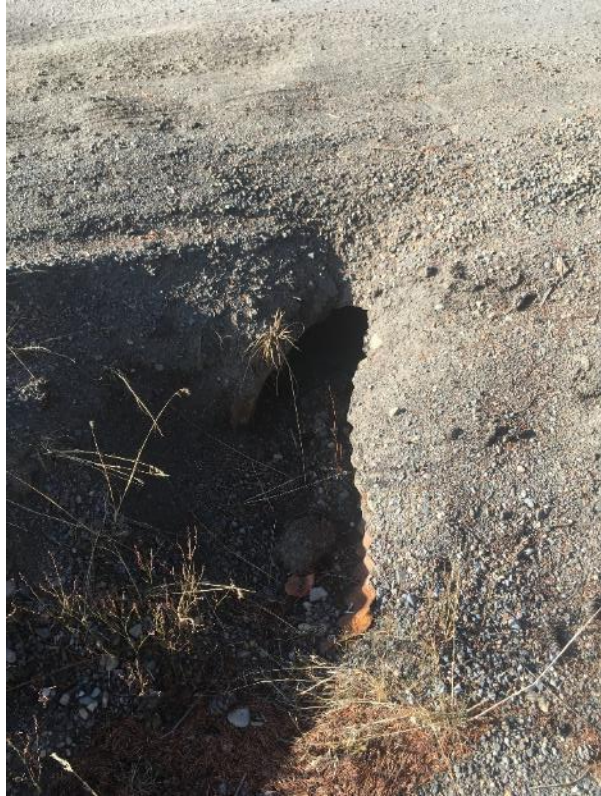
Figure 12: Feature O- 18" CMP entrance

| OFF-SITE ANALYSIS DRAINAGE SYSTEM TABLE SURFACE WATER DESIGN MANUAL, CORE REQUIREMENT #2 | | | | | | |
|---|--|--|---|---|--|---|
| O | 18" CMP | 2-3 ft of cover, 50 ft long | CP3 | 450 ft downstream | debris buildup at pipe entrance and pipe is partially squashed | Conveys flow under Sparks Rd to a roadside gravel ditch on the west side of the road |
