## Joint Aquatic Resources Permit Application (JARPA) Form<sup>1,2</sup> [\[help\]](#)

Fairview Road Culvert Replacement Project

Kittitas County Public Works

**Vicinity Map, Site Plans, and Drawings**

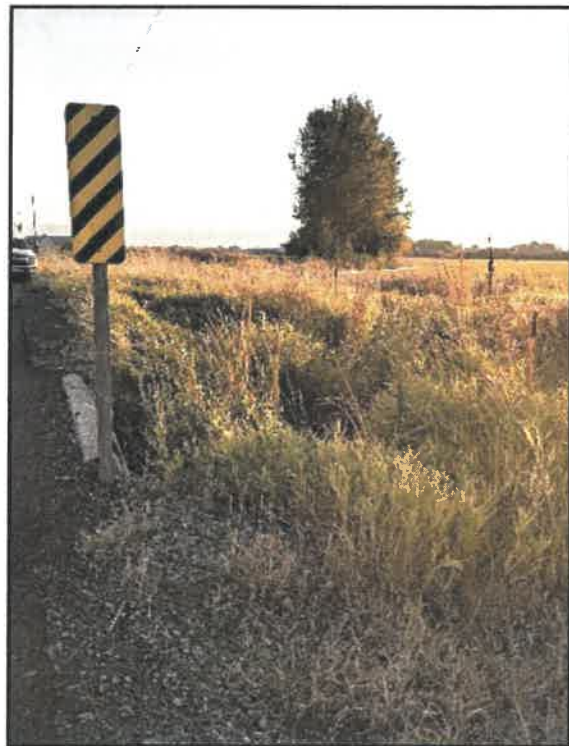
Figure 4. Photos of Coleman Creek Segment 4 looking west from Fairview Road at outlet from Culvert 3 (left) and south at Coleman Creek as it exits the project limits (right), will be impacted.

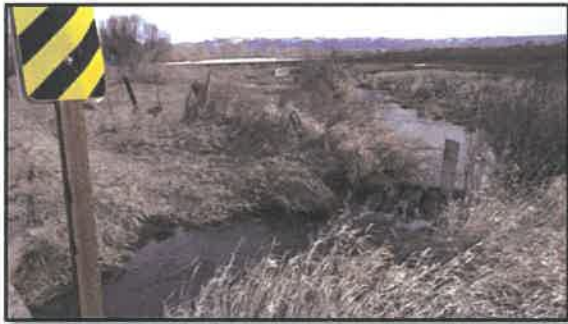
Figure 6. Photo of Coleman Creek at Culvert 3 looking northeast, likely impacted.

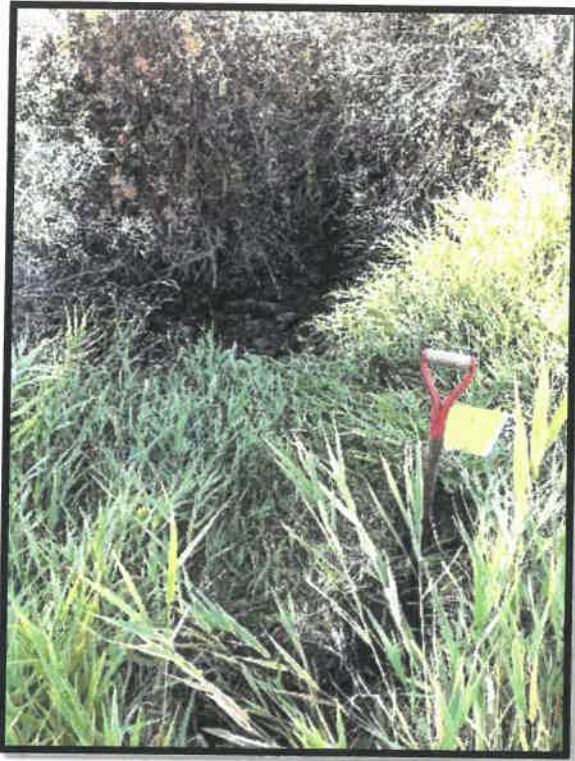
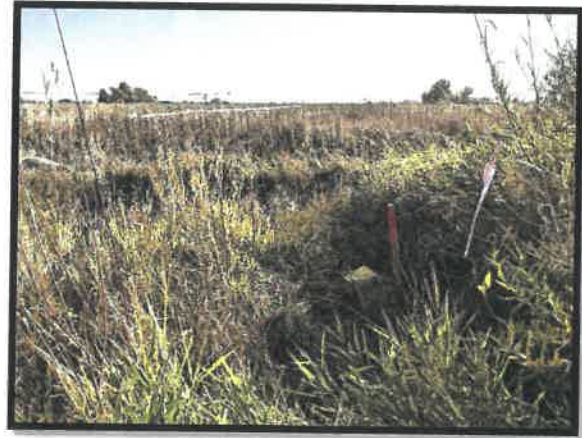
Figure 2. Photos of Data Plots SP1 (left) and SP2 (right) in Coleman Creek Segment 3.

Field verification indicated there are no wetlands or wetland buffers within the project limits. Some of the terraces outside of the OHWM of Coleman Creek contained characteristic hydric vegetation, such as small-fruited bulrush (*Scirpus microcarpus*, OBL) and reed canarygrass (*Phalaris arundinacea*, FACW); however, these sites did not meet criteria for hydric soils or wetland hydrology. Data plots were taken at two such locations to document these conditions (Figure 2, Attachment A).

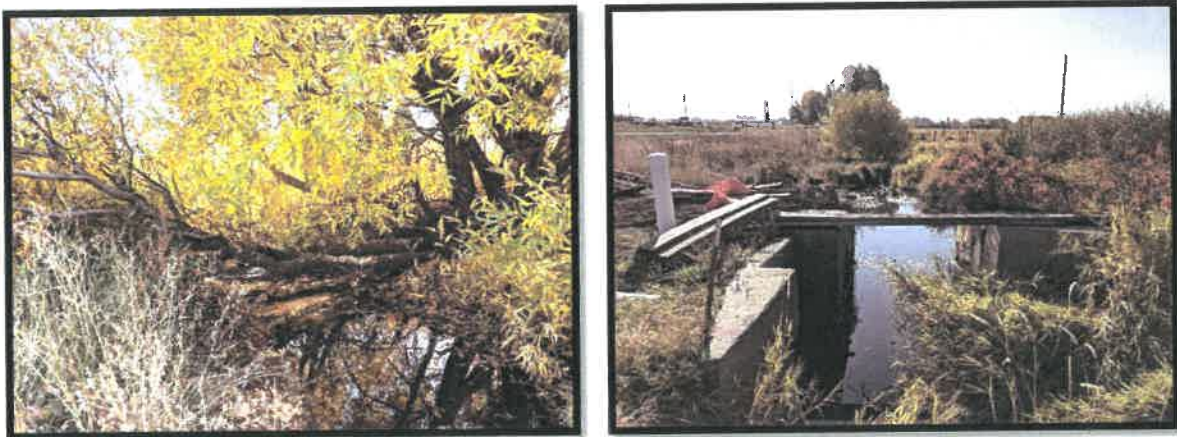
Figure 4. Photos of Coleman Creek Segment 3 looking downstream at riparian habitat along the creek (left) and at irrigation diversion structure within this segment (right).

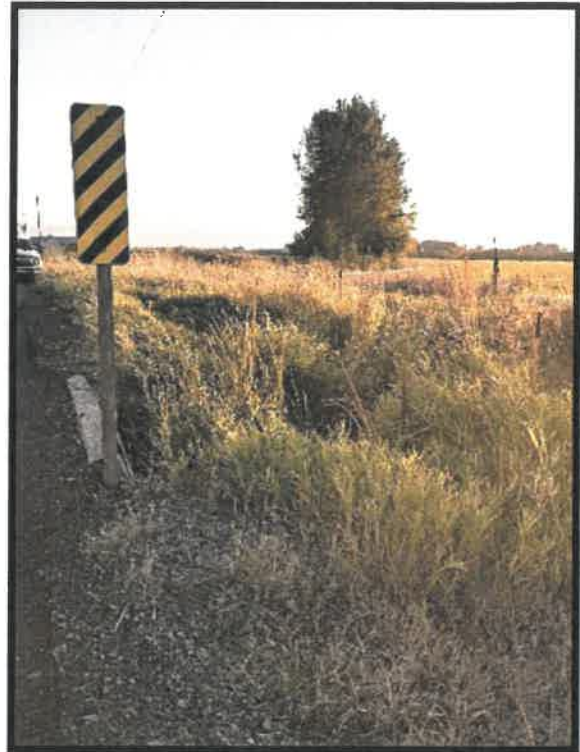
Figure 6. Photos of Coleman Creek Segment 4 looking west from Fairview Road at outlet from Culvert 3 (left) and south at Coleman Creek as it exits the project limits (right).

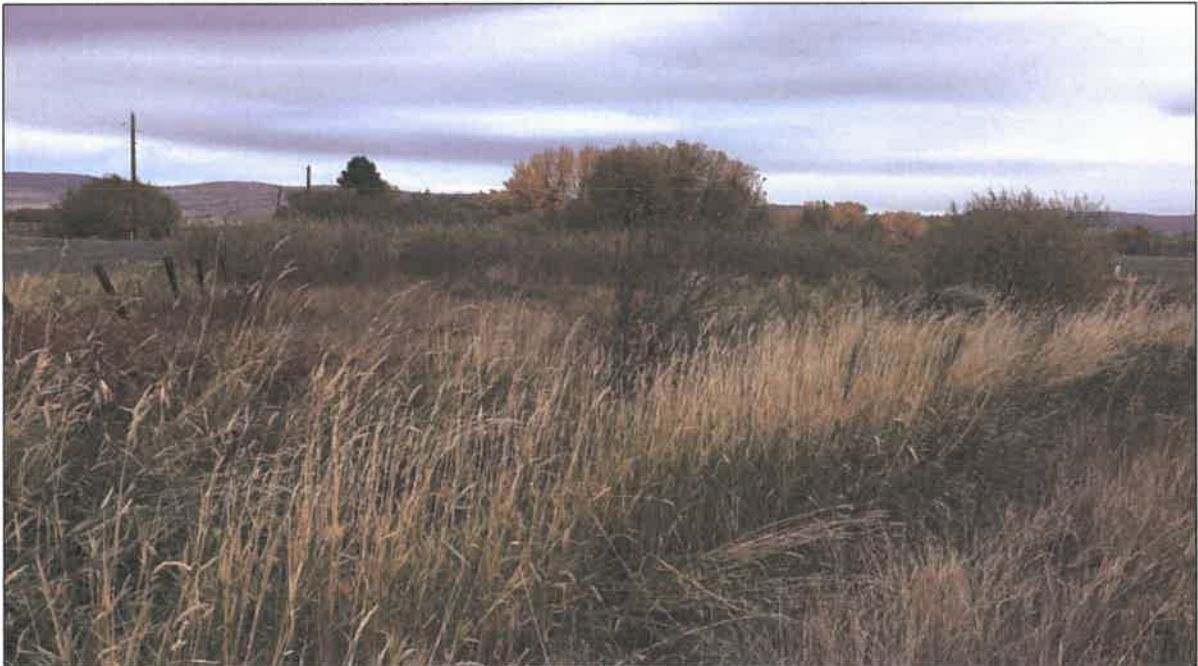
**Figure 6.** Disturbed area surrounding existing Coleman Creek culvert, view north.

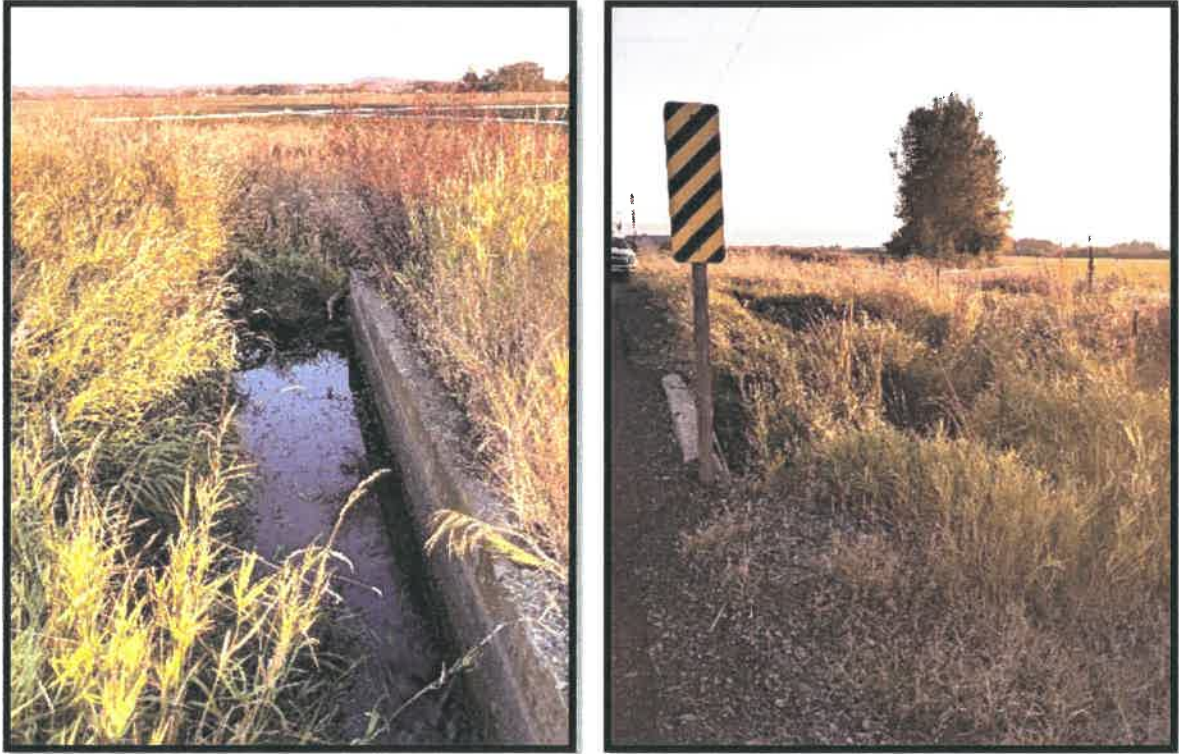
Figure 3. Photos of Coleman Creek Segment 4 looking west from Fairview Road at outlet from Culvert 3 (left) and south at Coleman Creek as it exits the project limits (right).

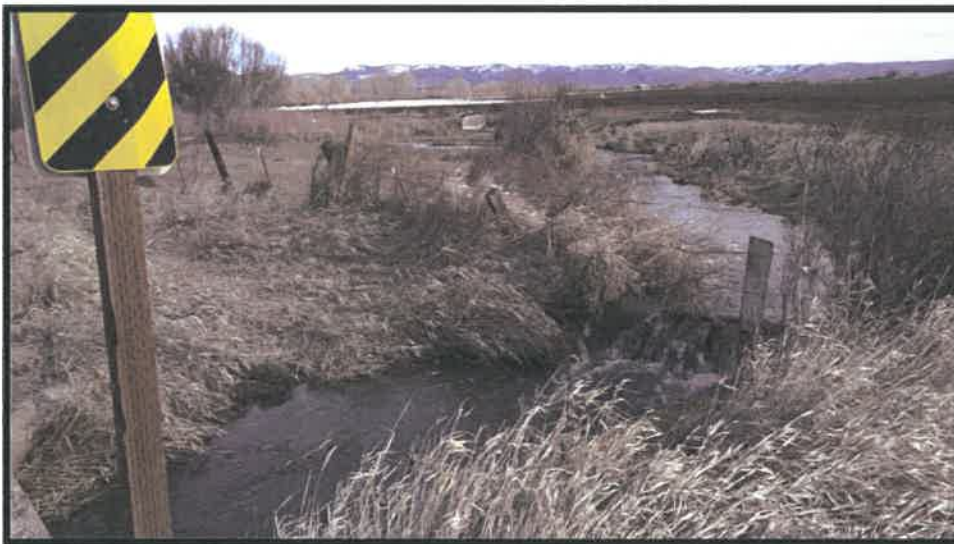
Figure 4. Photo of Coleman Creek at Culvert 3 looking northeast.
