REMEDIAL INVESTIGATION REPORT

Performed at:
Summit Deli & Chevron
521 State Route 906
Snoqualmie Pass, Washington 98068

AEROTECH
Environmental Consulting Inc.

November 23, 2020

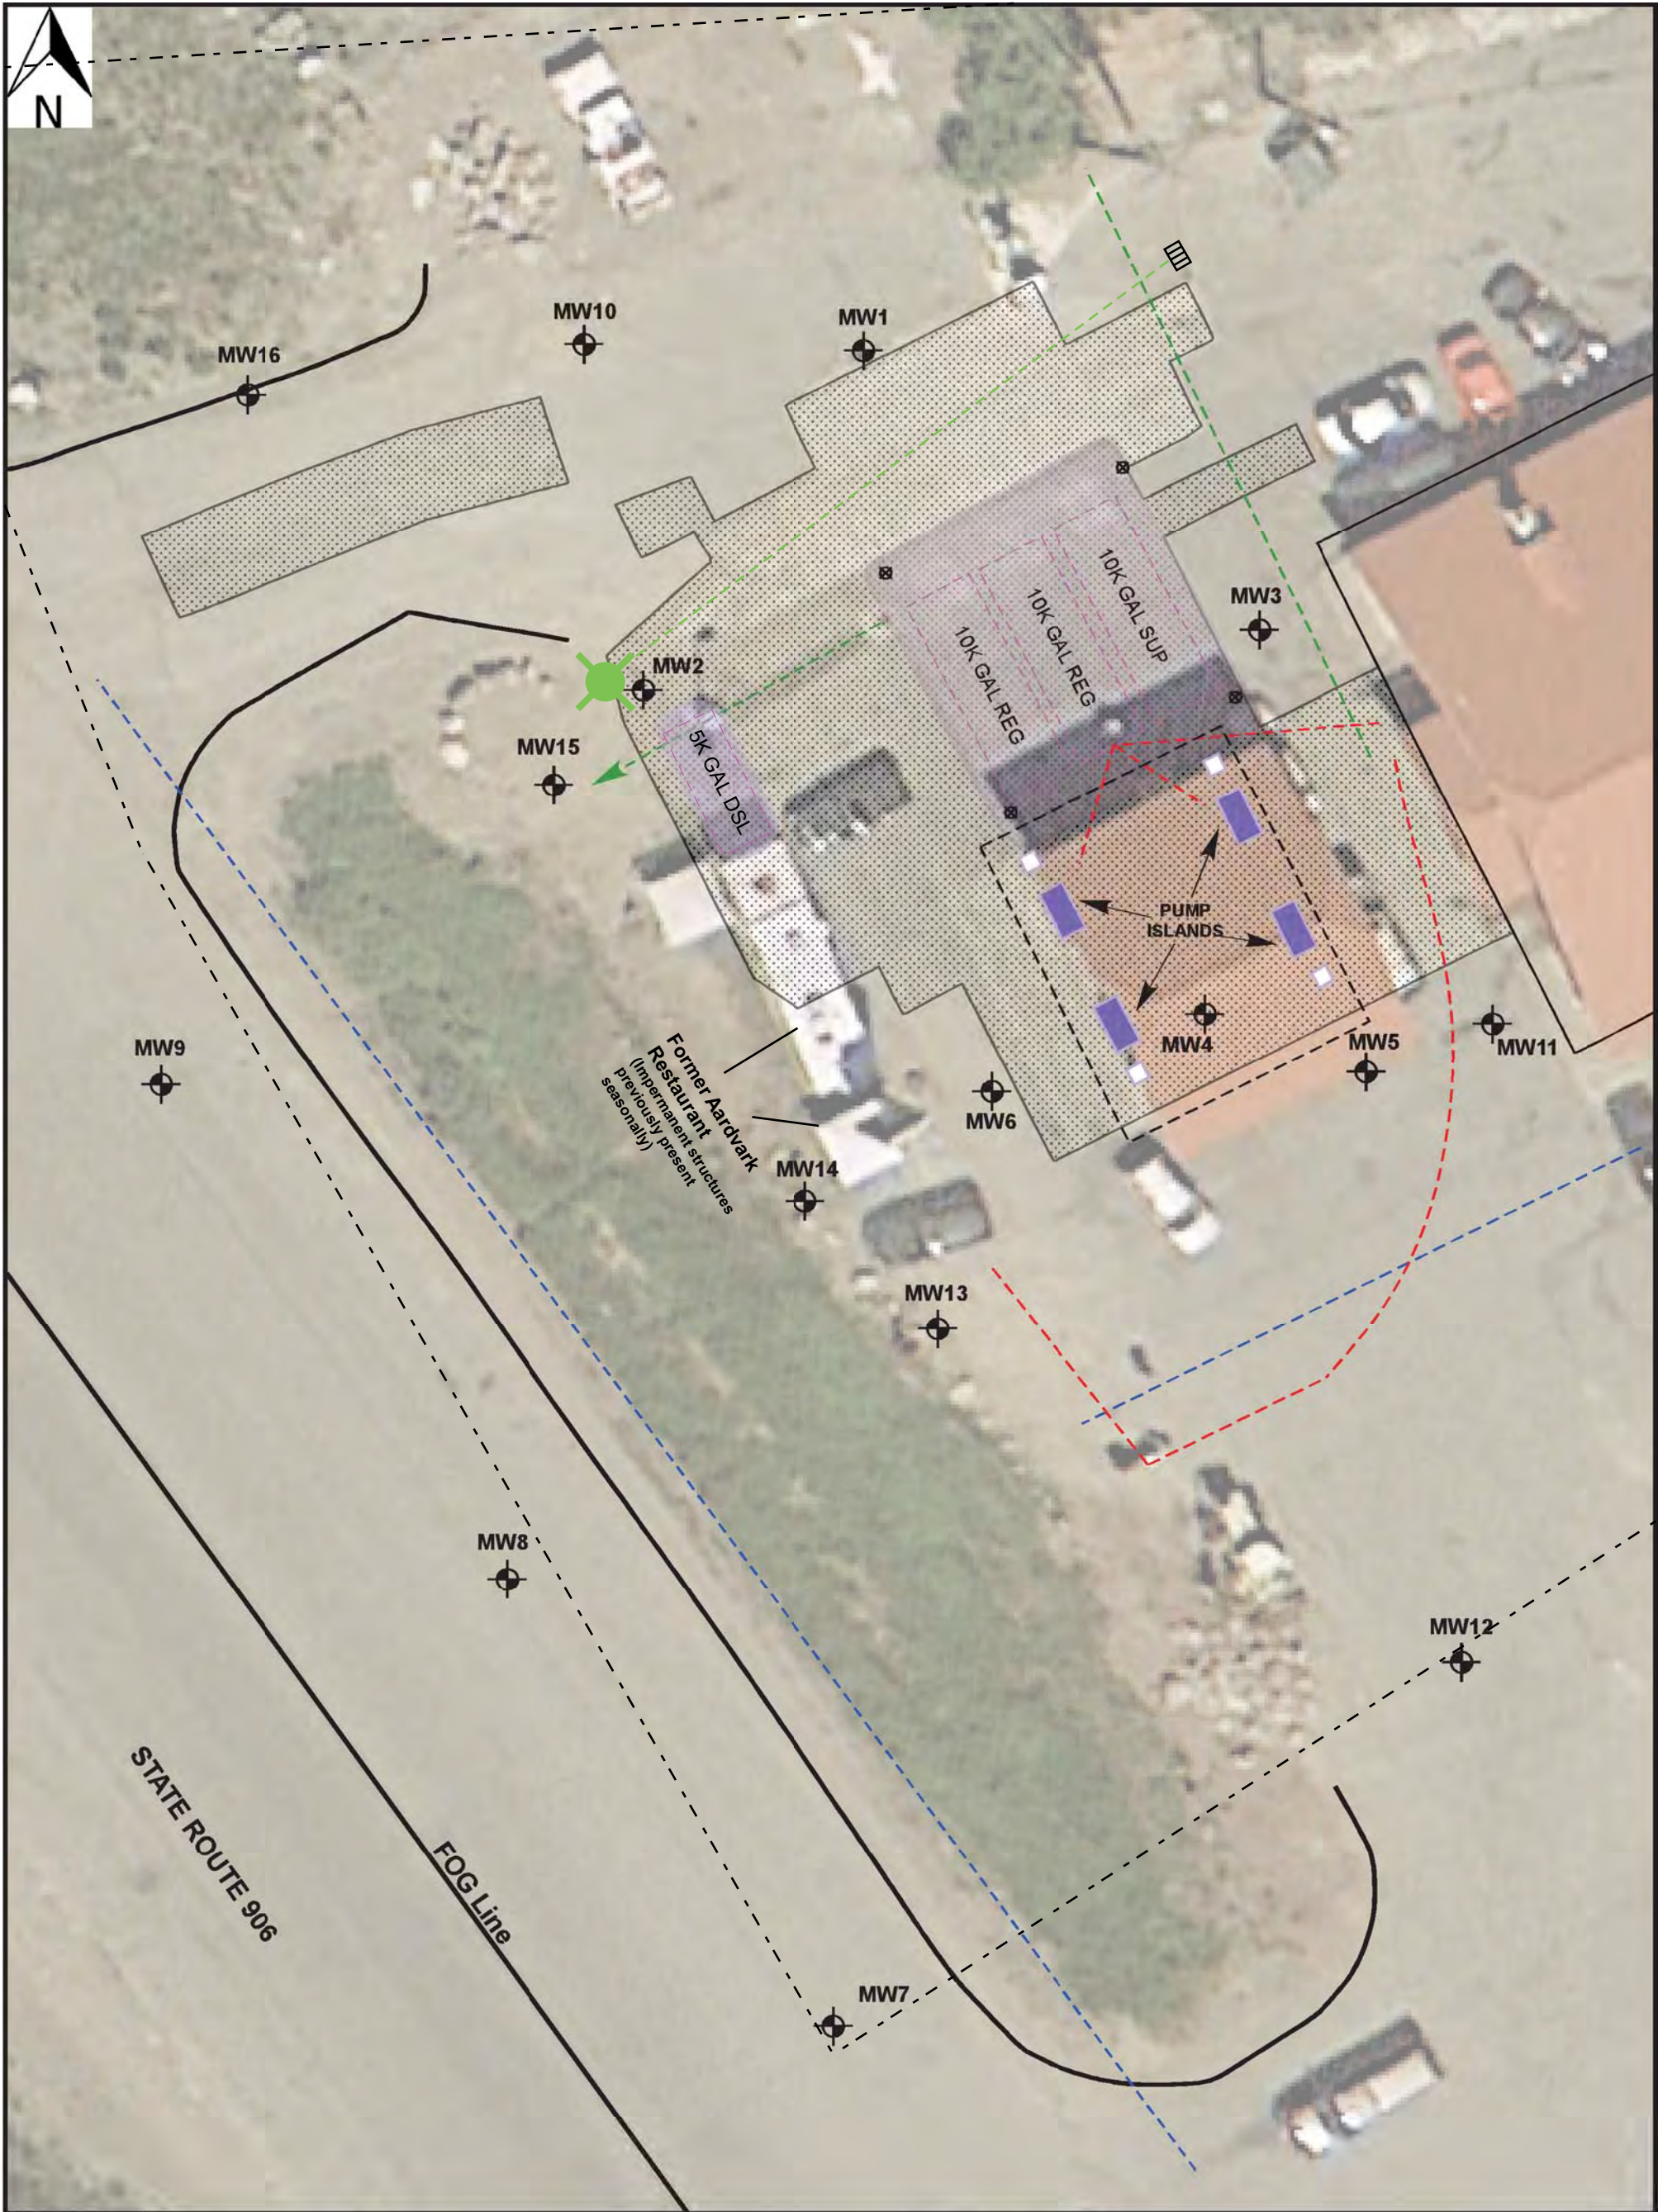
Date: 11/12/20
 By: Justin Foslien
 Figure: 3

EXPLANATION			
	Groundwater Monitoring Well		Concrete Surface
	UST Basin Observation Well		Catch Basin
	Dry Well		Property Boundary
			Underground Utility: Electrical (Red); Storm Water / Sanitary (Green); Water (Blue)

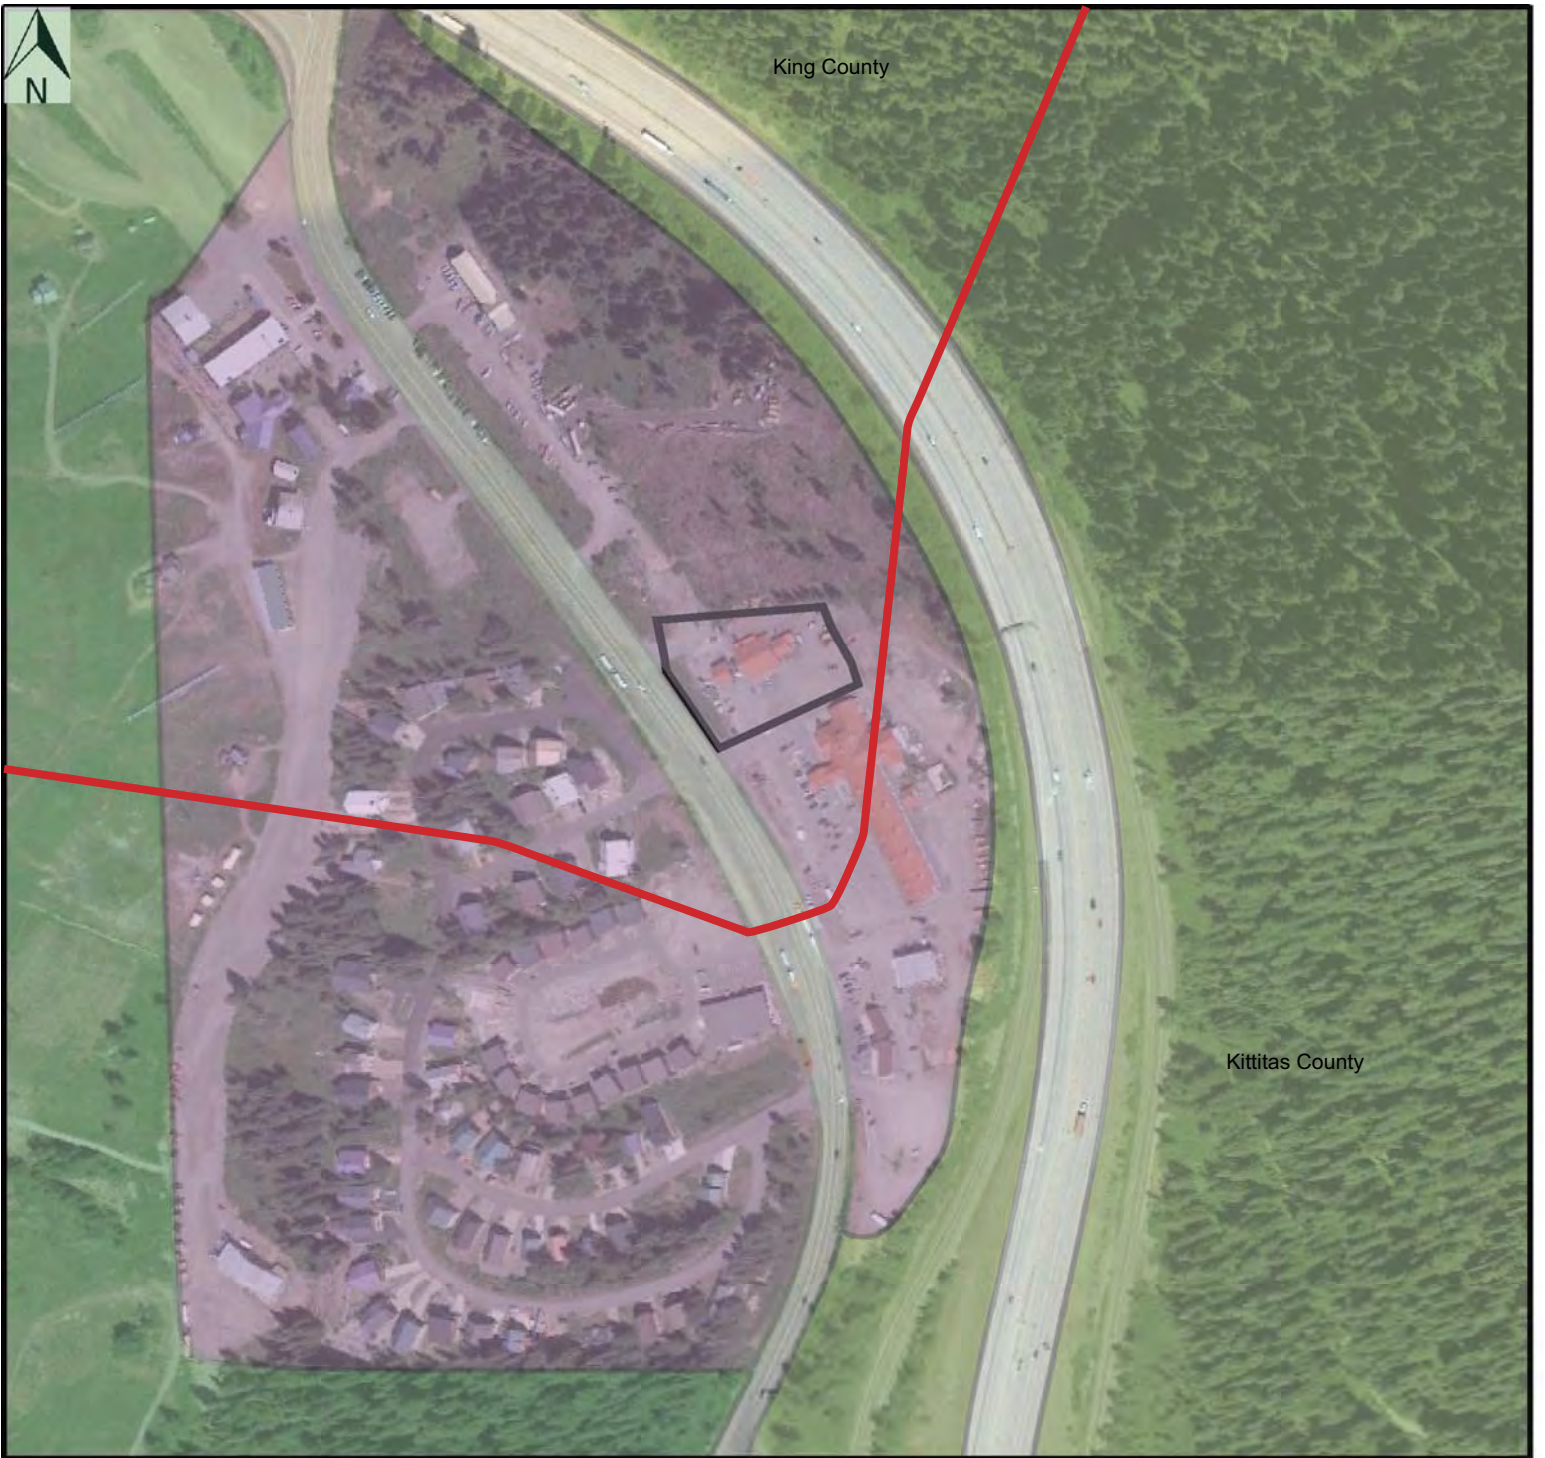
Date: 11/13/20
By: Nick Gerkin
Figure: 5

A masonry and wood framed canopy covering four pump islands, with a total of eight fuel pumps is located west of the convenience store building. Directly north of the canopy is the Underground Storage Tank ("UST") Basin, which contains three 10,000-gallon USTs (Figure 5). The two western tanks hold regular unleaded gasoline, while the eastern tank holds super unleaded gasoline. Four observation wells are located at each corner of the UST Basin. A 6,000-gallon capacity diesel UST was installed southwest of the gasoline UST Basin in 2017.

The potential sources of hydrocarbons include existing USTs and the fuel conveyance system including the fuel dispensers located in the vicinity of the pump island pad and UST basin. Secondly, the dry well located in the northeast area of the Site near groundwater monitoring well MW2 is a pathway. It receives water in its vicinity and directly from a catch basin located on the east side of the UST Basin (Figure 5). The dry well consists of a pit with a depth of approximately 6.5-feet.

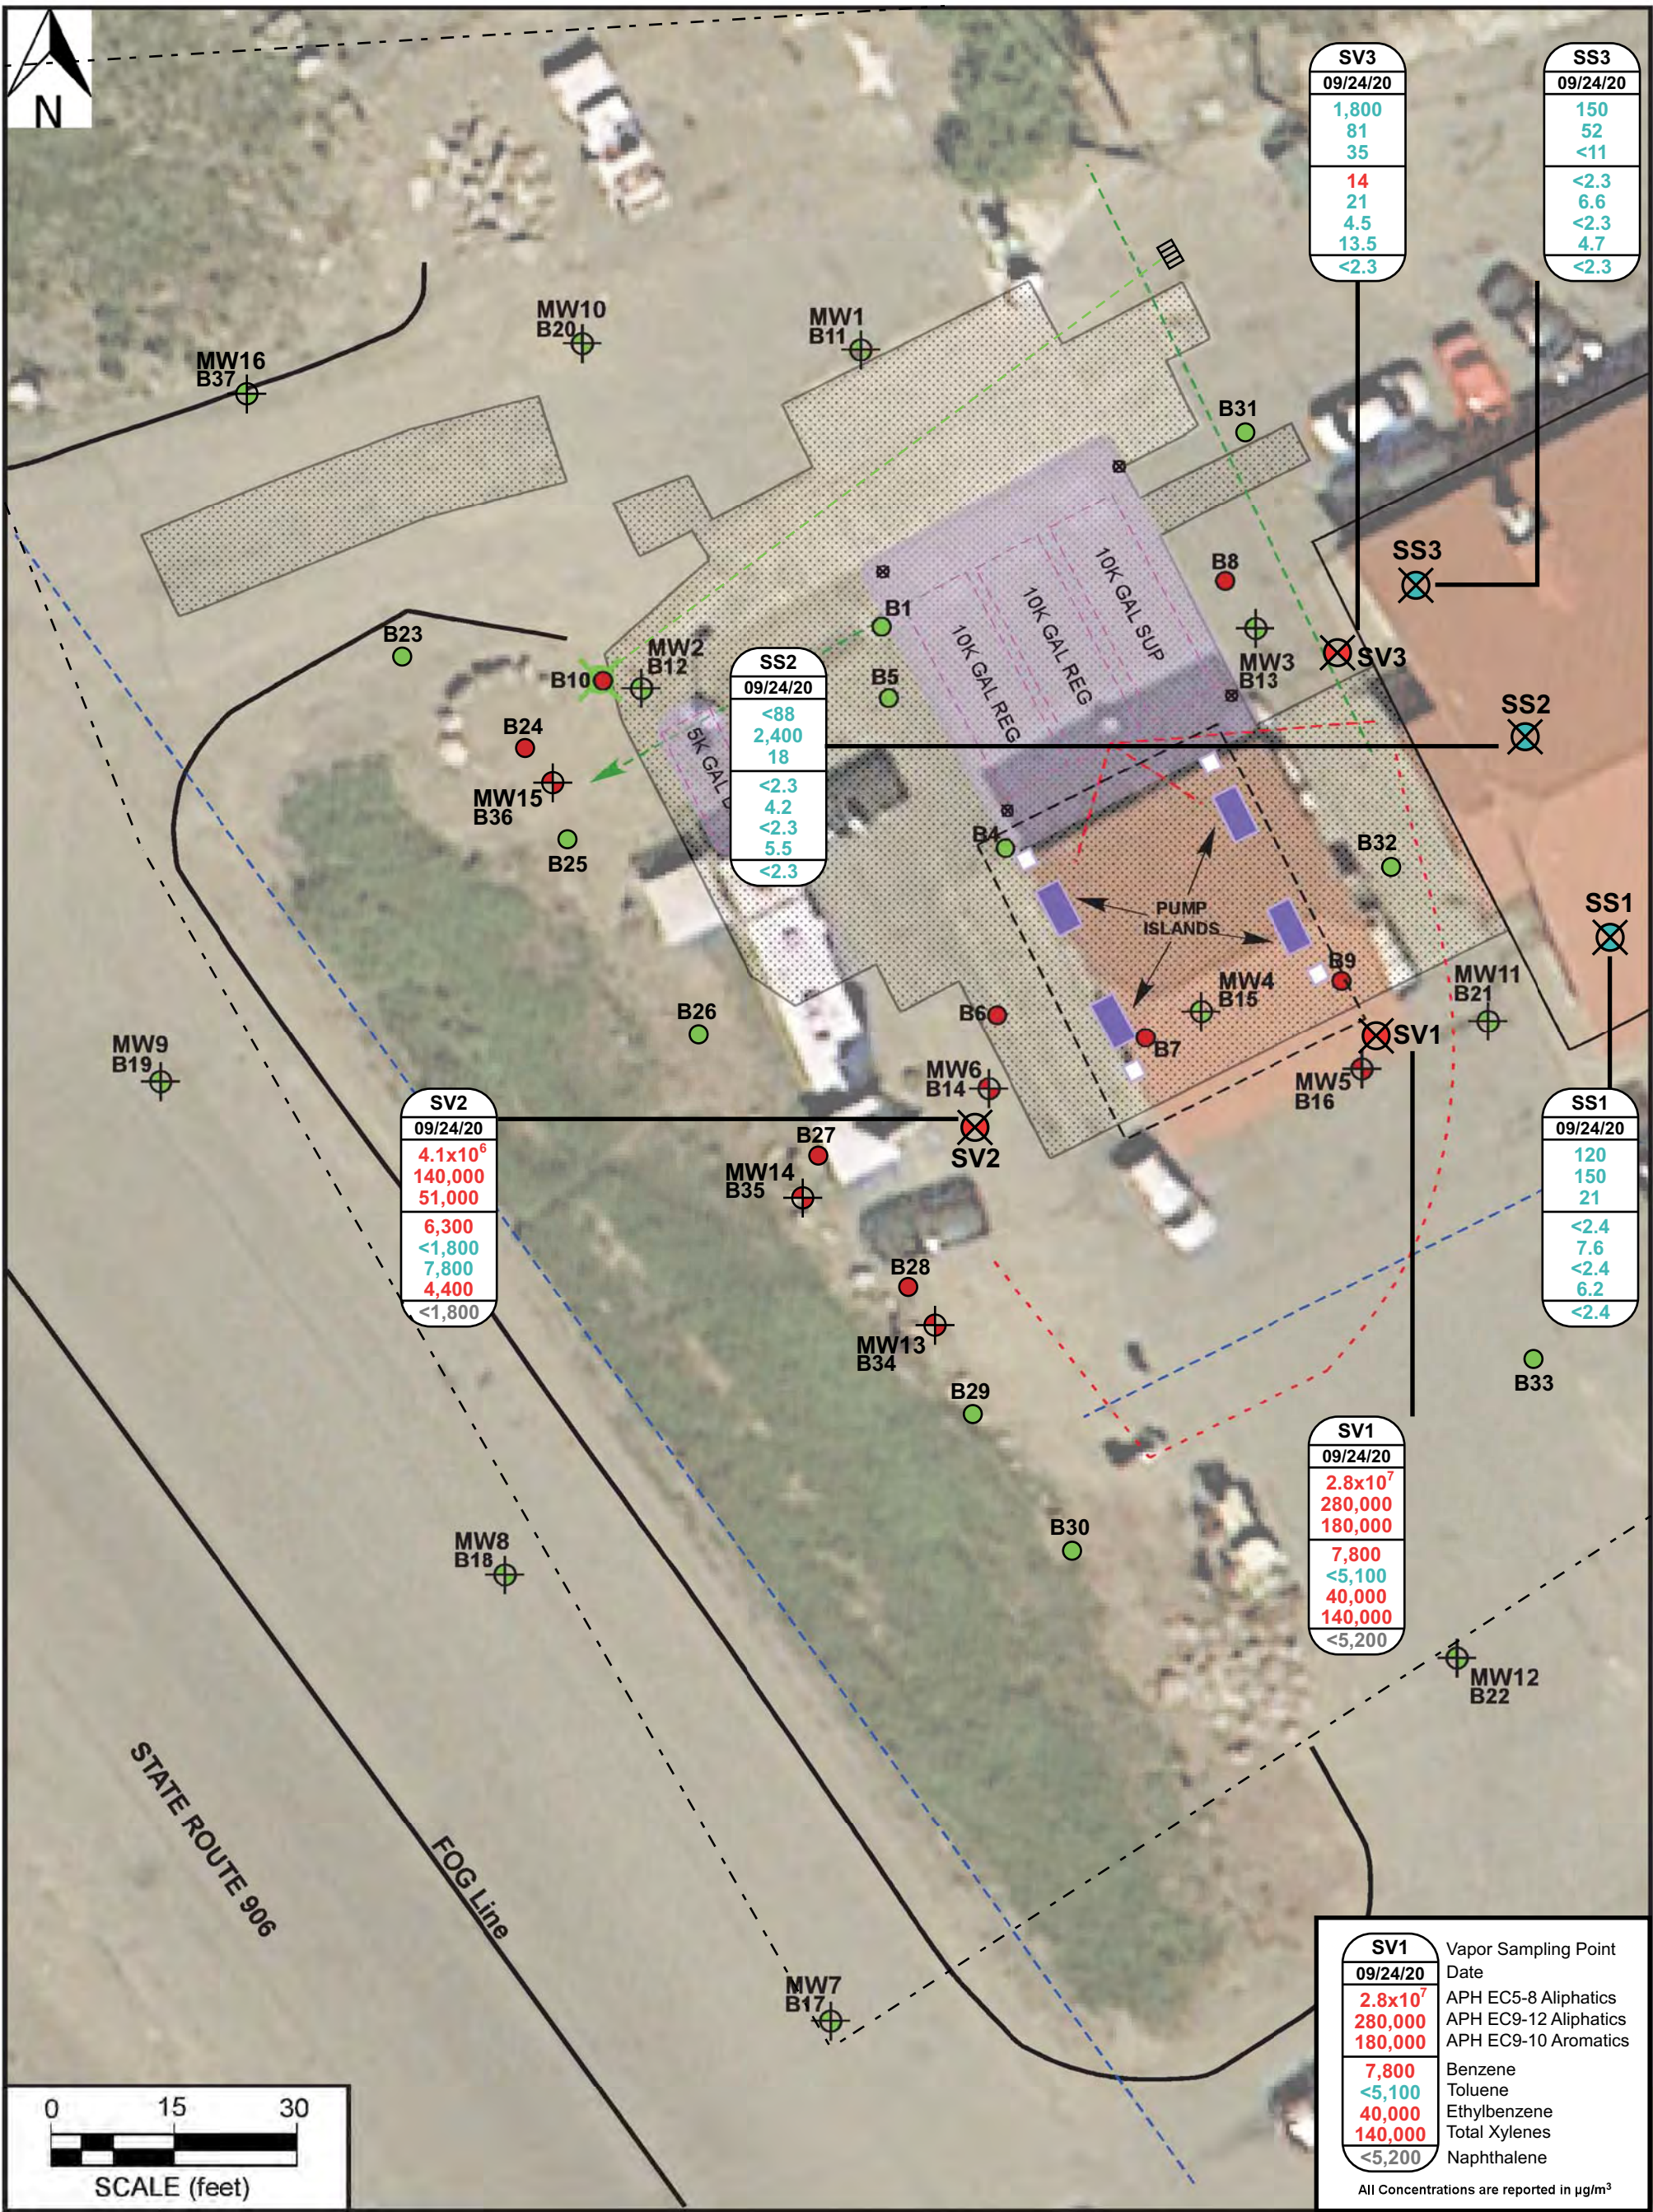
Date: 11/20/20
By: Nick Gerkin
Figure: 8

Teal numbers and symbols indicate concentrations below the MTCA Method B Cleanup Levels for Subslab Soil Gas

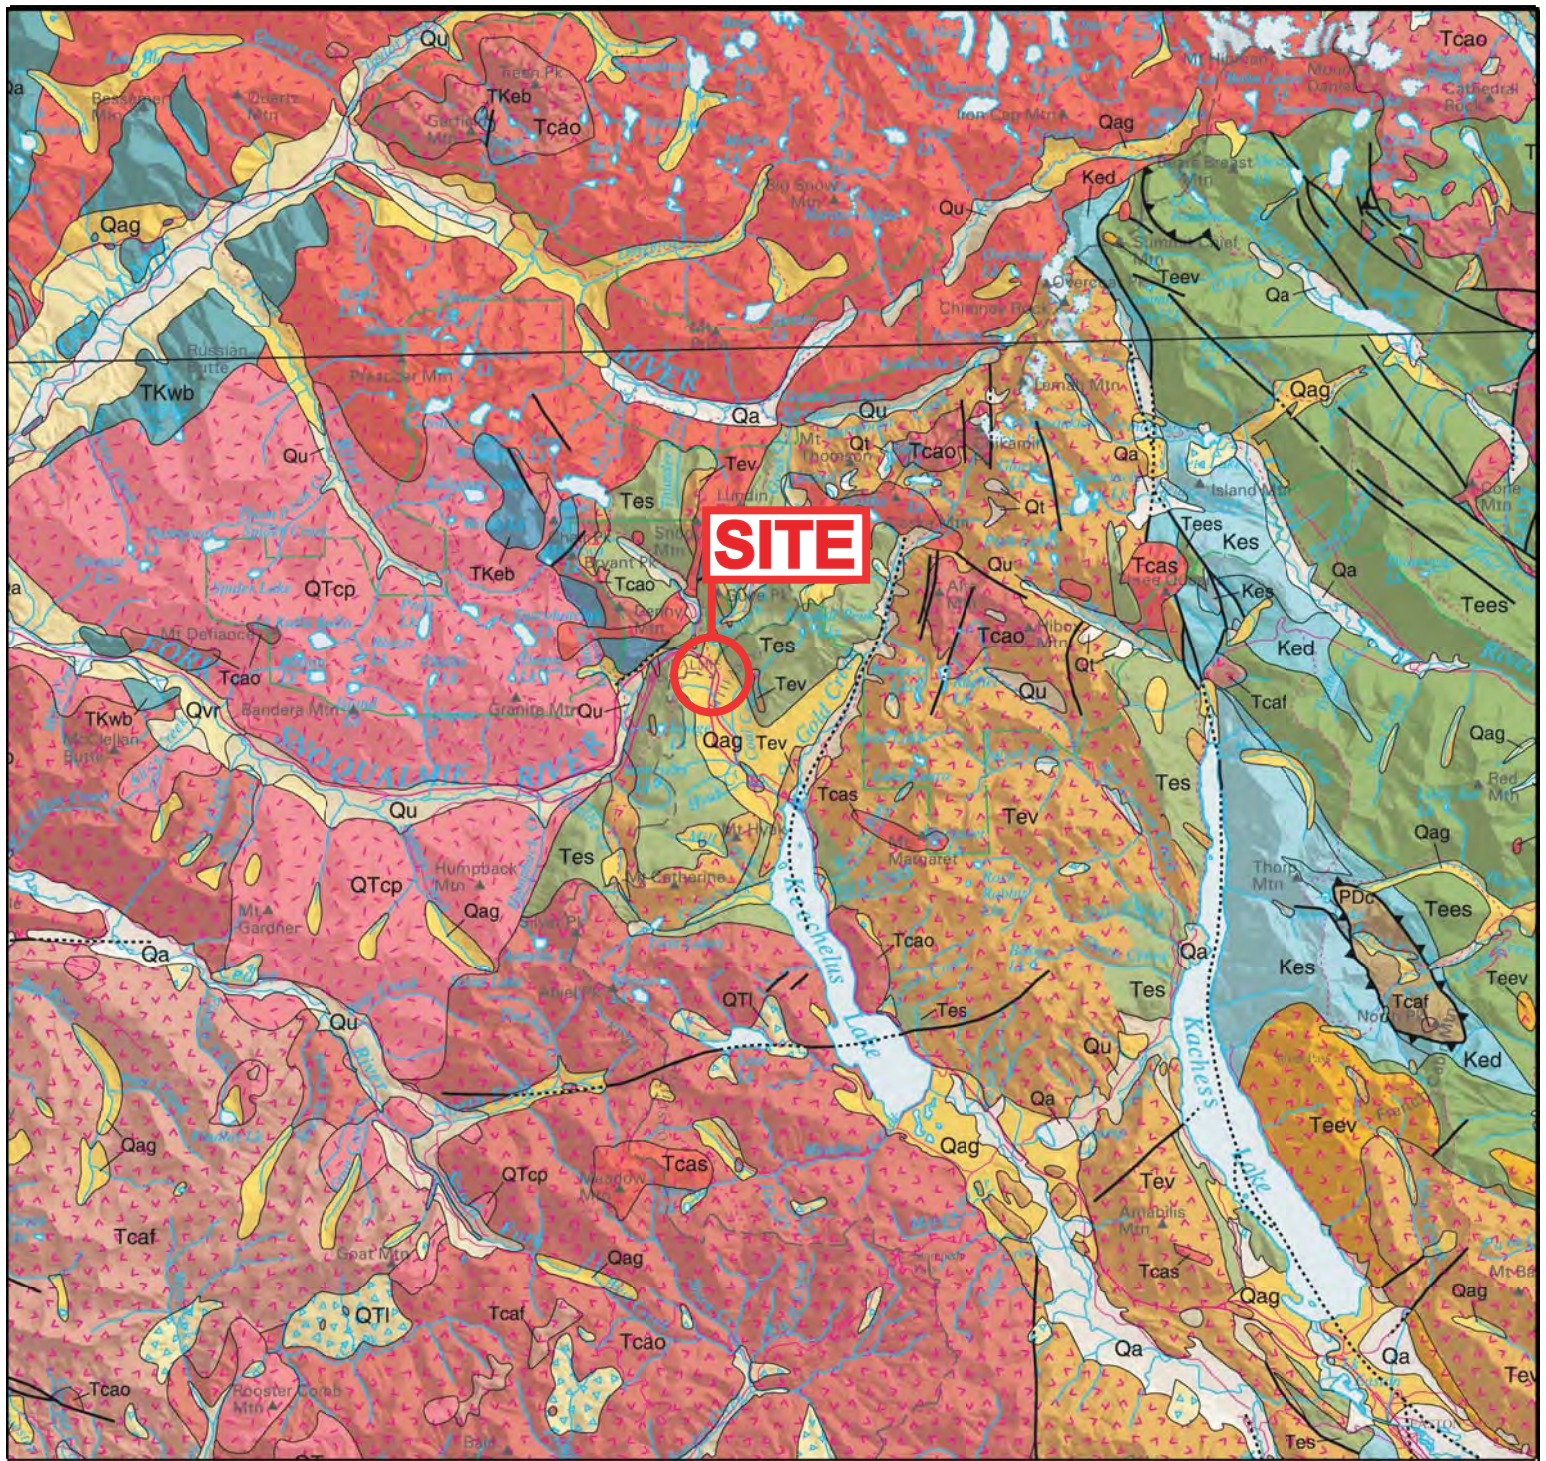
Modified from *Geologic Map of the North Cascade Range, Washington* by Haugerud and Tabor 2009

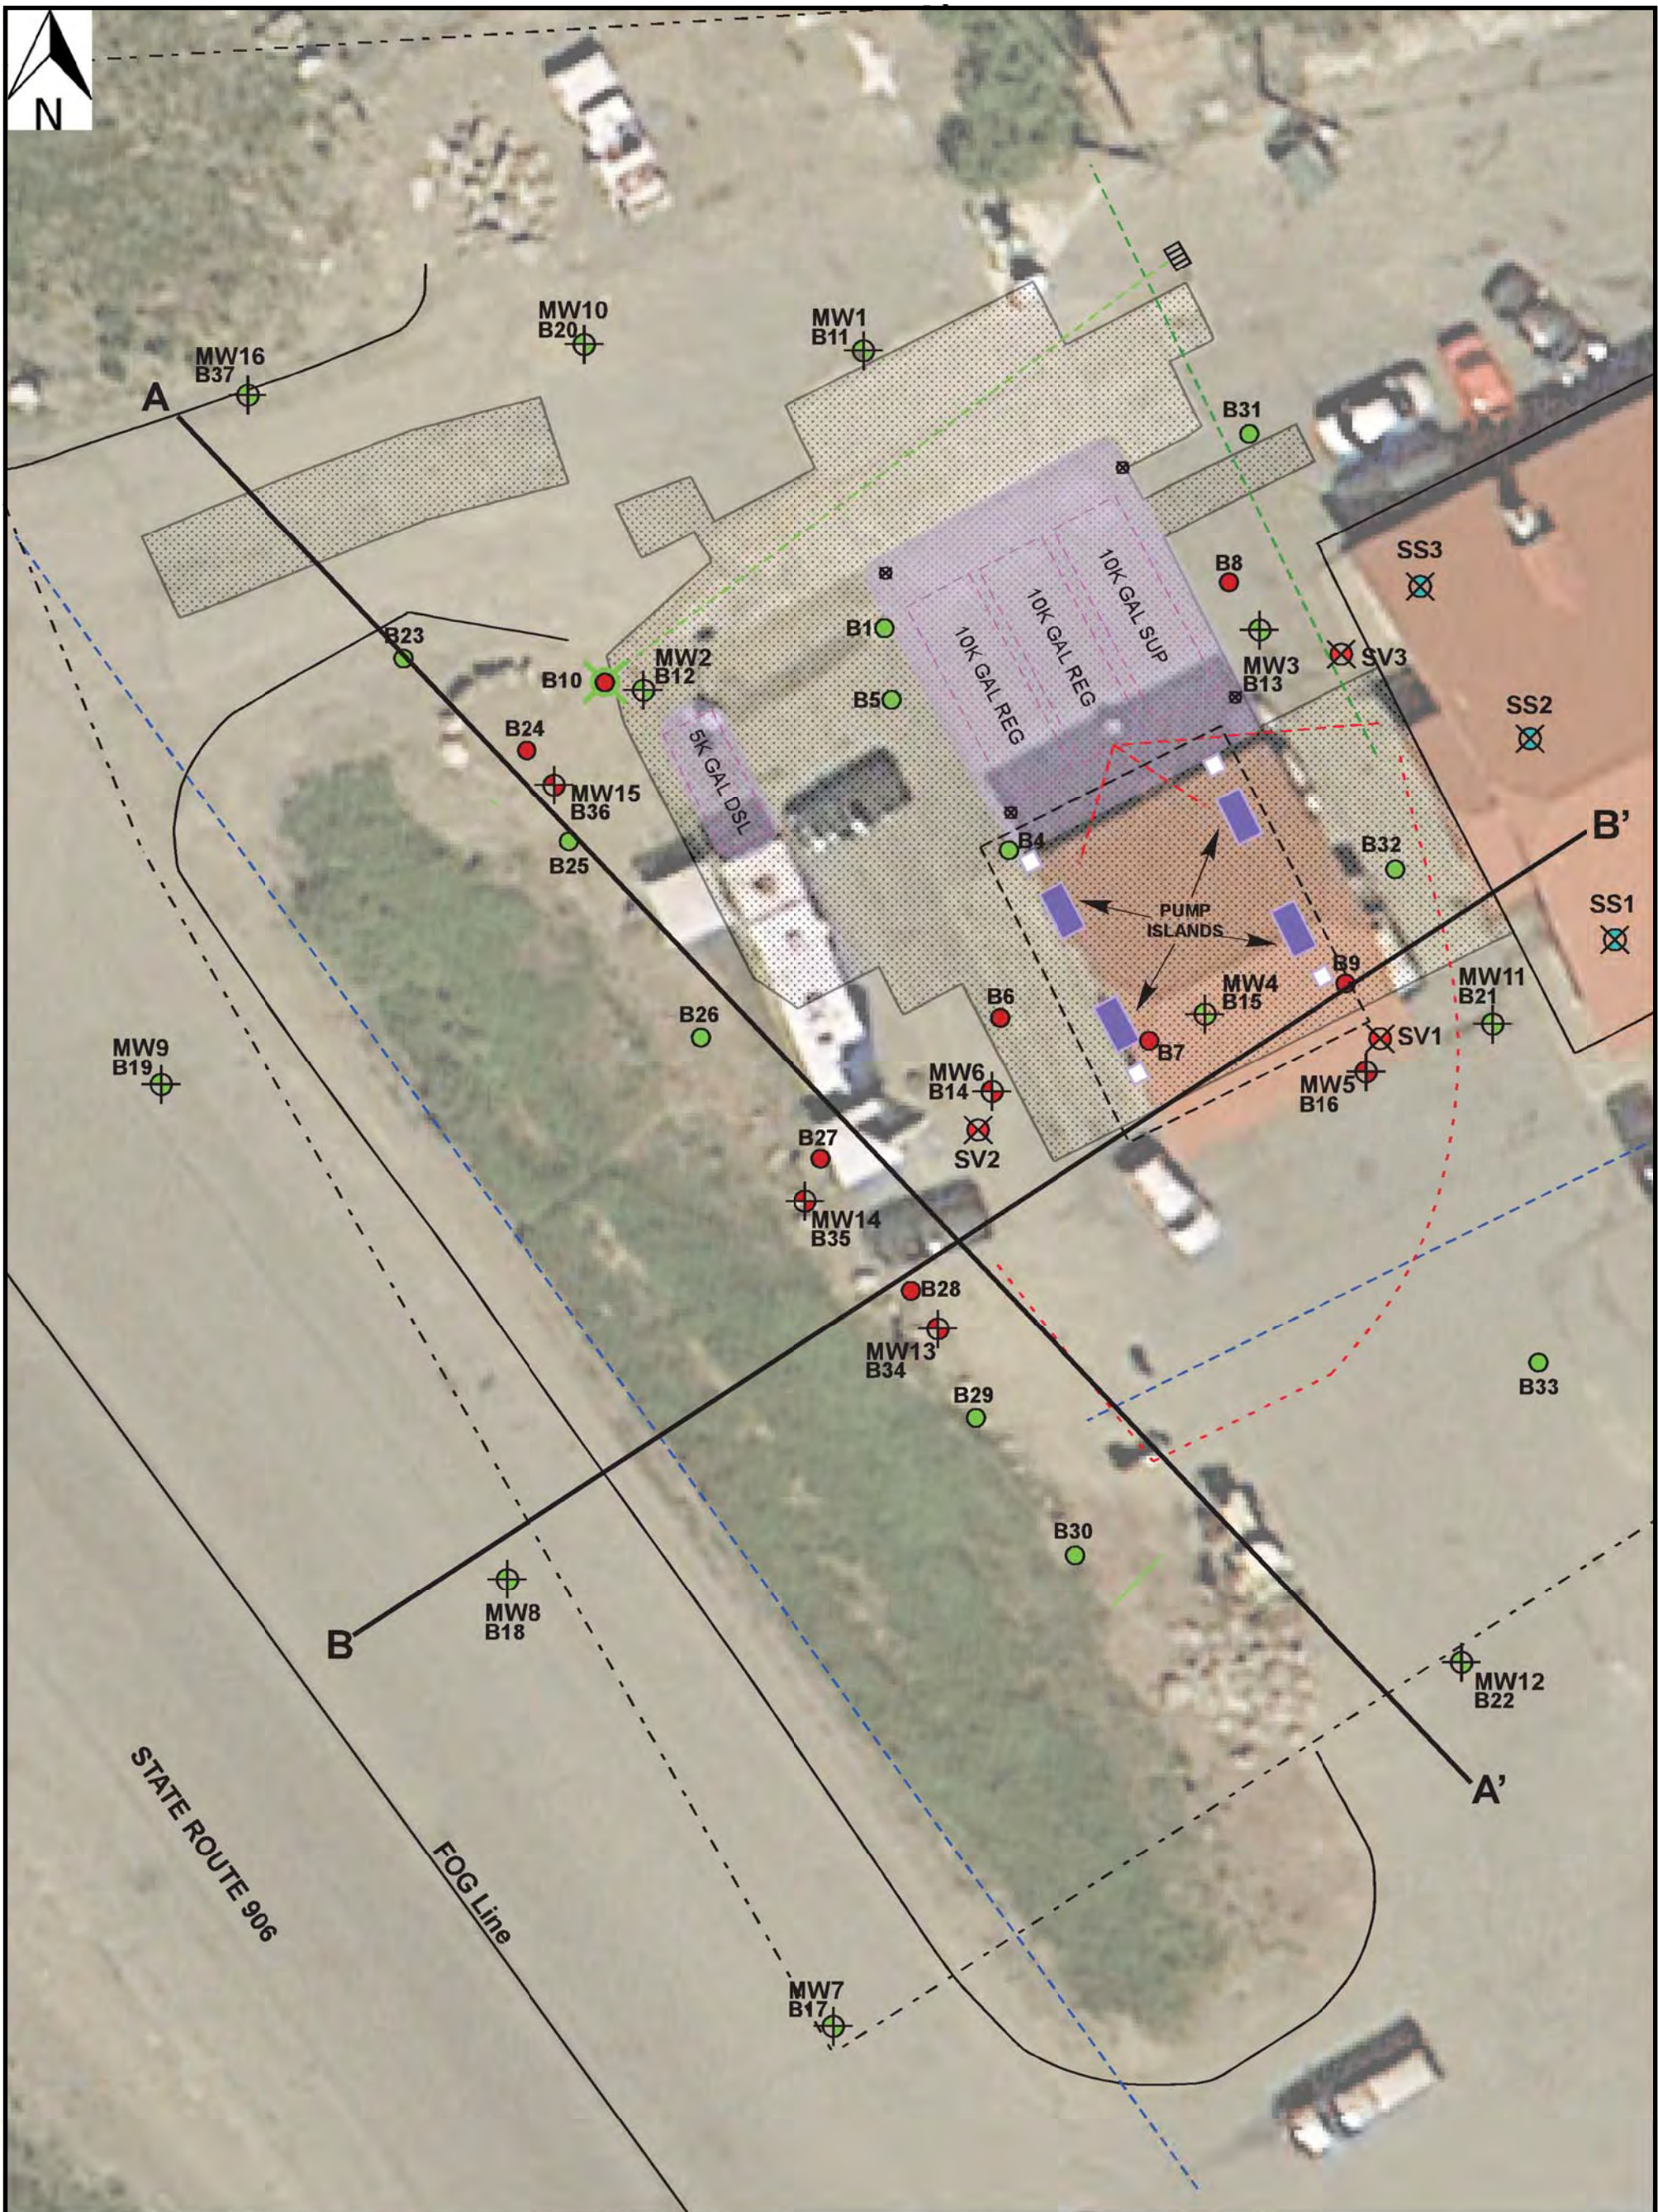
<h2>CROSS SECTION TRAVERSE</h2>	Summit Deli & Chevron 521 State Route 906 Snoqualmie Pass, Washington	Date: 11/15/20 By: Nick Gerkin Figure: 11
---------------------------------	--	---

Northwest-Southeast trending and East-West trending geologic cross sections illustrating subsurface conditions observed at the Property can be found on Figures 11 and 12.

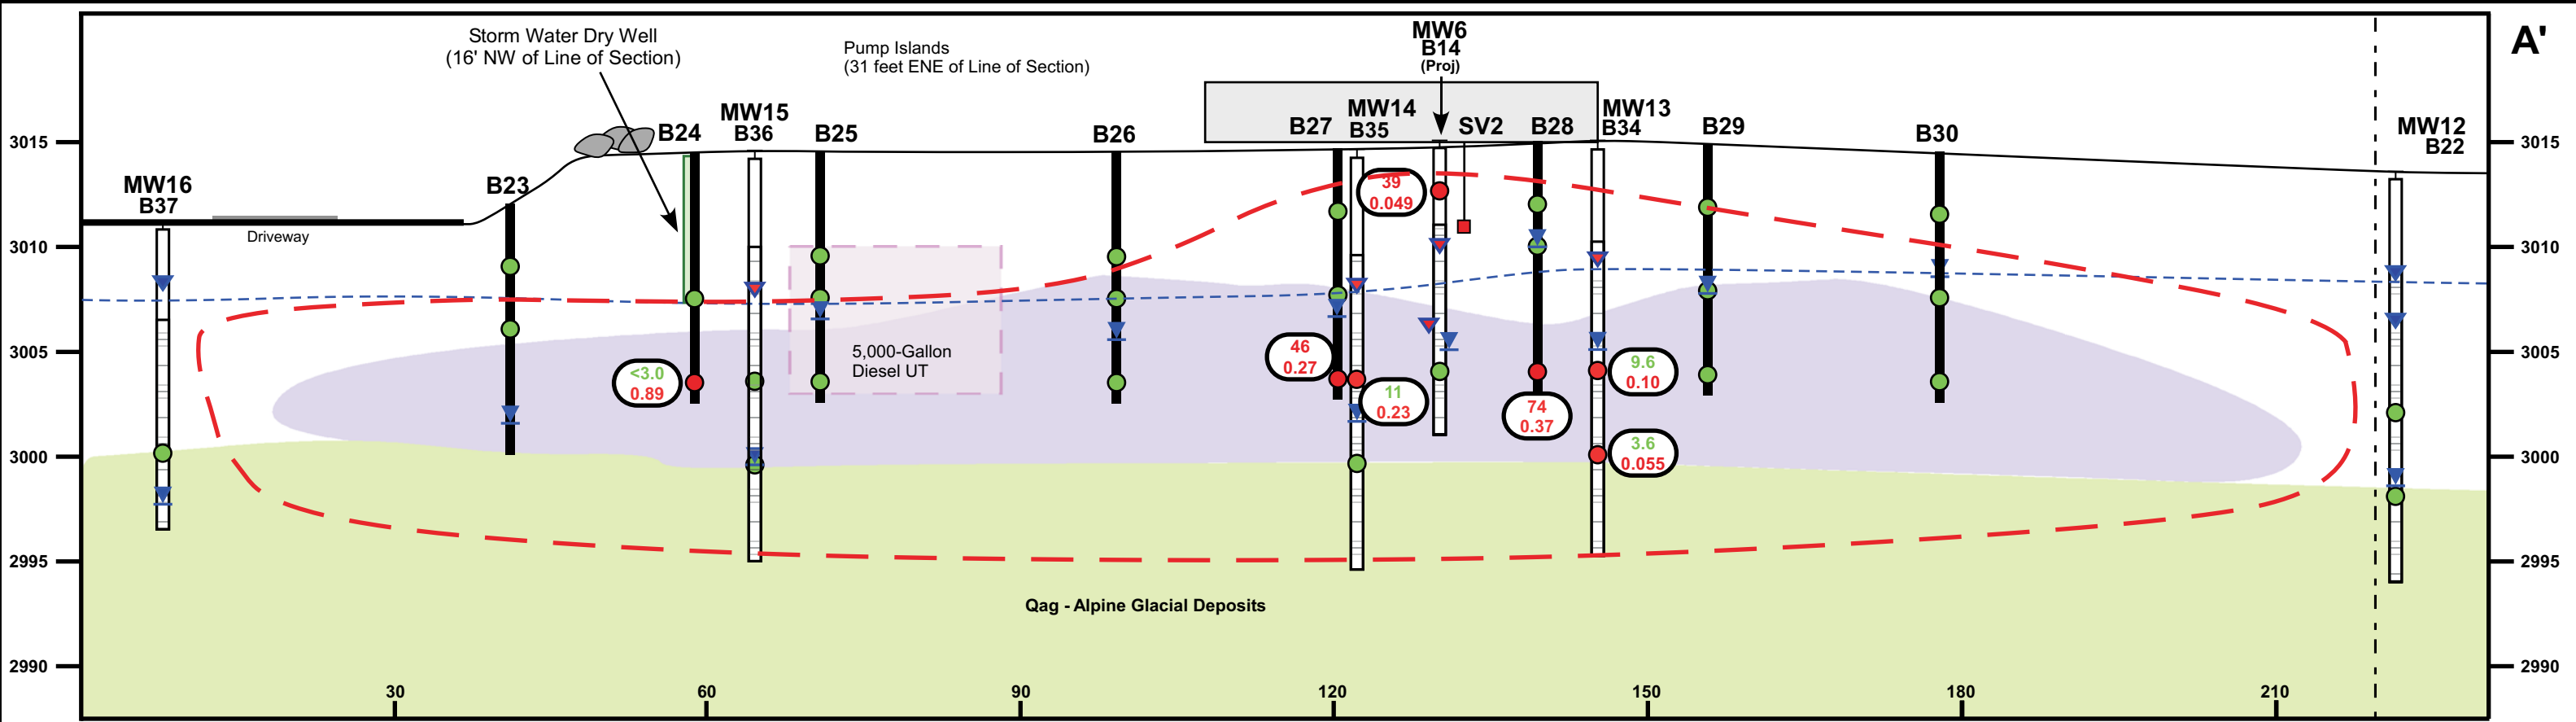
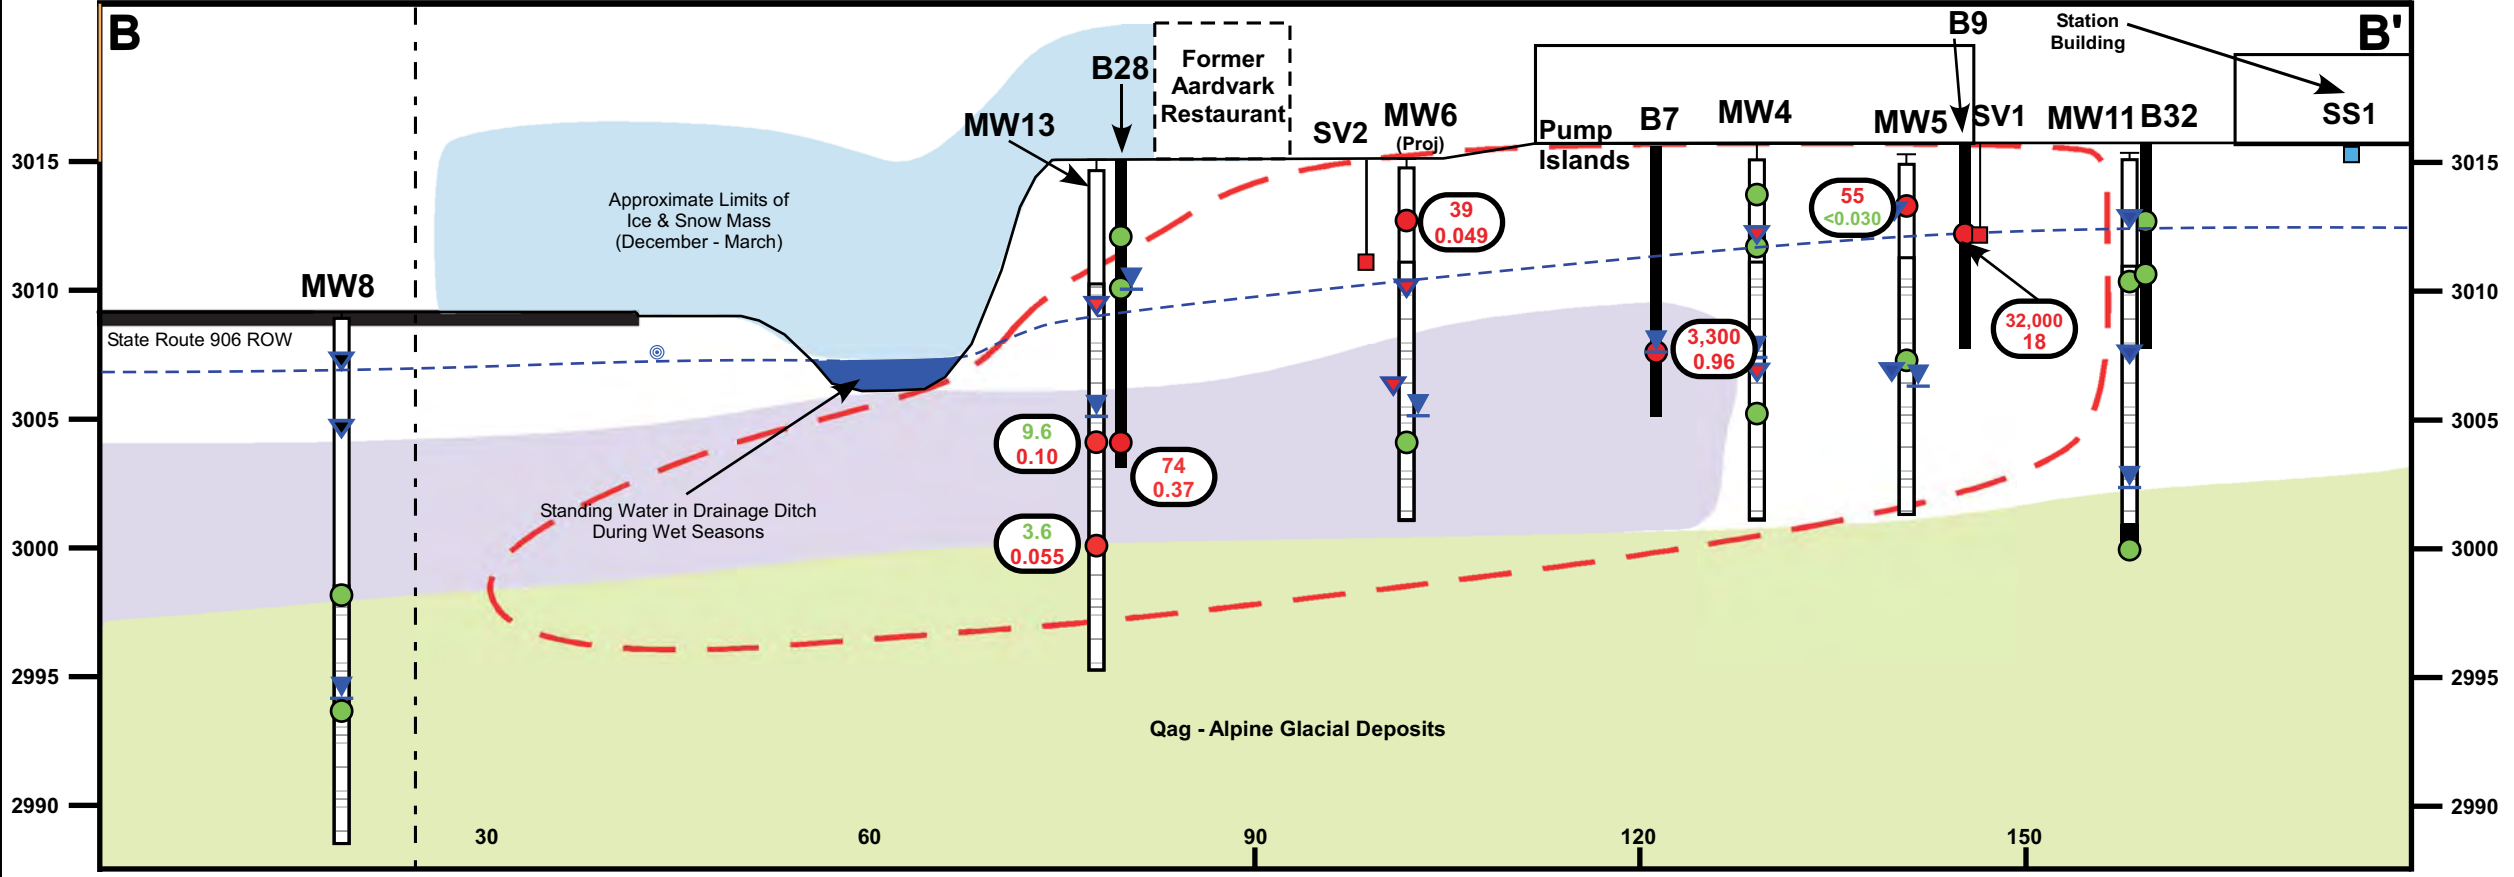
● Teal indicates concentrations below the MTCA Method B Cleanup Levels for Subslab Soil Gas
 ● Blue indicates concentrations below the MTCA Method A Cleanup Levels for Groundwater
 ● Green indicates concentrations below the MTCA Method A Cleanup Levels in Soil
 ● Red numbers and symbols indicate concentrations above the MTCA Method A Cleanup Levels
