REMEDIAL INVESTIGATION REPORT

Performed at:
Summit Deli & Chevron
521 State Route 906
Snoqualmie Pass, Washington 98068

AEROTECH
Environmental Consulting Inc.

November 23, 2020

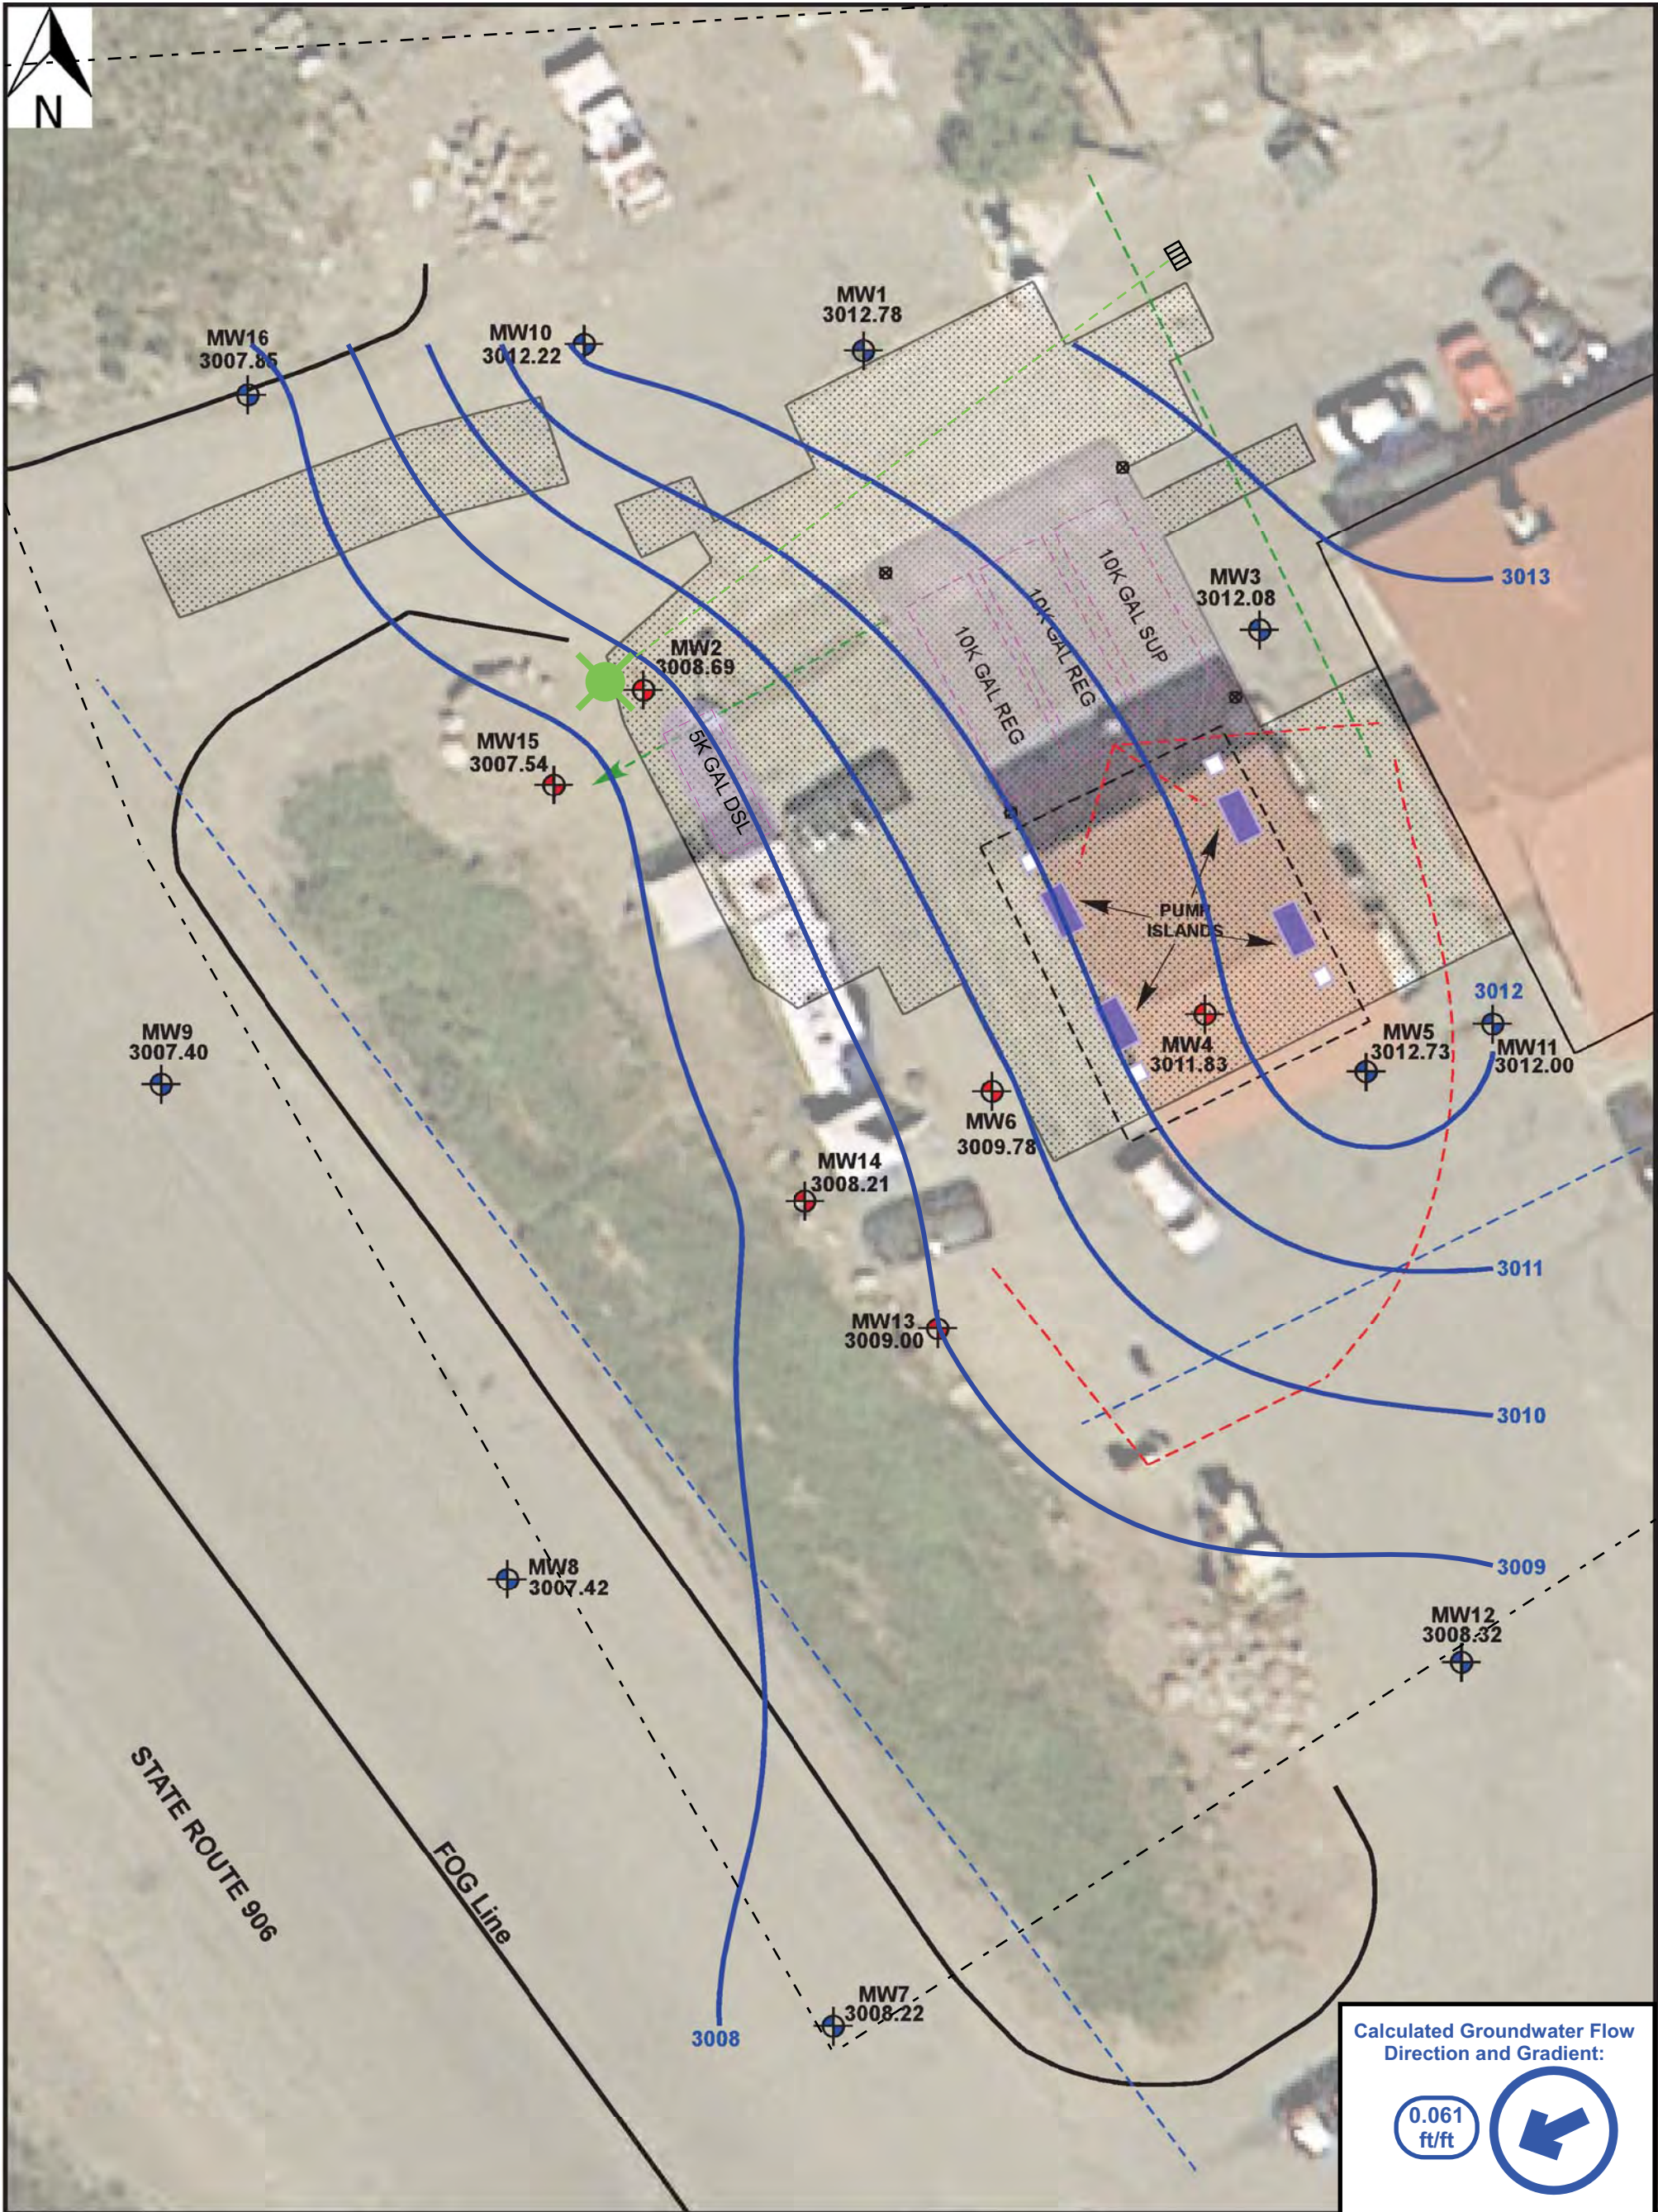
Calculated Groundwater Flow Direction and Gradient:

Hydraulic Gradient is expressed in ft/ft

Based on groundwater monitoring and sampling events performed by Aerotech and lithologic conditions, shallow groundwater is present in the silty sand and gravelly silt sediments. Well locations within these deposits have a low recharge compared to the wells installed within the deeper and more conductive sand with gravel. The interpreted groundwater flow direction is to the southwest Figures 13 and 14.

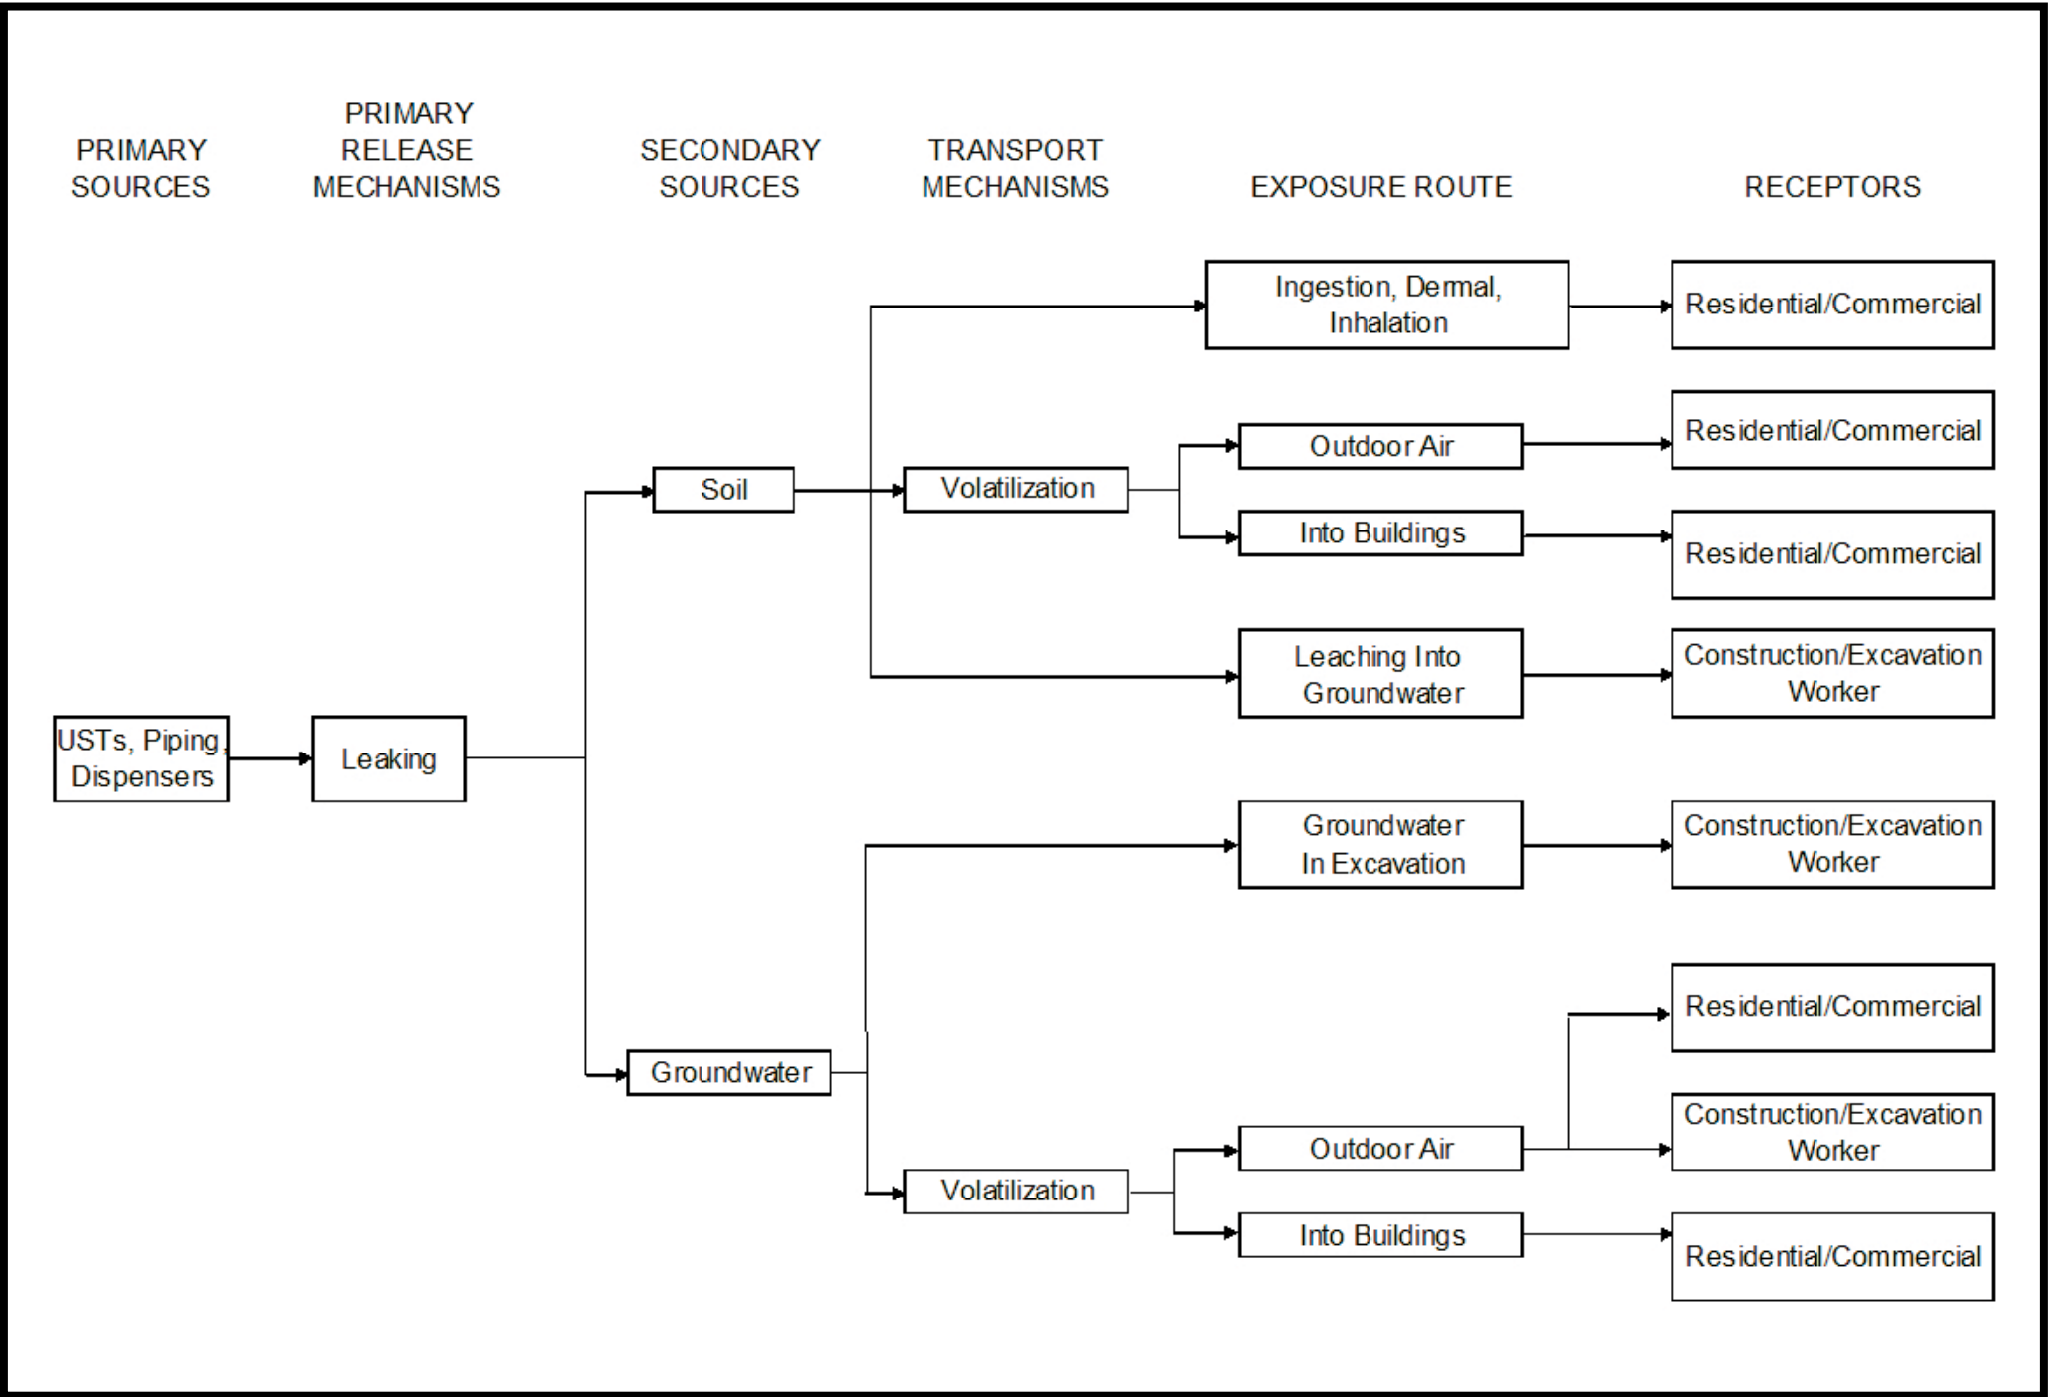
CONCEPTUAL SITE MODEL

Summit Deli & Chevron
 521 State Route 906
 Snoqualmie Pass, Washington

The conceptual site model is a “conceptual understanding of a site that identifies potential or suspected sources of hazardous substances, types and concentrations of hazardous substances, potentially contaminated media, and actual and potential exposure pathways and receptors.” As defined by MTCA WAC 173-340-200 (WAC, 2017). This report has provided details regarding how COPCs were released, the types and extent of constituents detected at the Site, and actual and potential receptors. This section provides a conceptual summary of the detailed information described in the previous sections. Figure 15 presents a graphical representation of the conceptual model for the Site.

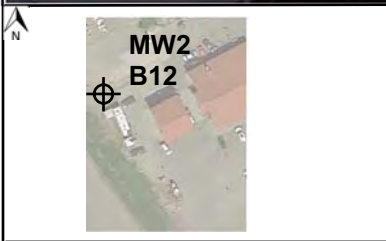
Depth (Ft)	Sample Interval/ Recovery	Blow Counts	PID Reading	USCS Classification	Description	Well Construction
1				GP	Surface: 1-inch asphalt GRAVEL: Dark brown angular fine gravel with 25% coarse gravel; 20% coarse sand; wet; no product odor	
2						
3						
4				GM	SILTY GRAVEL: Dark grey angular coarse gravel with 20% fine gravel; 25% silt; strong induration; damp to wet; no product odor	
5						
6						
7						
8				GP	GRAVEL: Dark grey fine gravel with 35% angular coarse gravel; 10% coarse sand; trace silt; saturated; no product odor	
9						
10						
11						
12						
13						
14						
15						
16					Boring terminated at 16 feet below ground surface ("bgs"). On 09/17/18 Holt Services, Inc. overdrilled the boring to 20 feet bgs and installed a 2-inch diameter groundwater monitoring well screened from 7.5 to 17.5 feet bgs.	
17						
18						
19

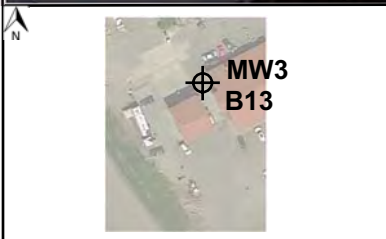
Depth (Ft)	Sample Interval/ Recovery	Blow Counts	PID Reading	USCS Classification	Description	Well Construction
1				GP	Surface: 1-inch asphalt GRAVEL: Dark brown fine gravel with 25% angular coarse gravel; 15% coarse sand; damp; faint product odor	
2						
3						
4						
5				GC	CLAYEY GRAVEL: Dark olive green subangular coarse gravel with 20% fine gravel; 25% low plasticity clay; weak induration; wet; faint product odor	
6						
7						
8						
9						
10				SP	SAND with SILT: Dark olive brown medium sand with 20% coarse sand; 10% subangular coarse gravel; 15% fine sand; 5% silt; saturated; weak induration; faint product odor	
11			0.5			
12						
13					Boring terminated at 16 feet below ground surface ("bgs"). On 09/17/18 Holt Services, Inc. overdrilled the boring to 20 feet bgs and installed a 2-inch diameter groundwater monitoring well screened from 7 to 17 feet bgs.	
14						
15						
16						
17

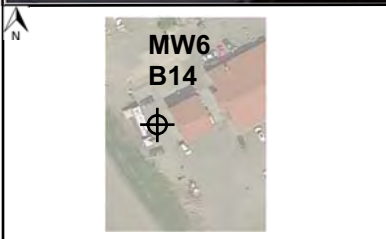
Depth (Ft)	Sample Interval/ Recovery	Blow Counts	PID Reading	USCS Classification	Description	Well Construction
1				GP	Surface: 1-inch asphalt GRAVEL: Dark grey fine gravel with 20% subangular coarse gravel; 15% coarse sand; damp; no product odor	
2						
3						
4						
5						
6			0.0			
7						
8						
9						
10				SP	SAND with SILT: Dark grey coarse sand with 20% fine gravel; 30% medium sand; strong induration; saturated; no product odor	
11			0.1			
12						
13				GP	GRAVEL: Dark grey angular coarse gravel with 20% fine gravel; 10% coarse sand; trace silt; strong induration; saturated; no product odor	
14						
15			0.1			
16					Boring terminated at 16 feet below ground surface ("bgs"). On 09/17/18 Holt Services, Inc. overdrilled the boring to 20 feet bgs and installed a 2-inch diameter groundwater monitoring well screened from 8 to 18 feet bgs.	
17						
18						
19

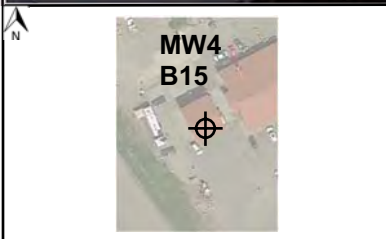
Depth (Ft)	Sample Interval/ Recovery	Blow Counts	PID Reading	USCS Classification	Description	Well Construction
1				GM	Surface: 1-inch asphalt SILTY GRAVEL: Dark red-brown subangular coarse gravel with 20% fine gravel; 15% silt; moderate induration; damp; faint to strong product odor	
2			8.6			
3						
4			28			
5						
6						
7				SM	SILTY SAND: Dark olive green fine sand with 40% silt; strong induration; damp; strong product odor	
8			8.6 2.8			
9						
10			6.5			
11						
12						
13						
14						
15					Boring terminated at 12 feet below ground surface ("bgs"). On 09/18/18 Holt Services, Inc. overdrilled the boring to 15 feet bgs and installed a 2-inch diameter groundwater monitoring well screened from 4 to 14 feet bgs.	
16						
17						
18						
19

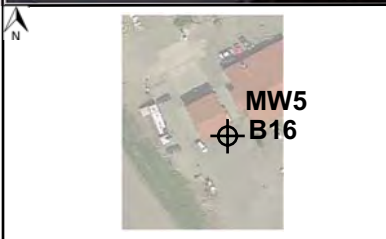
Depth (Ft)	Sample Interval/ Recovery	Blow Counts	PID Reading	USCS Classification	Description	Well Construction	
1				GM	Surface: 6-inch concrete		
2			60			SILTY GRAVEL: Dark brown fine gravel with 20% coarse sand; trace silt; damp; strong product odor	
3							
4			127.3			No recovery 4 to 8 feet	
5							
6							
7							
8							
9						Dark grey to dark brown angular coarse gravel with 20% fine gravel; 10% coarse sand; 5% silt; strong induration; saturated; strong product odor below 8 feet	
10			54.3				
11							
12							
13							
14							
15						Boring terminated at 12 feet below ground surface ("bgs"). On 09/18/18 Holt Services, Inc. overdrilled the boring to 15 feet bgs and installed a 2-inch diameter groundwater monitoring well screened from 4 to 14 feet bgs.	
16							
17							
18							
19

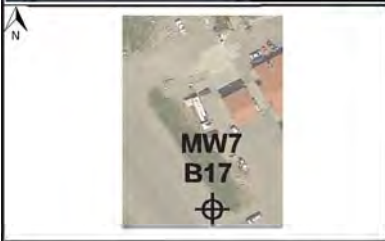
Depth (Ft)	Sample Interval/ Recovery	Blow Counts	PID Reading	USCS Classification	Description	Well Construction
1				GM	Surface: 1-inch asphalt SILTY GRAVEL: Dark brown coarse gravel with 20% fine gravel; 10% coarse sand; 15% silt; damp; strong induration; strong product odor	
2		49.6				
3						
4						
5					Dark grey with 60% angular coarse gravel; 20% fine gravel; 5% coarse sand; 15% silt; strong induration; damp to dry; no product odor	
6						
7						
8			0.5			
9					Saturated below 9 feet	
10						
11						
12						
13						
14						
15					Boring terminated at 12 feet below ground surface ("bgs"). On 09/18/18 Holt Services, Inc. overdrilled the boring to 15 feet bgs and installed a 2-inch diameter groundwater monitoring well screened from 4 to 14 feet bgs.	
16						
17						
18						
19

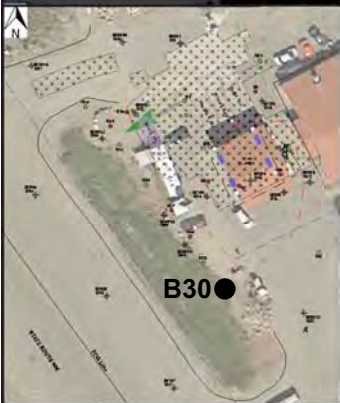
Depth (Ft)	Sample Interval/ Recovery	Blow Counts	PID Reading	USCS Classification	Description	Well Construction
1				GM	Surface: Gravel SILTY GRAVEL: Yellow-brown subrounded coarse gravel with 20% fine gravel; 15% fine sand; 20% silt; strong induration; dry; no product odor	
2						
3			1.2			
4						
5						
6						
7			1.1			
8				SM	SILTY SAND: Dark brown fine sand with 10% coarse gravel; 35% silt; 5% low plasticity clay and organic matter; damp to wet; no product odor	
9						
10						
11			0.8			
12					Boring terminated at 12 feet below ground surface	
13						
14						
15						
16						
17						
18						
19

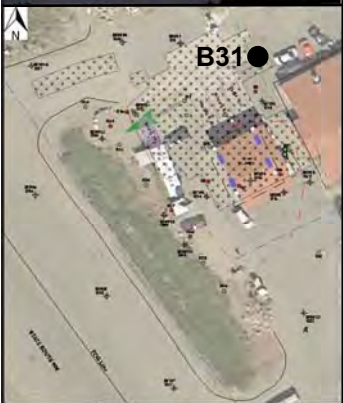
Depth (Ft)	Sample Interval/ Recovery	Blow Counts	PID Reading	USCS Classification	Description	Well Construction
1				GM	Surface: Gravel SILTY GRAVEL: Light to dark brown angular coarse gravel with 25% fine gravel; 10 to 25% silt; strong induration; dry; no product odor	
2						
3			0.9			
4						
5						
6			0.6	OL	ORGANIC CLAY: Dark brown low plasticity clay with organic matter with inch-scale sand lens; 20% fine sand; moderate induration; wet; no product odor	
7						
8						
9						
10			0.5	SM	SILTY SAND: Dark olive-green fine sand with 30% silt; strong induration; wet; no product odor	
11						
12					Boring terminated at 12 feet below ground surface	
13						
14						
15						
16						
17						
18						
19

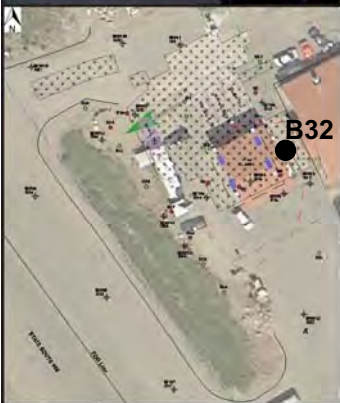
Depth (Ft)	Sample Interval/ Recovery	Blow Counts	PID Reading	USCS Classification	Description	Well Construction
1				GM	Surface: Gravel SILTY GRAVEL: Dark grey angular coarse gravel with 20% fine gravel; 20% silt; strong induration; damp; no product odor	
2						
3			0.9			
4						
5					Wet below 5 feet	
6			0.6			
7						
8						
9						
10						
11			0.4			
12					Boring terminated at 12 feet below ground surface	
13						
14						
15						
16						
17						
18						
19

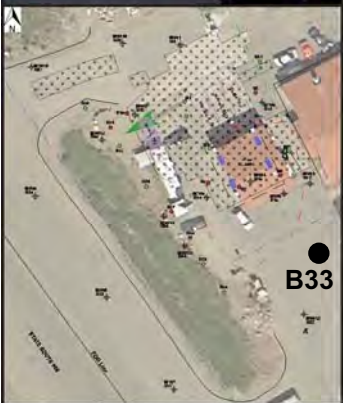
Depth (Ft)	Sample Interval/ Recovery	Blow Counts	PID Reading	USCS Classification	Description	Well Construction
1				GM	Surface: Gravel SILTY GRAVEL: Red-brown angular coarse gravel with 35% silt; moderate induration; wet; no product odor	
2			0.7			
3						
4					Dark olive-green below 4 feet	
5			0.3			
6					Boring terminated at 6 feet below ground surface	
7						
8						
9						
10						
11						
12						
13						
14						
15						
16						
17						
18						
19

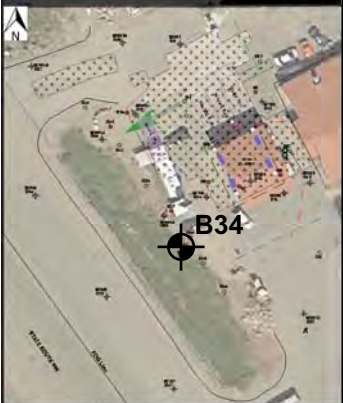
Depth (Ft)	Sample Interval/ Recovery	Blow Counts	PID Reading	USCS Classification	Description	Well Construction
1				GM	Surface: 1-inch asphalt SILTY GRAVEL: Light brown angular coarse gravel with 25% coarse sand; 30% silt; strong induration; dry; no product odor	
2			0.8			
3					Trace organic matter 3 to 4 feet	
4						
5						
6					Dark grey with 70% coarse angular gravel; 10% coarse sand; 20% silt; damp to wet; no product odor	
7						
8			0.5			
9					Boring terminated at 9 feet below ground surface	
10						
11						
12						
13						
14						
15						
16						
17						
18						
19

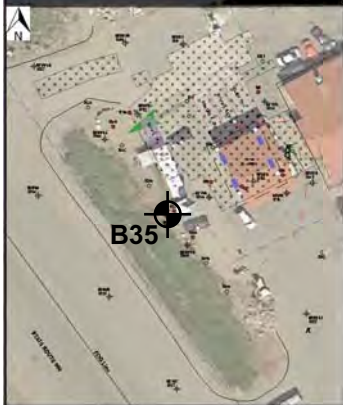
Depth (Ft)	Sample Interval/ Recovery	Blow Counts	PID Reading	USCS Classification	Description	Well Construction
1				GM	Surface: Gravel SILTY GRAVEL: Dark green-brown coarse subangular gravel with 15% medium sand; 25% silt; strong induration; dry; no product odor	
2						
3						
4						
5						
6						
7						
8						
9						
10		26				
11		50/3				
12		12	4.6			
12		50/4				
13						
14						
15		50/4			Saturated below 15 feet	
16						
17						
18						
19						
Boring terminated at 20 feet below ground surface

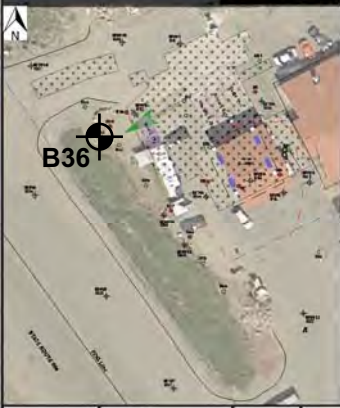
Depth (Ft)	Sample Interval/ Recovery	Blow Counts	PID Reading	USCS Classification	Description	Well Construction
1				GM	Surface: Gravel SILTY GRAVEL: Dark grey coarse subangular gravel with 30% coarse sand; 20% silt; very dense; damp; no product odor	
2						
3						
4						
5						
6						
7						
8						
9						
10		23	7.7		Strong product odor below 10 feet	
11		50		OC	ORGANIC CLAY: Dark brown low plasticity clay with 10% subrounded coarse gravel; very dense; wet; no product odor	
12						
13				GM	SILTY GRAVEL: Dark grey subangular coarse gravel with 35% coarse sand; 15% silt; very dense; saturated; no product odor	
14						
15		12			Saturated below 15 feet	
16		16				
17		50				
18						
19						
Boring terminated at 20 feet below ground surface

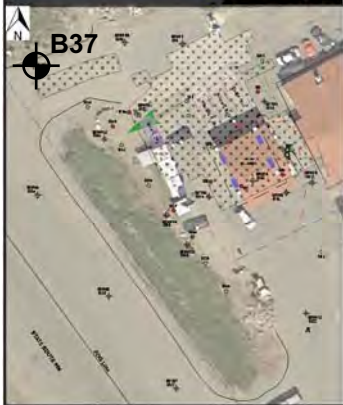
Depth (Ft)	Sample Interval/ Recovery	Blow Counts	PID Reading	USCS Classification	Description	Well Construction	
1				GM	Surface: Gravel SILTY GRAVEL: Medium brown subangular coarse gravel with 20% coarse sand; 25% silt; 5% organic low plasticity clay; loose; damp; no product odor		
2							
3							
4							
5							
6							
7							
8							
9							
10		2	7.7				
11		2 6					
12							
13							
14							
15		50/6					Saturated below 15 feet
16							
17							
18							
19							
Boring terminated at 20 feet below ground surface
