CRITICAL AREAS ASSESSMENT REPORT

Wetland Delineation and Conceptual Mitigation Plan Westside Solar Site Cle Elum, WA

October 2019

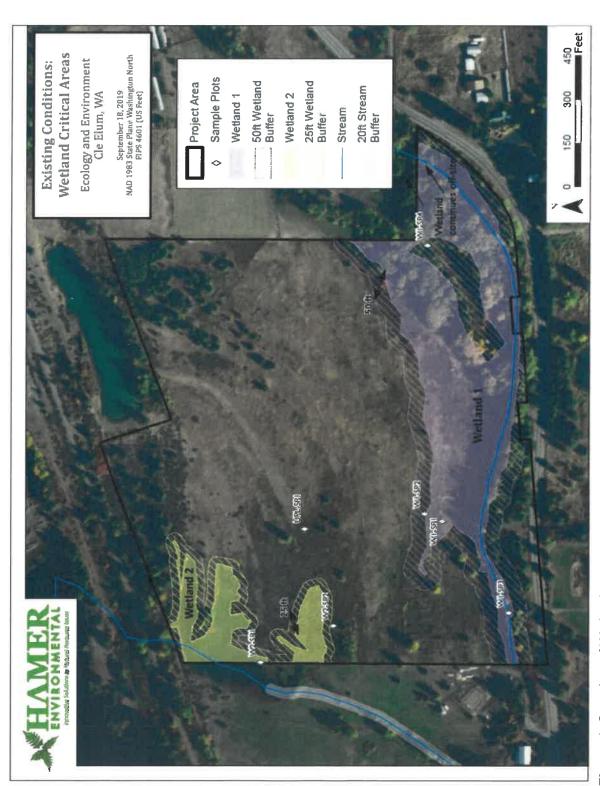
Figure 4. Overview of Wetlands 1 and 2 and streams within the study area.

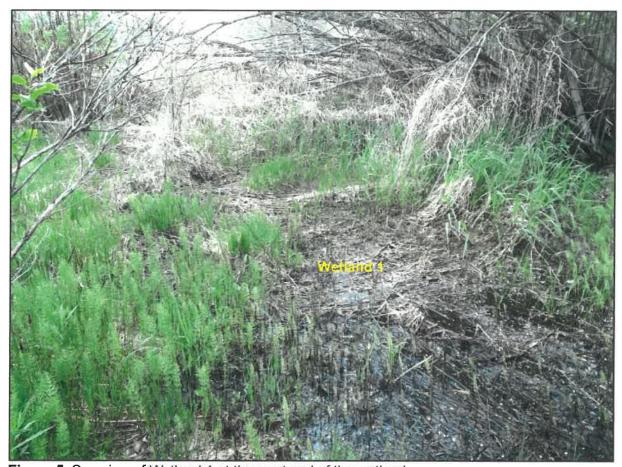
Figure 5. Overview of Wetland 1 at the west end of the wetland.
