# MEMORANDUM

Project No.: 230234

Re: **Yakima River Campground Channel Migration Zone Preliminary Evaluation,  
Teanaway, Washington**

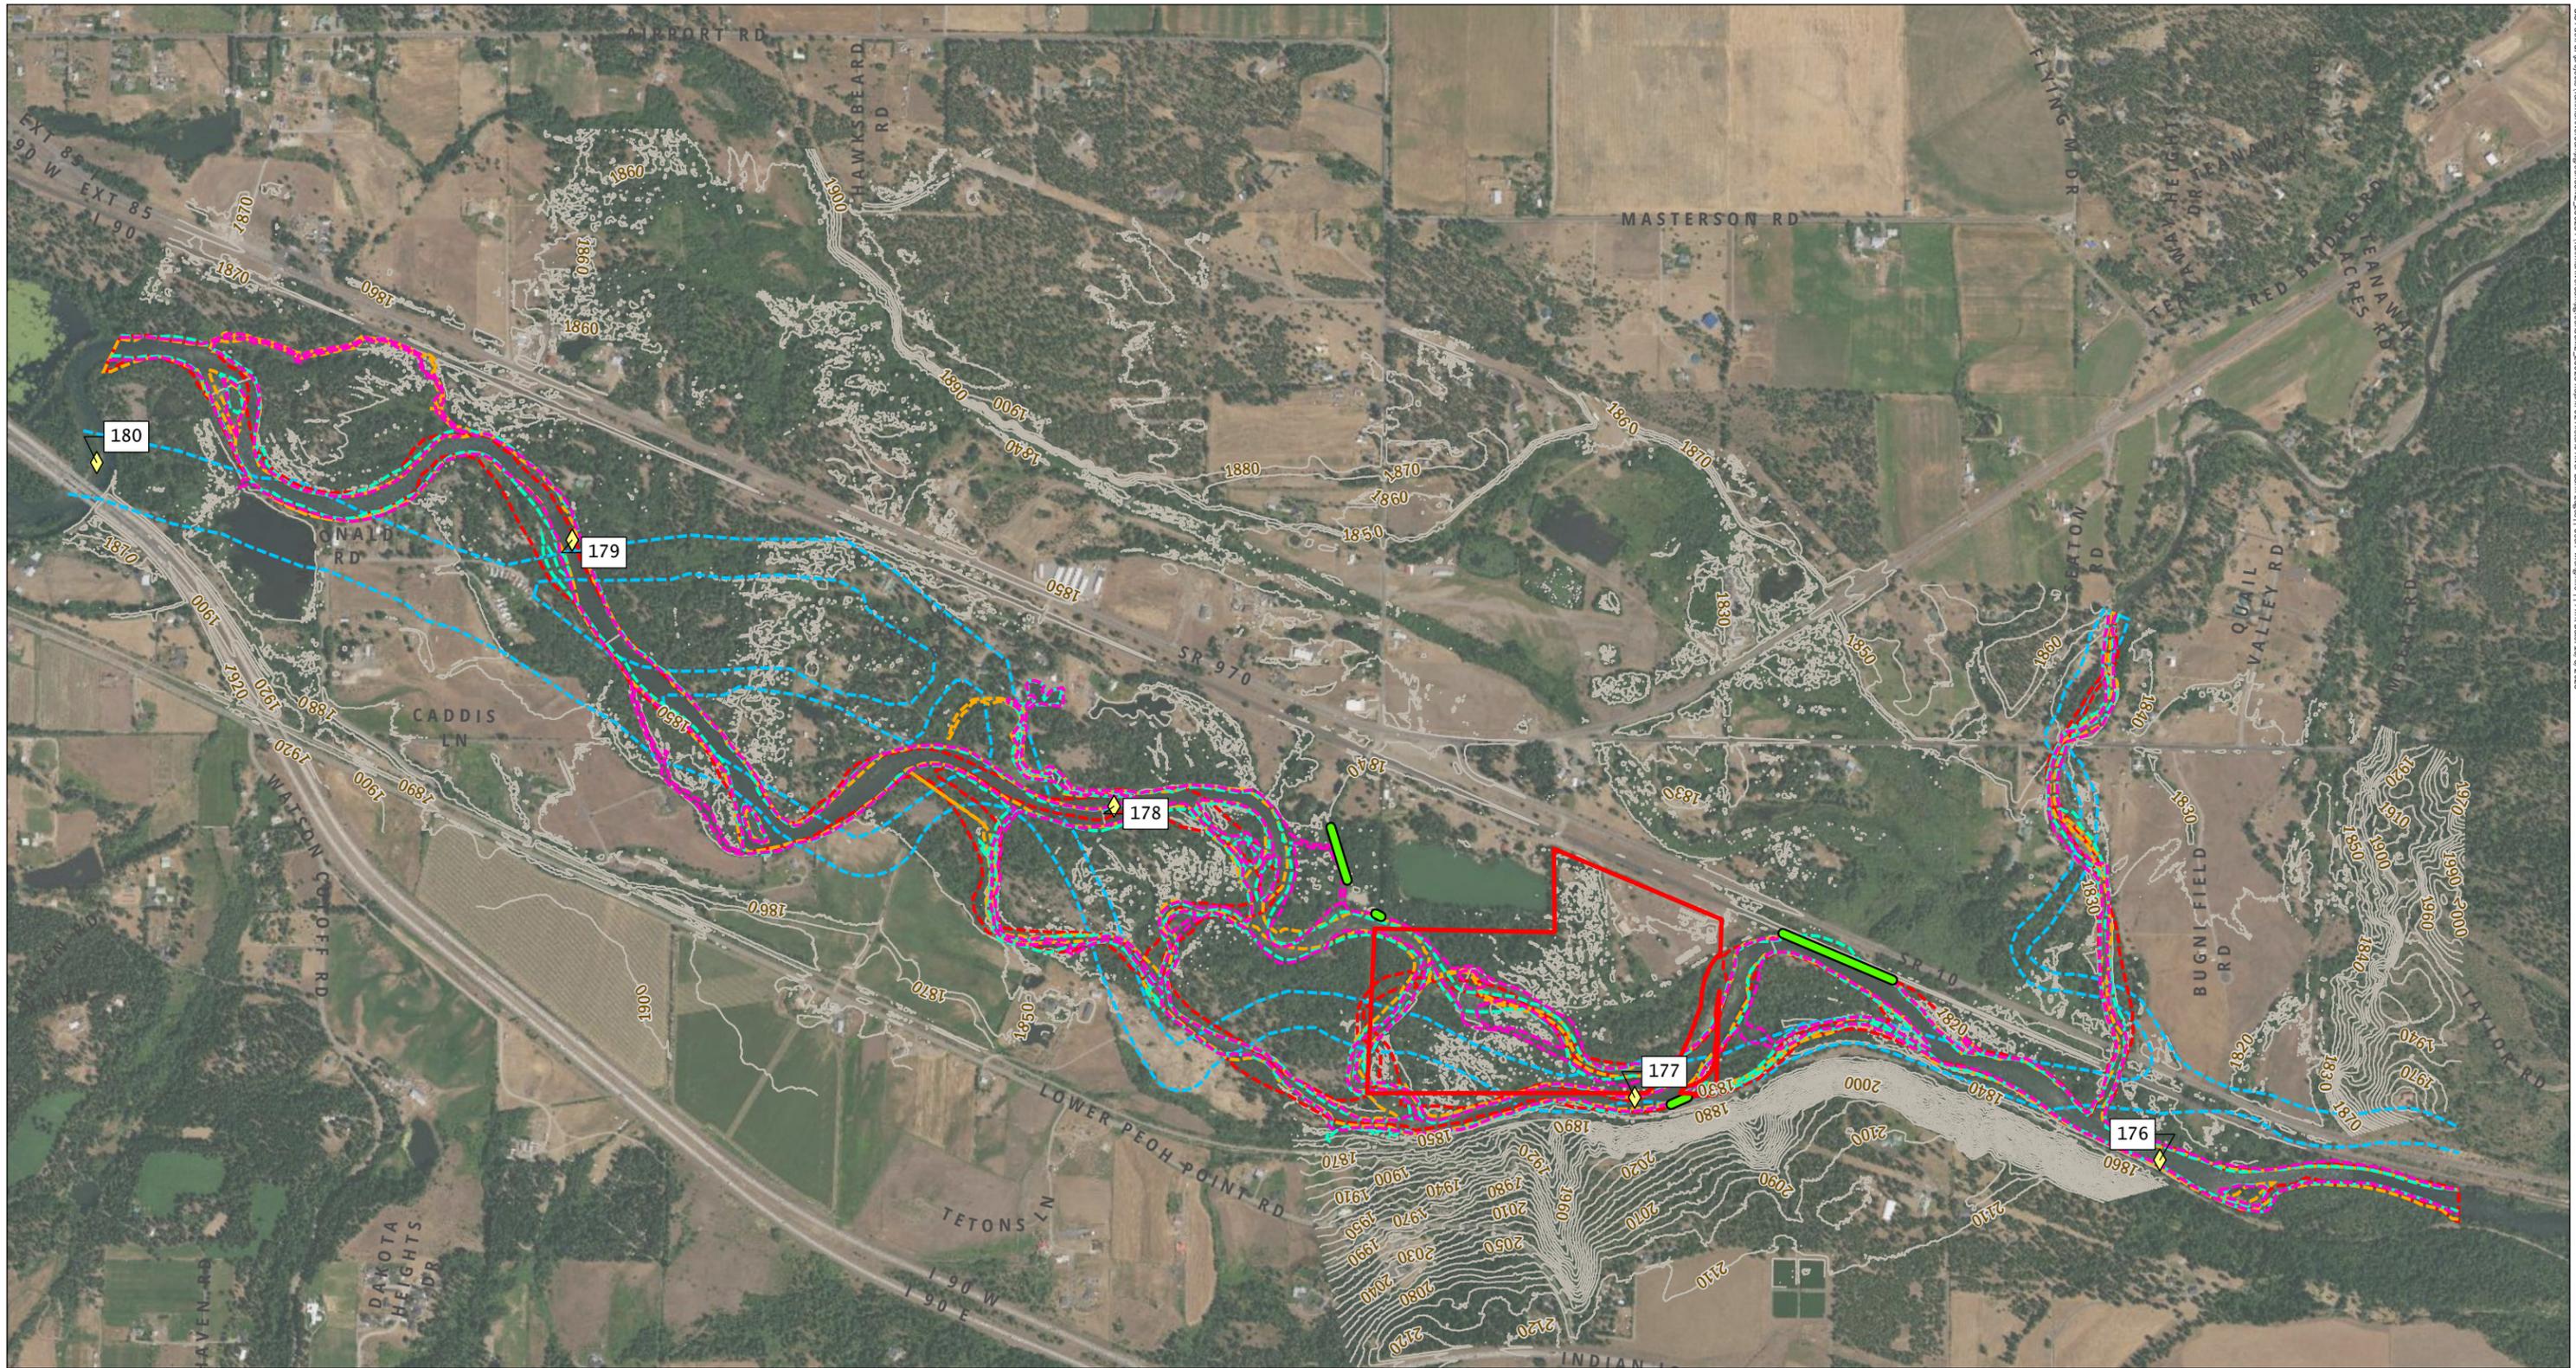
OCT-2023	BY: CB / WBL	FIGURE NO. <b>2</b>
	<small>PROJECT NO.</small> 230234	<small>REVISED BY:</small> --- / ---

- River Bank Edges**
- 2021 Bank Edge
  - 2005 Bank Edge
  - 1994 Bank Edge
  - 1954 Bank Edge
  - 1800 Bank Edge
- Legend:**
- Bank Protection
  - Site
  - ◆ River Miles
  - ~ 10ft Contour

### Historic River Bank Edges

To evaluate the Yakima River channel behavior in the reach, we reviewed GLO maps from 1880 and historical aerial photographs from 1954, 1994, 2005, and 2021 and digitized channel banks spanning a period of record of 141 years. The results of digitizing the various year's channel banks are provided on Figure 2. From our review of the aerial photographs, we noted that the apparent lake waterbody (Figure 2) that is west of the Site was not present in the 1954 aerial photograph and likely represents a former sand and gravel borrow pit.

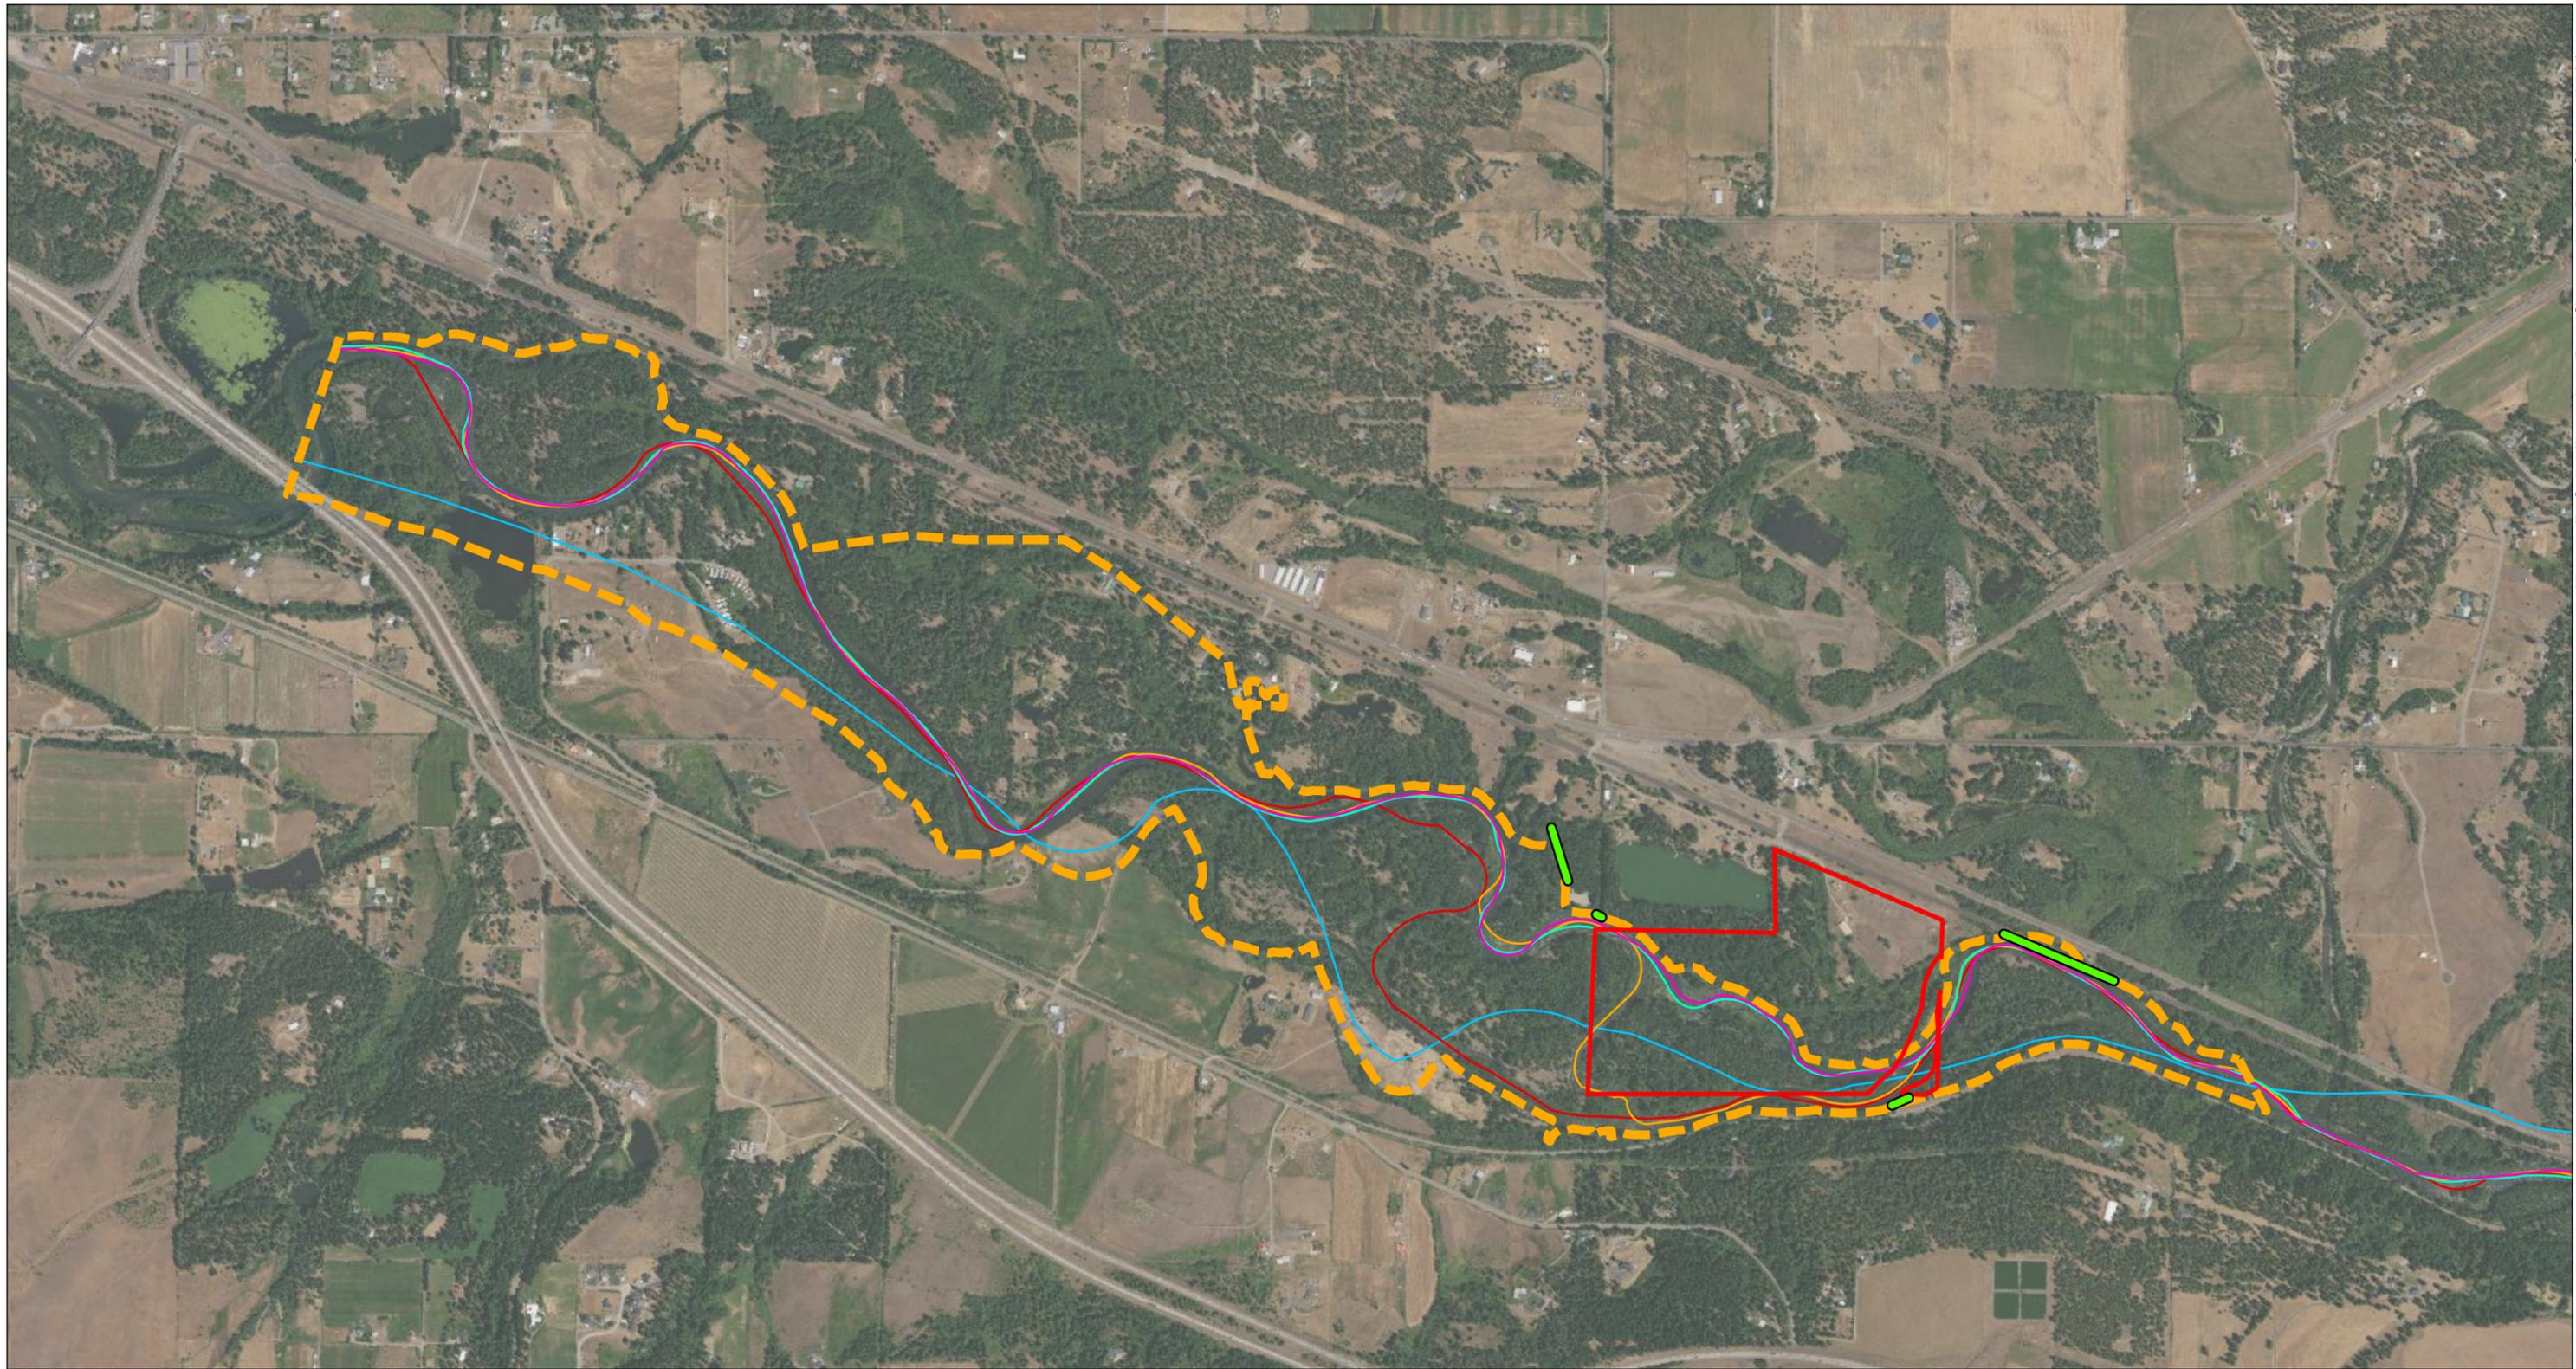
OCT-2023	BY: CB / WBL	FIGURE NO. <b>3</b>
	<small>PROJECT NO.</small> 230234	<small>REVISED BY:</small> --- / ---

- River Centerlines**
- 2021 River Centerline
  - 2005 River Centerline
  - 1994 River Centerline
  - 1954 River Centerline
  - 1880 River Centerline

- Site
- HMZ
- Bank Protection

**Historic Migration Zone**  
Yakima River Campground  
Teanaway, Washington

The channel bank data was used along with LiDAR data to develop a historical migration zone (HMZ) that identifies current and past locations of the river banks (Figure 3). The HMZ represents areas where the channel has been located historically; it does not necessarily include areas where flooding has historically occurred. For example, the channel may have flooded north of SR 10, as interpreted from the 1954 aerial photographs; however, it is unlikely that the channel would migrate into this zone now because of existing highway and railway infrastructure and evidence of local bank hardening that restricts channel migration.
