# LAND & WATER SOLUTIONS, LLC

December 29, 2017

Project# TWC17E32

RE: Wetland Reconnaissance - Kittitas County Parcel #: 18-18-27030-00019

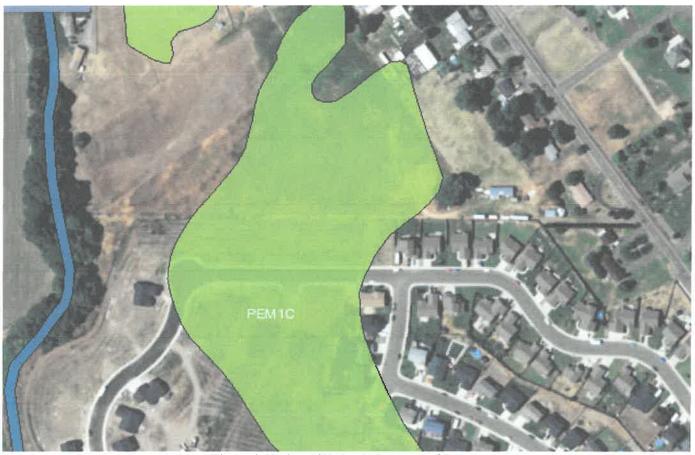
Figure 1. National Wetlands Inventory Map

The USFWS NWI map shows a Palustrine Emergent Seasonally Flooded (PEMC) within the site.

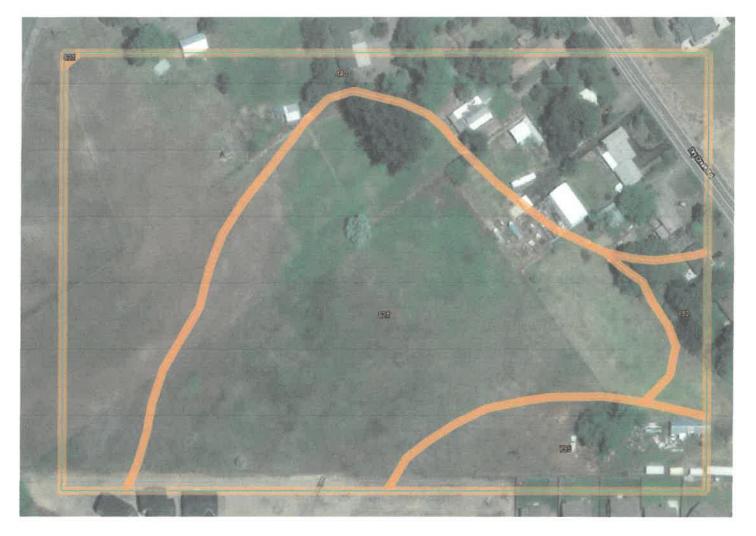
Figure 2. NRCS SOIL MAP

The following soil series are identified within the subject property according to the NRCS Online Soil Survey.

480—Nanum ashy loam, 0 to 2 percent slopes

621—Mitta ashy silt loam, flooded, 0 to 2 percent slopes

The drainage classes of these soils are referenced by the NRCS to range from somewhat poorly drained to moderately well drained. Mita Ashy Silt Loam (621) is listed by the NRCS as having an occasional frequency of flooding.
