Cottonwood Logs in Channel

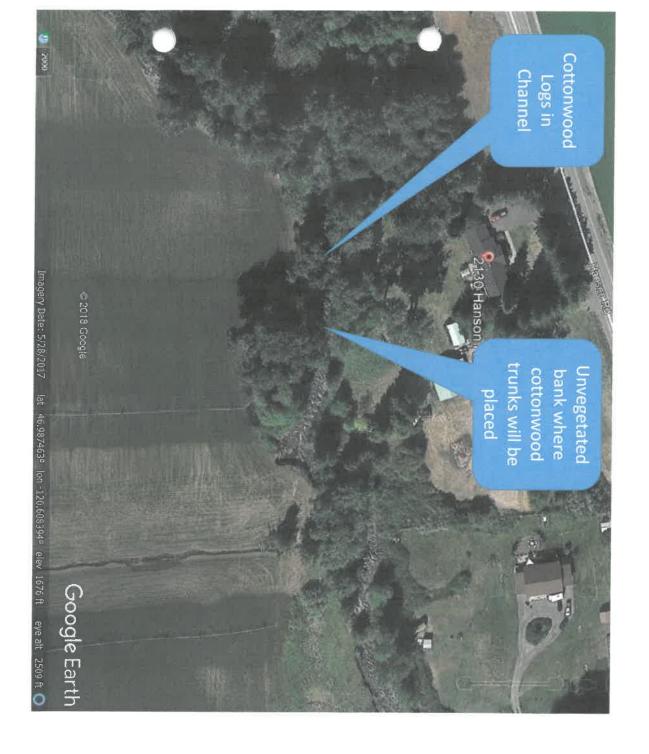
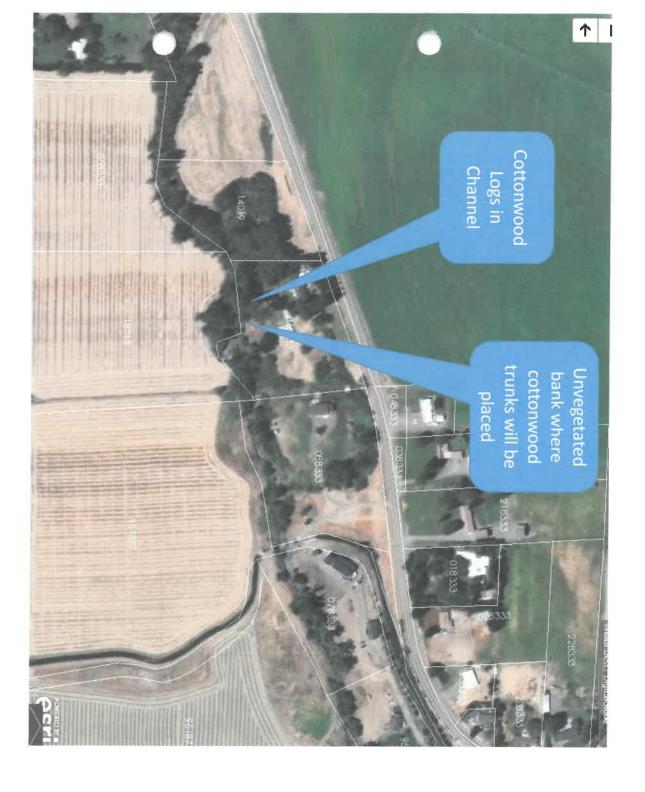
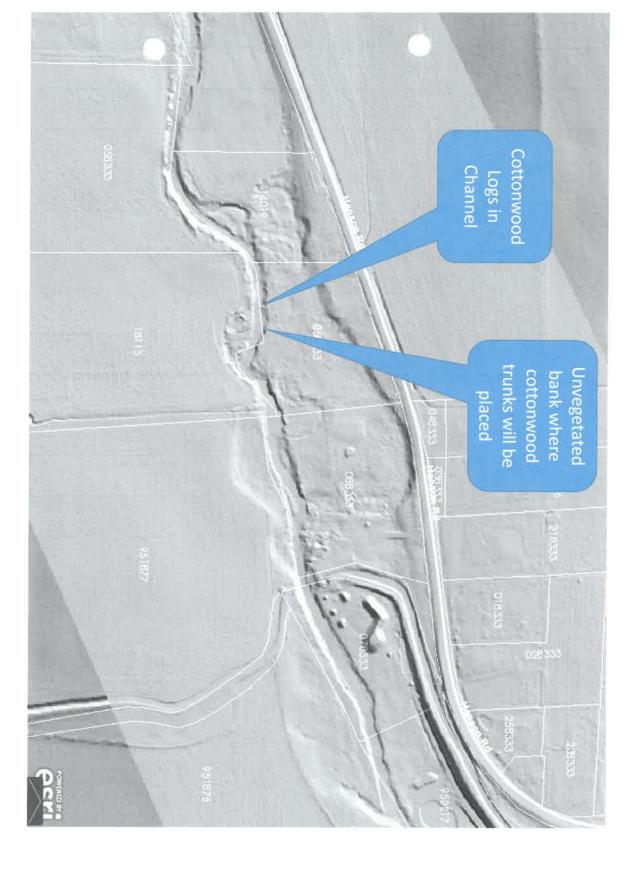
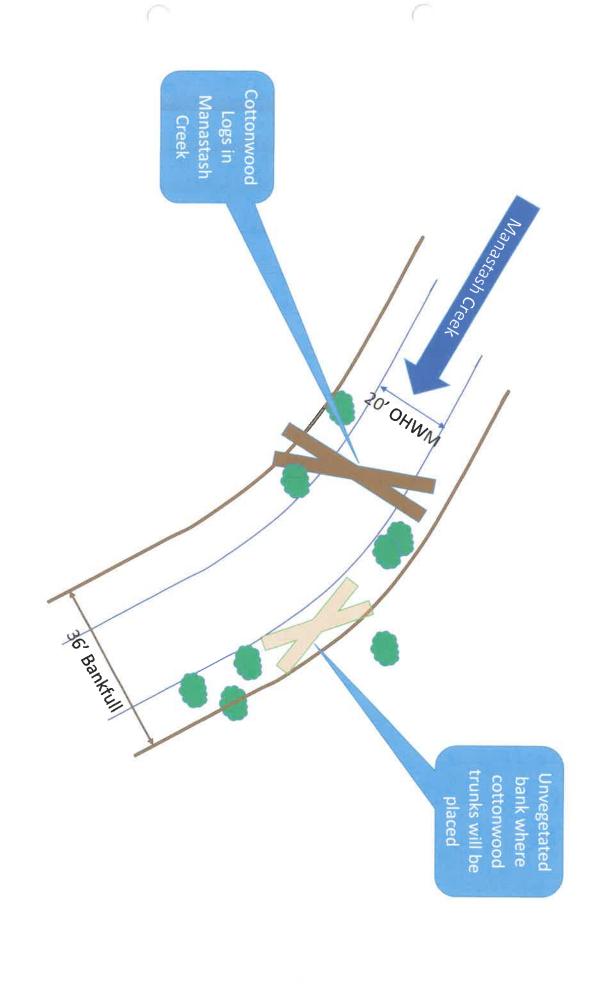
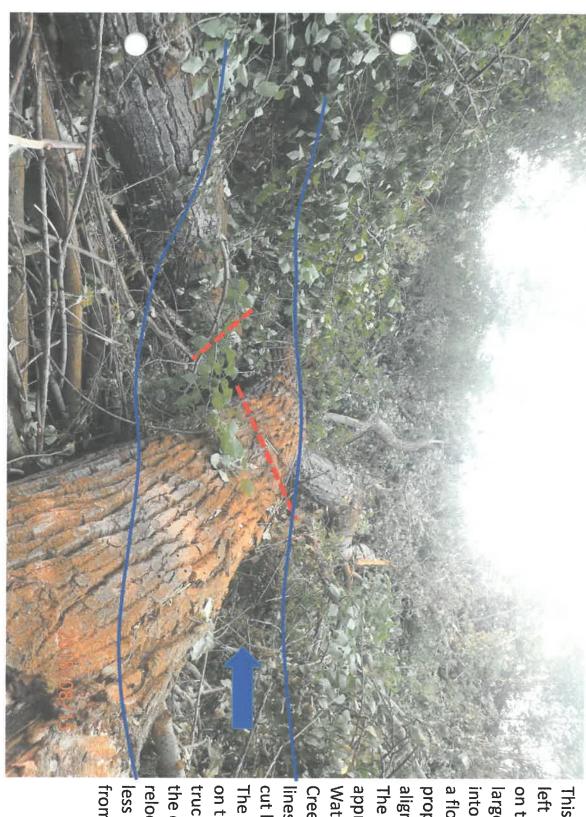
This photo was taken from the left bank of Manastash Creek on the Schwab property. Two large cottonwood trees fell into the creek and are creating a flood hazard for surrounding properties in their current alignment.

The blue lines show the approximate Ordinary High Water Marks of Manastash Creek (~20'). The red dashed lines show the approximate cut locations for the two trees. The broken tops will remain on the right bank, but the trucks will be picked up from the center of the channel and relocated along the left bank less than 50 feet downstream from this location.

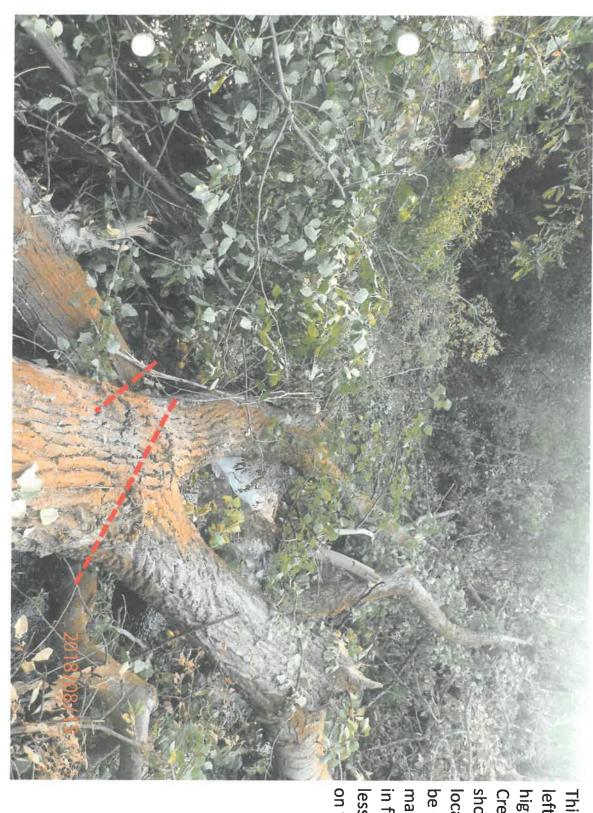
This photo is taken from the left bank, within the ordinary high water mark of Manastash Creek. The dashed red lines show the approximate locations where the trunks will be cut. The trunks within the main channel will be removed in full suspension and placed less than 50 feet downstream on the left bank.

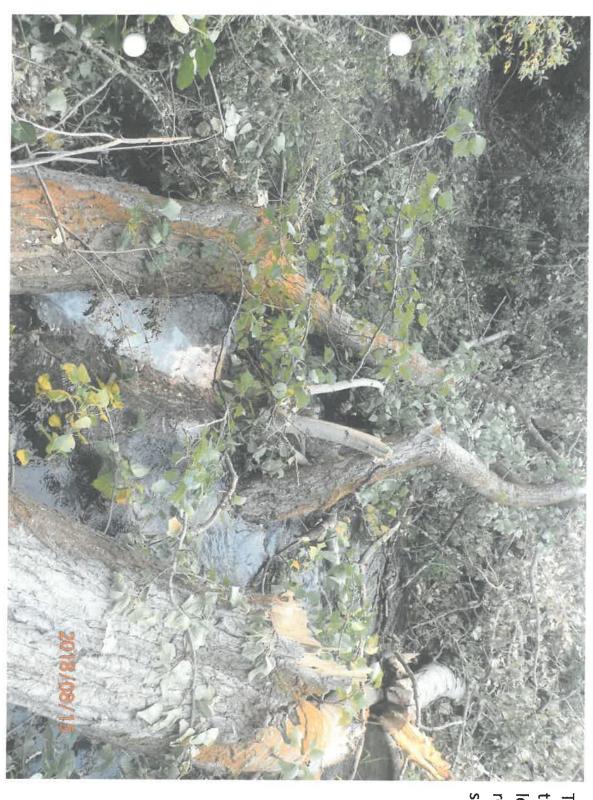
This photo is a close up of the trunks to be relocated to the left bank downstream to reduce flood risks to surrounding properties.

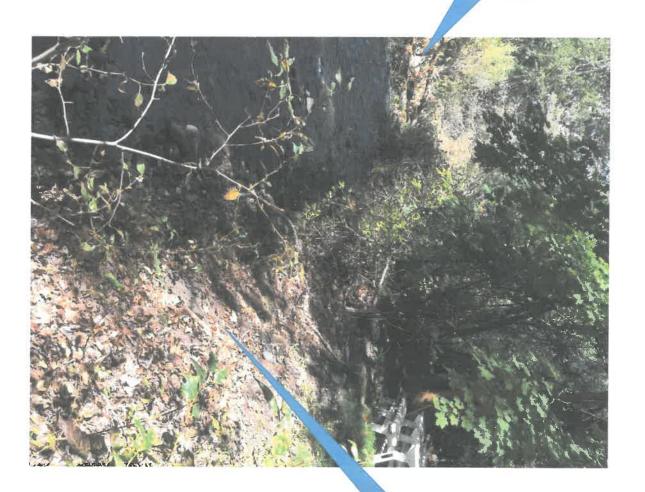
Unvegetated bank where cottonwood trunks will be placed
