## PHASE I ENVIRONMENTAL SITE ASSESSMENT

SNOQUALMIE SUMMIT PROPERTIES  
SR 906

SNOQUALMIE PASS, WASHINGTON

SEPTEMBER 23, 2008

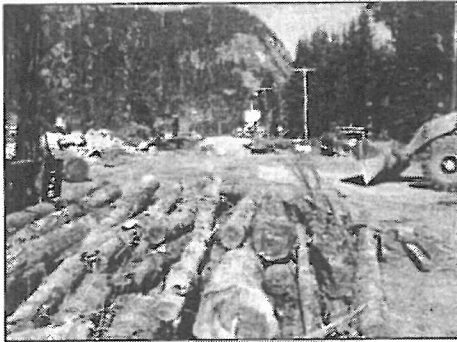
- De minimus amounts of black oily surficial soil were observed randomly throughout the Site (from parking of heavy equipment).
- Telephone pole-size logs were stacked on the southern portion of the Site (Appendix A Photograph 1).

Photograph 1: View north from south end of King County parcel east of SR 906. Logs and machinery belong to a tenant, Mr. Pat Matner.

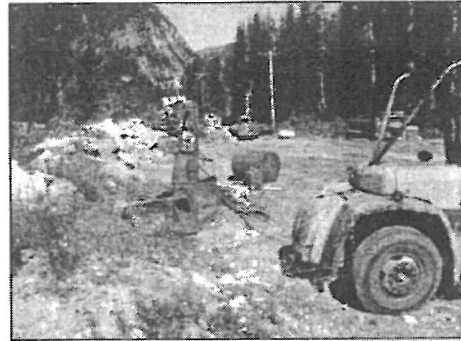
Photograph 2: View north along west property border of the King County parcel east of SR 906. Note scrap iron including an empty UST.

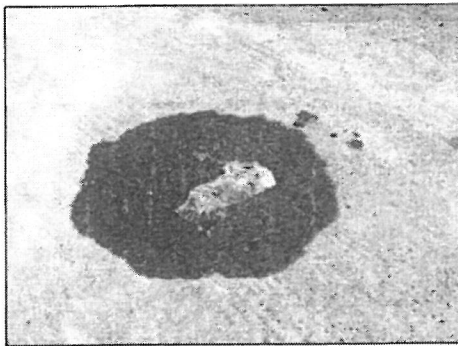
Photograph 3: Fresh release of hydraulic oil on King County parcel east of SR 906.

The east King County parcel is leased by a snowplow and earth works contractor who kept heavy equipment at the Site. During RGI's Phase I Environmental Site Assessment, RGI observed fresh spills of what appeared to be hydraulic oil and a heavy odor of oil emanating from the fill soil on the southern portion of the Site. At the time of this Phase II, most of the equipment had been removed.

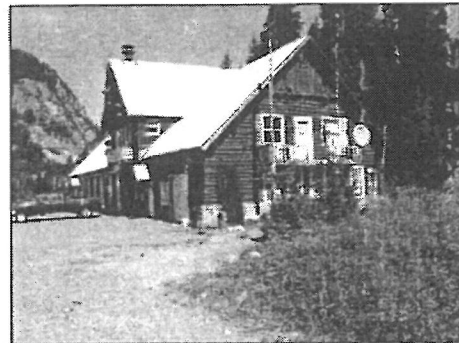
Photograph 4: Development north and adjacent to King County parcel east of SR 906 include the Forest Service Fire Station.

- North of Site:** U.S. Forest Service Fire Station, north of the eastern King County parcel, (Appendix A, photograph 4). An access road to the ski area is north of the west King County parcel; and, single family homes are north of the Kittitas County parcel.

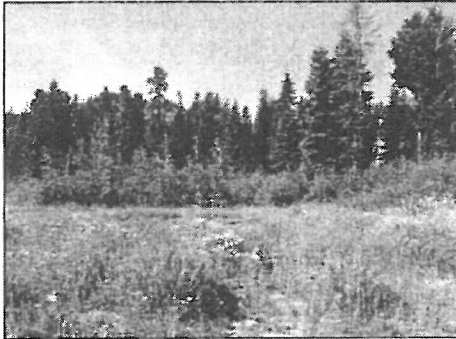
Photograph 5: North and adjacent property to King County parcel east of SR 906.

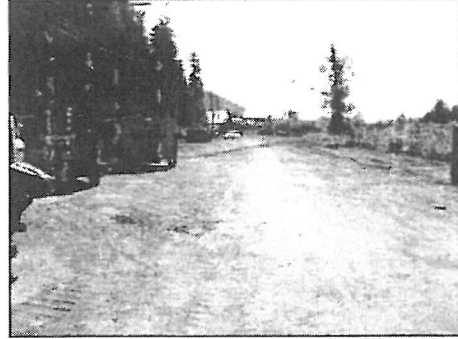
- Several "roll-off" containers, labeled recycling were observed. According to the owner, King County is allowed to store these containers on the Site (Appendix A Photograph 6).

Photograph 6: View south of King County parcel east of SR 906. Owner allows King County to store recycling containers on the Site.

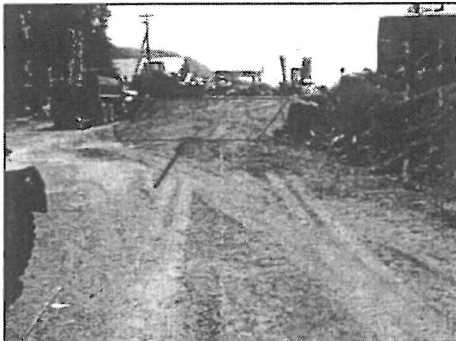
Photograph 7: View south of fill soil (indicated by arrow) on King County parcel east of SR 906.

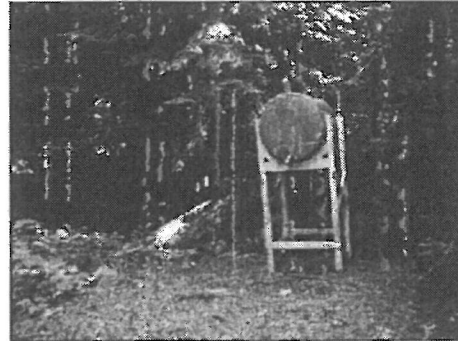
- An AST reportedly containing diesel-fuel was observed (see Appendix A Photograph 8). Evidence of a release to the ground surface beneath the AST was not observed.

One (reportedly) diesel-fuel AST was observed on the east portion of the King County Site, tucked into the woods, in the approximate north/south center of the Site. The AST is supported by a wood-frame structure, approximately seven feet above ground surface; there was not a concrete pad beneath it. Evidence of a release was not observed, there were no odors or stained ground in the vicinity of the AST. The AST is apparently used by the tenant for refueling equipment.

Photograph 8: View of diesel-fuel AST on King County parcel east of SR 906. Stained soil was not observed beneath spigot, which was locked.

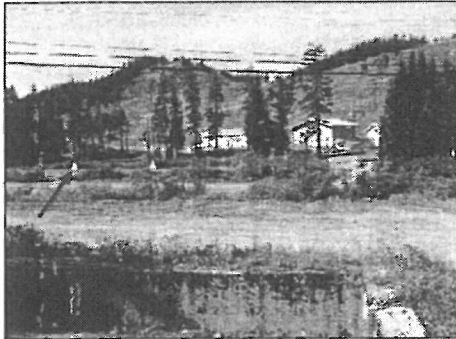
Photograph 9: View west toward King County parcel west of SR 906. Triangular structure (indicated by arrow) contains a hydrant. Power is provided to this parcel via an off-site electrical transformer. Access road to the Summit Learning Center (ski school) is on the north adjacent property.

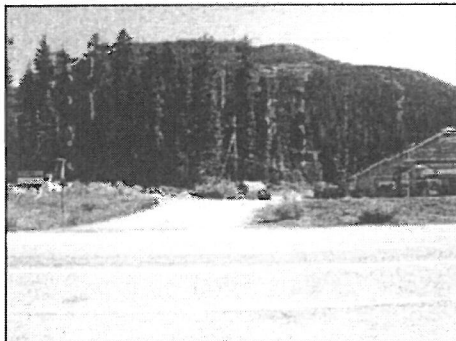
One 20,000-gallon, empty and out of service propane AST was observed on the southern property boundary of the eastern portion of the King County parcel (Appendix A Photograph 11). This AST was reportedly for emergency heating fuel for the Snoqualmie Summit Inn before it was converted to natural gas.

Mr. Zenger stated that the 20,000 gallon propane AST (located on the southern property boundary of the King County parcel) has been out of service for several years. It was originally used for backup heating fuel for the Summit Inn in the event of a power failure at The Pass.

Photograph 11: View east from west side of SR 906 looking at property boundary between the King County parcel east of SR 906 and a south adjacent Chevron gasoline and convenience store. The red AST is a 20,000 gallon (empty and out of service) propane tank on the subject Site. SR 906 is in the foreground.

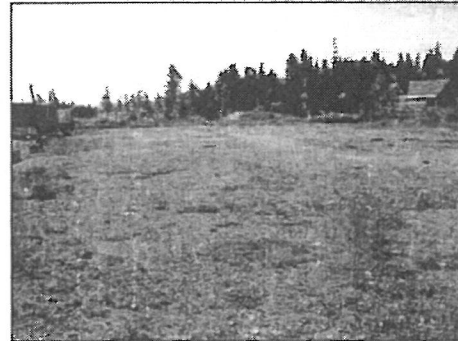
- This parcel is unpaved, partially gravel-surfaced with some vegetation growing through the gravel (Appendix A Photograph 12).
- The foundation from the former Rock Chalet is located on the north central portion of the Site.
- A foundation from a former gasoline station is located on the southeast quadrant of the Site. The foundation features the remnants of a tiled-floor. (Appendix A Photographs 14, 15, 16).
- A foundation for a single car garage is located on the northeast corner of the Site and is overgrown with vegetation.

Photograph 12: View southwest of the Kittitas County parcel. Property west and adjacent are single-family recreational homes.

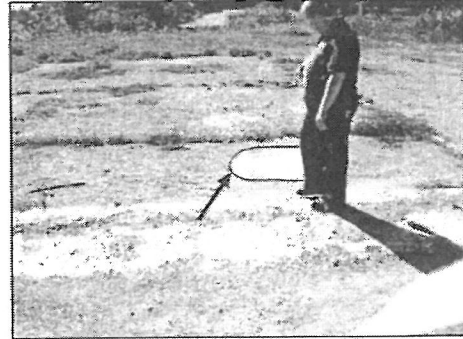
Photograph 14: View of the former gas station foundation on the Kittitas County parcel. The remnant of a tiled floor is indicated by arrow.

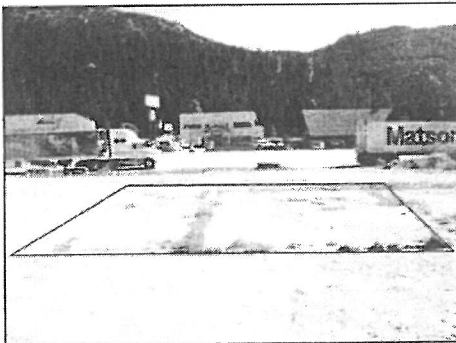
Photograph 15: View east across former gasoline station foundation (outlined). Lee's Summit Grocery is in the background on east side of SR 906.

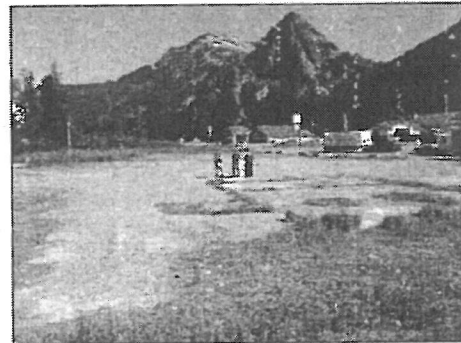
Photograph 16: View north across Kittitas County parcel. Three people are standing just north of former gasoline station foundation. Red-roofed building is the Summit Inn. Truck is parked on west shoulder of SR 906. The Rock Chalet was located on the northwest quadrant of this parcel.

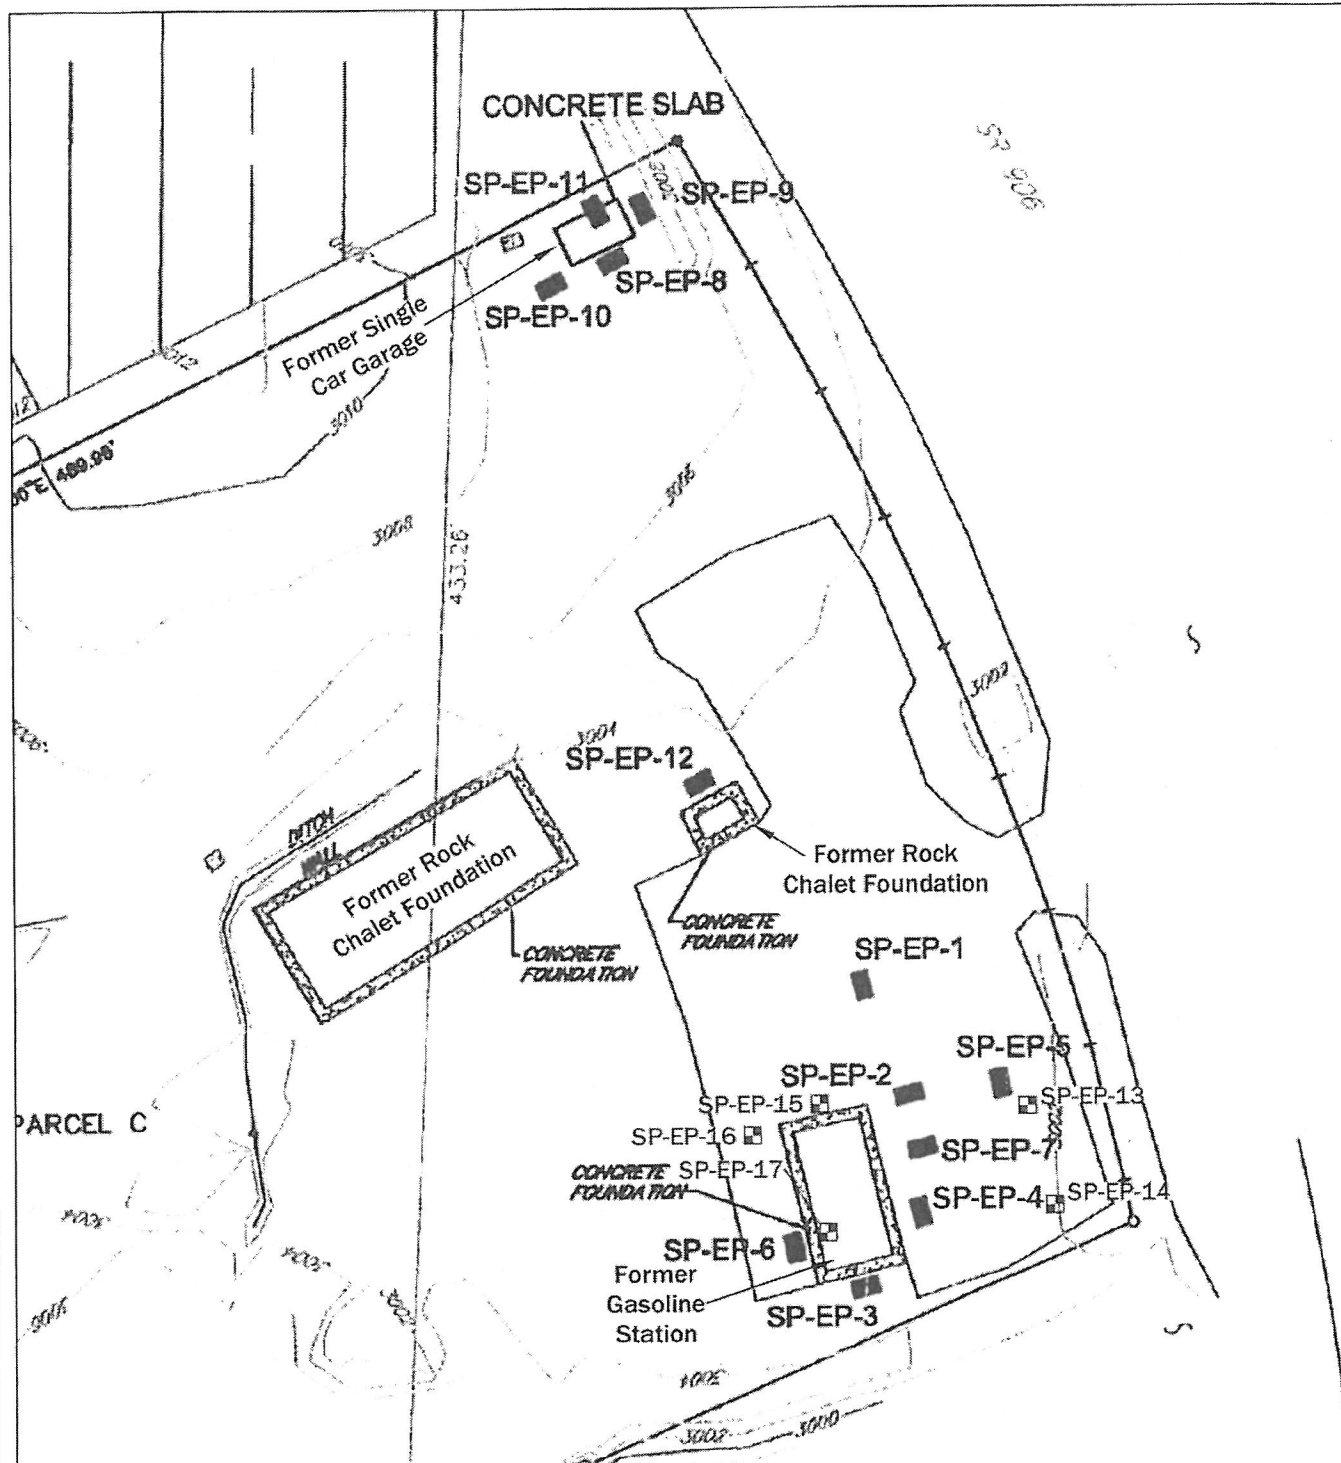
On October 6, 2008, RGI advanced a total of 11 test pits to a maximum depth of 11 feet bgs. Test pits were placed around the former gasoline station foundation on the Kittitas County parcel and on the east King County parcel (Figure 2 and Figure 3, respectively).

SP-EP-1 ■ Approximate location of ECI exploration pit, November 2007.

SP-EP-13 ■ (in red) RGI test pit location 10/06/08.

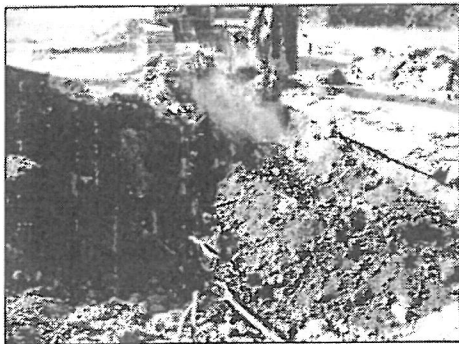
Photograph 1: Exposing former gasoline station foundation in south excavation (SPS). View looking west.

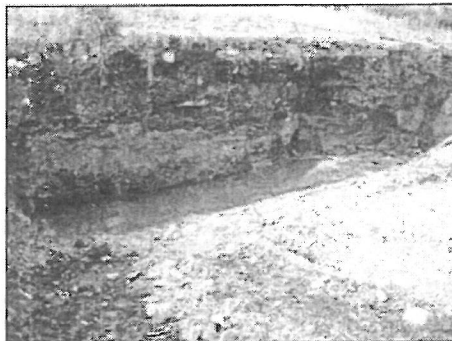
Photograph 2: SPS soil stratigraphy showing fill materials overlying glacial lacustrine sediments on south sidewall. View looking south.

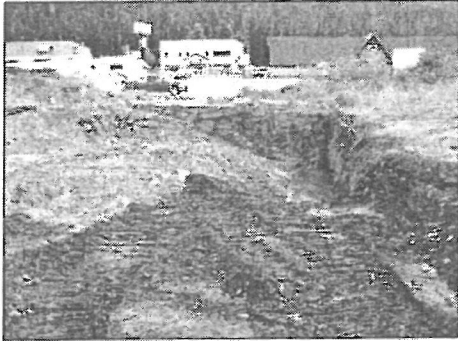
Photograph 5: View east across south end of SPS during backfilling.  
SR906 in background.

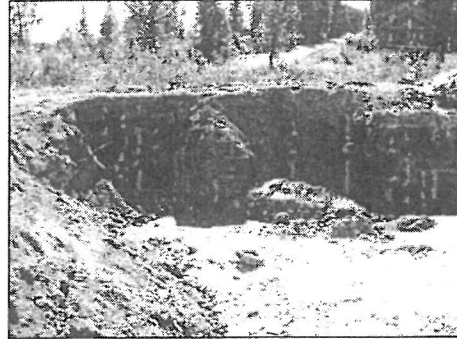
Photograph 6: View looking south across SPS after final excavation of PCS.  
Excavation has been partially backfilled.

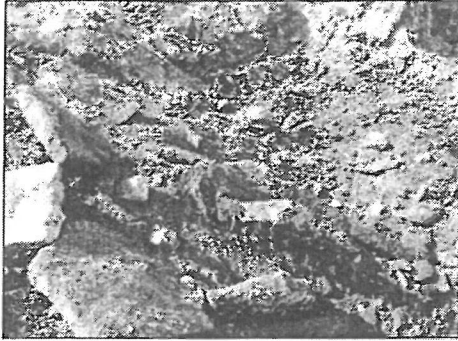
Photograph 1: Concrete debris in north excavation (SPN).

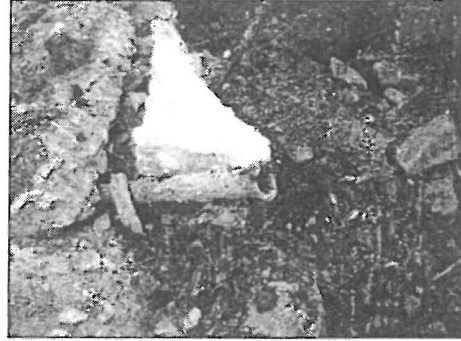
Photograph 2: Shallow soil and auto parts, piping, organic tree roots debris exposed in SPN.

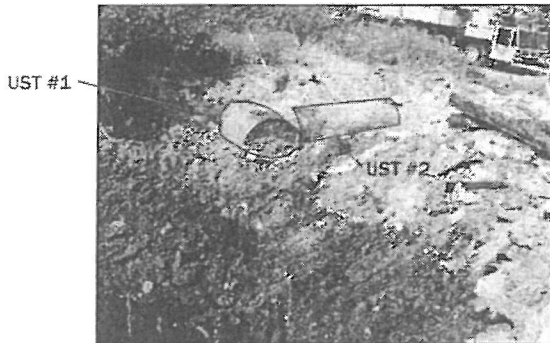
Photograph 3: USTs discovered east and adjacent to SPN, looking northeast. Refer to Figure 4.

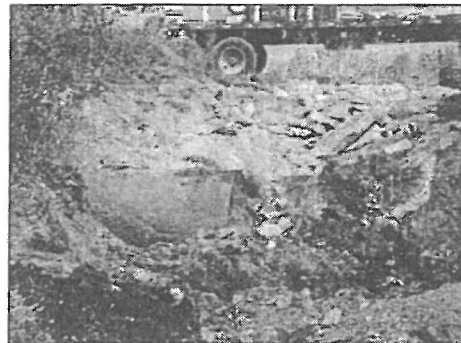
Photograph 4: Rubble and UST in SPN, looking east. UST #1 in foreground.

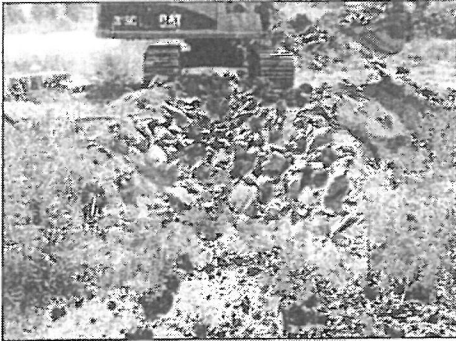
Photograph 5: Eastern end of SPN south of USTs. View looking south. Large cobbles with very little soil matrix precluded sampling but not field screening.

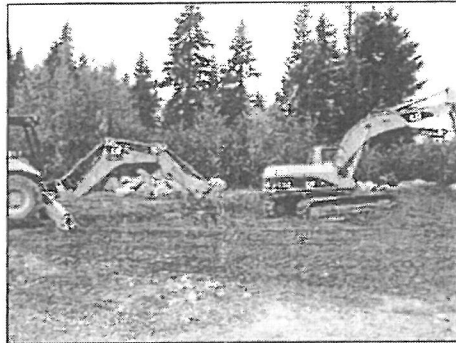
Photograph 7: Placing backfill in SPN. View looking north.
