Wetland Identification and Delineation Report

Snoqualmie Summit
60X SR 906 Snoqualmie Pass
Kittitas County Parcel Number: 142436

Prepared for:
Evo Properties

August 13, 2008

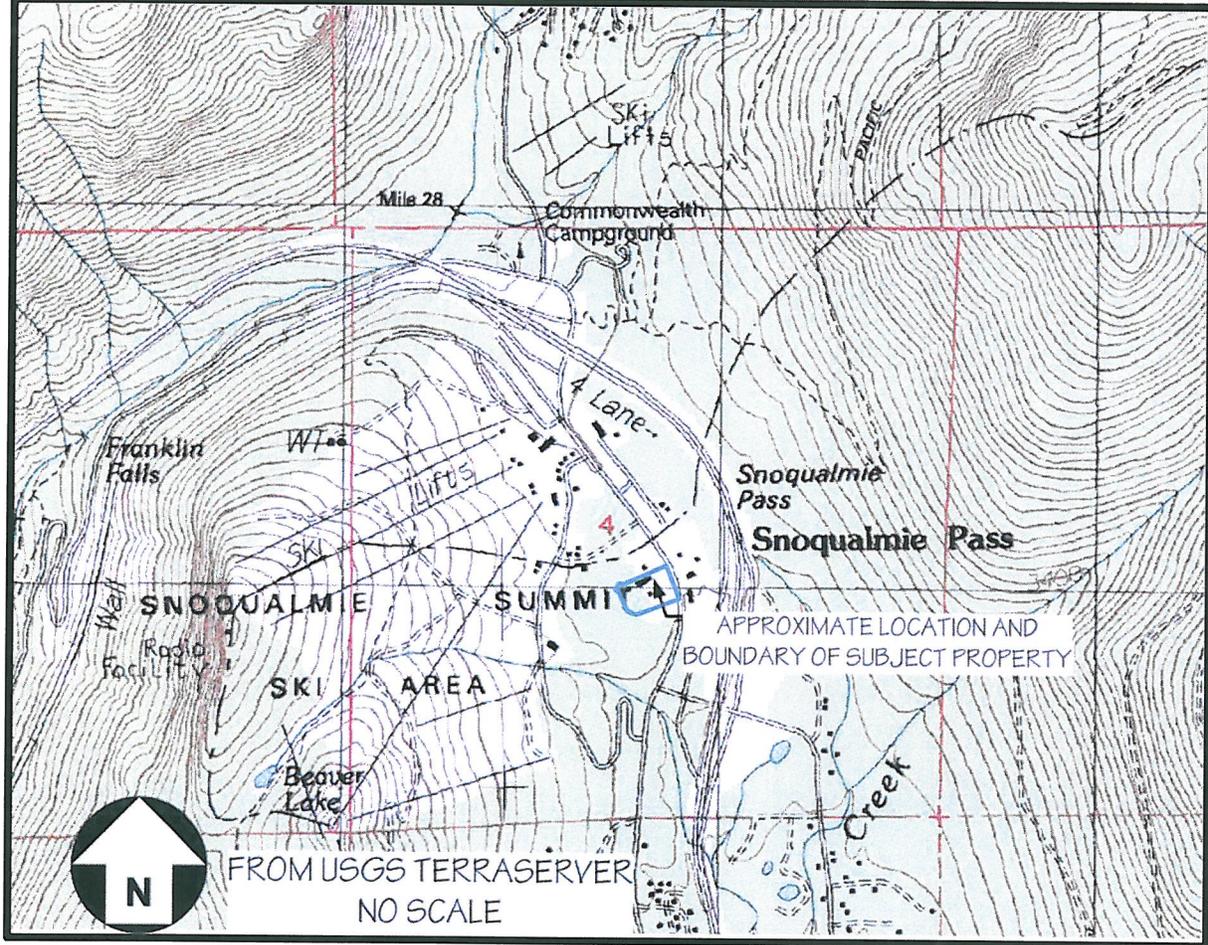
Figure 2-3 - Topographic Map

The subject property has relatively low topographic relief because it is located near the base of a small valley with relatively steep sides including the Summit at Snoqualmie ski area on the western slopes. (Figure 2-3 Topographic Map). Regionally, the topography is mountainous, characterized by the Cascade Mountains (Figure 2-4 LIDAR Map). The origins of the Snoqualmie River are found near the summit, north of the subject property.

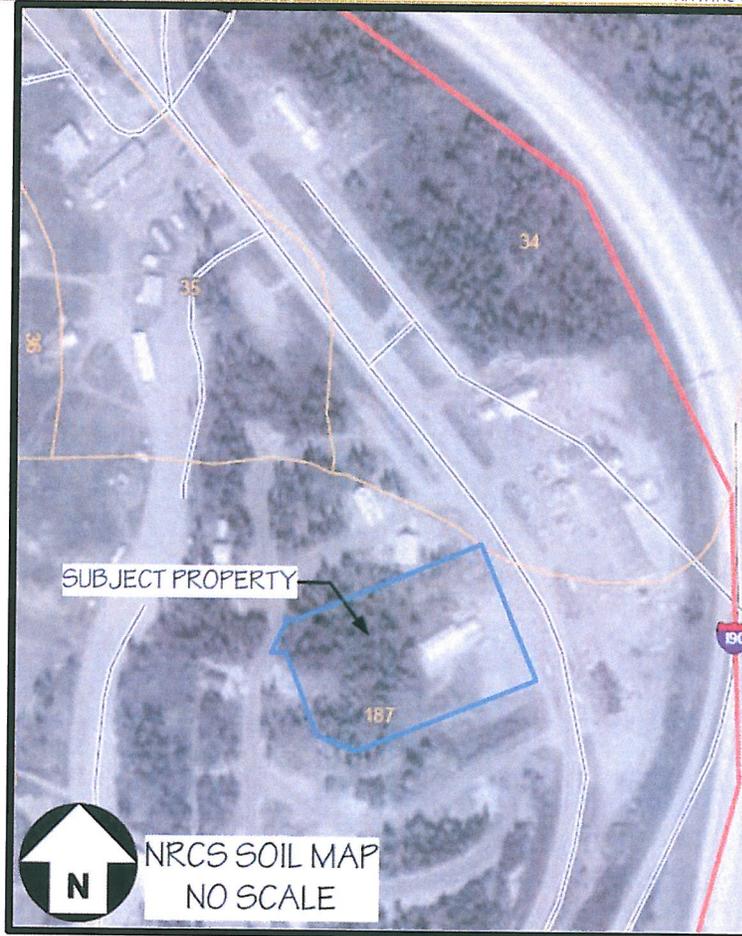
Figure 3-1 - NRCS Soil Map

The NRCS Web Soil Survey Map for the subject property indicates that the soil type is identified as Chinkmin ashy loam, on 5-30% slopes. Because the subject property lies near the border between King and Kittitas Counties, the soil legend represents two different soil surveys which differ on the amounts of ash and sand found in the soil (Figure 3-1 and 3-2 NRCS Soil Map and Legend).

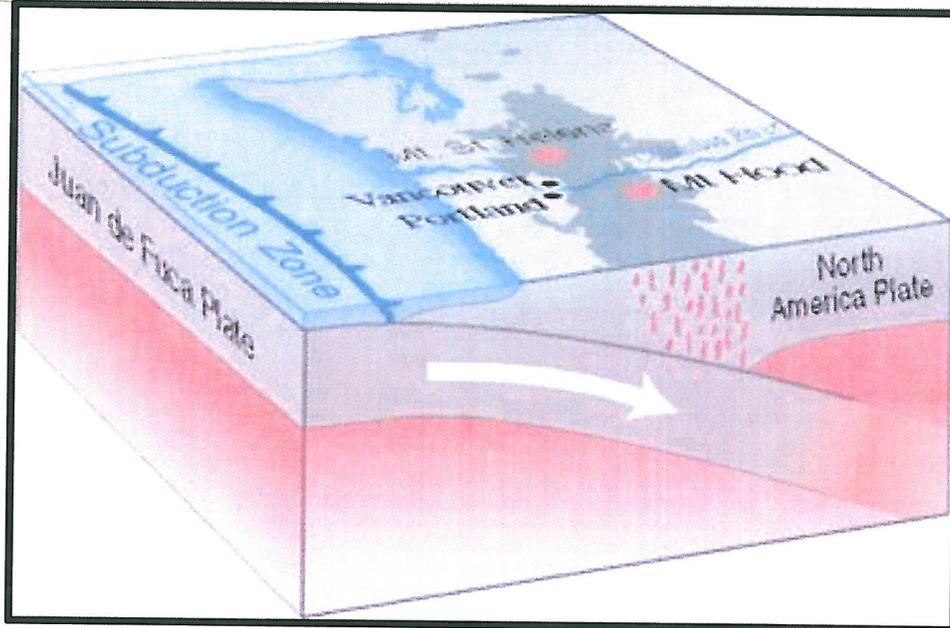
Figure 3-4 - Cross Section of the Cascadia Subduction Zone (from USGS)

The Cascadia subduction zone is a result of the collision between the Juan de Fuca oceanic plate and the continental North American plate. Oceanic plates are comprised of dense material and will sink or “subduct” beneath the less dense continental plates (Figure 3-4). As the ocean plate subsides down towards the mantle of the Earth, the heat from the mantle causes the oceanic plate to melt. As the plate melts, the heat is released and rises toward the continental crust. The hot material rising up from the mantle created many of the large volcanoes such as Mount Saint Helens and Mount Rainier.

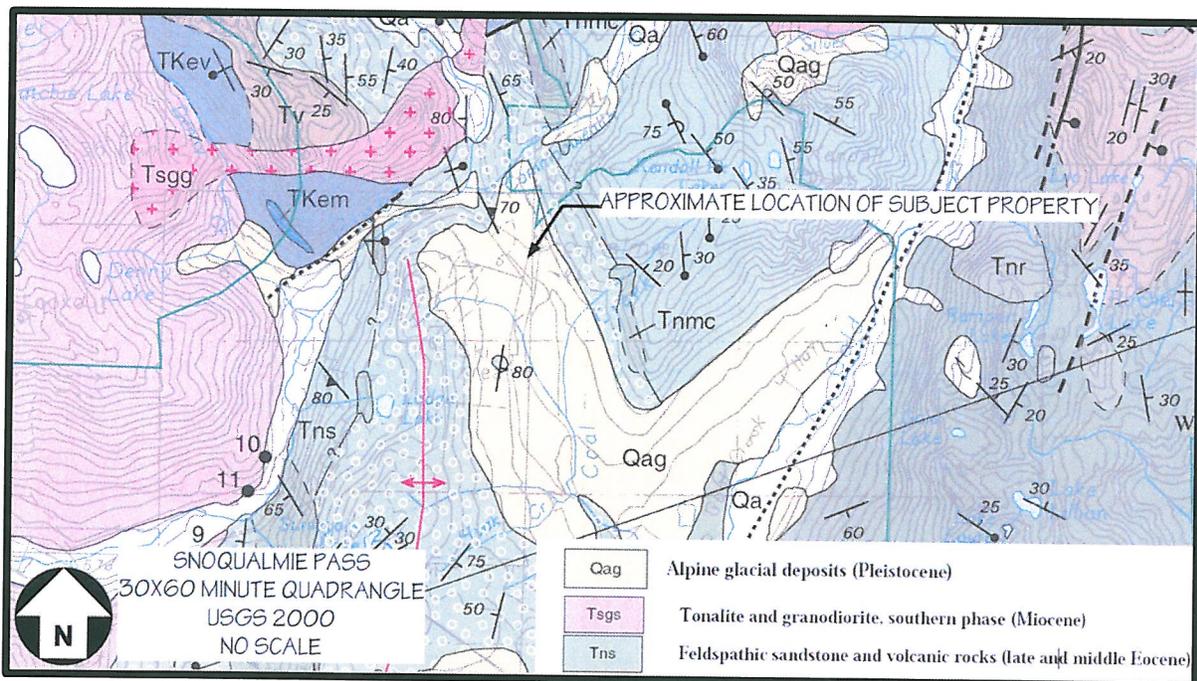
Figure 3-5 Geologic Map of Subject Property and Vicinity

The geologic deposits found on the subject property are glacial in origin, but also include some volcanic ash and tephra. The deposits SNR observed in the field include materials that would be the equivalent to outwash deposits, most likely associated with a receding Pleistocene age alpine glacier. These outwash deposits are actually water transported deposits that resemble fluvial (stream or river transported) deposits. These deposits reportedly overly lodgment till, which may overly glacial advance outwash deposits. These deposits overly volcanic deposits and sediments derived from volcanic deposits. These volcanic deposits are extrusive volcanic deposits that include andesites, rhyolites, and tonalities.

The geologic map does show interpreted and observed fault traces in the vicinity of the subject property, however, none of these fault traces are in the immediate vicinity of the subject property. Additionally, SNR did not observe evidence of faulting on the subject property, however, fault traces can often be difficult to distinguish in forested areas and the LIDAR imagery for the subject property is not detailed enough to provide information on potential fault traces.

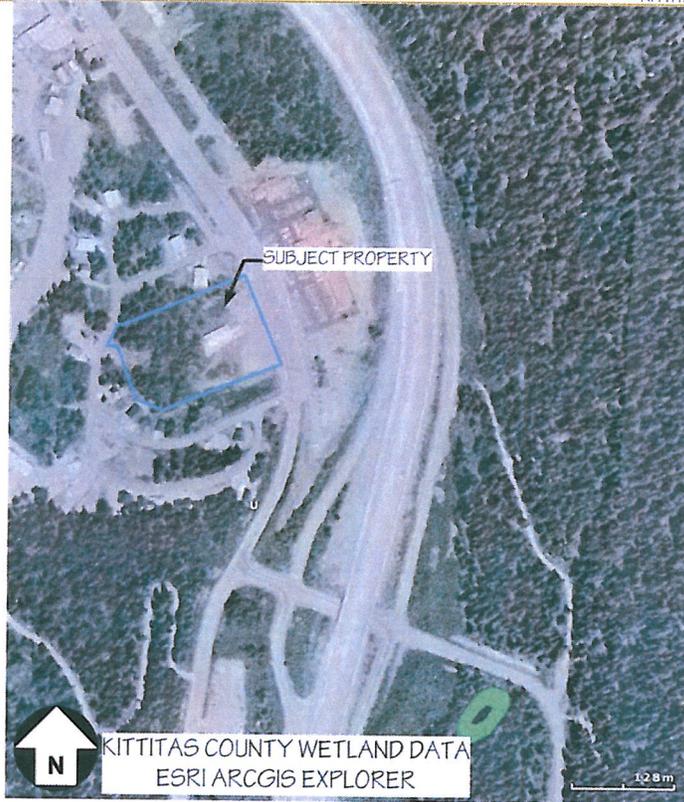
Figure 3-6 - Kittitas County Wetland Map

The research of public documents conducted by SNR suggests that there are no mapped streams or mapped wetland areas on or in the immediate vicinity of the subject property. This research included the Kittitas County sensitive areas maps, (Figure 3-6) the US FWS Wetland Mapper (Figure 3-7), the WDFW Salmonscape (Figure 3-8), the USGS topographic map (Figure 2-3) and geologic map (Figure 3-5), or the USGS StreamStats (Figure 3-9) none of which show any wetland areas or streams to be present on or in the immediate vicinity of the subject property.

The USF&WS Wetland Inventory Map SNR generated for the subject property and surrounding area (Figure 3-7) suggests that there are no ratable wetlands areas on or in the immediate vicinity of the subject property. The Kittitas County sensitive areas database also did not identify any wetland areas or streams on or in the immediate vicinity of the subject property (Figure 3-6). The WDFW Salmonscape map (Figure 3-8) does not show any streams or fish passages in the vicinity of the subject property.

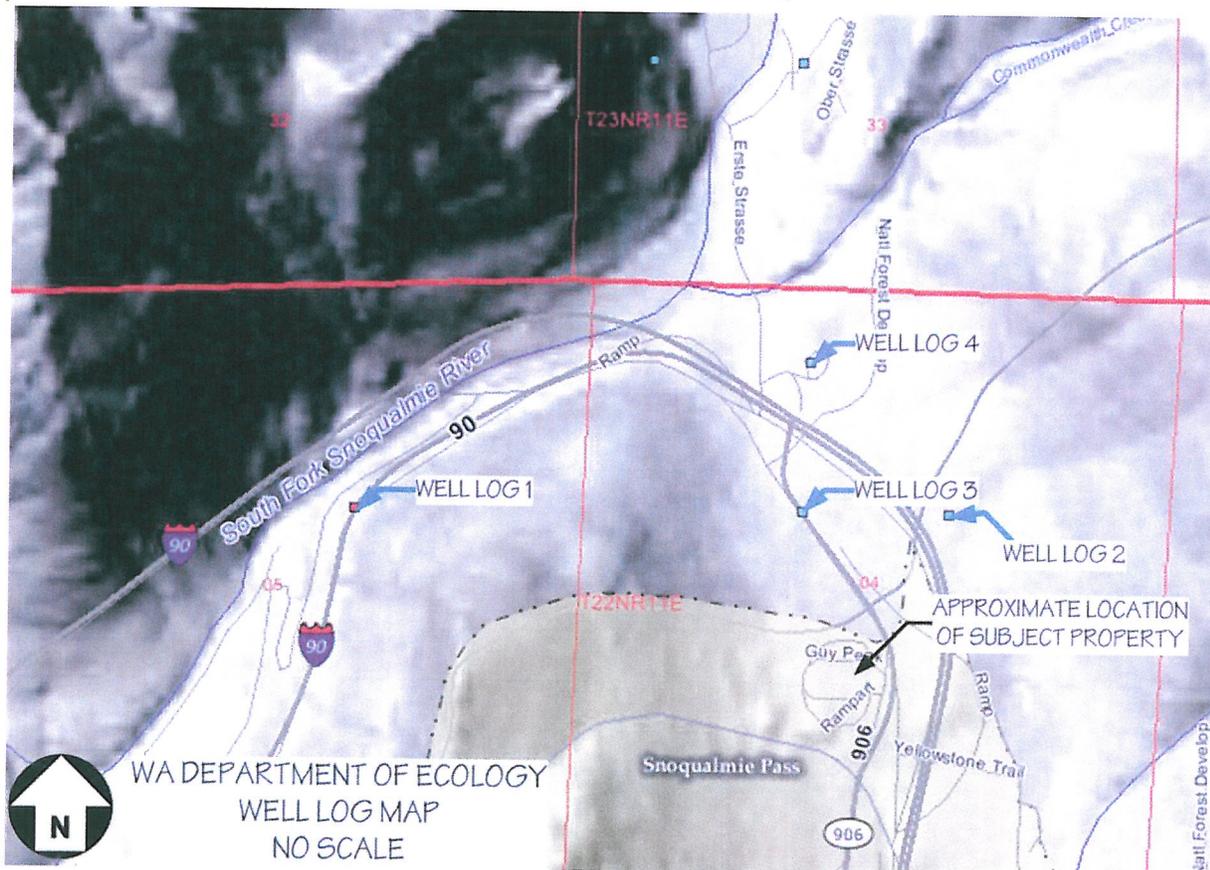
Figure 3-10 WA Department of Ecology Registered Wells Map

The well logs in the vicinity of the subject property are interesting because the well logs indicate that most of the wells are screened in fractured igneous bedrock, which is less common in the lower elevations of the Puget Lowland (Figures 3-10 – 3-16). The well logs suggest that there is less glacial till (which is absent in some of the logs) than would typically be observed in the Puget Lowlands and that there are more fluvial deposits (including outwash deposits) above old basalt deposits. The drinking water aquifer is apparently located in fractured basalts beneath the glacial and alluvial deposits.

The well logs are similar in the descriptions of the fractured, dark basaltic bedrock that underlies the glacial and alluvial deposits. This dark basalt parent material (almost always having low hues and low chromas on the Munsell color chart) is what the glacial deposits are derived from and is what leads to the naturally darker soil that is derived from these sediments. The only metamorphic material described in the well logs is minor amounts of shale; this due to the subject property being located in the southern Cascades which is dominated by volcanic material, not metamorphic rocks.

Some of the well logs indicate that small amounts of perched ground water was found between 4-18 feet below ground surface on glacial till (hardpan) where till was present. However, these perched conditions were not found to be present in the near surface deposits or soils (within 30 inches of the ground surface).

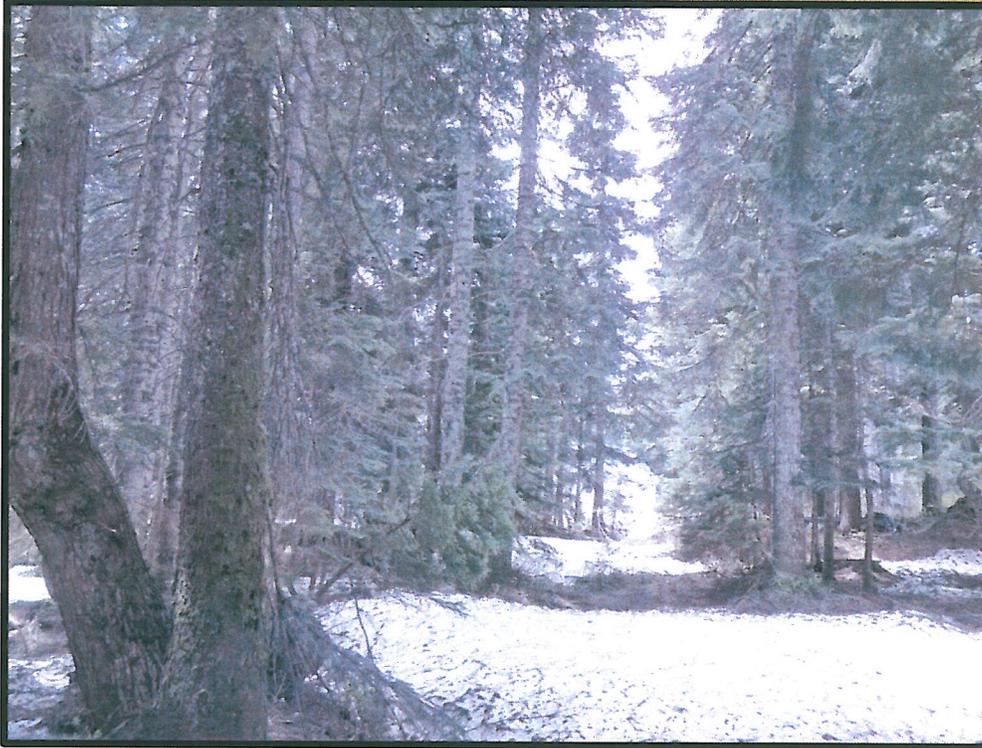
Figure 4-5 Typical Vegetation and Snow Encountered at Subject Property

According the Washington State Department of Natural Resources, State Heritage Site, the vegetation observed on the subject property is generally characteristic of the *Pseudotsuga menziesii* - *Abies lasiocarpa* cover type- Douglas-fir - Subalpine Fir Forest, abbreviated as PSME-ABLA environment (Figure 4-5). Other references suggest that this is the silver fir climatic zone.

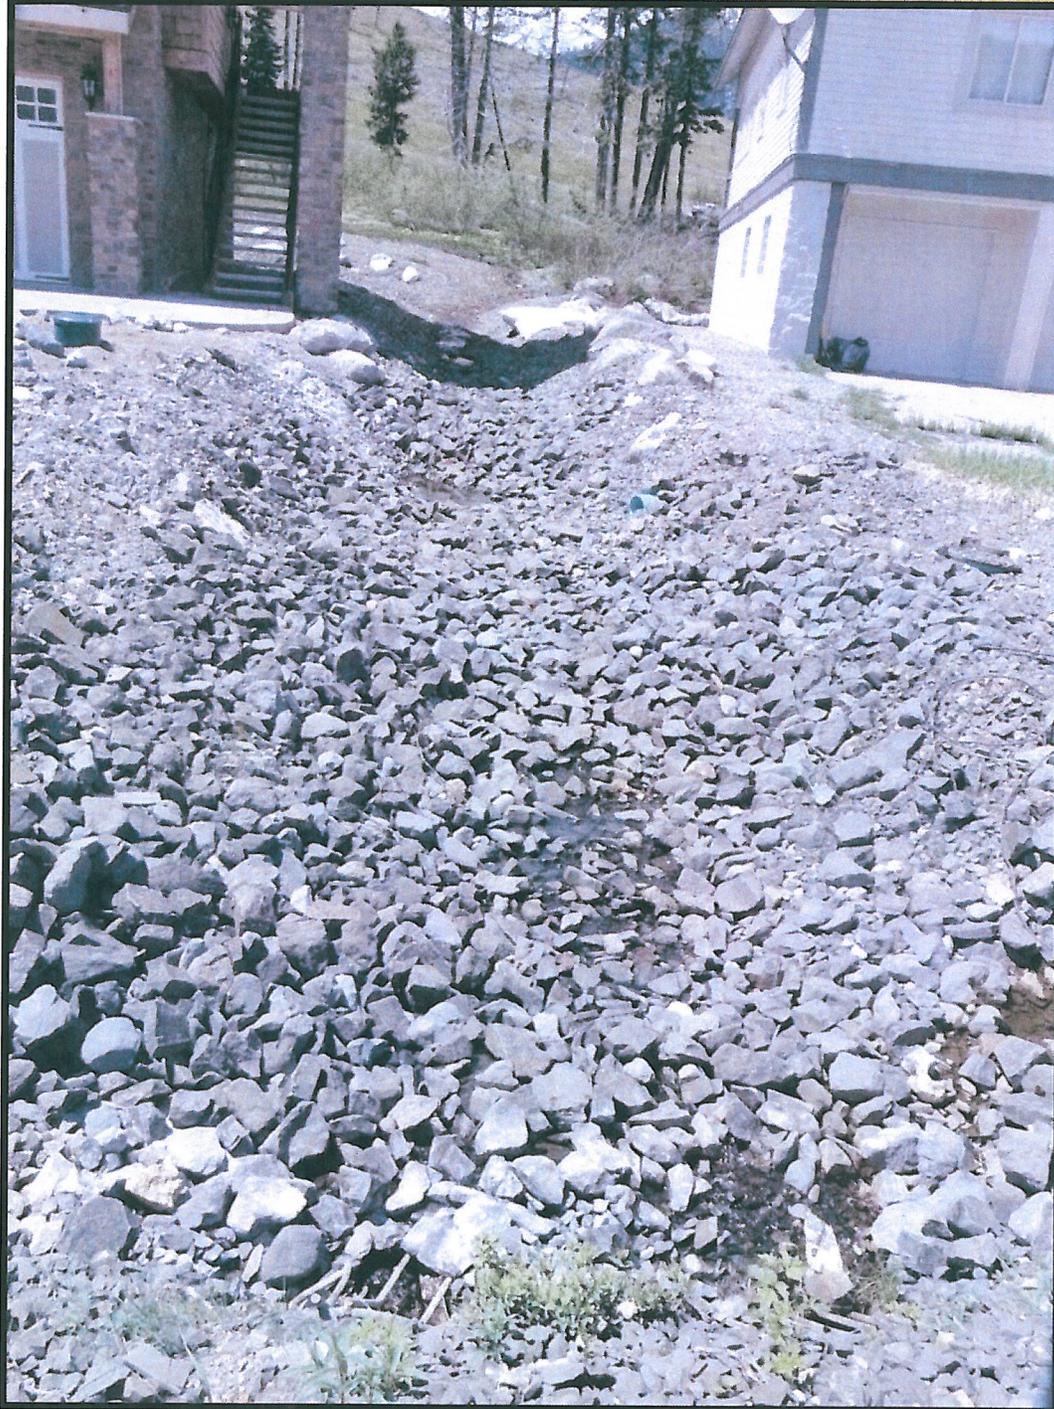
Figure 4-6 Confluence of Three Storm Water Conveyances west of Guye Peak Lane

The storm water on the subject property originates from a culvert located west of the subject property and from storm water ditches located on both sides of Guye Peak Lane. The culvert serves as a confluence for three storm water conveyances (Figure 4-6), which then flow east under Guye Peak Lane in a culvert that discharges into a storm water conveyance which discharges into a small detention pond which bounds the western edge of the subject property (Figure 4-7). This small detention pond was created by a resident by damming the storm water conveyance that originally flowed along the subject property's western property line and then turning to the east along the southern property line to an outfall into the storm water detention basin bounding the southeastern property line. This pond apparently built by a resident is too small to hold the volume of storm water that it receives (the outfall for this pond is also too small), and as a result, the pond overflows onto the subject property. Storm water ditches have been excavated on the subject property to divert some of the overflow from the western pond towards the storm water detention ditch located west of the gravel parking area.

Storm water also enters a storm water ditch the subject property from the eastern storm water ditch that bounds Guye Peak Lane. This storm water ditch passes through the subject property to the southeast and discharges into the storm water detention ditch located west of the gravel parking area.

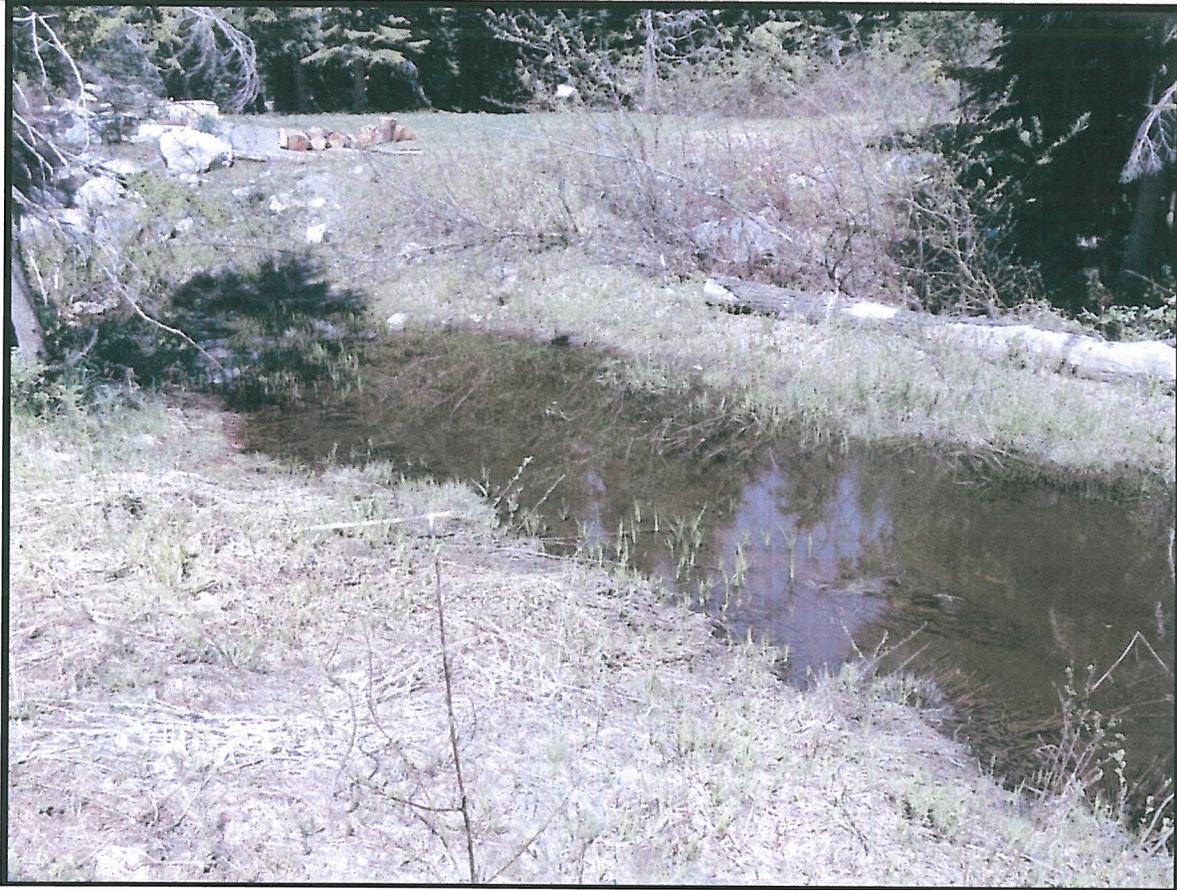
Figure 4-7 Storm Water Detention Pond on the Western portion of the Subject Property

The storm water detention facility located on the western portion of the subject property was apparently constructed without a permit and does not meet any State or County design standards. This pond and the ancillary storm water ditches associated with the outfalls and overflow from this pond do not meet the minimum requirements for best management practice erosion and sediment controls nor do they appear to follow any engineering design. This is also the case for the storm water detention ditch located in the eastern portion of the subject property. The detention ditch and the storm water ditches that discharge into this ditch do not meet typical minimum design standards nor do they appear to be permitted facilities.

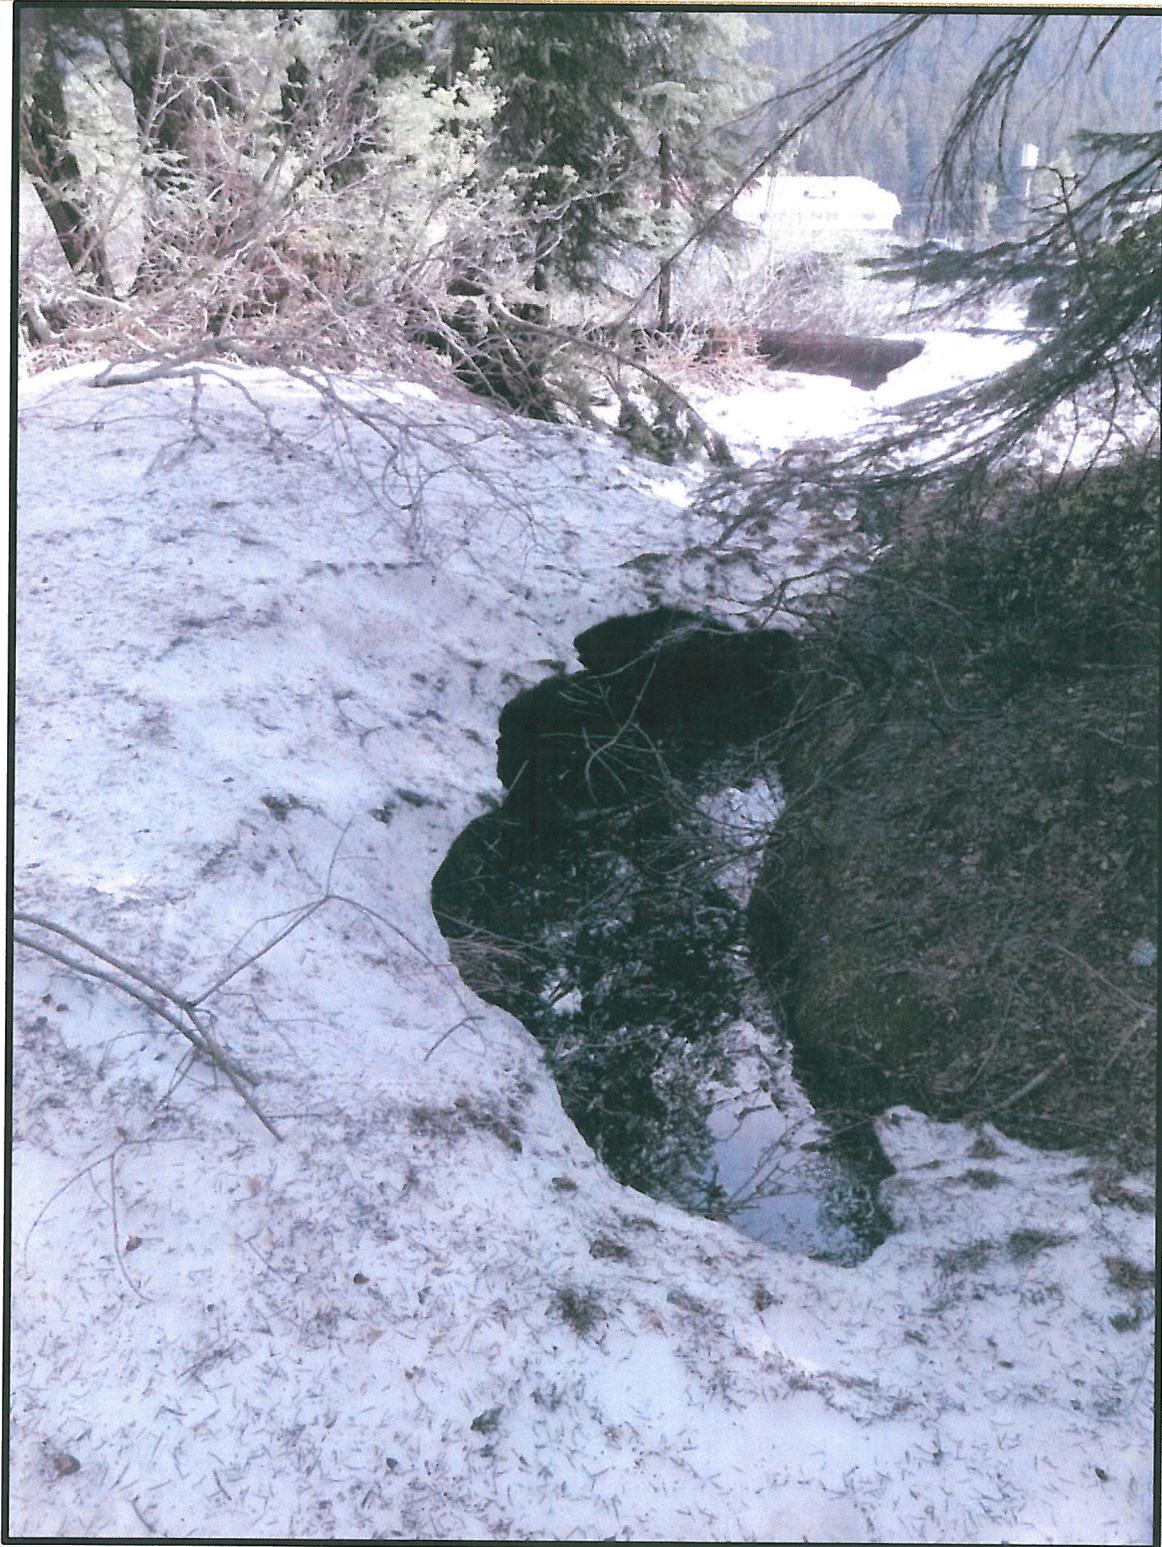
Figure 4-8 Storm Water Ditch

Storm water from the western storm water detention pond outfall enters a shallow storm water ditch system (Figure 4-8). Fallen trees (some appear to have been intentionally felled) and debris were observed to occasionally block these ditches causing the storm water to pond in several areas of the subject property.

It is assumed that the original design of the storm water ditch system was to follow the right-of-way between the subject property and the houses along the western and southern boundaries. Based on communications with the property owner, over the years, the owners of the residences bounding the subject property have diverted this storm water back onto the subject property in attempts to prevent it from overflowing onto their property. Some of the storm water does flow along the southern property line of the subject property. This storm water and the storm water collected in the detention ditch in the eastern portion of the subject property are diverted into the storm water detention pond that bounds the southeast corner of the subject property (Figure 4-9). This larger storm water detention pond that bounds the southeastern corner of the subject property "overflows" into a culvert that is tightlined to storm water ditch that is located on the west side of SR 906. This storm water ditch is shown to eventually flow southeast and then east in a WSDOT storm water conveyance system that bounds I-90 until it eventually has an outfall on the Yakima River.

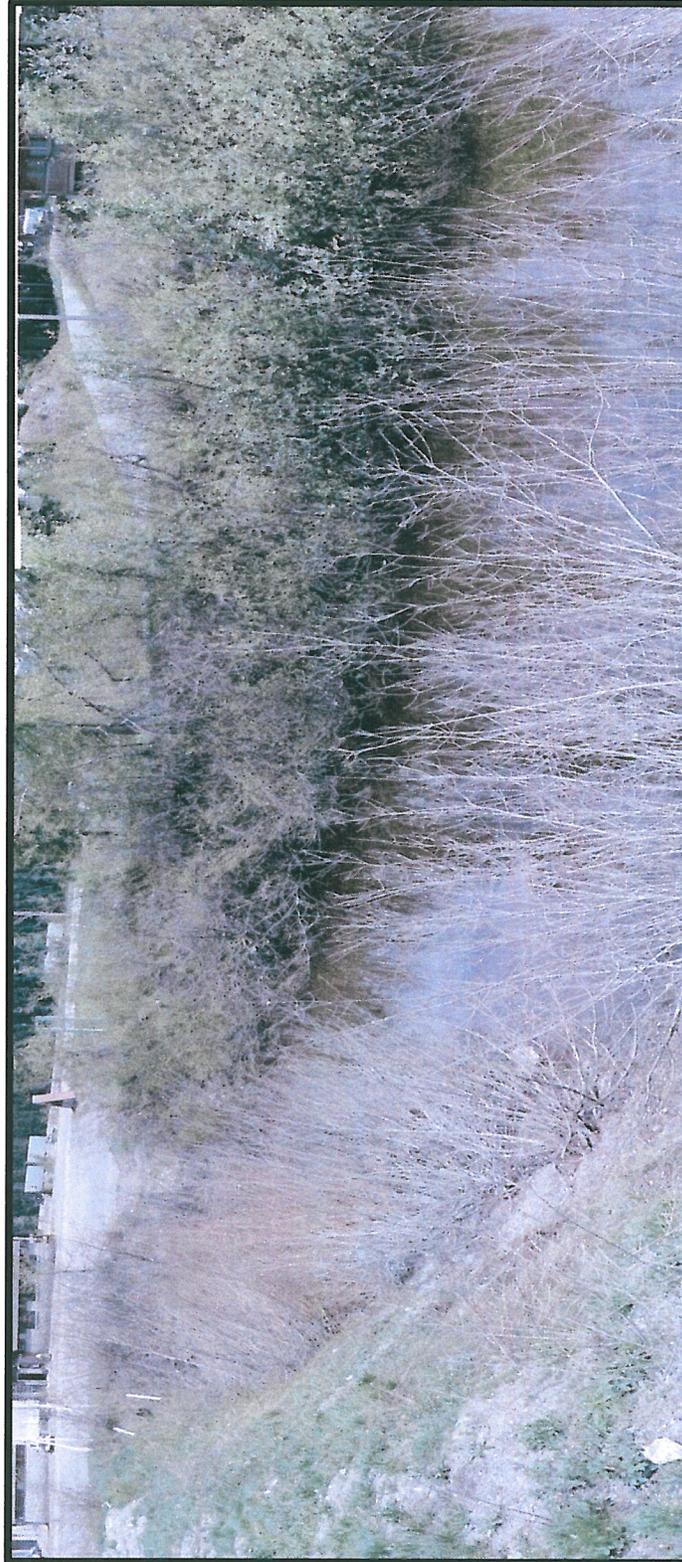
Figure 4-9 Panorama of Large Detention Pond in South East Corner of Subject Property

There are two storm water detention ponds in the near vicinity of the subject property which serve as the entrance and the exit of the storm water found on the subject property⁵. They are interconnected with a series of rudimentary storm water ditches found throughout the subject property. Hydric soils were not observed in any of the test plots conducted in these areas that are moist from the storm water flowing in these ditches.

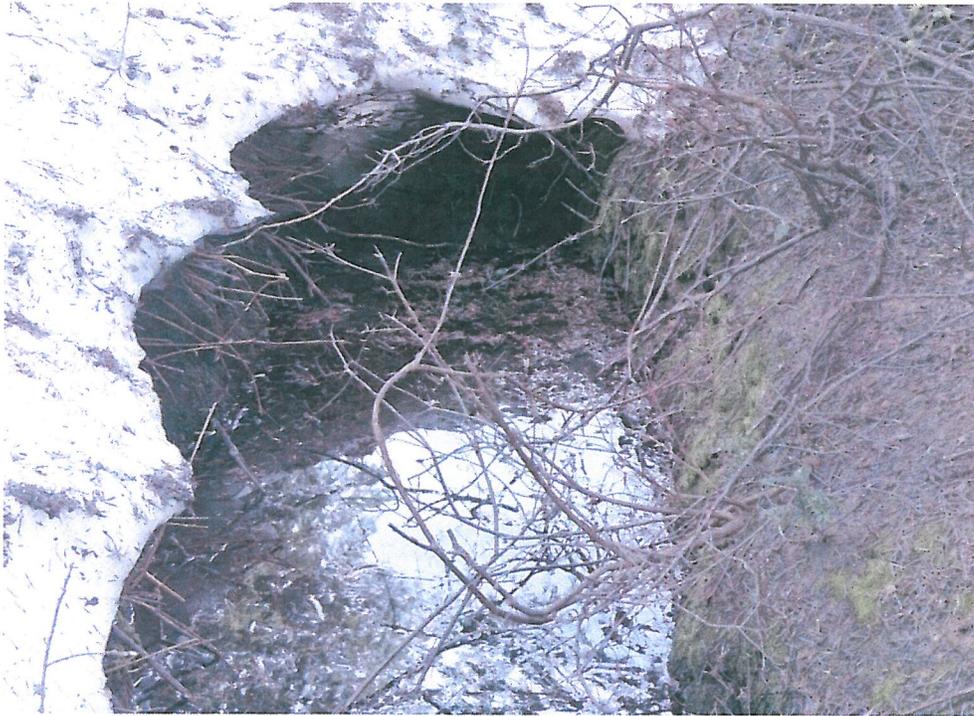
Storm Water Ditch on Subject Property

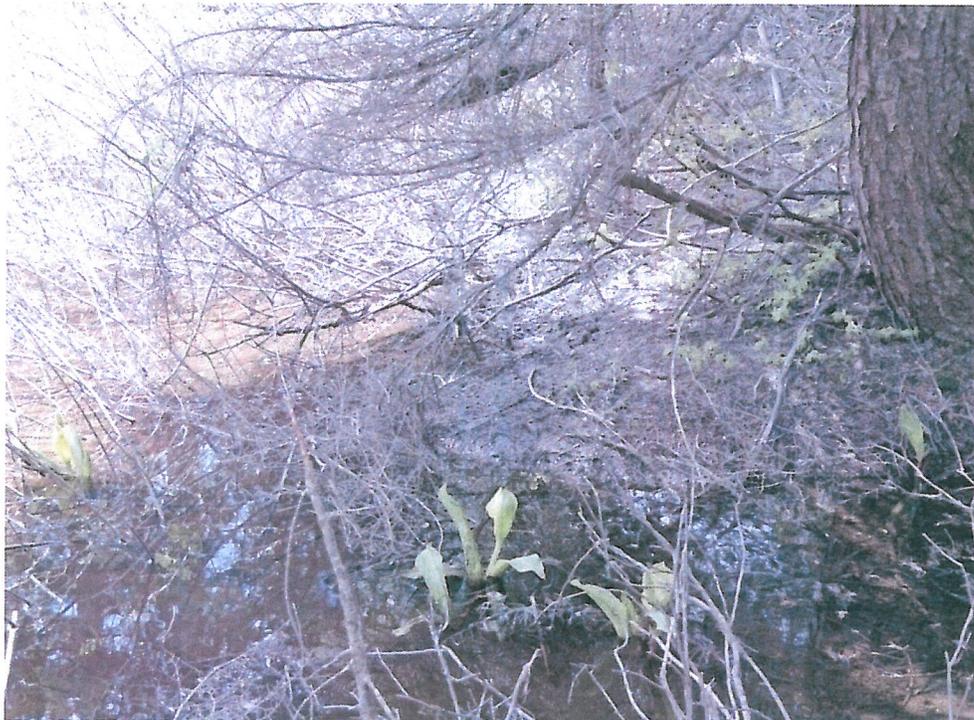
Ponded Storm Water on the Subject Property

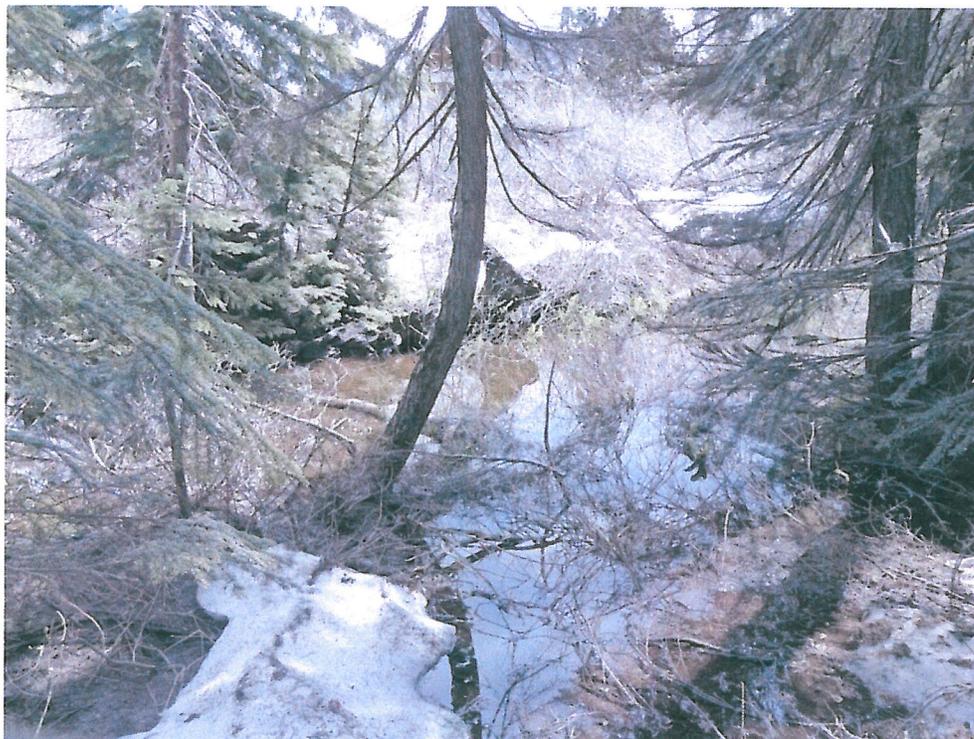
Ponded Storm Water on the Subject Property

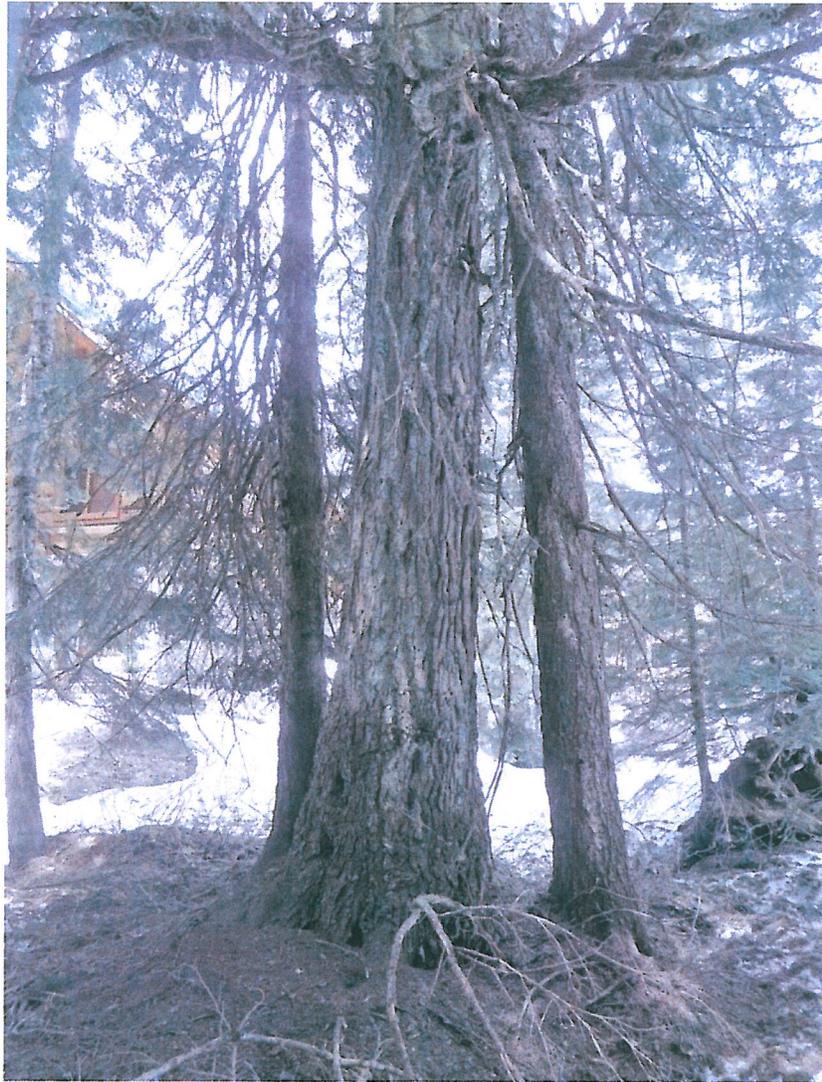
Sparse Vegetation at the Base of Conifers

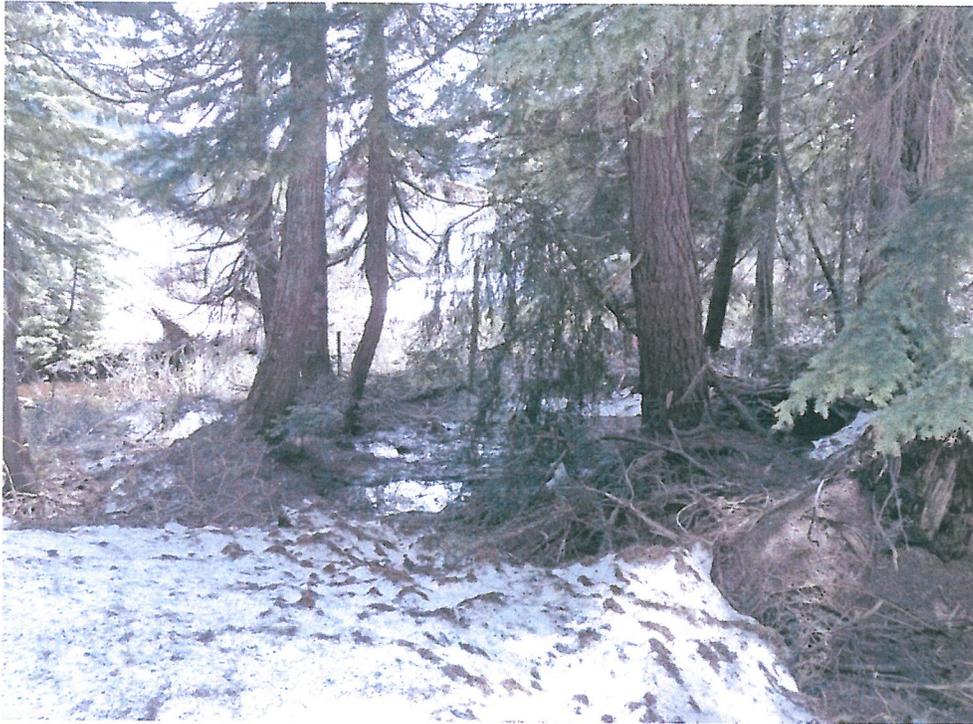
Ponded Storm Water at the Base of Douglas Firs

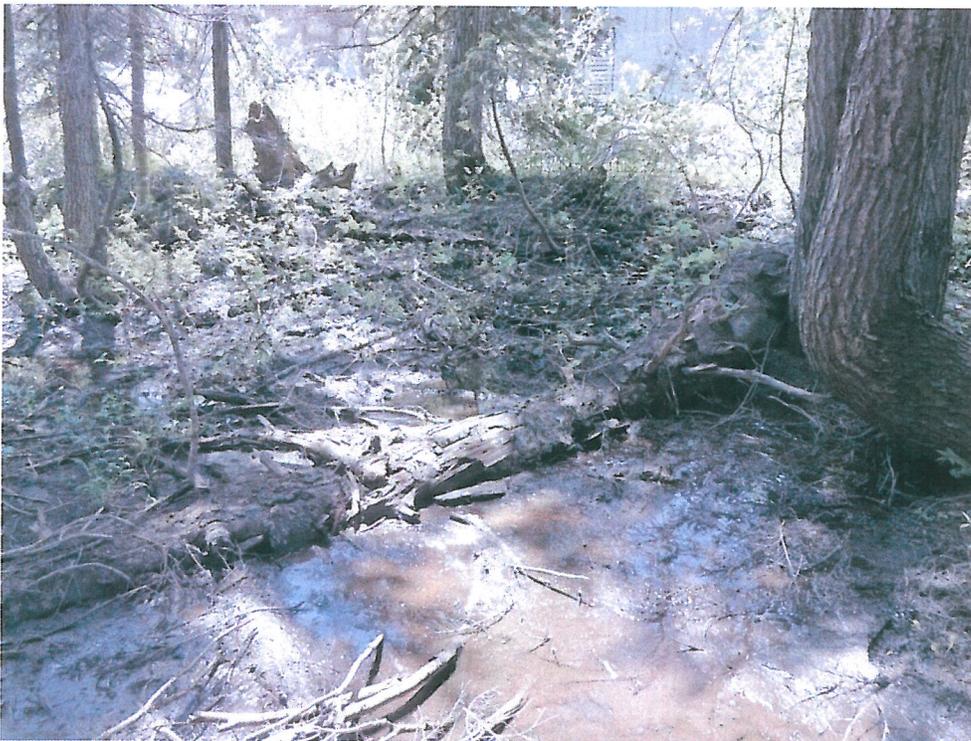
Ponded Storm Water on Subject Property – Note the Tree Blocking the Storm Water Flow is Believed to have Died from Storm Water Inundation

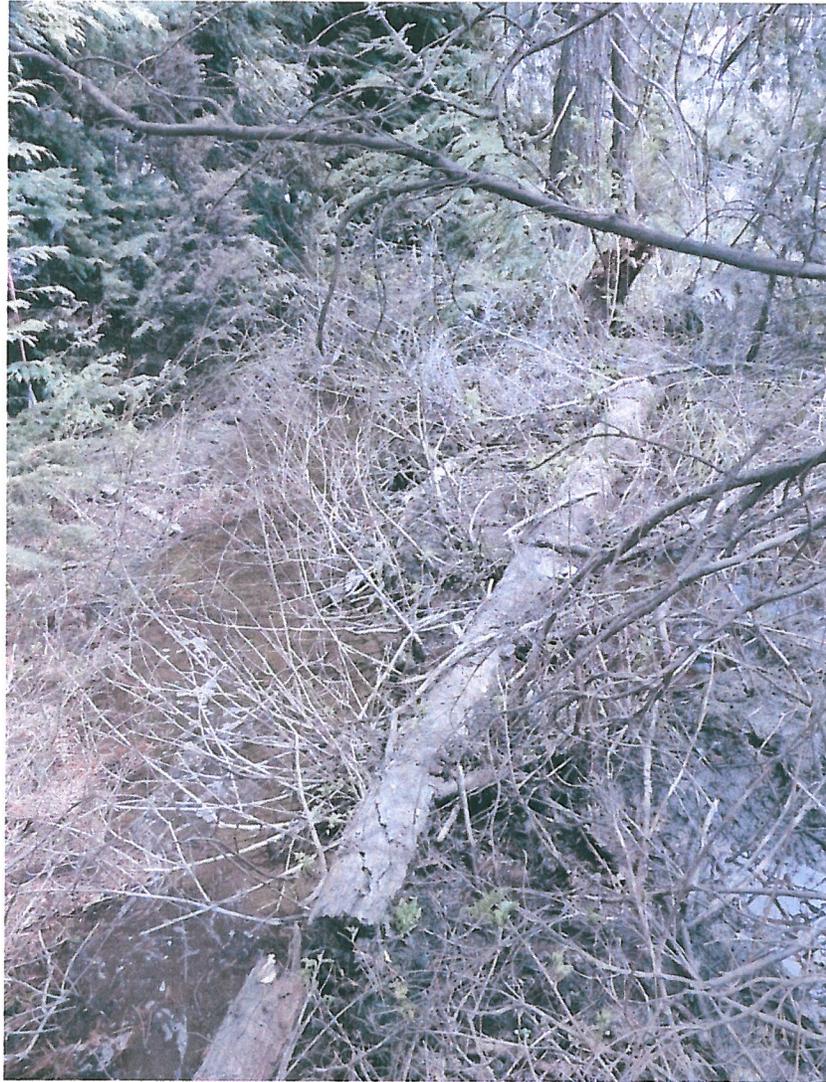
Dying Trees Causing Storm Water to Pond

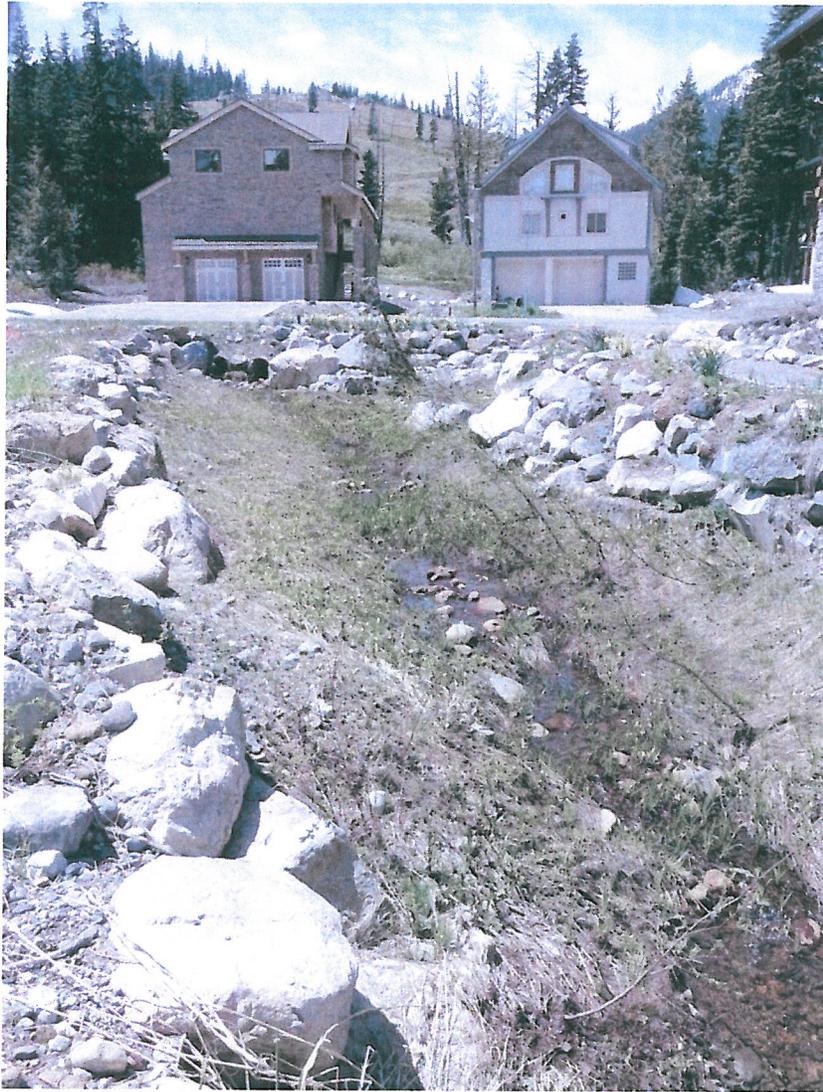
Storm Water Conveyance that Discharges to the Western Detention Pond

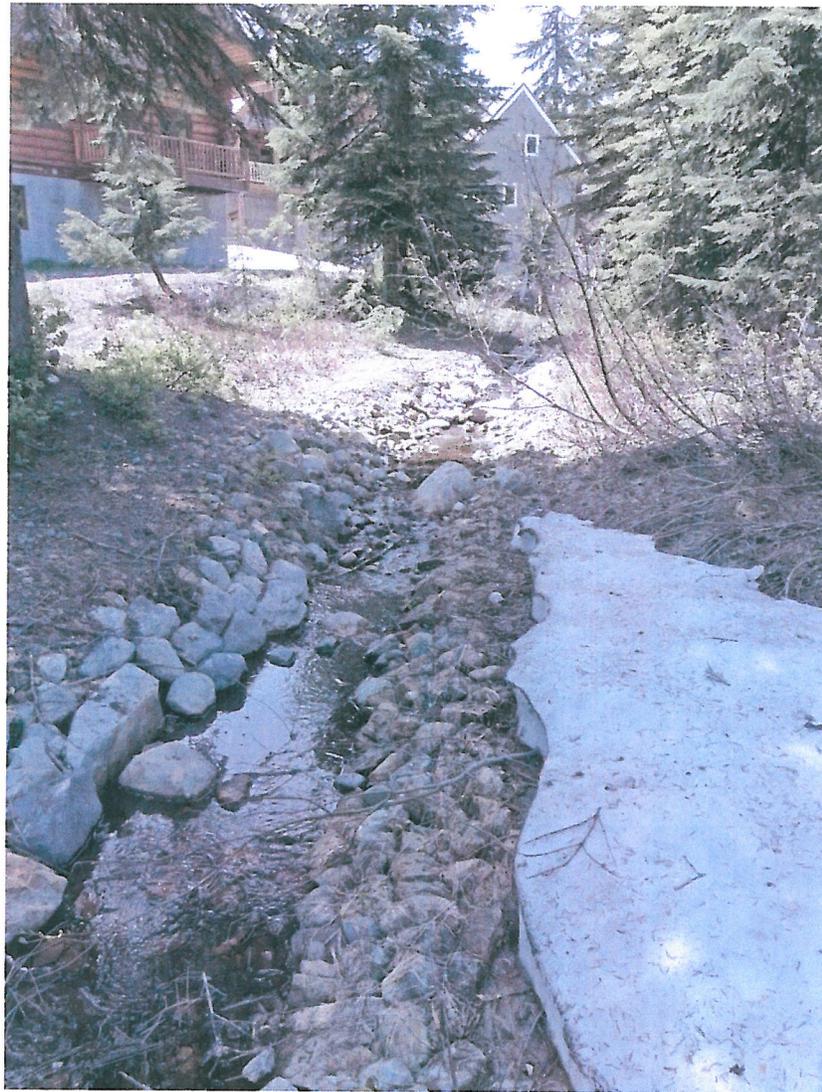
Storm Water Ditch Bounding the Southern Property Line

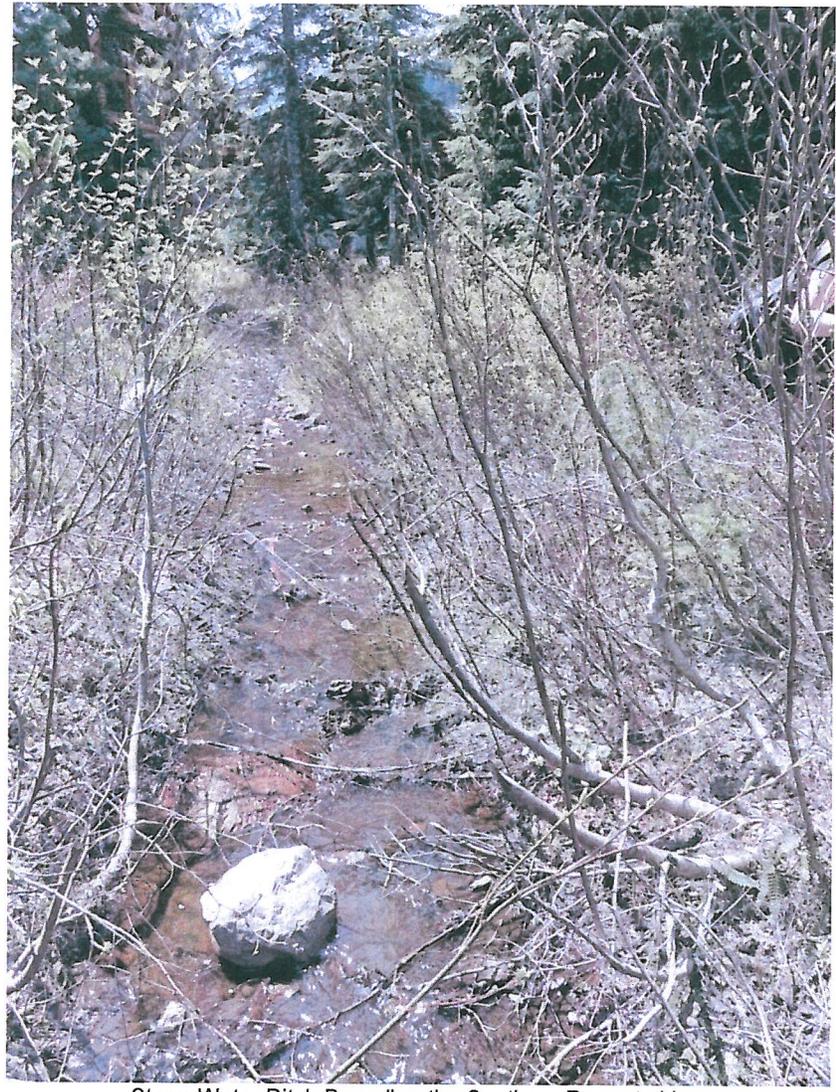
Storm Water Ditch Bounding the Southern Property Line

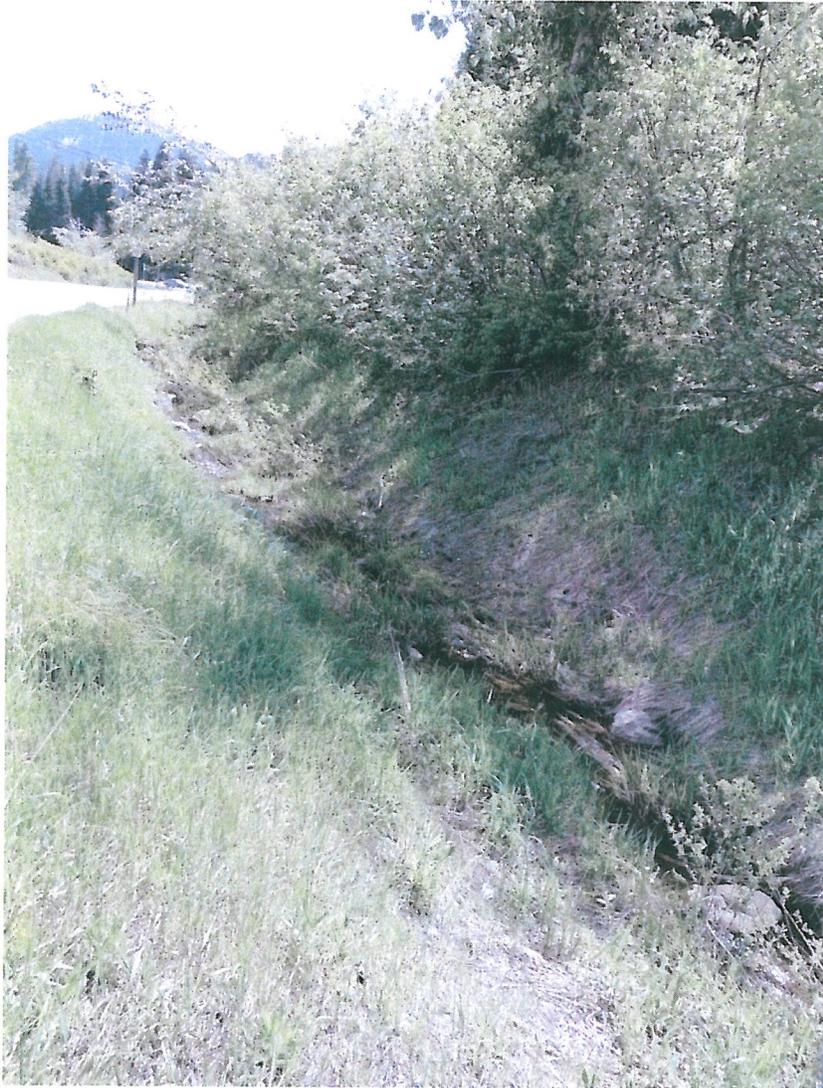
Tightline Outfall to the Storm Water Ditch Bounding the West Side of SR 906 from the Detention Pond Bounding the Southeast Corner of the Subject Property
