Casto Residence 561 Palouse Dr. Cle Elum, WA Kittitas County Parcel # 953974
4/6/2021
Pg. 1/1
Slope Failure

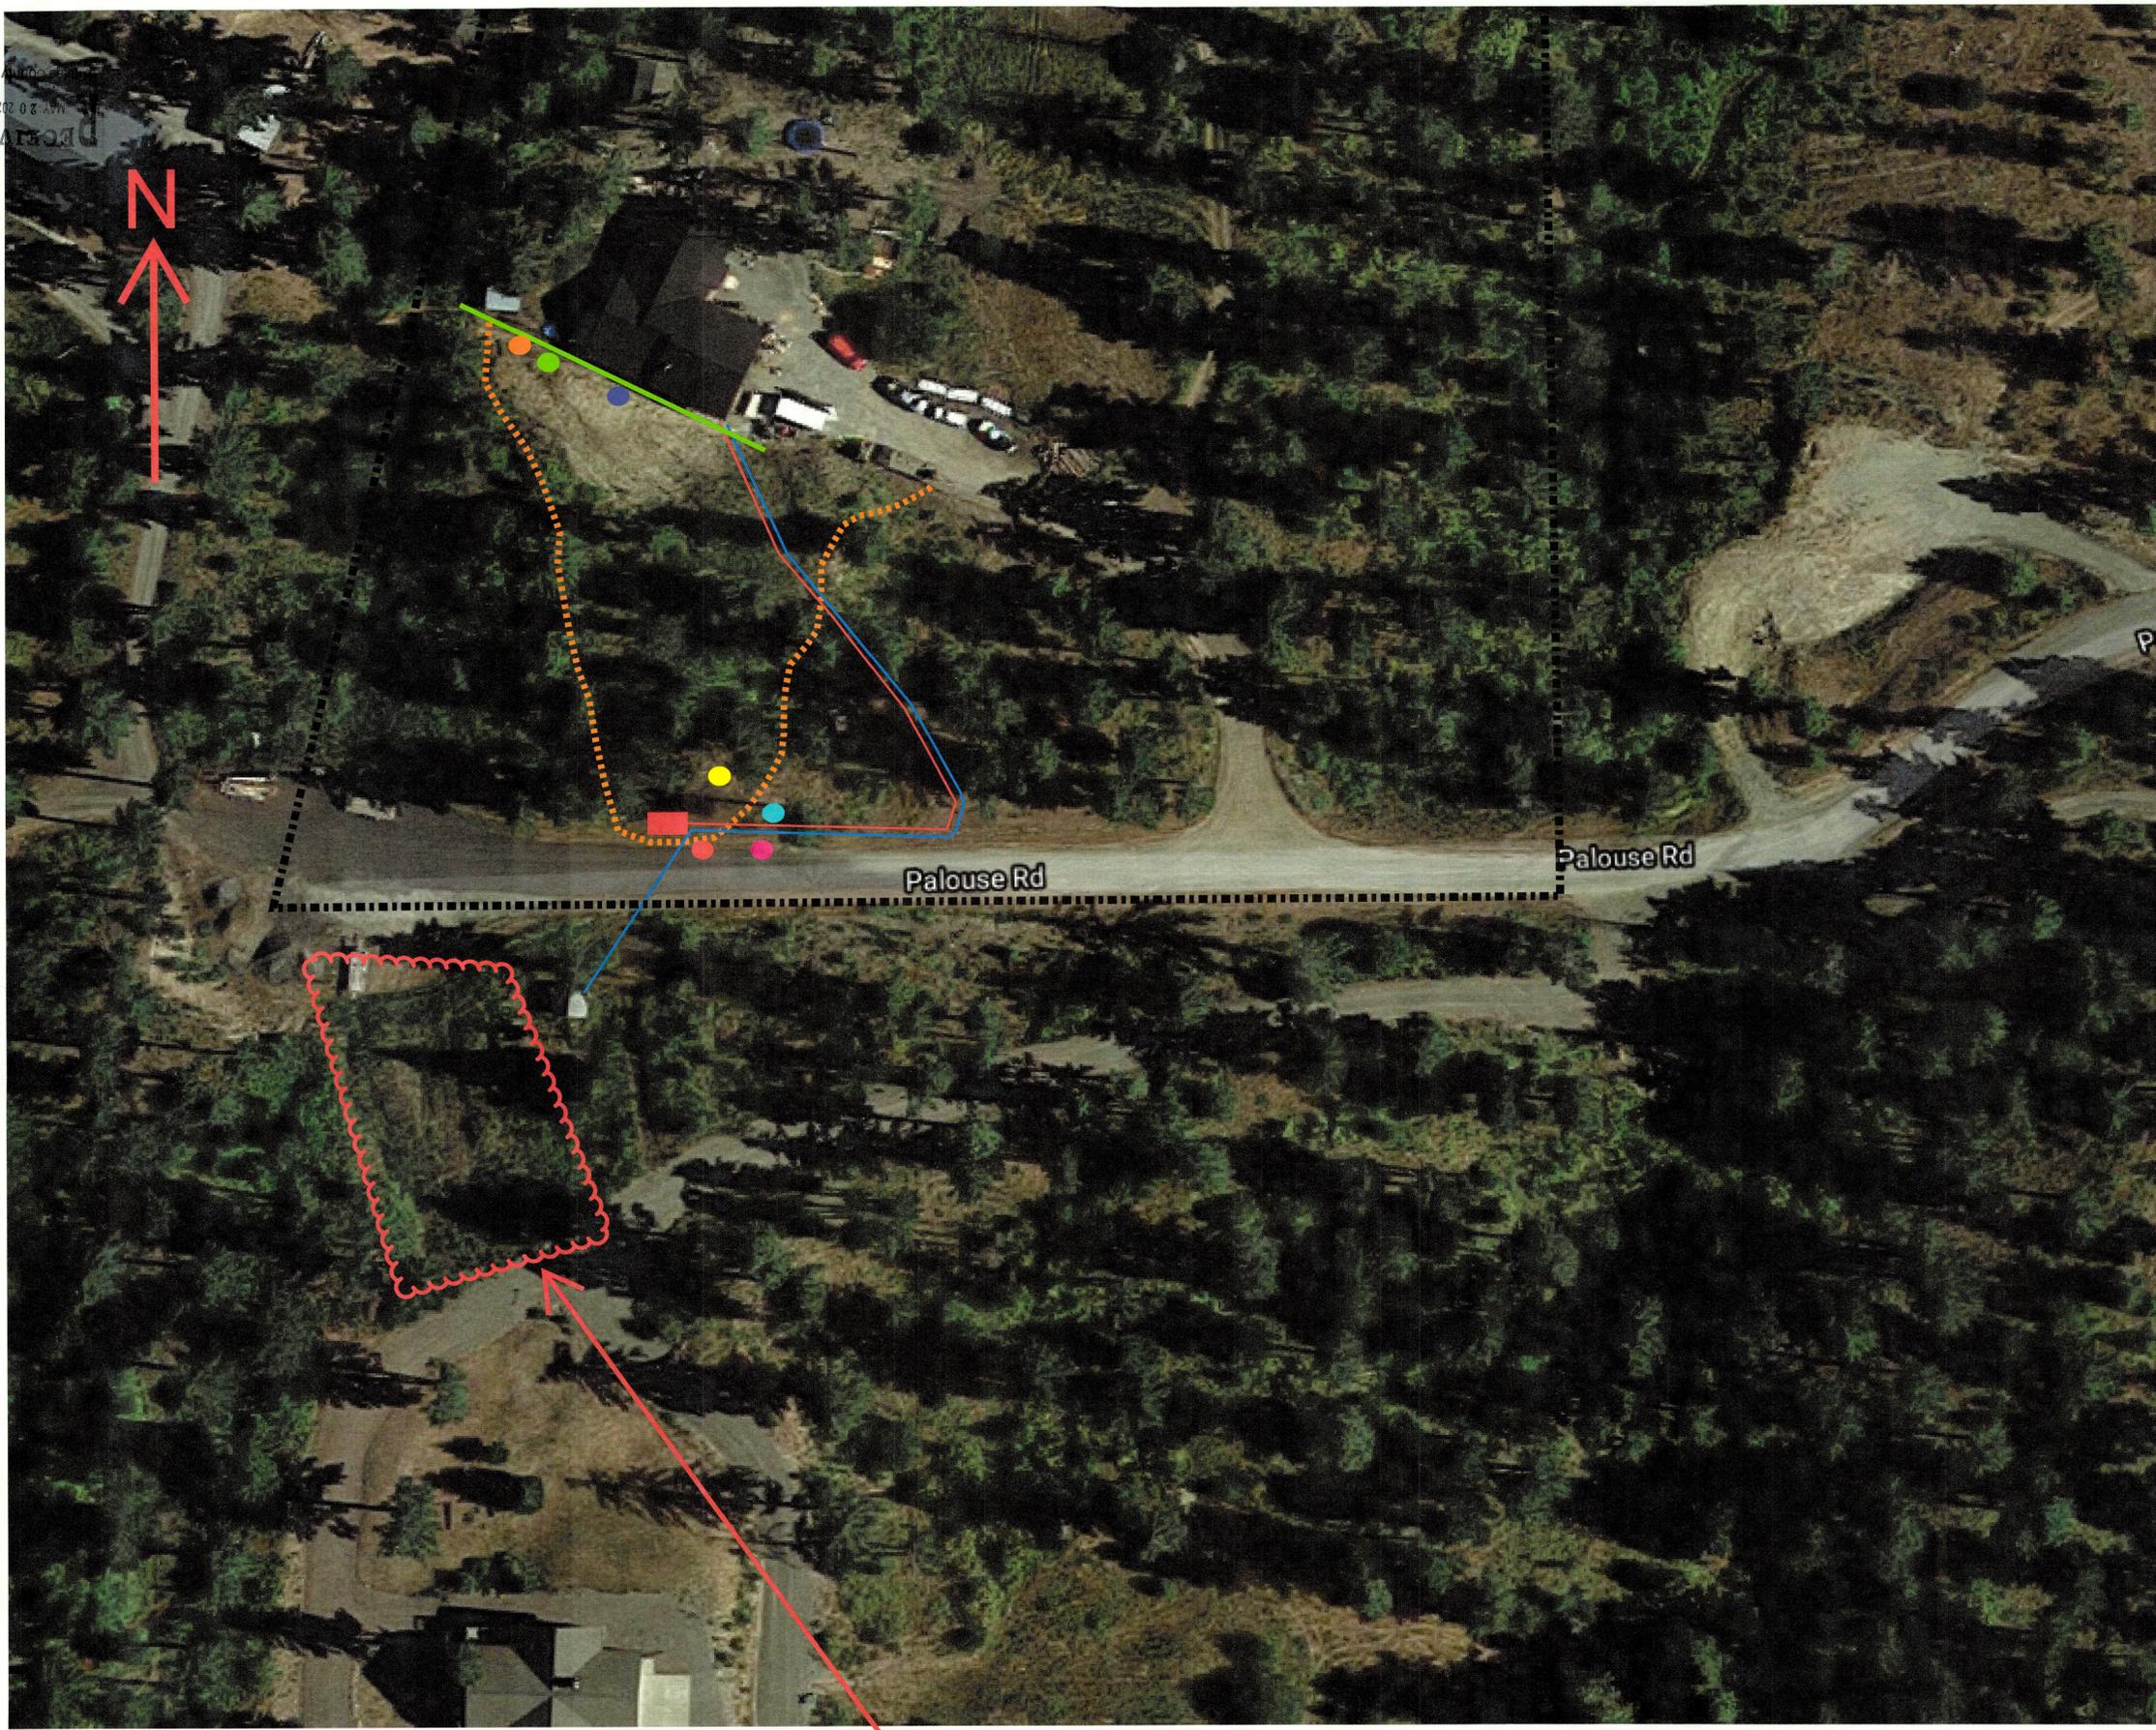
- Approximate Extent of Landslide and Location of Cracking
- PSE Electrical Vault
- PSE Underground Power Service to Residence
- Waterline from Community Well to Residence
- Approximate Property Boundary
- Toe of Cut Slope for Building Pad Excavation

- Photo 1, @ Vault looking North to House
- Photo 2, East of Vault looking West Along Road
- Photo 3, North East of Vault looking up and along road showing head scarp of slide
- Photo 4, North of Vault showing top of Slide and vault settlement
- Photo 5, @ Toe of Slope looking up and east at cut slope failure
- Photo 6, @ Toe of Slope looking east along toe
- Photo 5, @ Toe of Slope near mid point of cut showing local cut failure and small slide zone causing heave of existing grade near house

Approximate location of previous slope mitigation work. Mitigation involved drains and grading to drain water from slope. Water drains into roadside swale on South side of Cul-de-Sac.
