**From:** [White, Lori \(ECY\)](#)  
**To:** [Kelly Bacon \(CD\)](#)  
**Subject:** Sweetwater site visit  
**Date:** Wednesday, July 14, 2021 10:18:42 AM  
**Attachments:** [image001.png](#)

Thank you for attending and arranging the site visit yesterday, July 13, 2021. While onsite we talked with the applicant and their agent. The agent discussed plan changes including the removal of parking lot B, which was located in an area of concern. Due to the time of the year, the site investigation focused primarily on the presence of hydric soils.

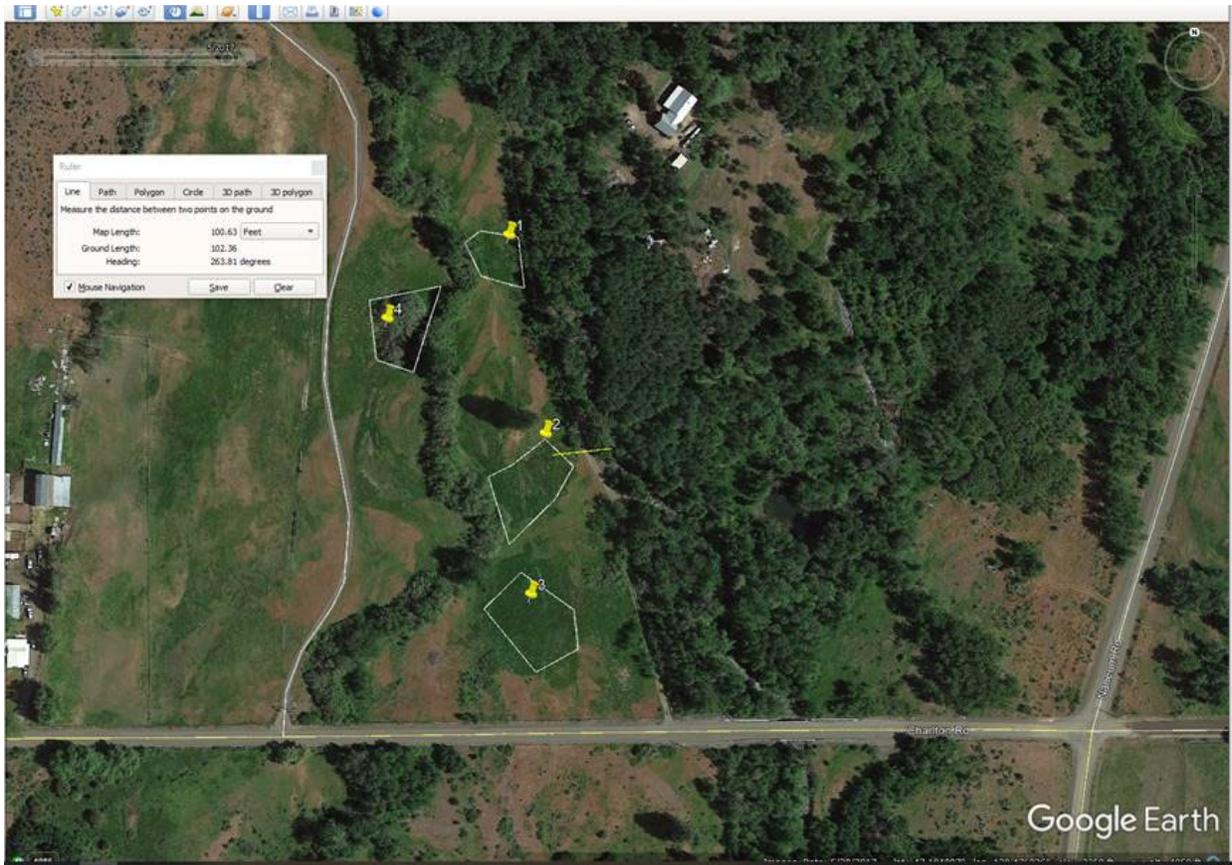
Ecology was present to review areas of interest, as a result of the review of Ed Sewall's 2019 wetland delineation. Four areas were outlined for review. Soil pits were dug in three of the four locations. Shovel refusal occurred at location 2 due to soil compaction (likely due to livestock) and cobbles. Each of the areas are detailed below and shown in the below map:

Area 1- Is located between Naneum Creek's riparian habitat and that of the nearby irrigation ditch, approximately within 100 feet of Naneum Creek. A small depression was noted in this area. Vegetation included horsetail, cottonwood seedlings, rush species, and various grasses. A dry, sandy loam substrate characterized by 10 YR 3/3 Munsell soil colors occurred in the top 8 inches of the soil profiles. Soil color changed below 8 inches and some redox was noted (~3%). Did not meet hydric soil indicators. Water is likely not staying in place long enough.

Area 2- Is located about 330 ft south of Area 1, near a large pine tree. Rush and various grass species were noted in this area. Soils were not able to be categorized due to shovel refusal.

Area 3- Is located approximately 100 feet south of Area 2, near Charlton Road. The area largely consisted of rush and various grasses. Soil was characterized as moist with the top 3 inches consisting of numerous fine roots and a 10YR 3/3 soil color. Soil below 3 inches had a color of 10YR 3/2 and prominent redoximorphic features consisting of at least 5%. The soil did meet hydric soil indicator F6.

Area 4- Is located west of the Irrigation Ditch in a small grove willows. Understory within the willows included upland species of snowberry, golden current, and rose species. Soil in this area was dry and characterized as 10YR 2/2 with no redoximorphic features noted.

Based on the information above, Area 3 should be further investigated for additional wetland characteristics. It would be in the applicant's best interest to have Mr. Sewall revisit the site and further investigate the areas mentioned for the three required wetland characteristics (hydrophytic vegetation, hydrology, hydric soils). Please note that several of the areas of interest are located within 200 feet of Naneum Creek (the OHWM was not determined nor were measurements taken onsite. Estimated on aerial images).
