Custom Soil Resource Report for Kittitas County Area, Washington

Winemaker's Cabins at Swiftwater Cellars

Subject: **Supplemental Coal Mine Hazards Assessment
Winemaker's Cabins at Swiftwater Cellars
301 Rope Rider Drive, Cle Elum, Kittitas, Washington**

GNN Project No. 217-871

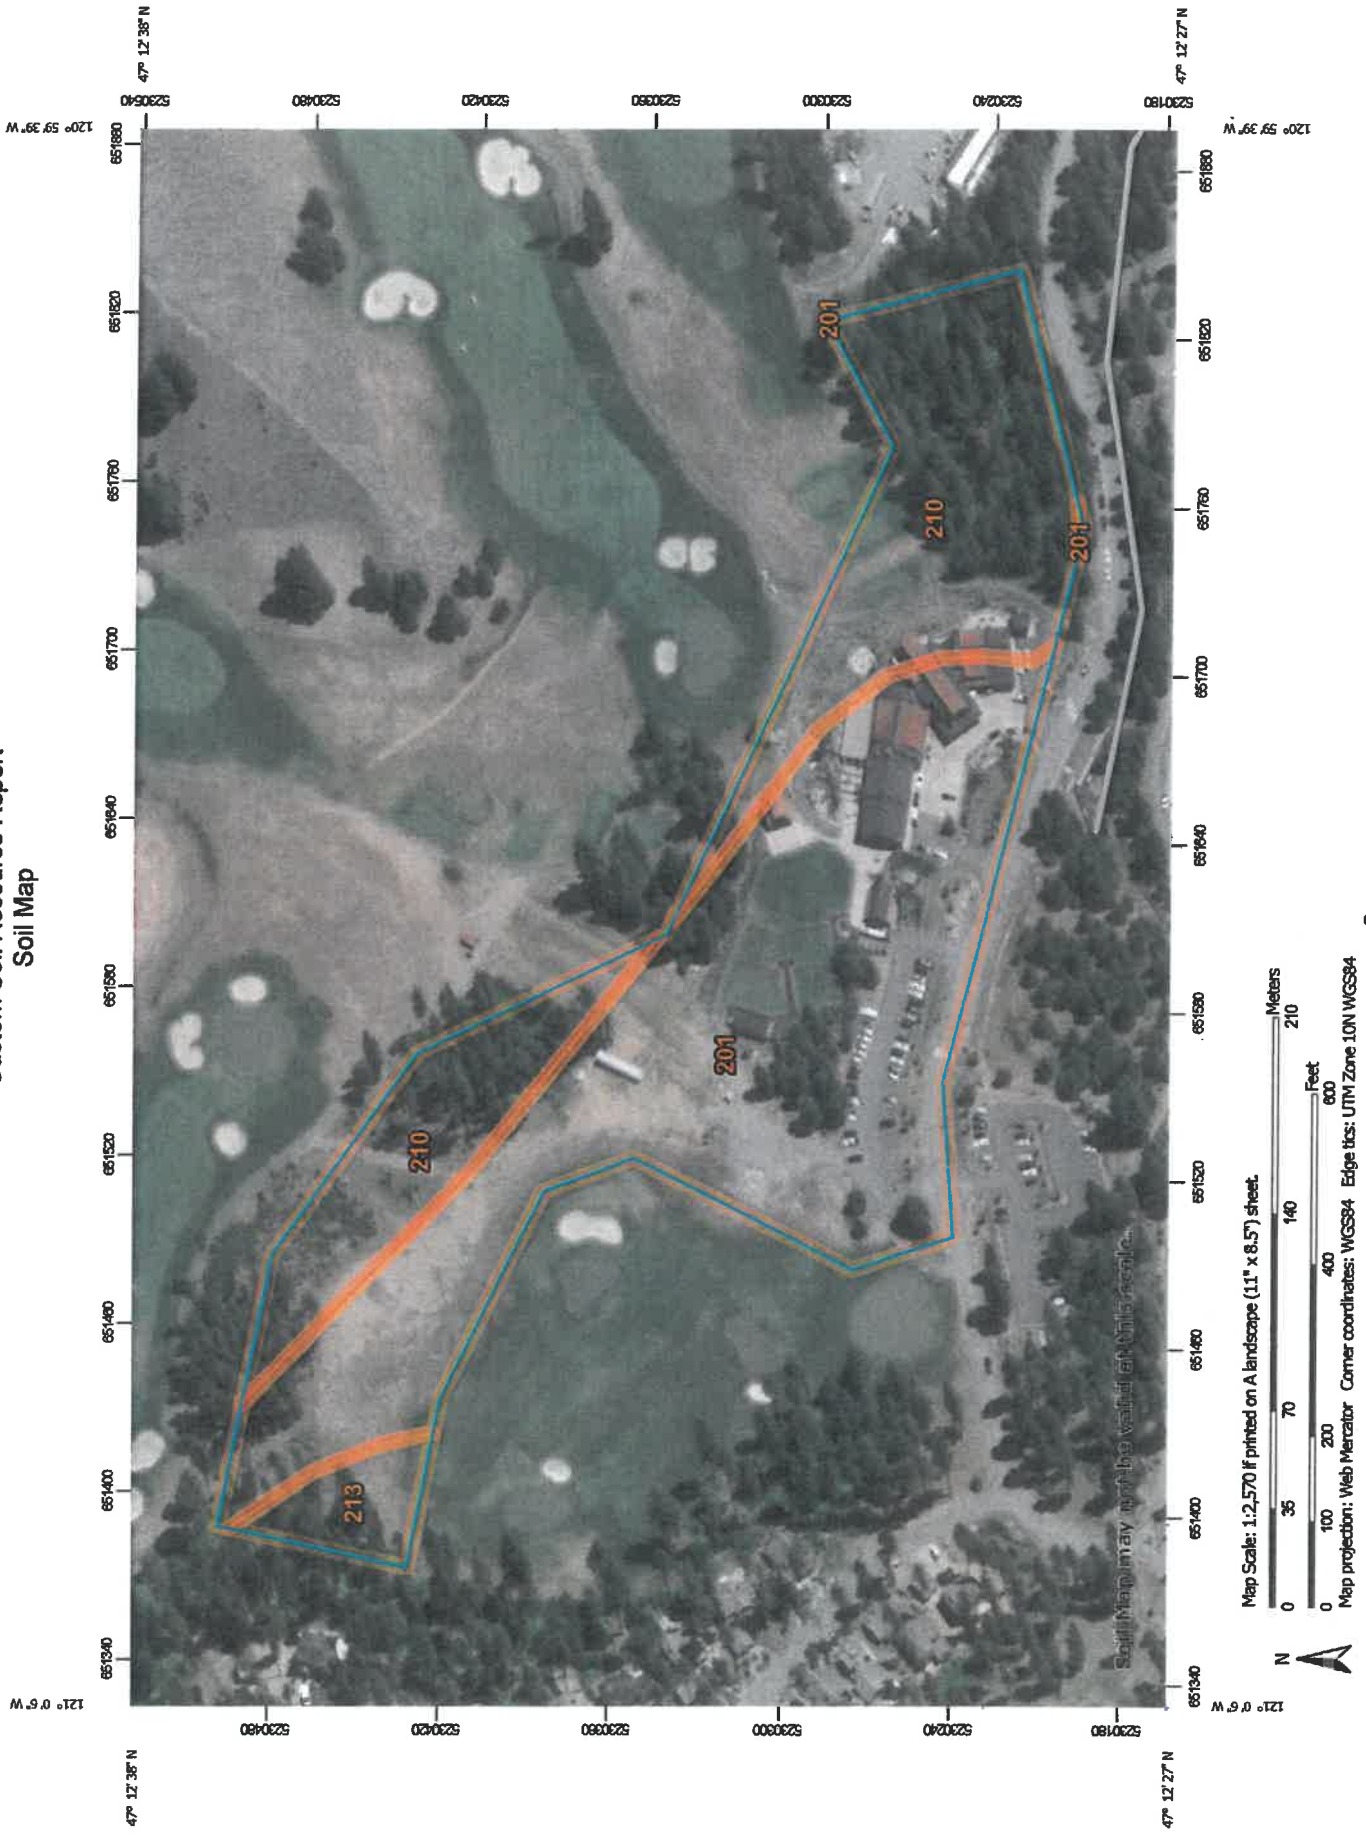
Custom Soil Resource Report Soil Map

Map Scale: 1:2,570 if printed on A landscape (11" x 8.5") sheet.

Map projection: Web Mercator Corner coordinates: WGS84 Edge tics: UTM Zone 10N WGS84

201—Roslyn ashy sandy loam, 0 to 5 percent slopes

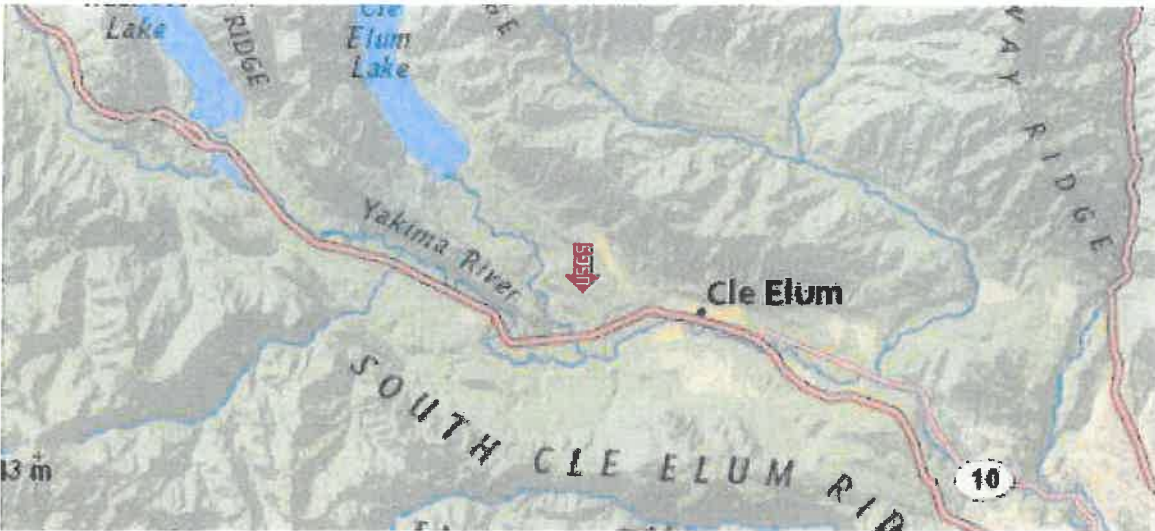
Site Coordinates 47.21028°N, 121.00097°W

Site Soil Classification Site Class C – “Very Dense Soil and Soft Rock”

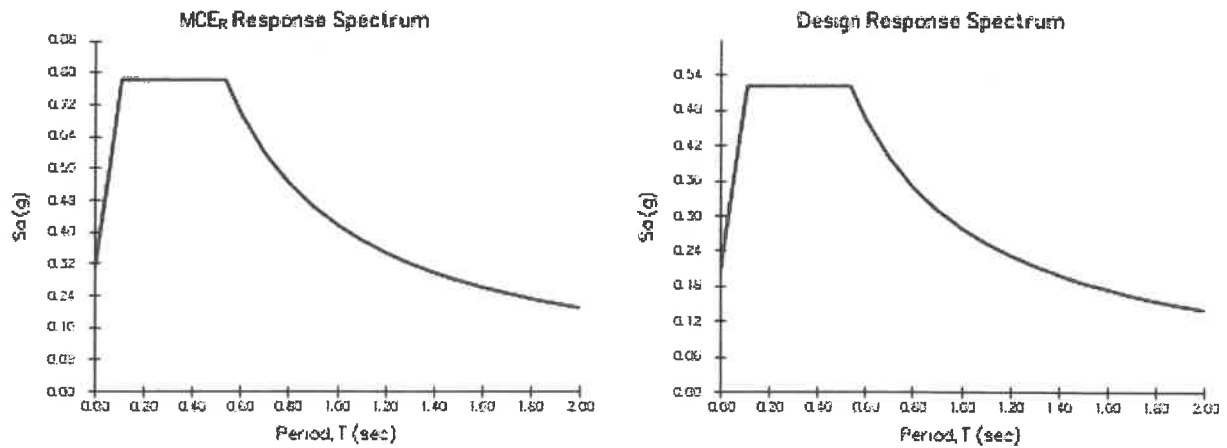
$S_s = 0.699 \text{ g}$	$S_{MS} = 0.783 \text{ g}$	$S_{DS} = 0.522 \text{ g}$
$S_1 = 0.275 \text{ g}$	$S_{M1} = 0.419 \text{ g}$	$S_{D1} = 0.279 \text{ g}$

For information on how the S_S and S_1 values above have been calculated from probabilistic (risk-targeted) and deterministic ground motions in the direction of maximum horizontal response, please return to the application and select the “2009 NEHRP” building code reference document.
