CHAPTER 3. UPPER COUNTY

This chapter describes the conditions within the shoreline inventory area of upper Kittitas County (including the City of Cle Elum and Town of South Cle Elum). The upper Kittitas County shorelines include the upper Yakima River and its tributaries from the Yakima River headwaters to the Taneum Creek confluence (Figure 3-1). The 35 streams and 29 lakes and ponds within the upper county are described in terms of their physical characteristics, ecological conditions, and human environment/land use characteristics. Readers are encouraged to review Chapter 2 and the maps in Appendix A for additional context on the information presented here.

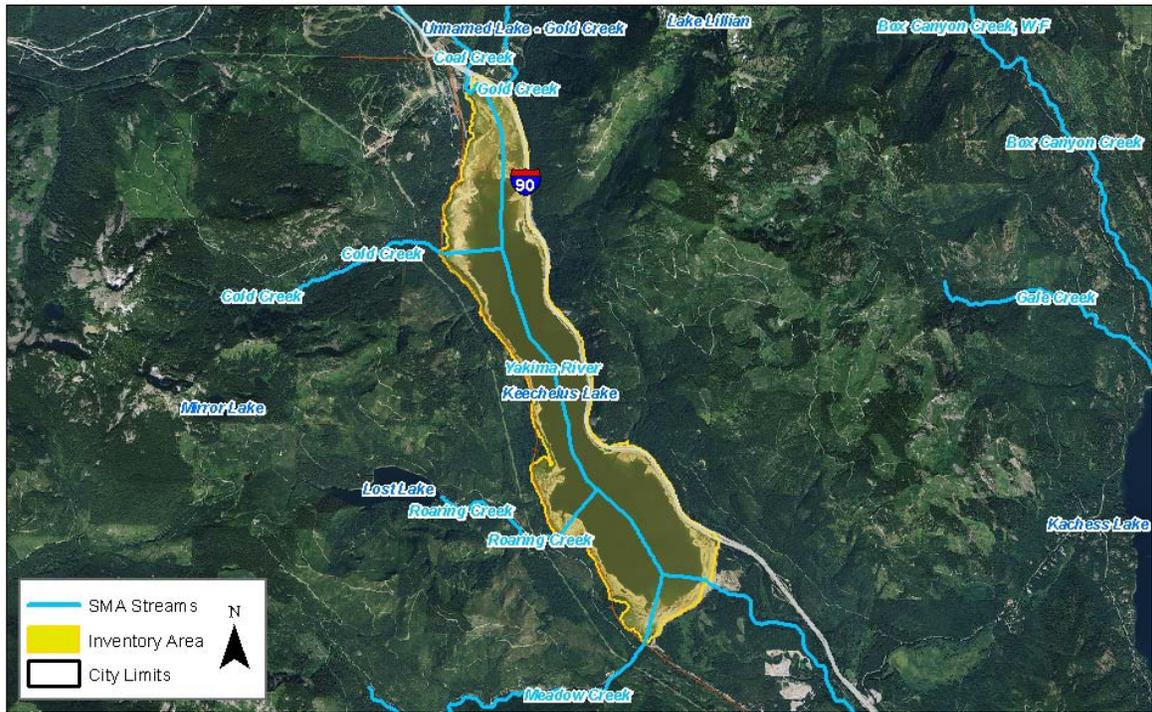
SHORELINE LENGTH:
49.5 Miles

WATERBODY AREA: 2,408.5 Acres
REACH INVENTORY AREA: 2,772.4 Acres

Roughly one-third of the reach (32%) is located within the FEMA 100-year floodplain and a few landslide hazard areas (1%) are mapped along the eastern shoreline of the lake.

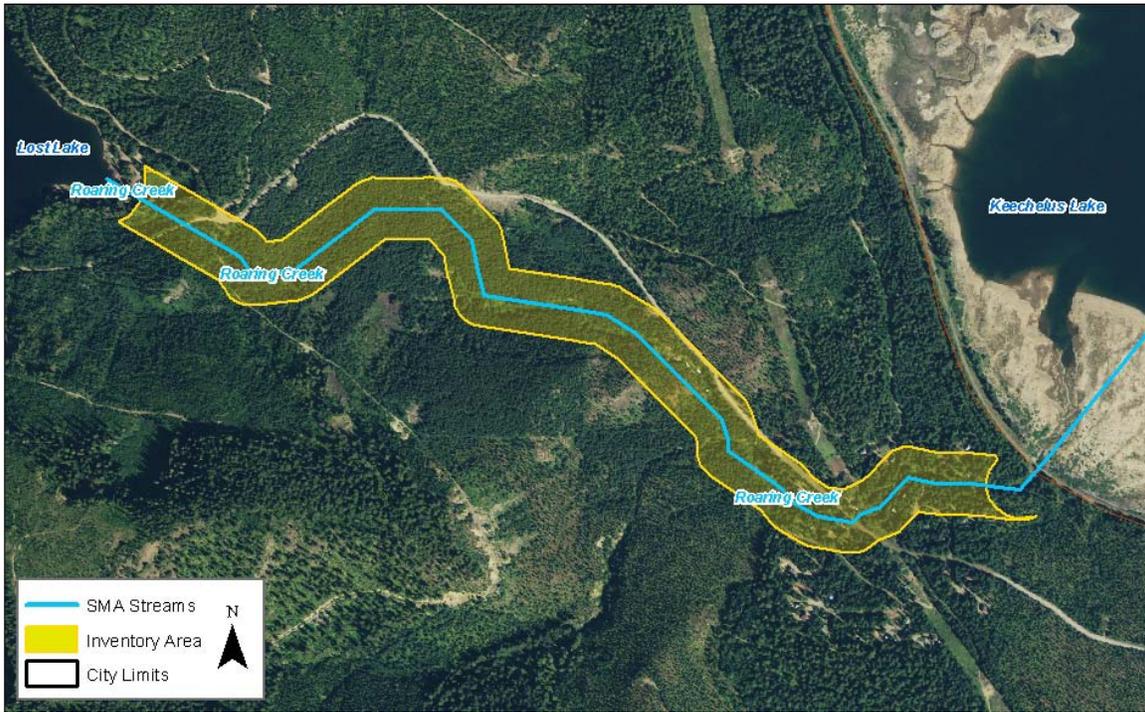
REACH INVENTORY AREA:

63.6 Acres

A limited extent (3%) of the reach is located within the FEMA 100-year floodplain. The upstream half of the reach (51%) has mapped landslide hazard areas.

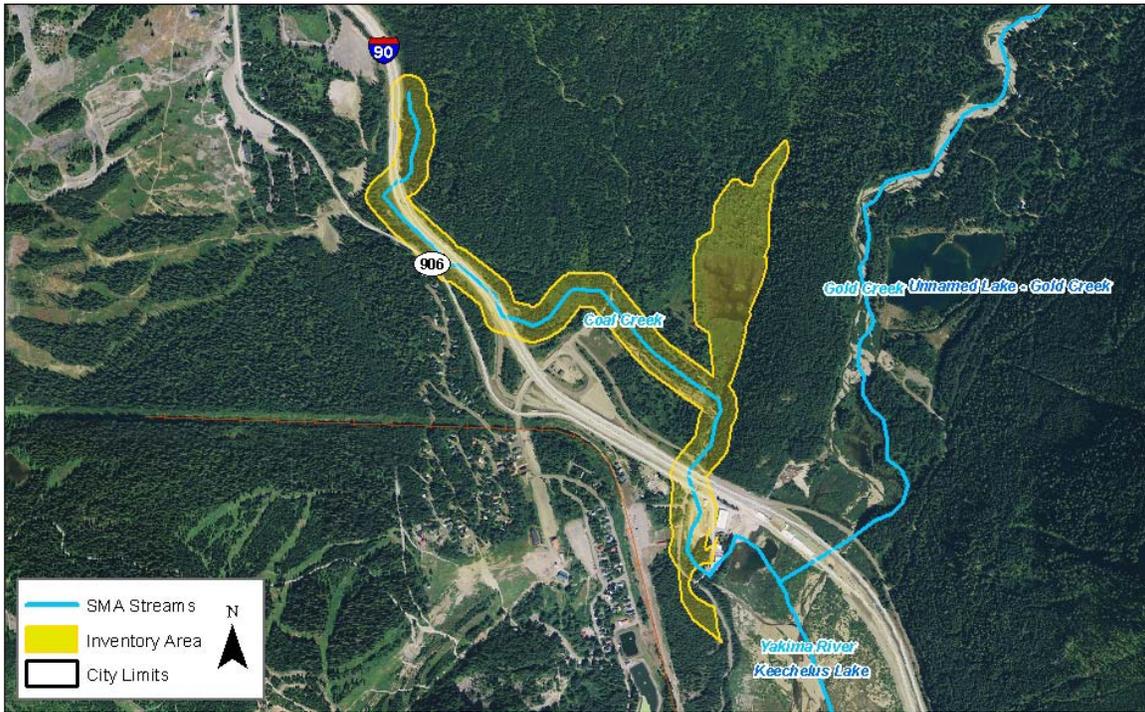
REACH INVENTORY AREA:

122.8 Acres

A small amount (8%) of the reach is located within the FEMA 100-year floodplain and a small number of landslide hazard areas (1%) are mapped near the upstream end of the reach. The entire reach has potential for channel migration.

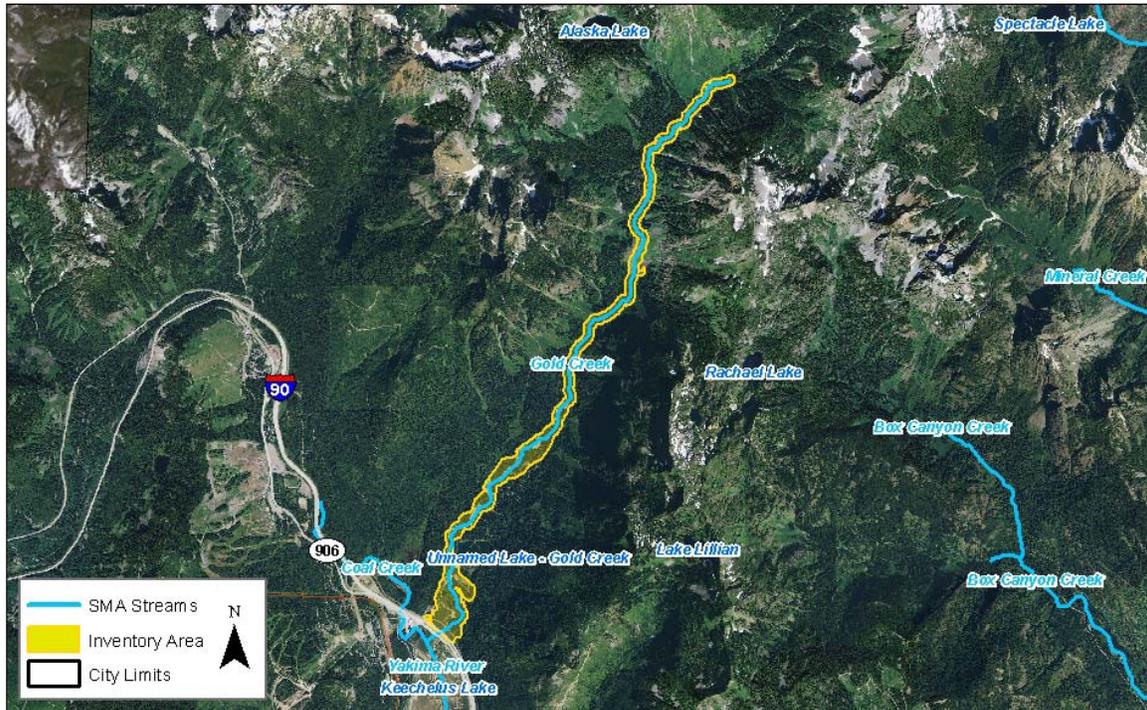
REACH INVENTORY AREA:

360.2 Acres

Approximately 42% of the reach is located within the FEMA 100-year floodplain and a very limited amount of landslide hazard areas (<1%) are mapped in the reach. The entire reach has potential for channel migration.

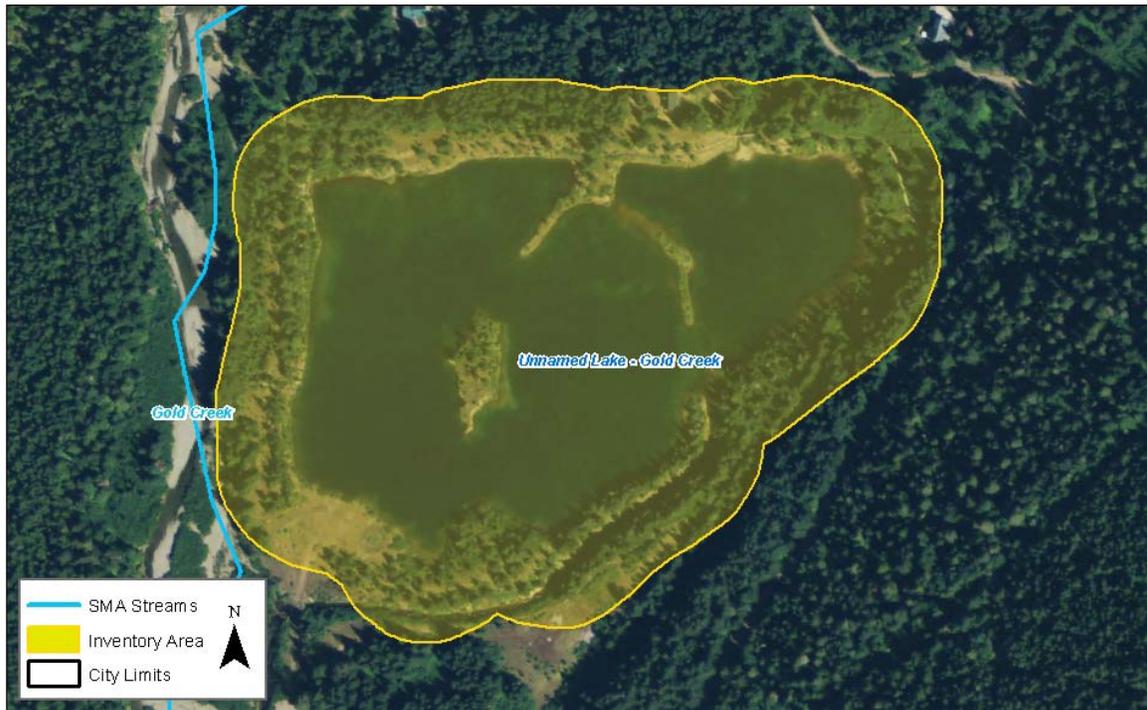
SHORELINE LENGTH:
1.3 Miles

WATERBODY AREA: 21.7 Acres
REACH INVENTORY AREA: 45.9 Acres

Approximately 11% of the reach is located within the FEMA 100-year floodplain. No landslide hazard areas are mapped within the reach.

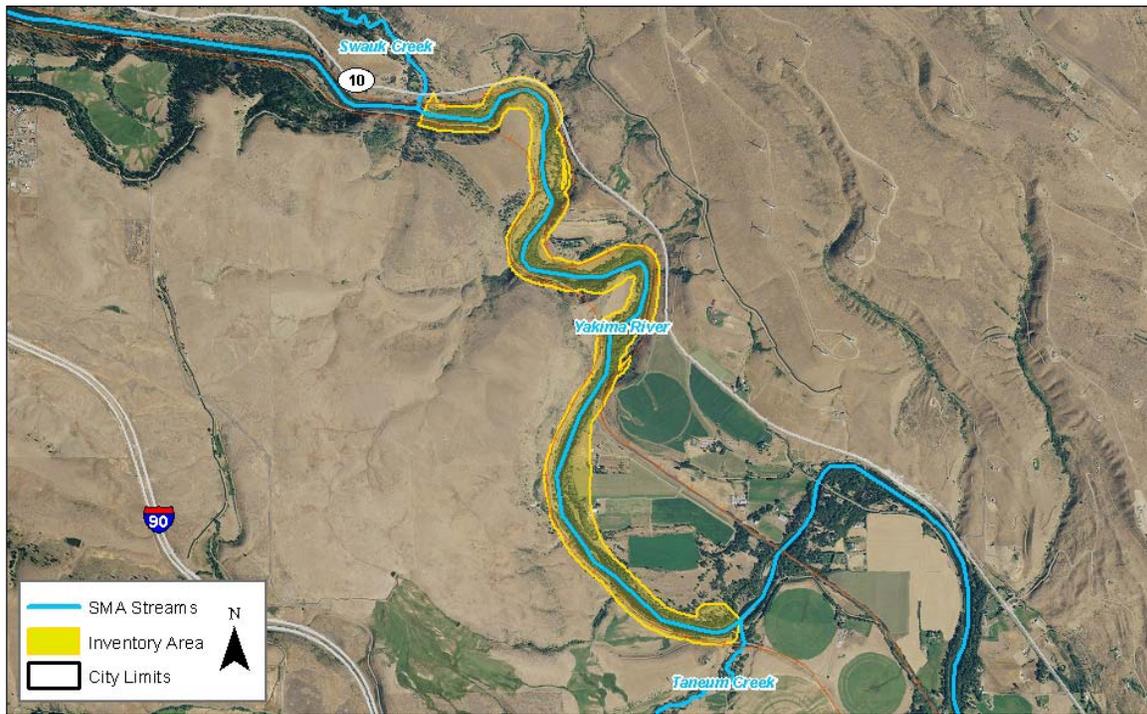
REACH INVENTORY AREA:

326.8 Acres

The majority of the reach (70%) is located within the FEMA 100-year floodplain. No landslide hazard areas are mapped within the reach. The downstream half of the reach has potential for channel migration.

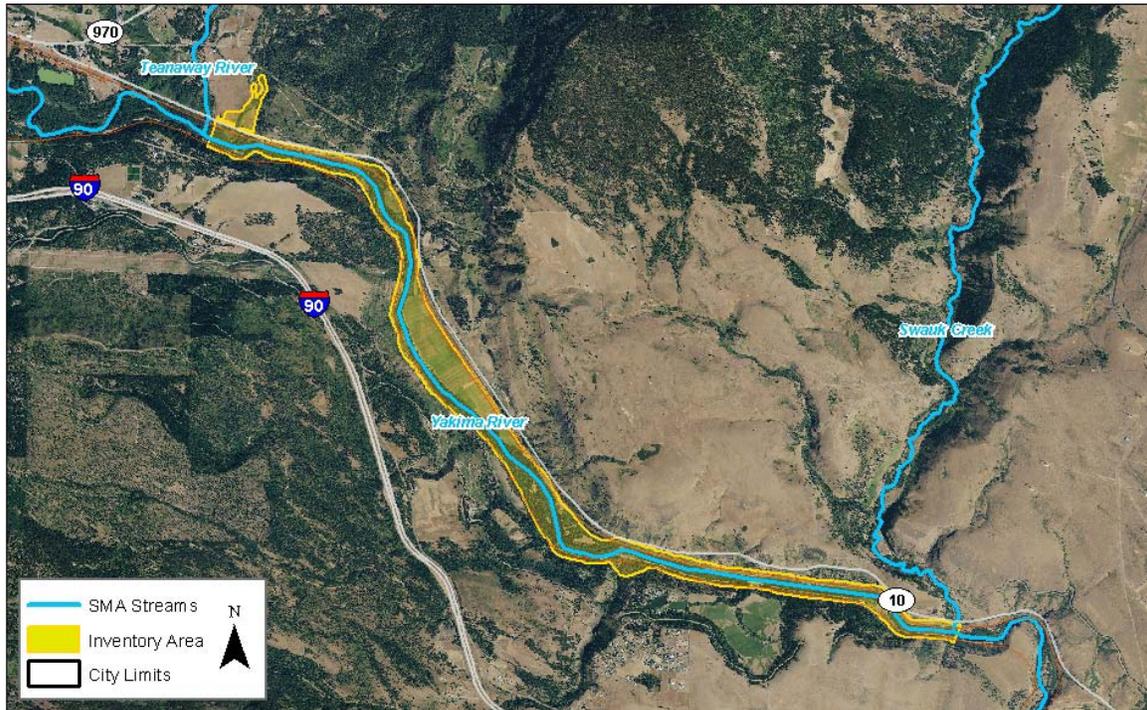
REACH INVENTORY AREA:

614.9 Acres

A large portion of the reach (71%) is located within the FEMA 100-year floodplain. No landslide hazard areas are mapped within the reach. The upstream half of the reach has potential for channel migration.

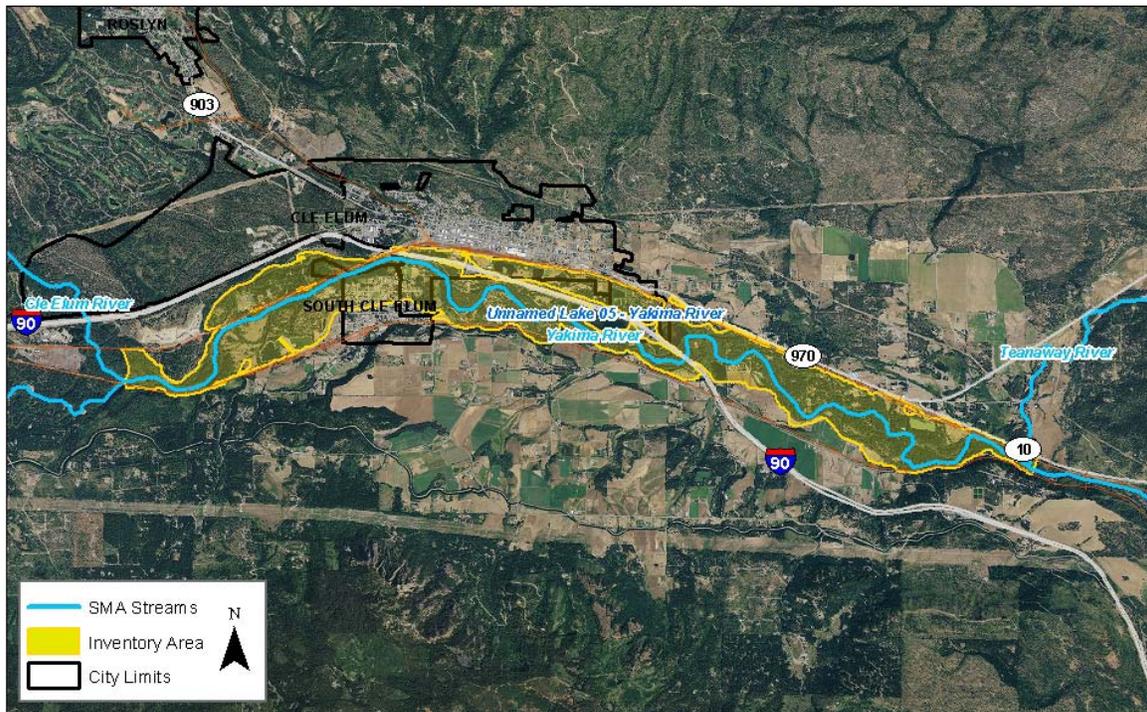
REACH INVENTORY AREA:

2,310.9 Acres

A significant area of the reach (96%) is located within the FEMA 100-year floodplain. No landslide hazard areas are mapped within the reach. The entire reach has potential for channel migration.

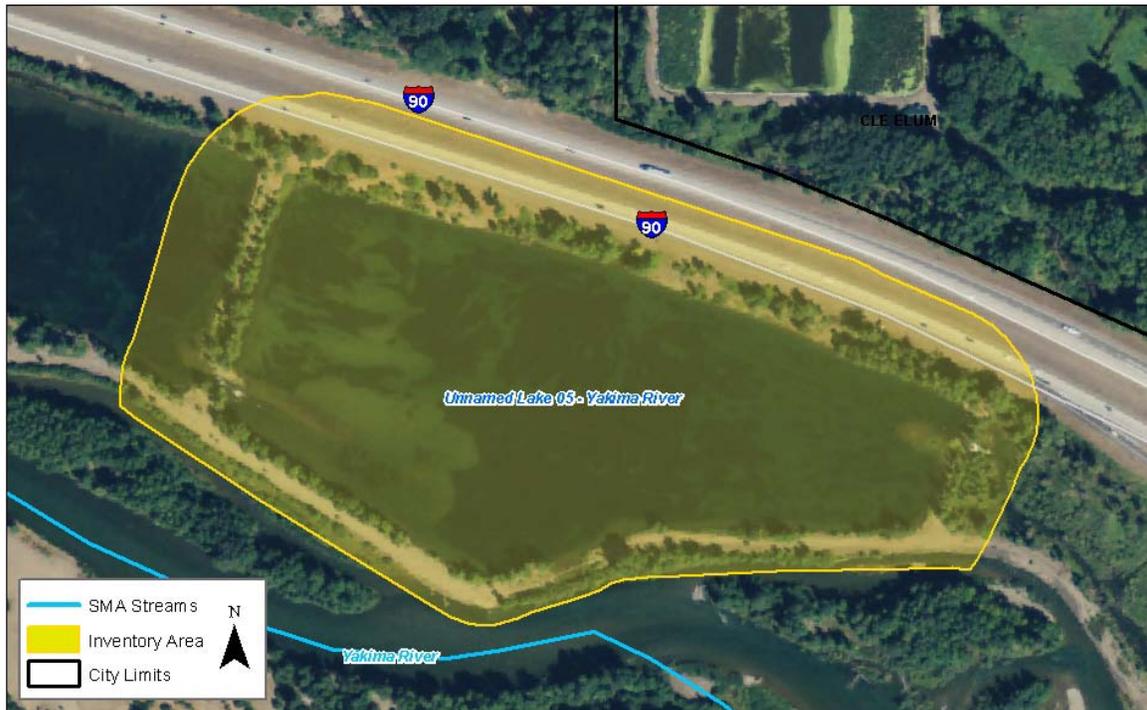
WATERBODY AREA: 18.3 Acres

REACH INVENTORY AREA: 36.2 Acres

The majority of the reach (83%) is located within the FEMA 100-year floodplain. No landslide hazard areas are mapped within the reach.

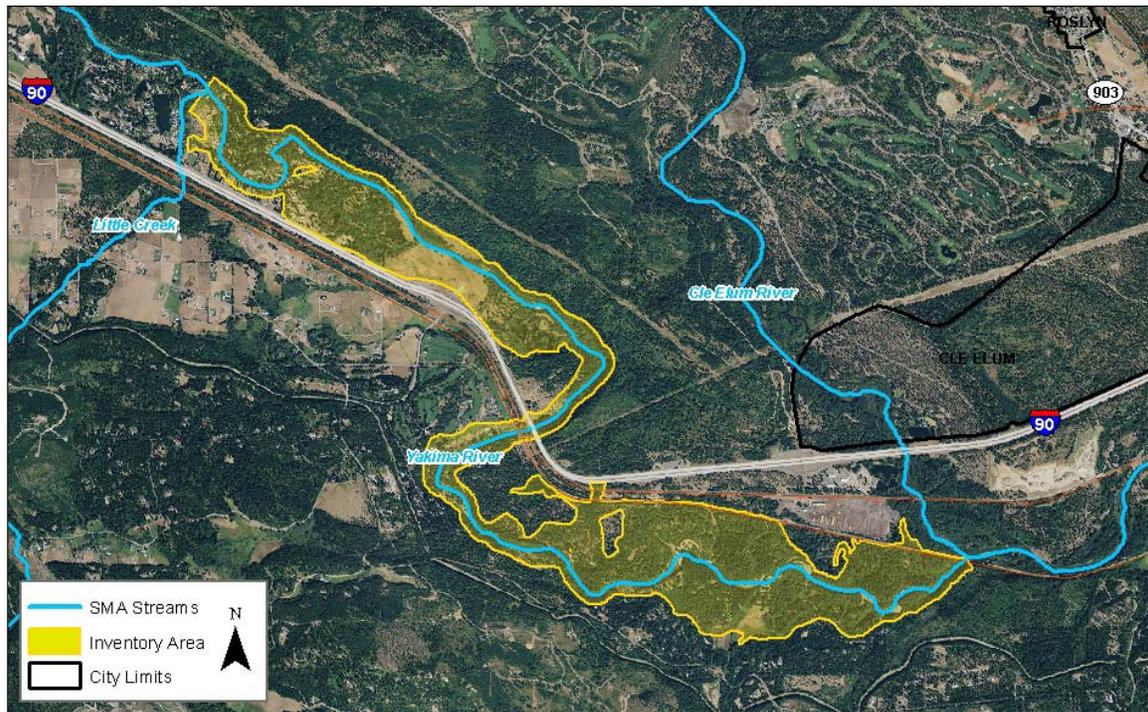
REACH INVENTORY AREA:

1,159.4 Acres

Roughly 91% of the reach is located within the FEMA 100-year floodplain. No landslide hazard areas are mapped within the reach. The entire reach has potential for channel migration.

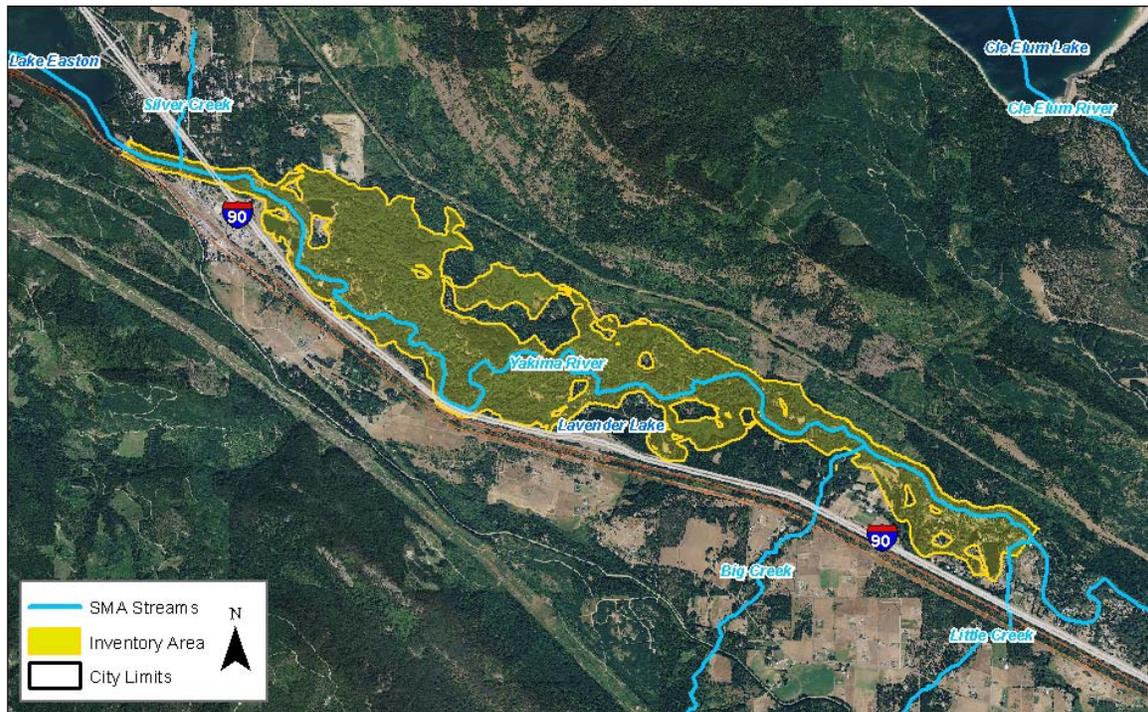
REACH INVENTORY AREA:

1,430.1 Acres

A large portion of the reach (82%) is located within the FEMA 100-year floodplain. No landslide hazard areas are mapped within the reach. The majority of the reach has potential for channel migration.

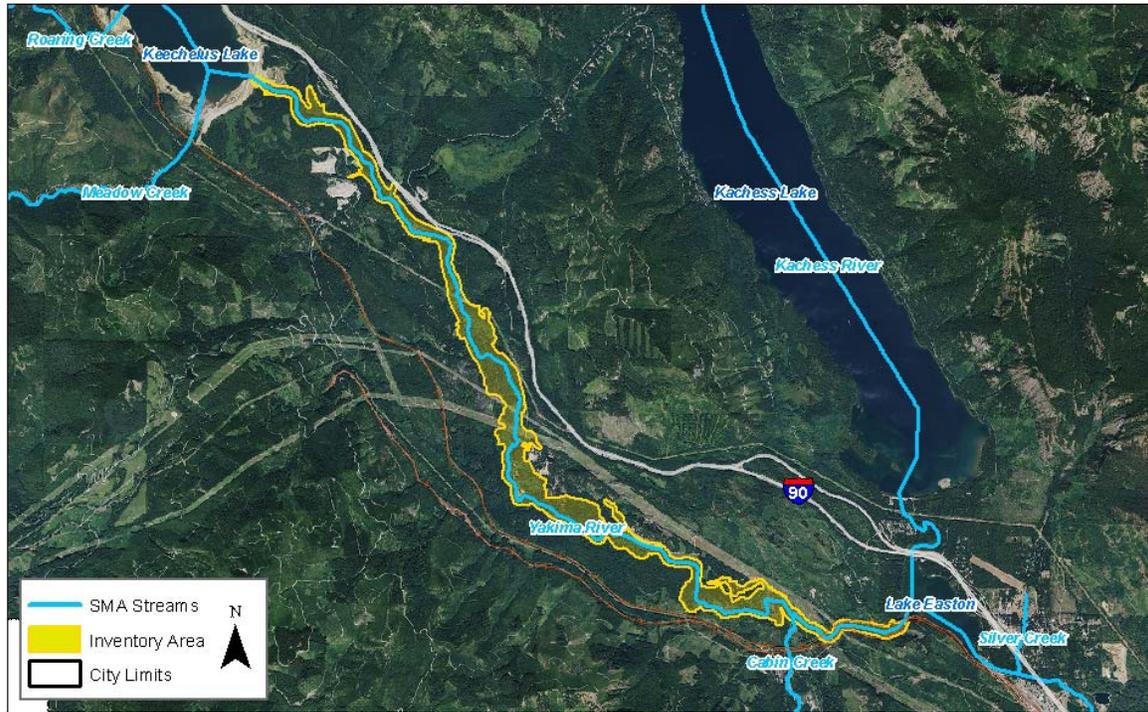
REACH INVENTORY AREA:

1,098.0 Acres

Much of the reach (78%) is located within the FEMA 100-year floodplain and very few landslide hazard areas (<1%) are mapped at the upstream and downstream ends of the reach. The entire reach has potential for channel migration.

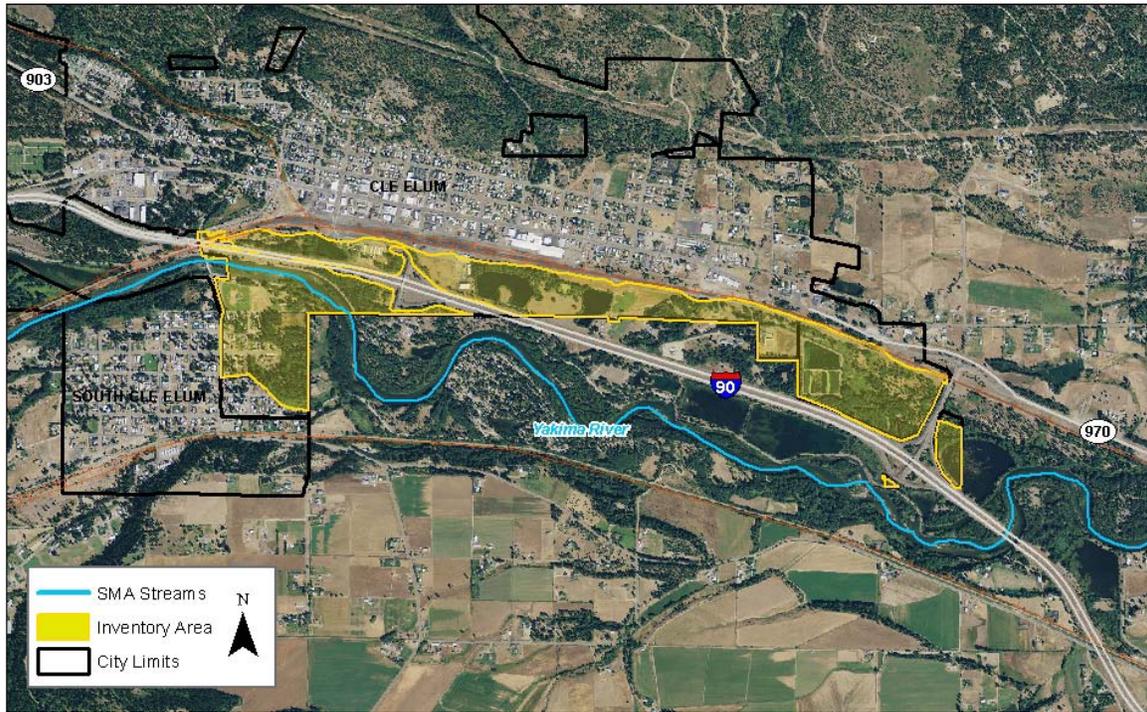
REACH INVENTORY AREA:

279.9 Acres

The majority of the reach (98%) is located within the FEMA 100-year floodplain. No landslide hazard areas are mapped within the reach. The entire reach has potential for channel migration.

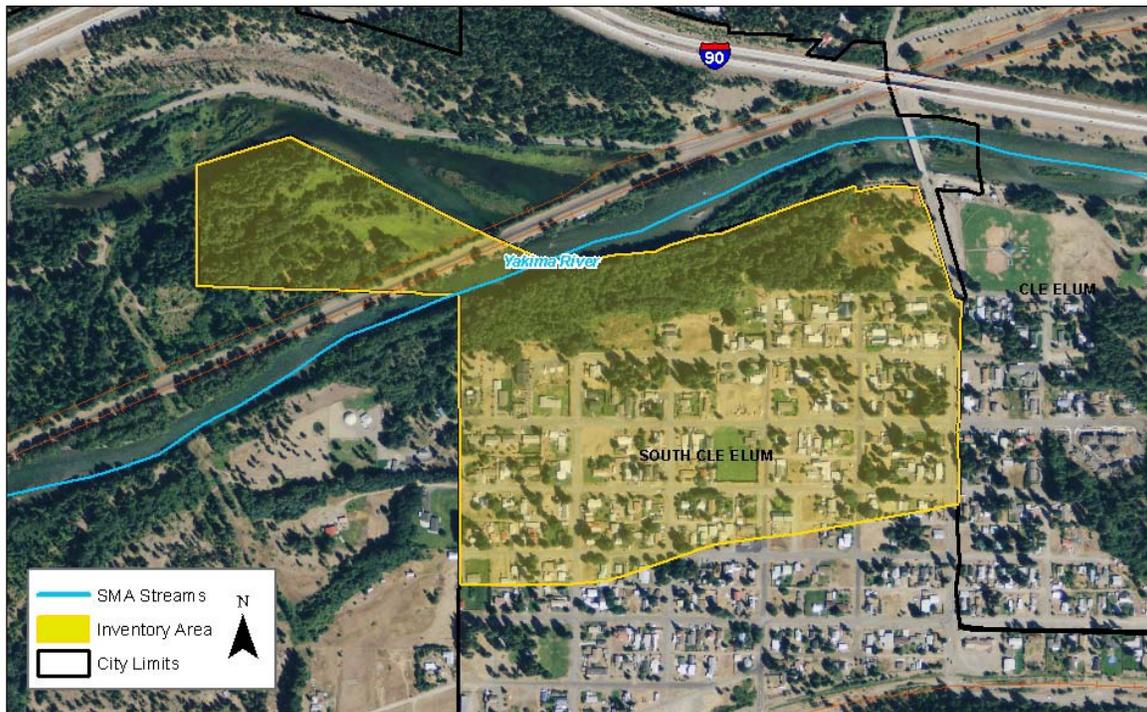
REACH INVENTORY AREA:

116.1 Acres

The reach (99%) is located within the FEMA 100-year floodplain. No landslide hazard areas are mapped within the reach. The entire reach has potential for channel migration.

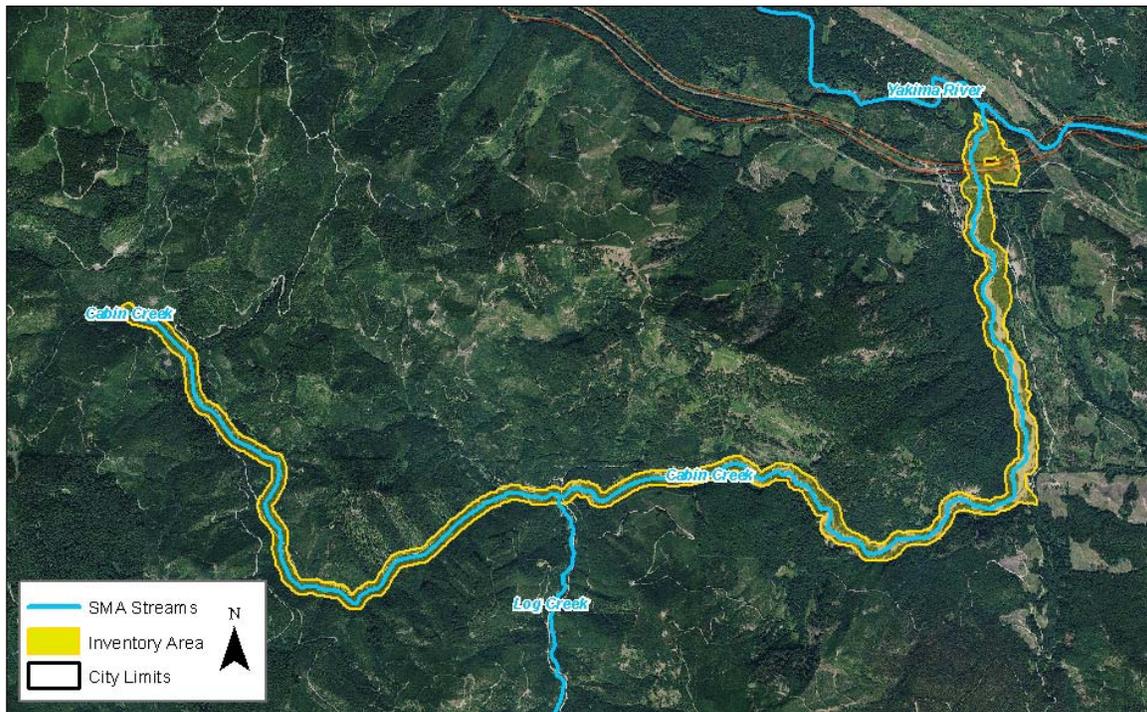
REACH INVENTORY AREA:

520.0 Acres

Roughly one-third of the reach (33%) is located within the FEMA 100-year floodplain and several landslide hazard areas (9%) are mapped along the reach. Downstream of the confluence with Log Creek, the reach has potential for channel migration.

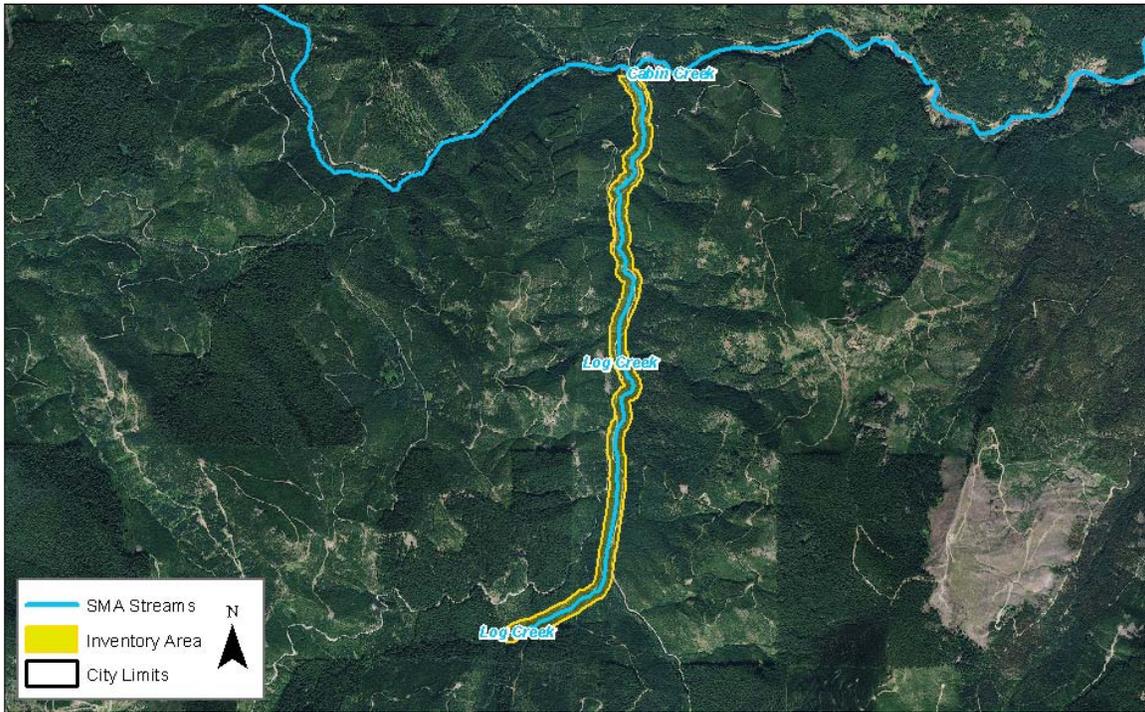
REACH INVENTORY AREA:

152.7 Acres

The reach is not located within the FEMA 100-year floodplain. Multiple landslide hazard areas (8%) are mapped within the reach. The downstream half of the reach has potential for channel migration.

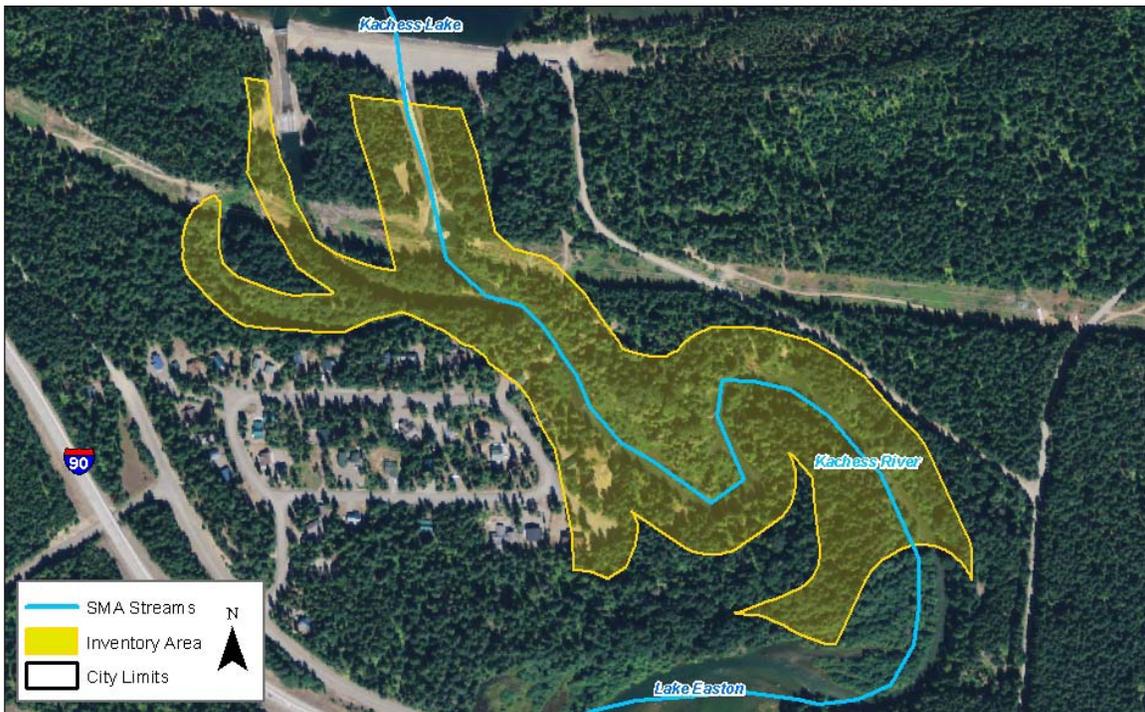
REACH INVENTORY AREA:

43.3 Acres

Approximately 71% of the reach is located within the FEMA 100-year floodplain and a very limited number of landslide hazard areas (<1%) are mapped on the left bank. The downstream half of the reach has potential for channel migration.

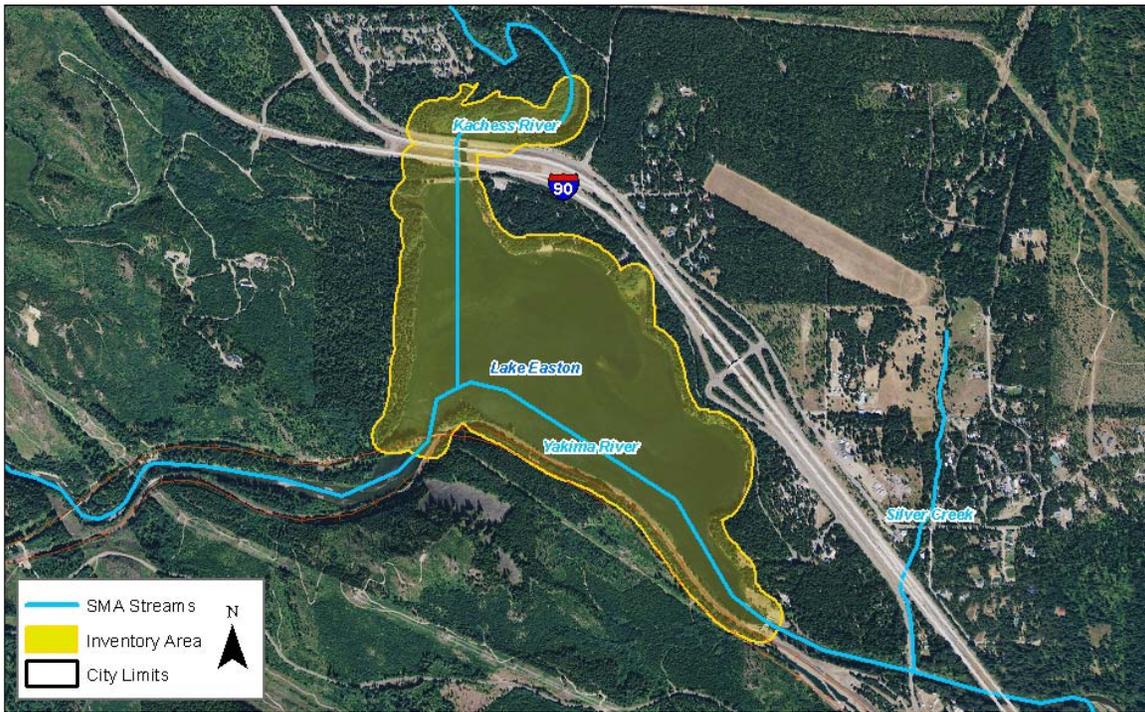
SHORELINE LENGTH:
8.0 Miles

WATERBODY AREA: 208.1 Acres
REACH INVENTORY AREA: 316.1 Acres

Approximately 33% of the reach is located within the FEMA 100-year floodplain and a few landslide hazard areas (1%) are mapped on the northern, western, and southern shorelines.

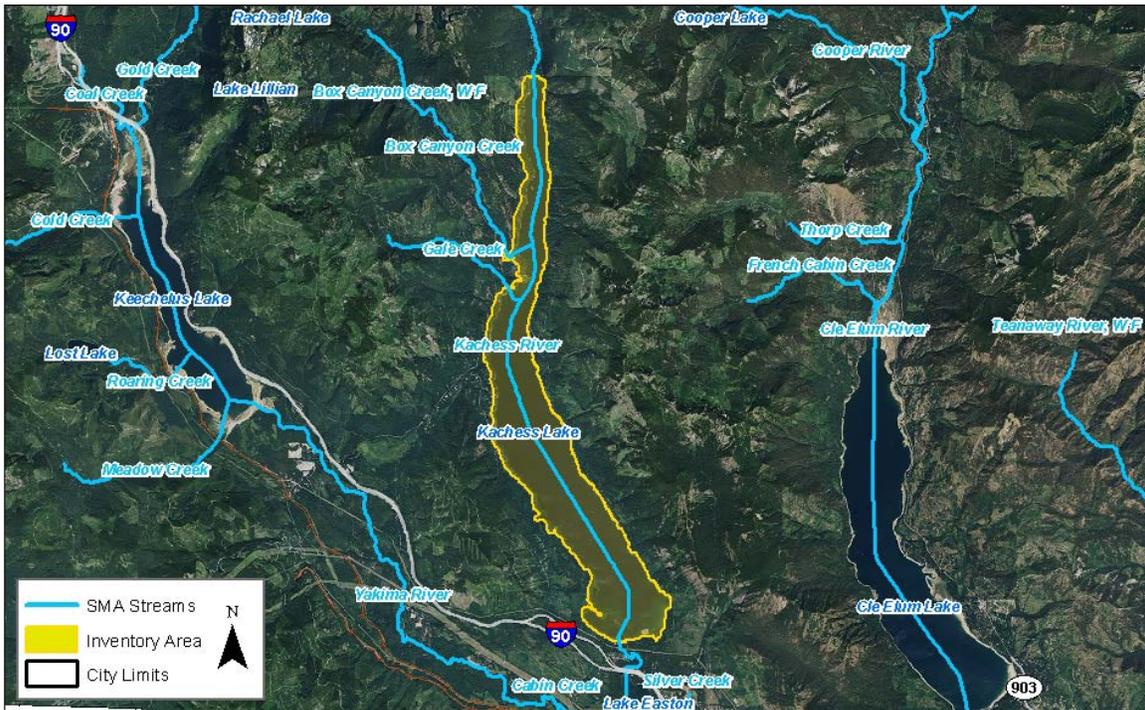
SHORELINE LENGTH:
77.1 Miles

WATERBODY AREA: 4,367.8 Acres
REACH INVENTORY AREA: 5,182.6 Acres

A large extent of the reach (61%) is located within the FEMA 100-year floodplain; several landslide hazard areas (3%) are mapped on the eastern shoreline of the lake.

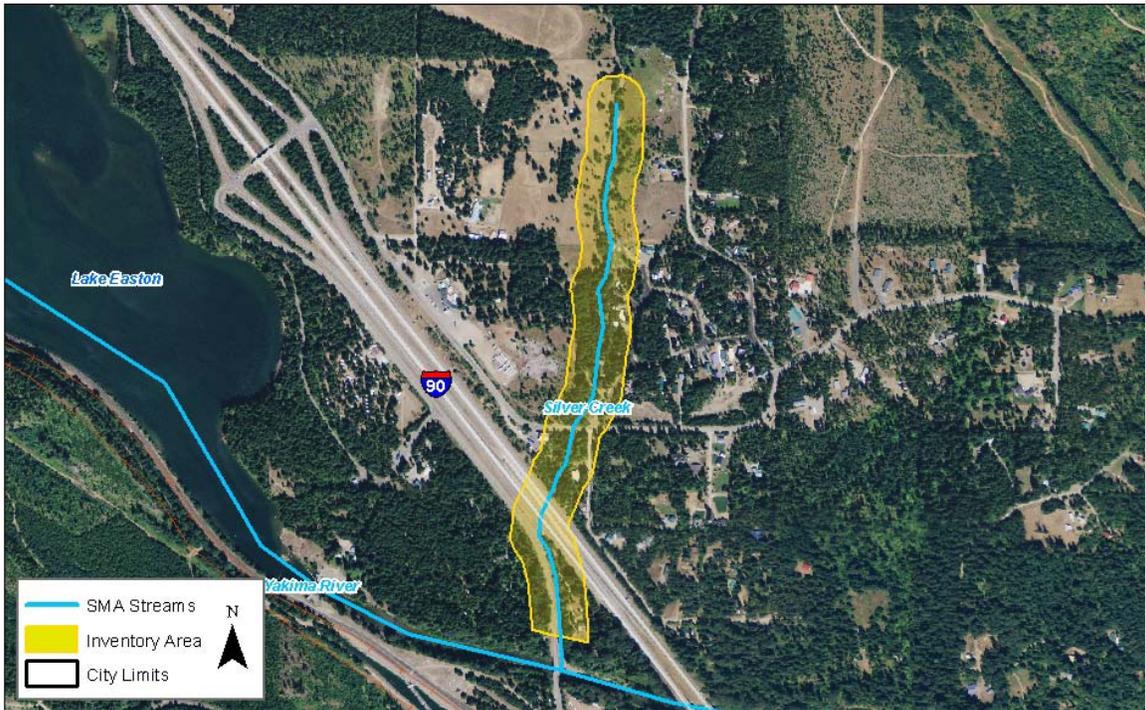
REACH INVENTORY AREA:

37.8 Acres

20% of the reach is located within the FEMA 100-year floodplain. No landslide hazard areas are mapped within the reach. The entire reach has potential for channel migration.

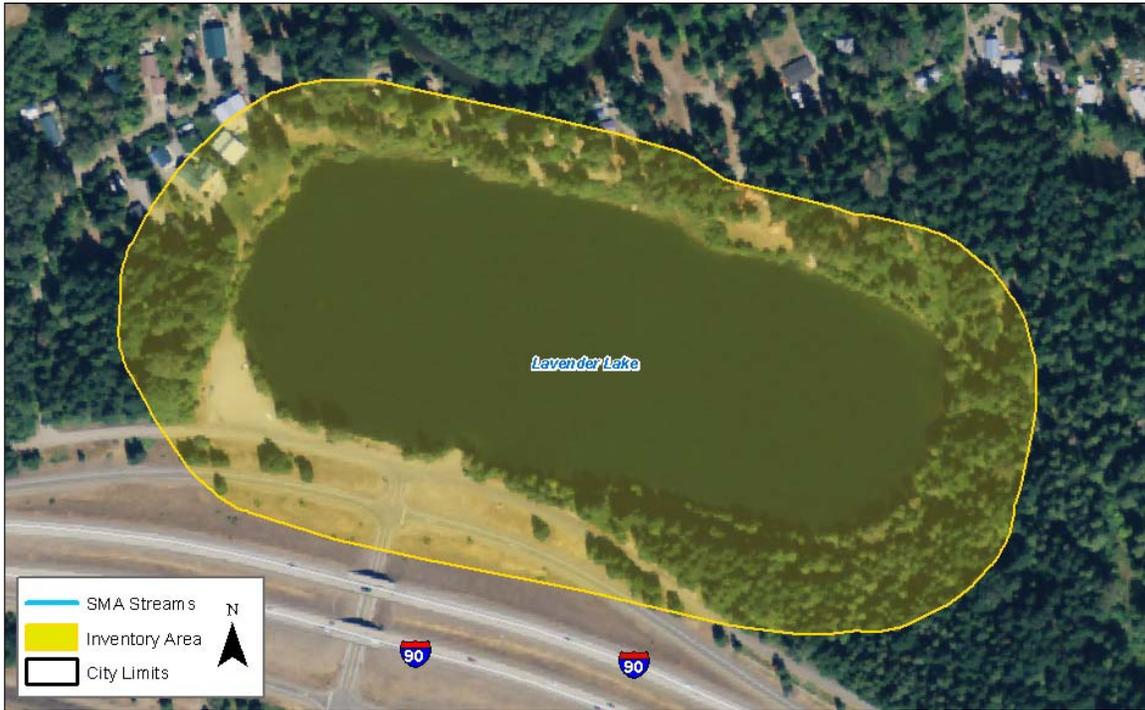
SHORELINE LENGTH:
1.0 Mile

WATERBODY AREA: 18.5 Acres
REACH INVENTORY AREA: 39.0 Acres

About one-quarter of the reach (27%) is located within the FEMA 100-year floodplain. No landslide hazard areas are mapped within the reach.

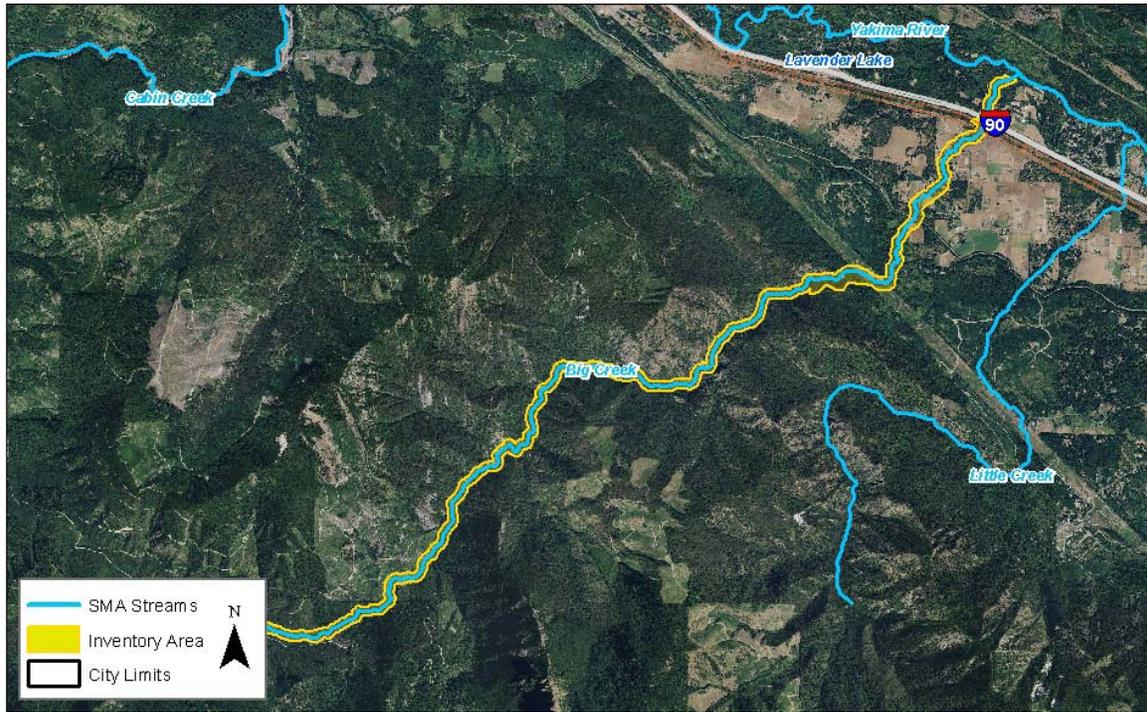
REACH INVENTORY AREA:

531.4 Acres

A portion of the reach (21%) is located within the FEMA 100-year floodplain and a several landslide hazard areas (3%) are mapped at the upstream end of the reach.

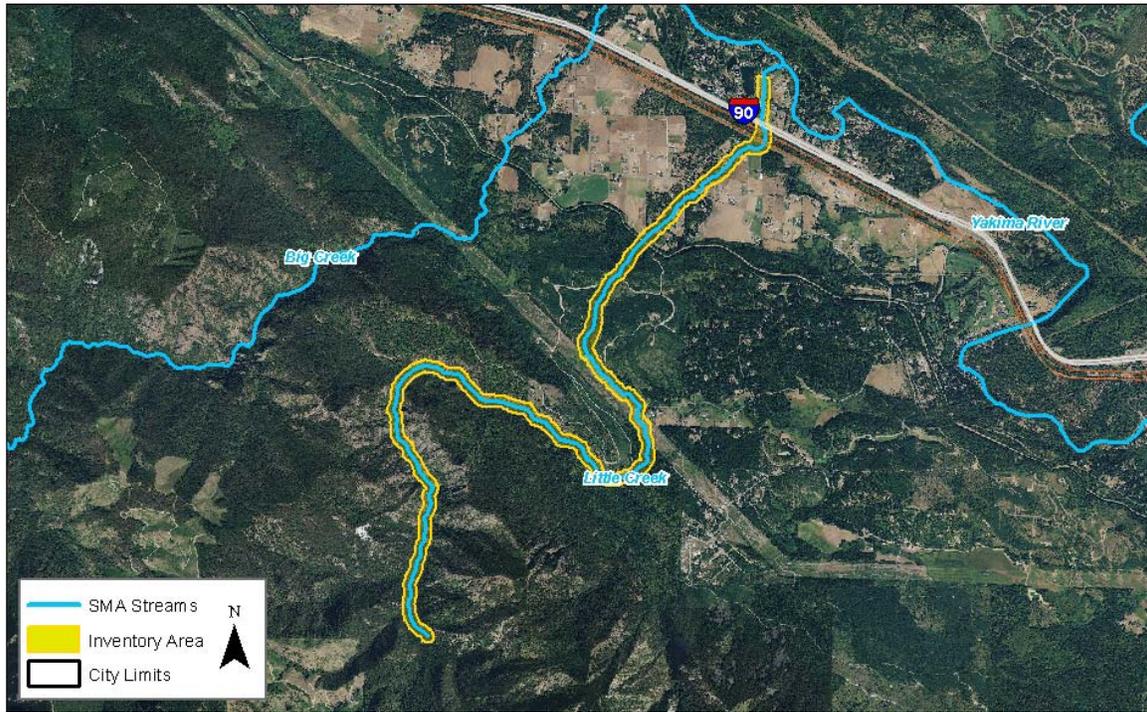
REACH INVENTORY AREA:

351.9 Acres

Approximately 36% of the reach is located within the FEMA 100-year floodplain. No landslide hazard areas are mapped within the reach.

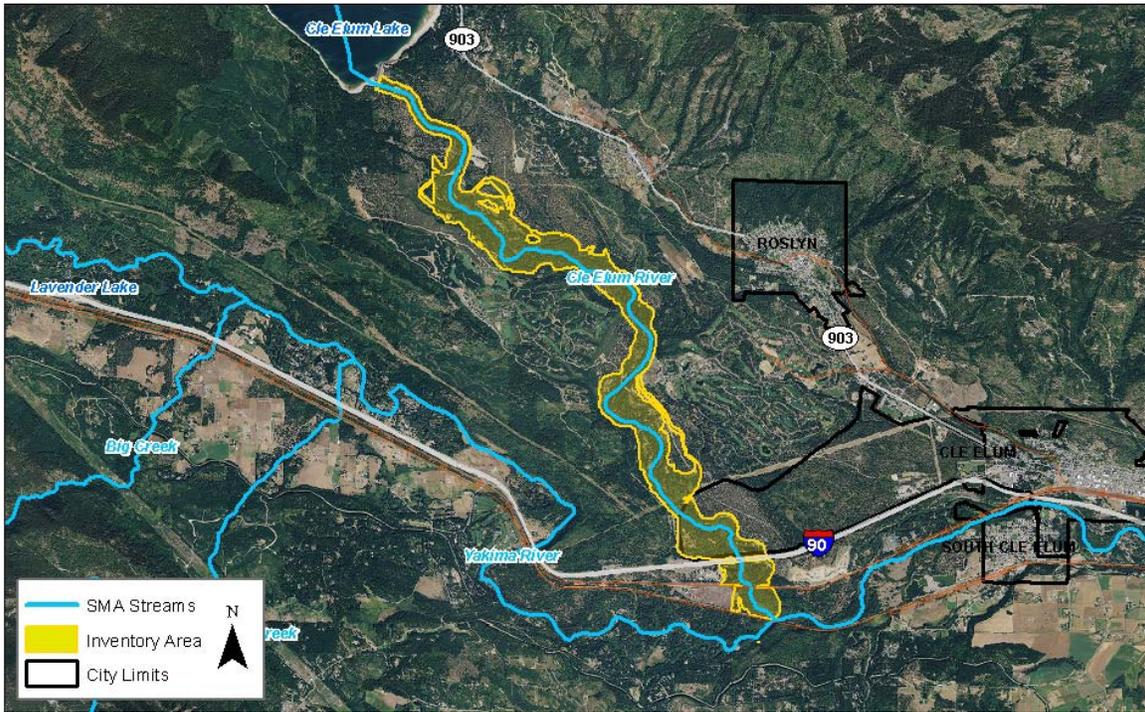
REACH INVENTORY AREA:

1,202 Acres

The majority of the reach (89%) is located within the FEMA 100-year floodplain and a few landslide hazard areas (2%) are mapped on both banks of the reach. The majority of the reach has potential for channel migration.

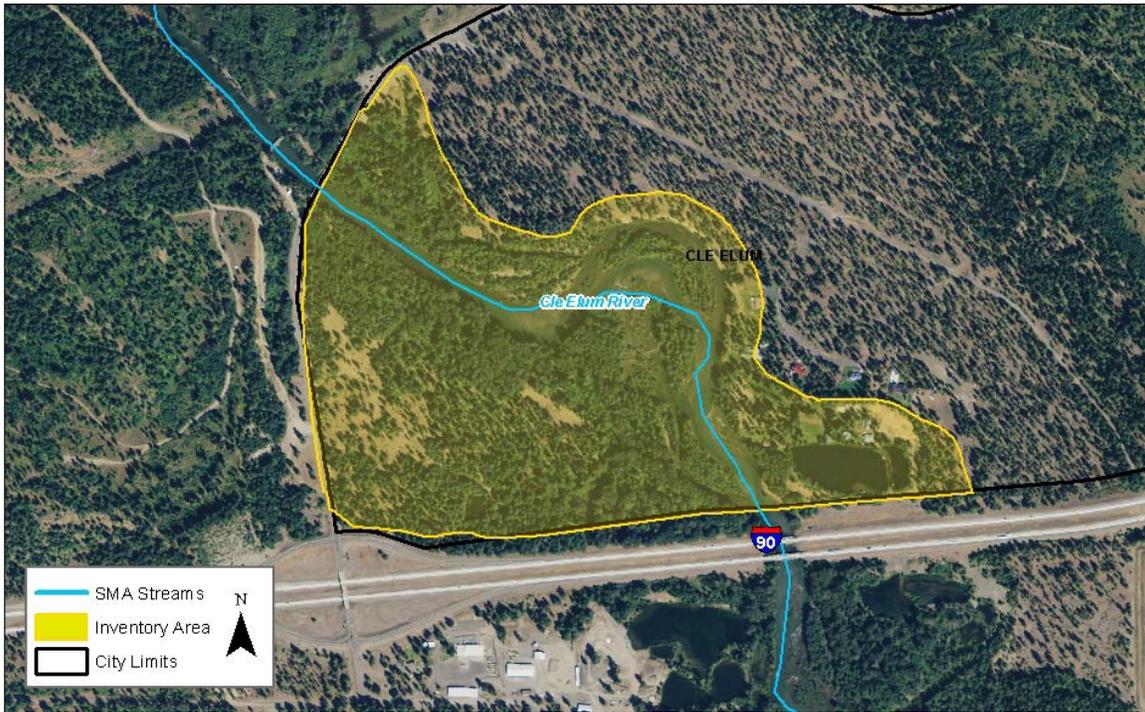
REACH INVENTORY AREA:

148.7 Acres

The majority of the reach (98%) is located within the FEMA 100-year floodplain. No landslide hazard areas are mapped within the reach. The entire reach has potential for channel migration.

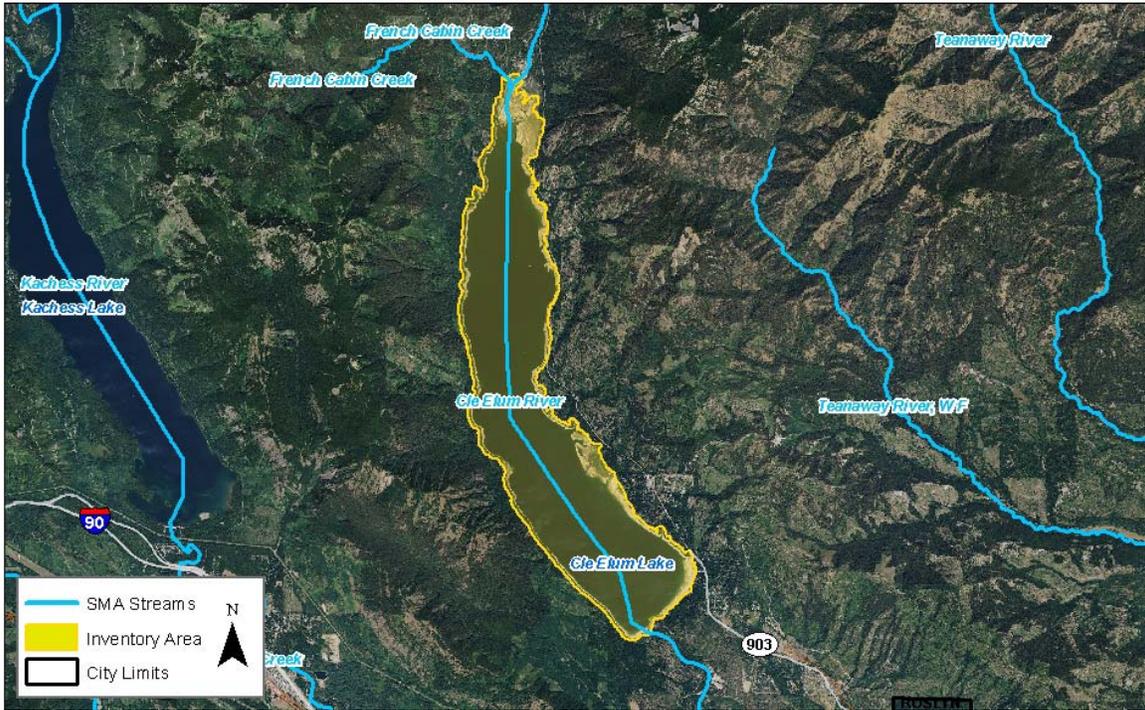
SHORELINE LENGTH:
43.9 Miles

WATERBODY AREA: 4,509.9 Acres
REACH INVENTORY AREA: 5,095.1 Acres

A significant portion of the reach (75%) is located within the FEMA 100-year floodplain. No landslide hazard areas are mapped within the reach.
