CHAPTER 3. UPPER COUNTY

This chapter describes the conditions within the shoreline inventory area of upper Kittitas County (including the City of Cle Elum and Town of South Cle Elum). The upper Kittitas County shorelines include the upper Yakima River and its tributaries from the Yakima River headwaters to the Taneum Creek confluence (Figure 3-1). The 35 streams and 29 lakes and ponds within the upper county are described in terms of their physical characteristics, ecological conditions, and human environment/land use characteristics. Readers are encouraged to review Chapter 2 and the maps in Appendix A for additional context on the information presented here.

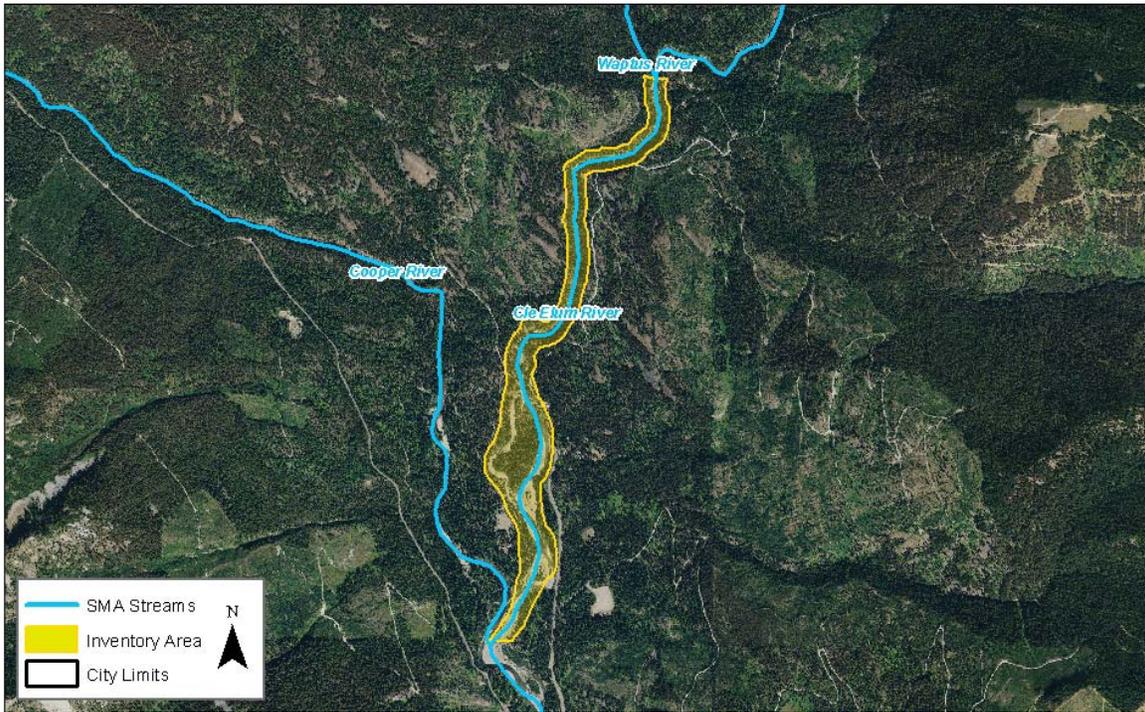
REACH INVENTORY AREA:

157.4 Acres

A little more than half (55%) of the reach is located within the FEMA 100-year floodplain and a limited amount of landslide hazard area (1%) is mapped at the upstream end of the reach. The downstream half of the reach has potential for channel migration.
