State of Washington
DEPARTMENT OF FISH AND WILDLIFE

RE: WDFW comments on PD-16-00001 and LP-17-00004 MDJ Rezone and Long Plat near Currier Creek

Subject: SEPA, Application for Long Plat – Reinstatement of the Currier Creek Estates project adjacent to Currier Creek, North of Highway 10 near Ellensburg, Sections 27 and 28, T18N, R18E

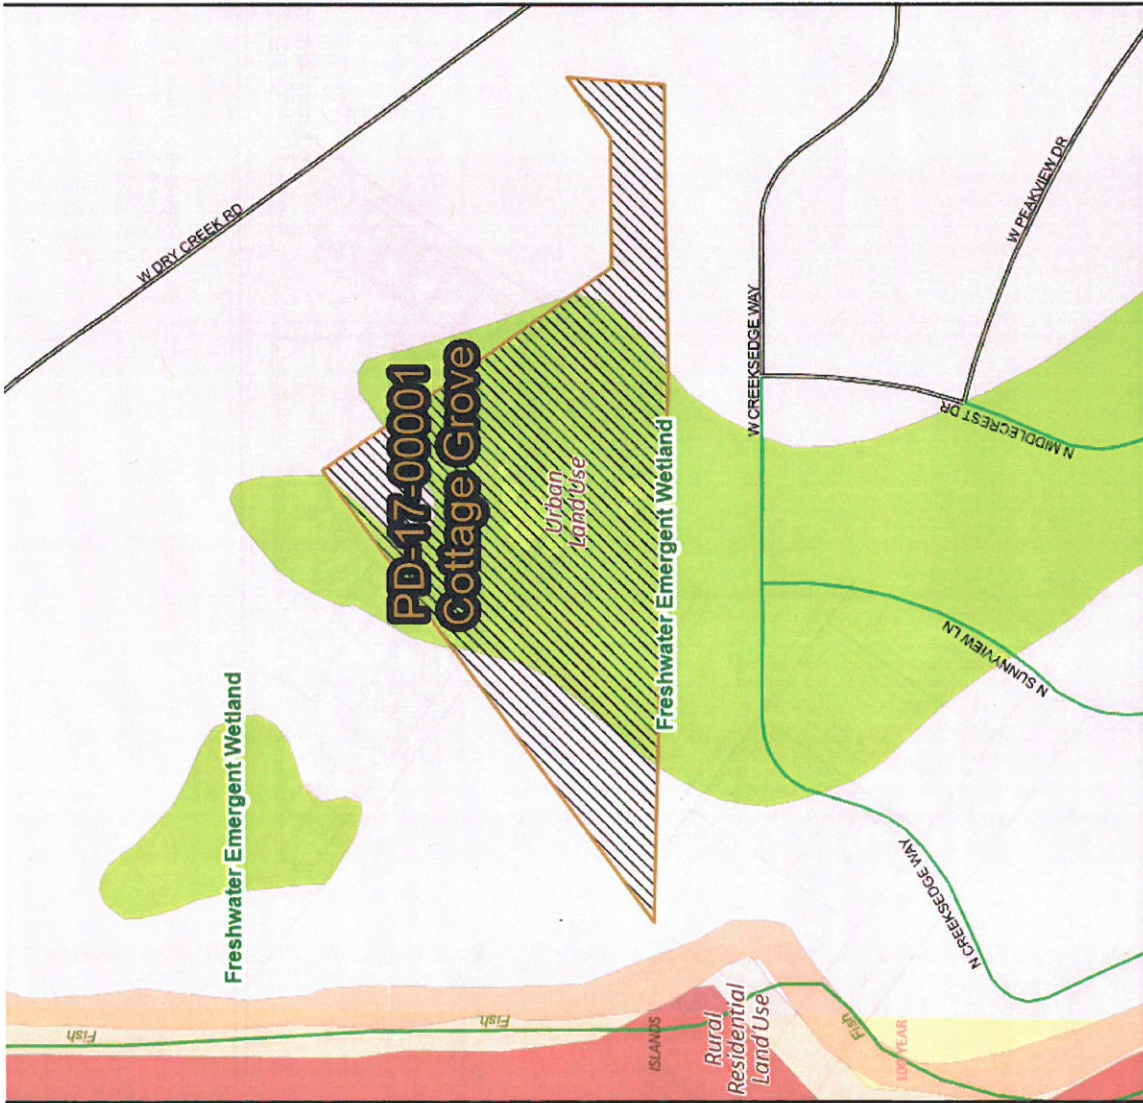
This image of the critical areas from the County's application materials shows a wetland covering nearly the entire parcel where development is proposed. The SEPA checklist references a wetland report completed in 2014, but it has not been made available for review or comment.

- Provide the wetland report referenced in the SEPA documents for public review and comment.
- Require a detailed study to determine whether or not the proposed development will increase flood risks to surrounding property owners and if the proposed new structures will be flooded. This study should also detail how flows (quantities and velocities) may be altered as they relate to Currier Creek and the fish and wildlife habitat associated with it.
- Require a detailed study to determine if there is a loss of floodplain conveyance and storage. Provide appropriate mitigation if warranted.
- If warranted based upon information from the studies mentioned above, reduce the lot density to allow for more floodplain storage. This may include enhancing wetland habitat within the proposed open space areas.

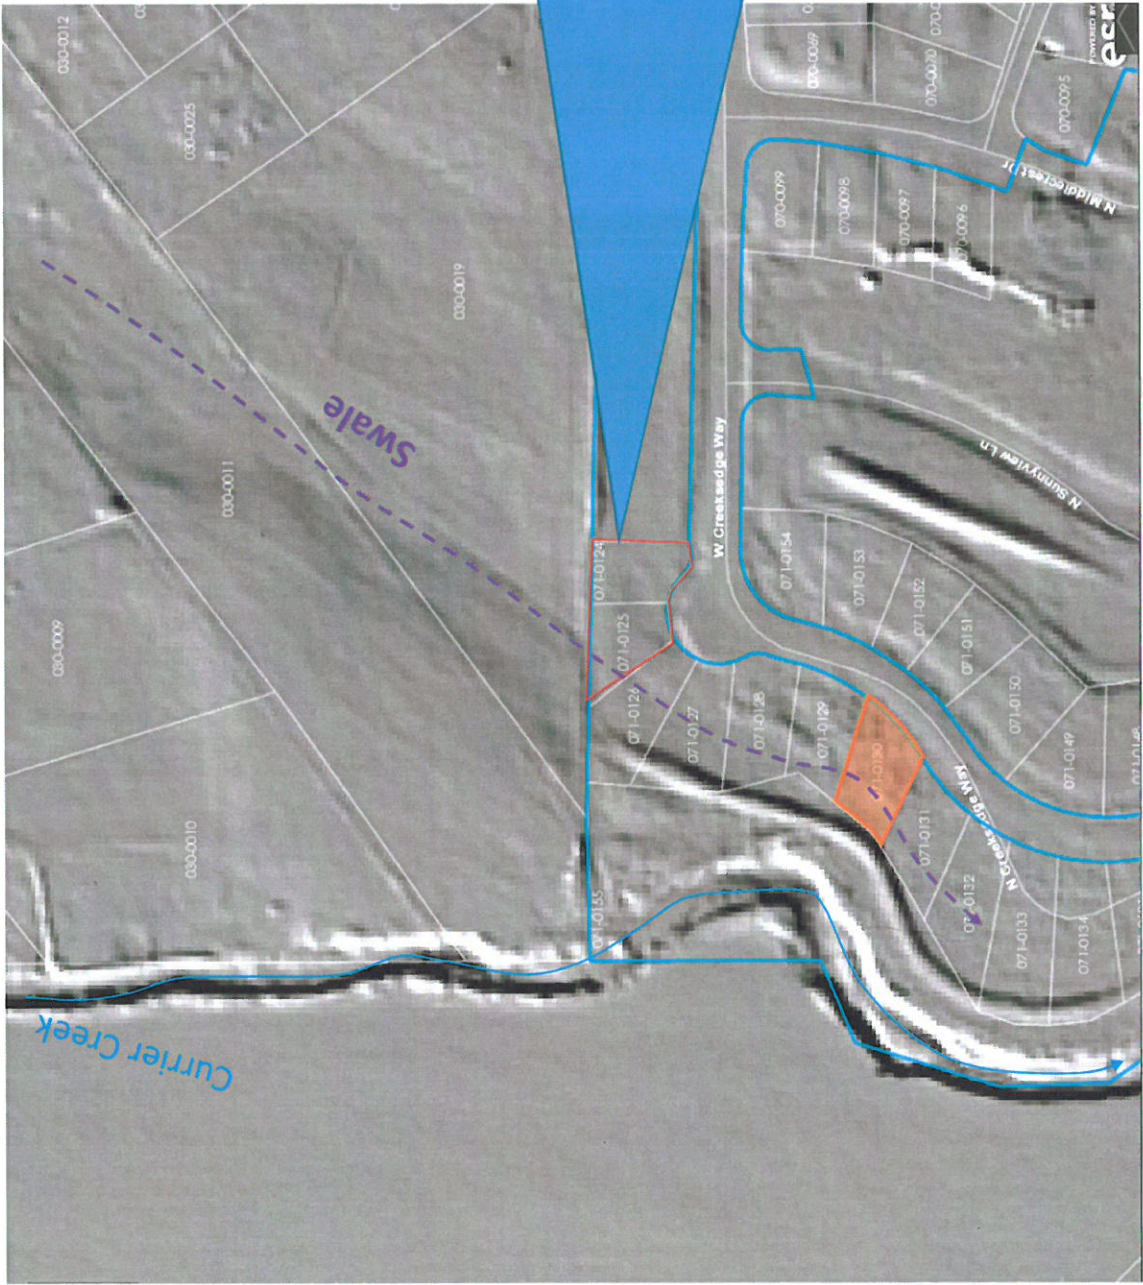
These 2 houses flooded while under construction in February 2016. Flood waters came from the swale on the property north of them (where the current development is proposed) and not overland flows from Currier Creek.

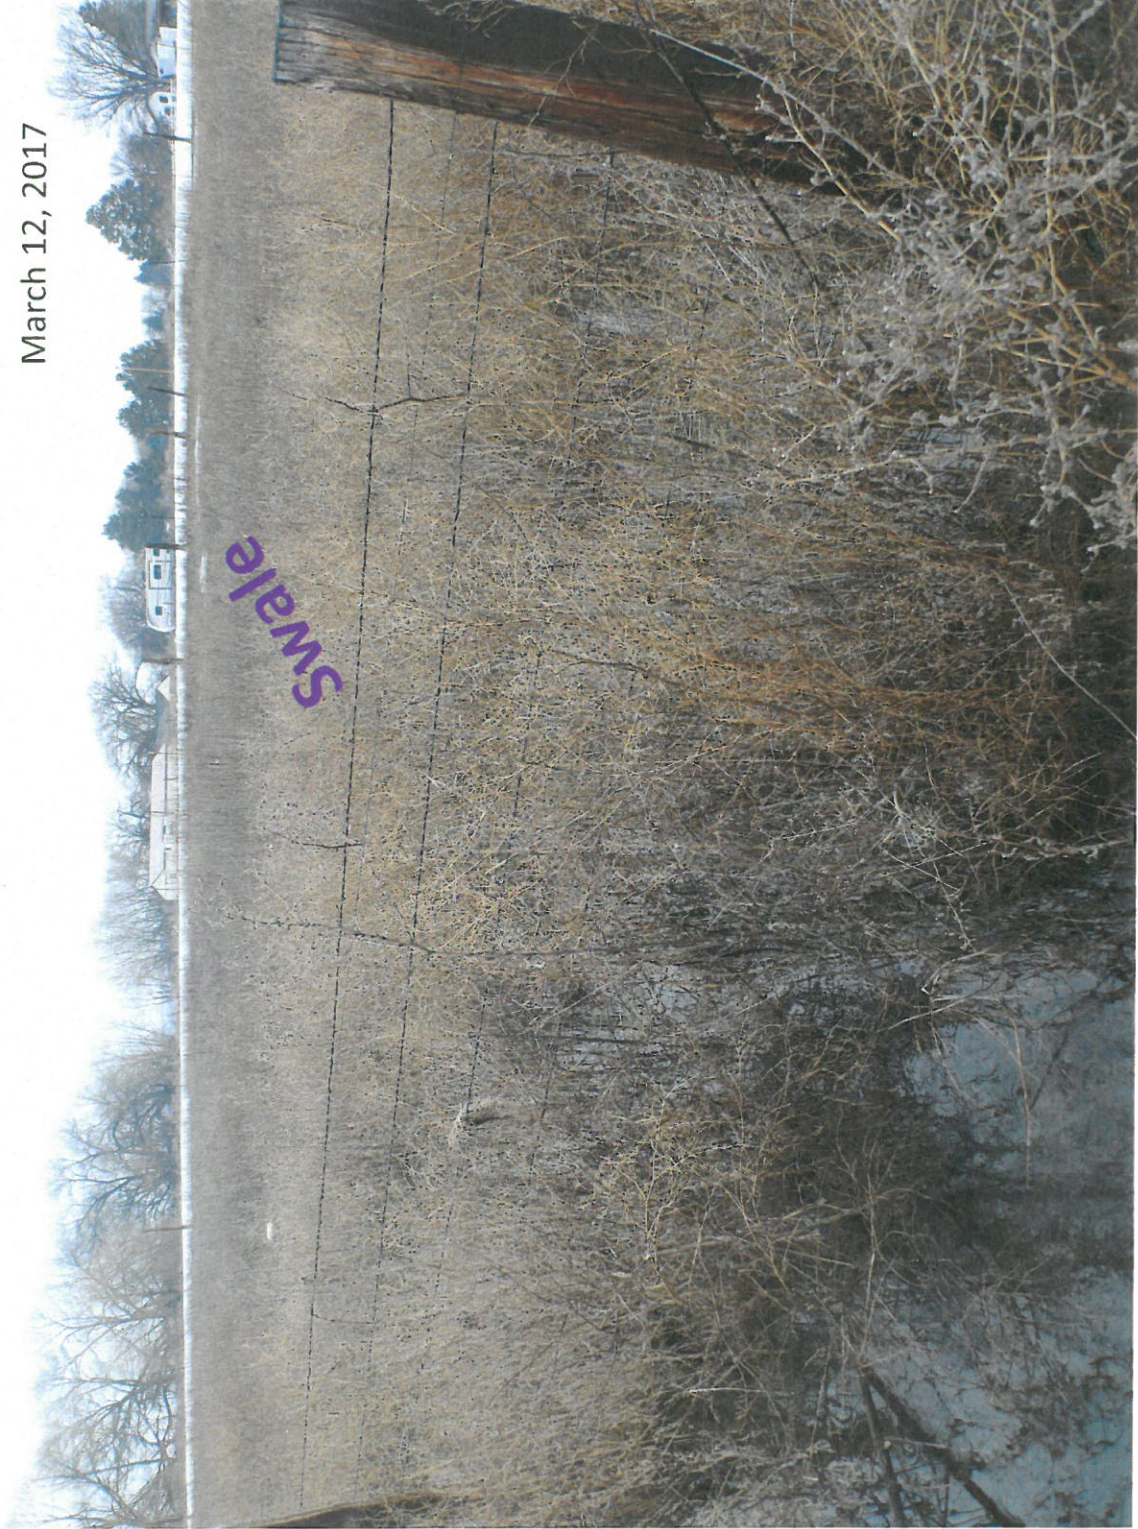
This photo was taken on March 12, 2017 from the northern most extent of 2115 Creeksedge Way in the Currier Creek Estates development. This photo is looking north onto the property currently proposed for development. The surface water is difficult to see through the vegetation, but the location of surface water can also be determined by looking at snow on the surrounding properties that do not have surface water present. Currier Creek is in the background of this photo (where the tall trees are).

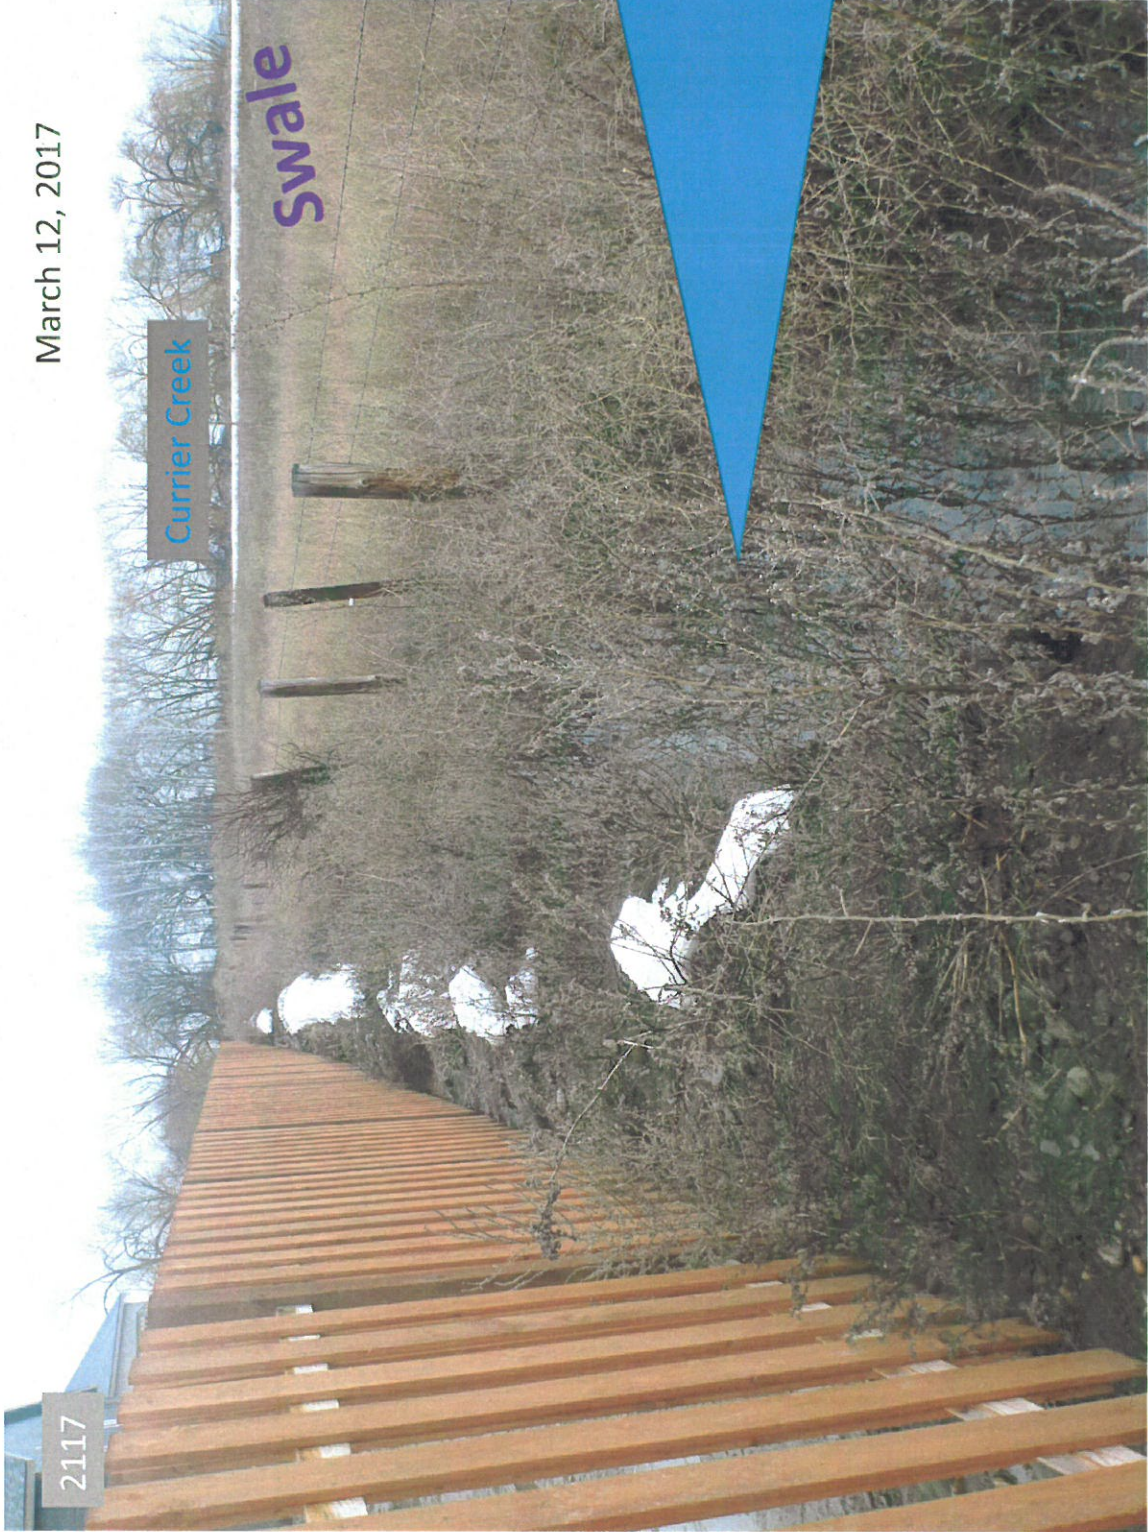
Trench behind homes on Creeksedge Way (2115 & 2117) runs perpendicular to Currier Creek and the swale through the proposed MDJ development. Presumably this trench was constructed to capture surface waters from the swale and reroute to Currier Creek, but there is too much water for the trench to convey.

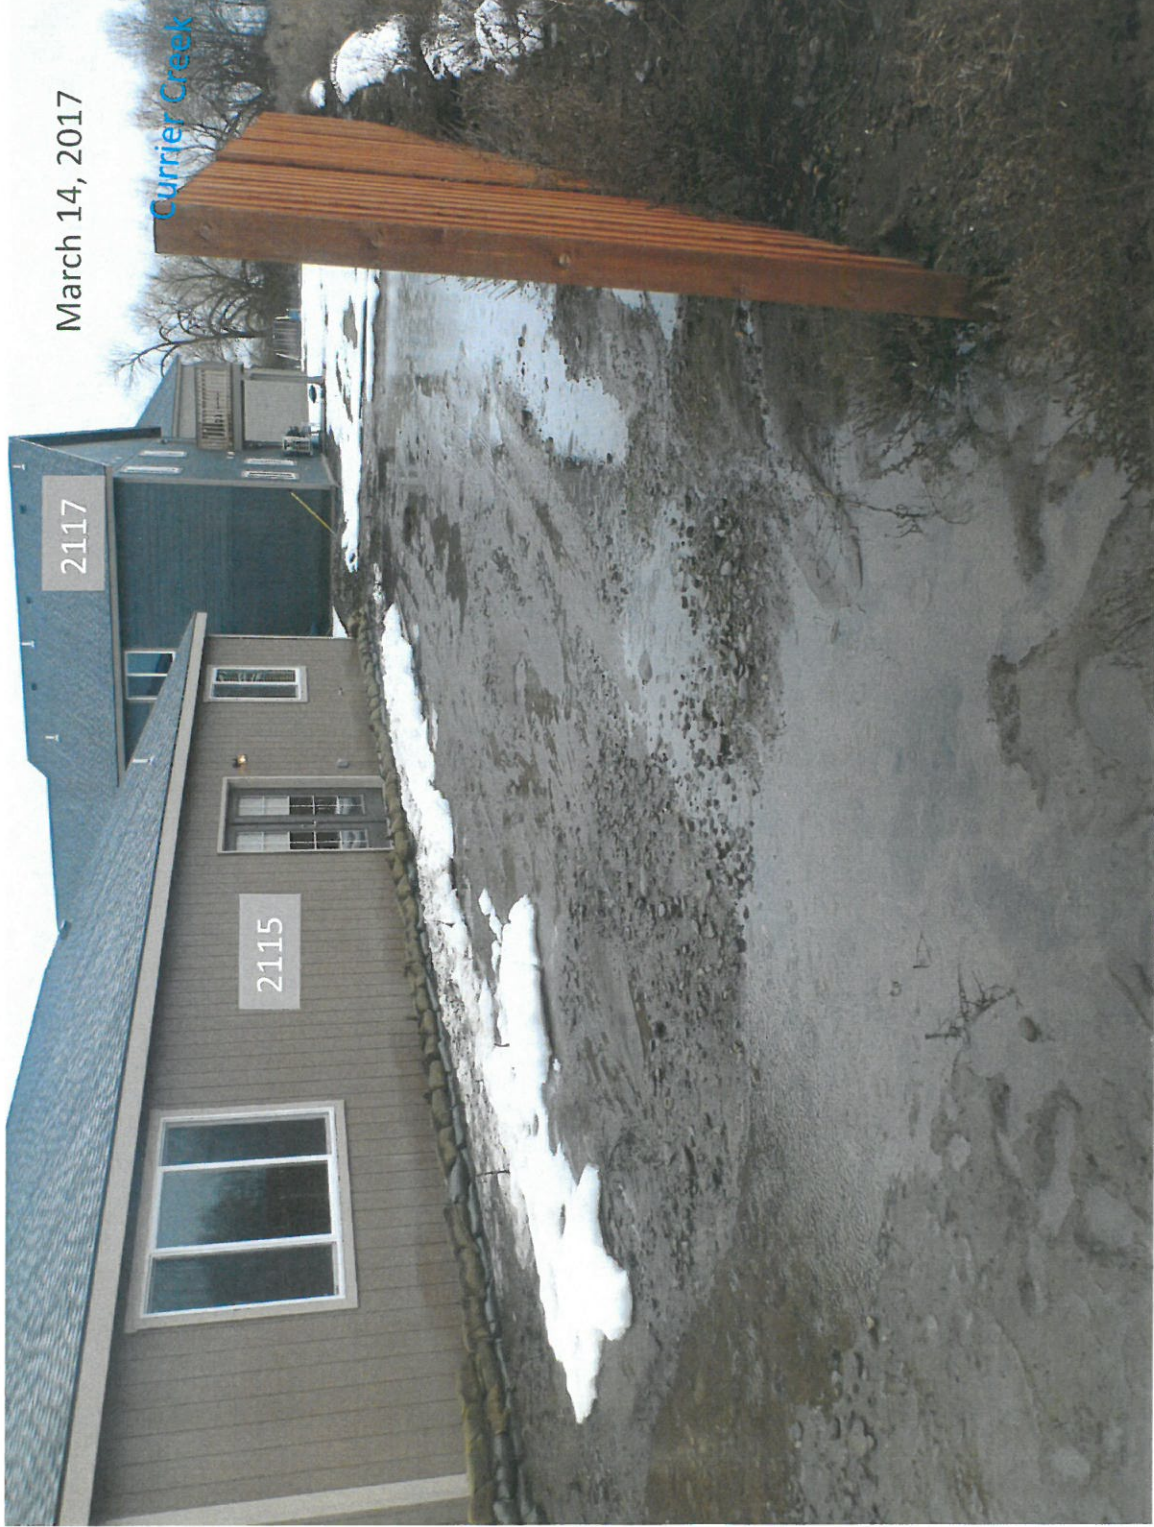
Properties on Creeksedge Way (2115 and 2117) that experienced flooding from the swale in March 2017. The trench north of their properties was at full capacity and overflowing into their property.

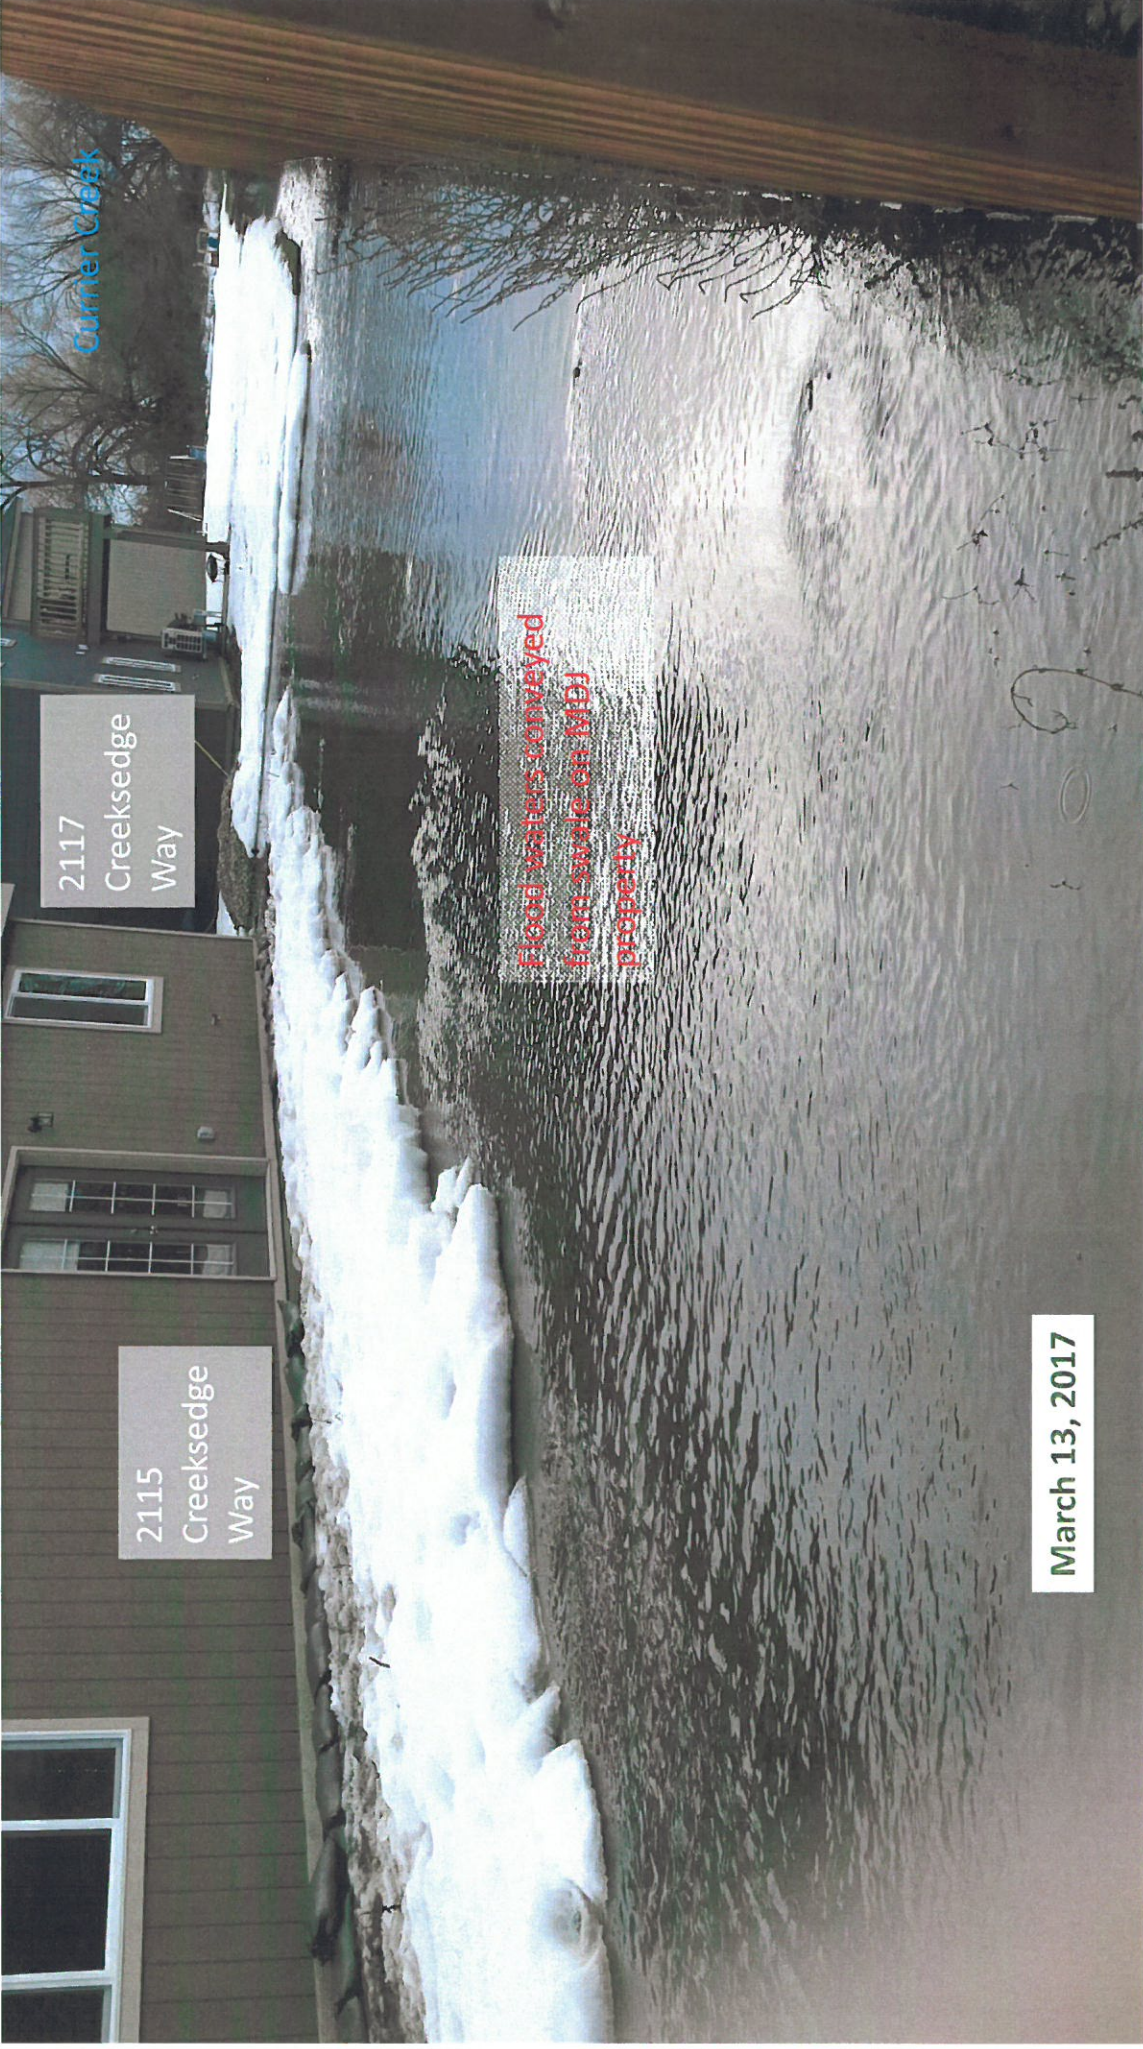
Flood waters conveyed
from main on MCH
property

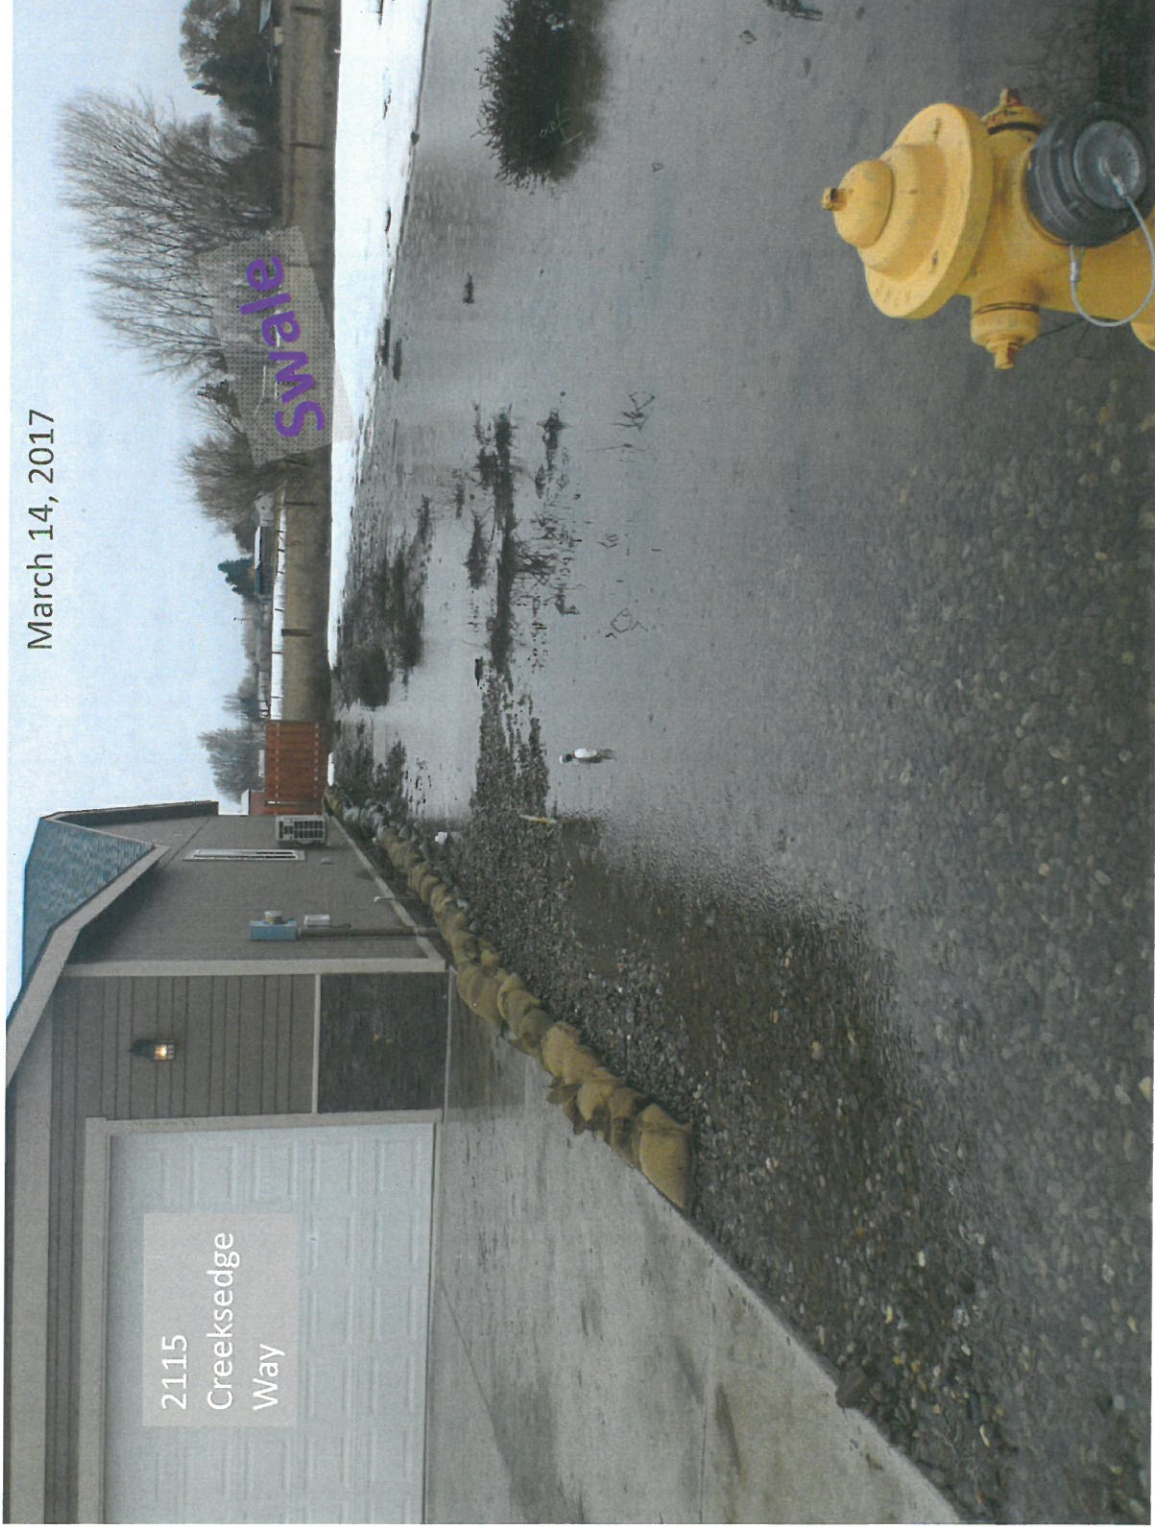
Properties on Creeksedge Way (2115 and 2117) that experienced flooding from the swale in March 2017. The trench north of their properties was at full capacity and overflowing into their property toward Creeksedge Way in the Currier Creek Estates development.

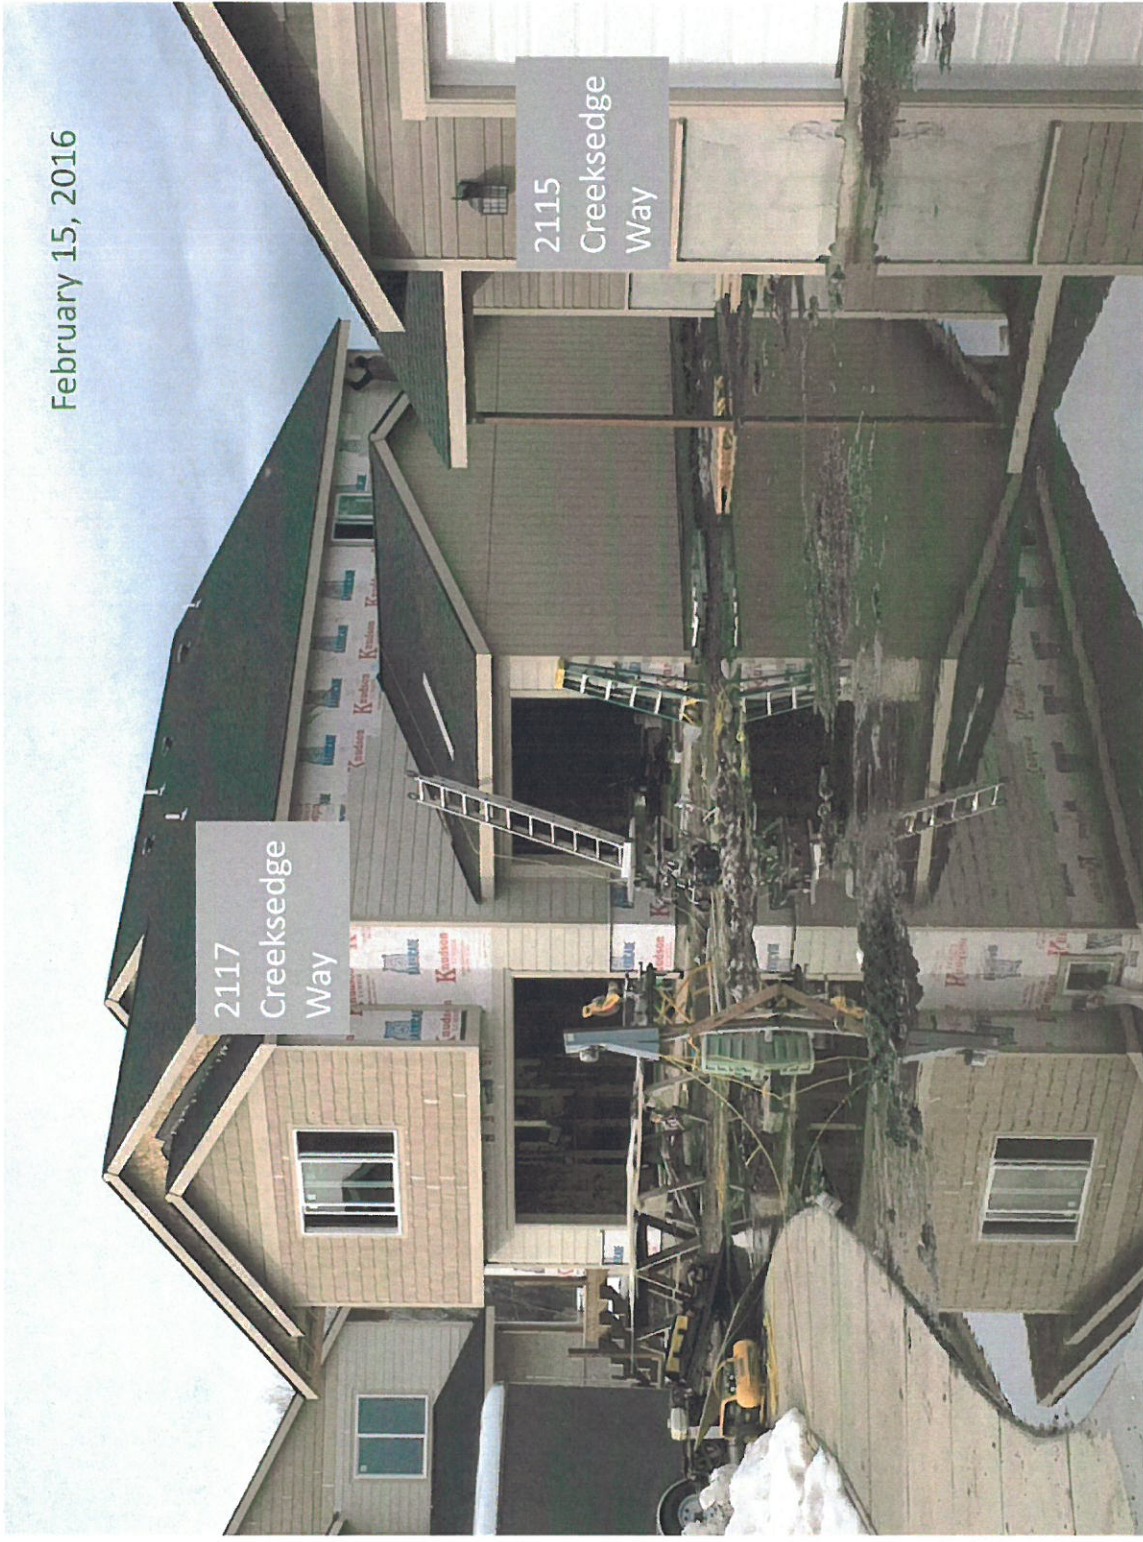
Properties on Creeksedge Way (2115 and 2117) also experienced flooding from the swale in February 2016 while they were still under construction. This flood water was not the result of Carrier Creek overtopping its banks.

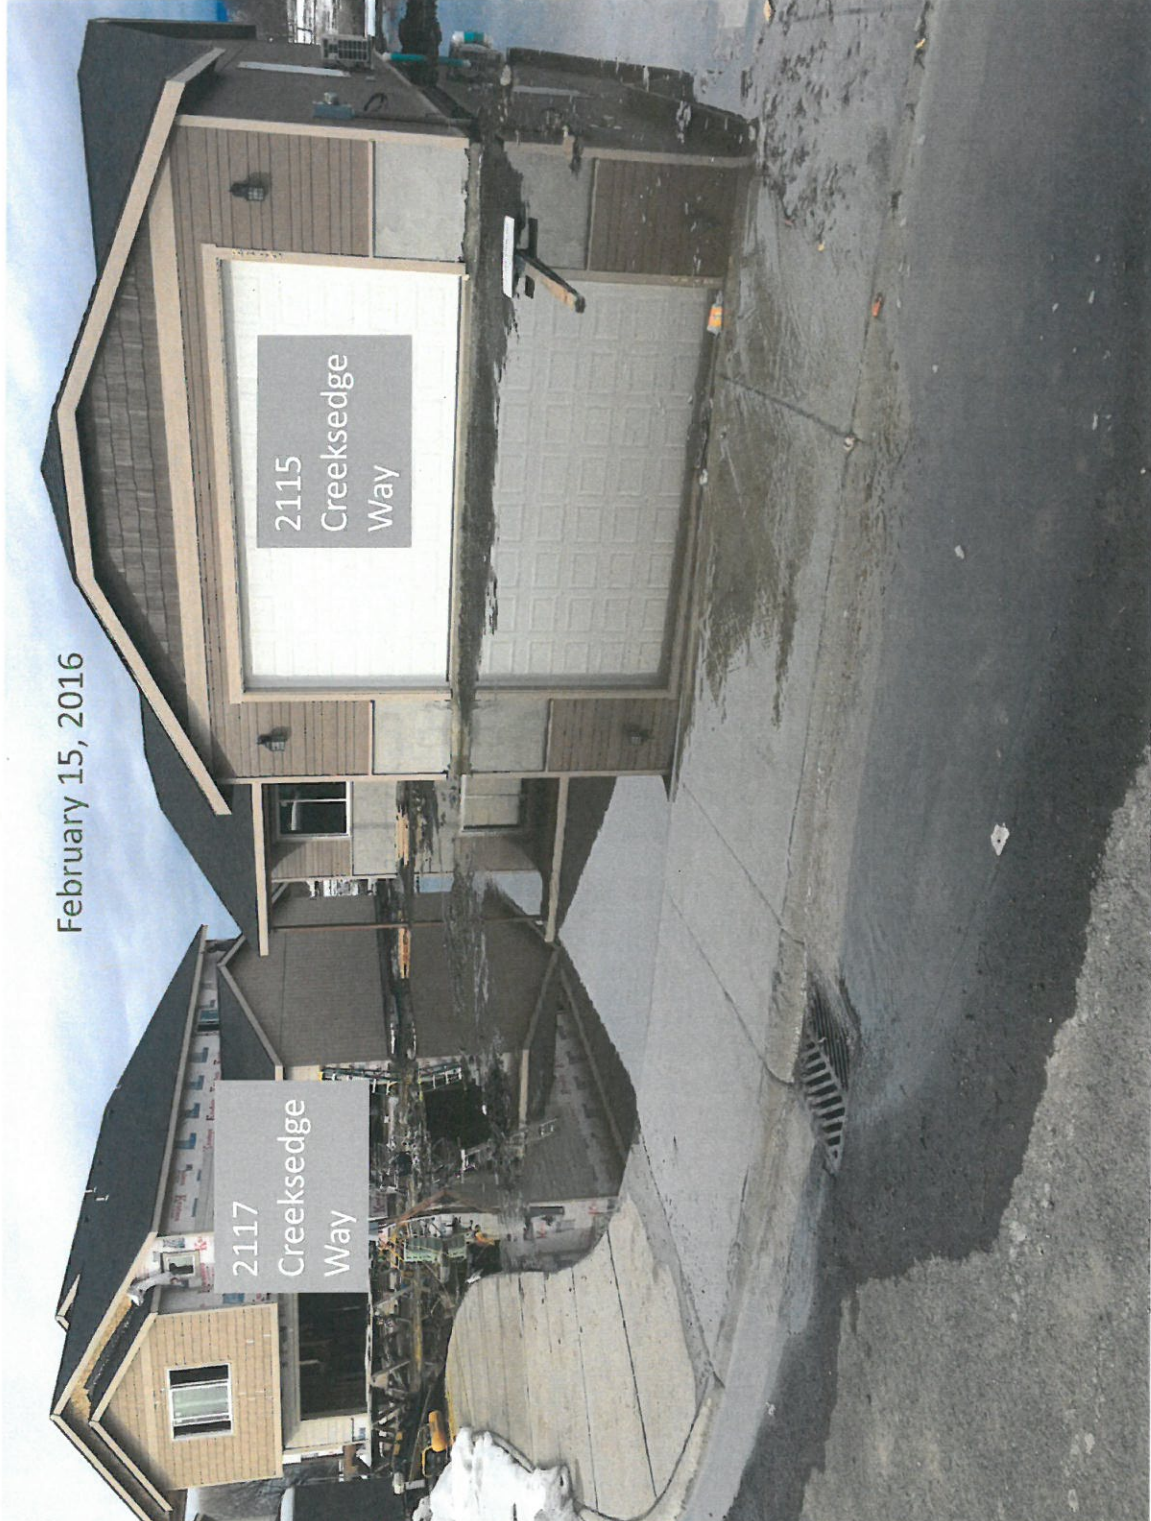
Properties on Creeksedge Way (2115 and 2117) also experienced flooding from the swale in February 2016 while they were still under construction. This flood water was not the result of Carrier Creek overtopping its banks.

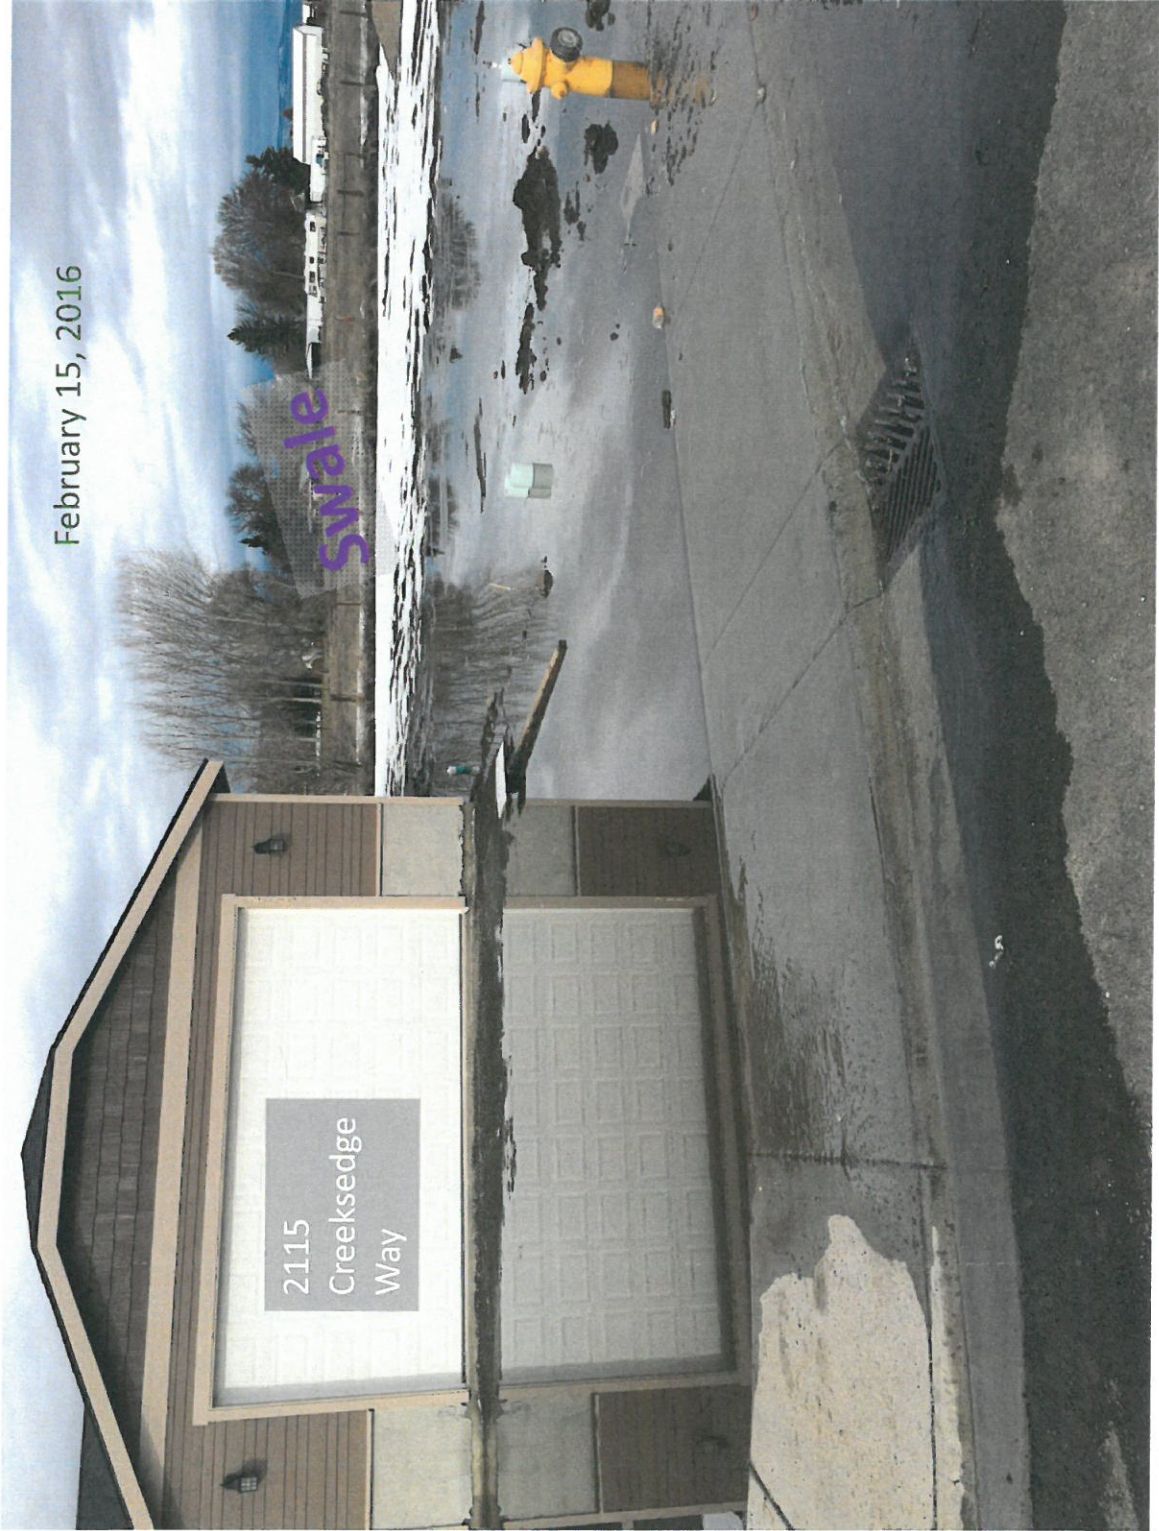
Properties on Creeksedge Way (2115 and 2117) also experienced flooding from the swale in February 2016 while they were still under construction. This flood water was not the result of Carrier Creek overtopping its banks.

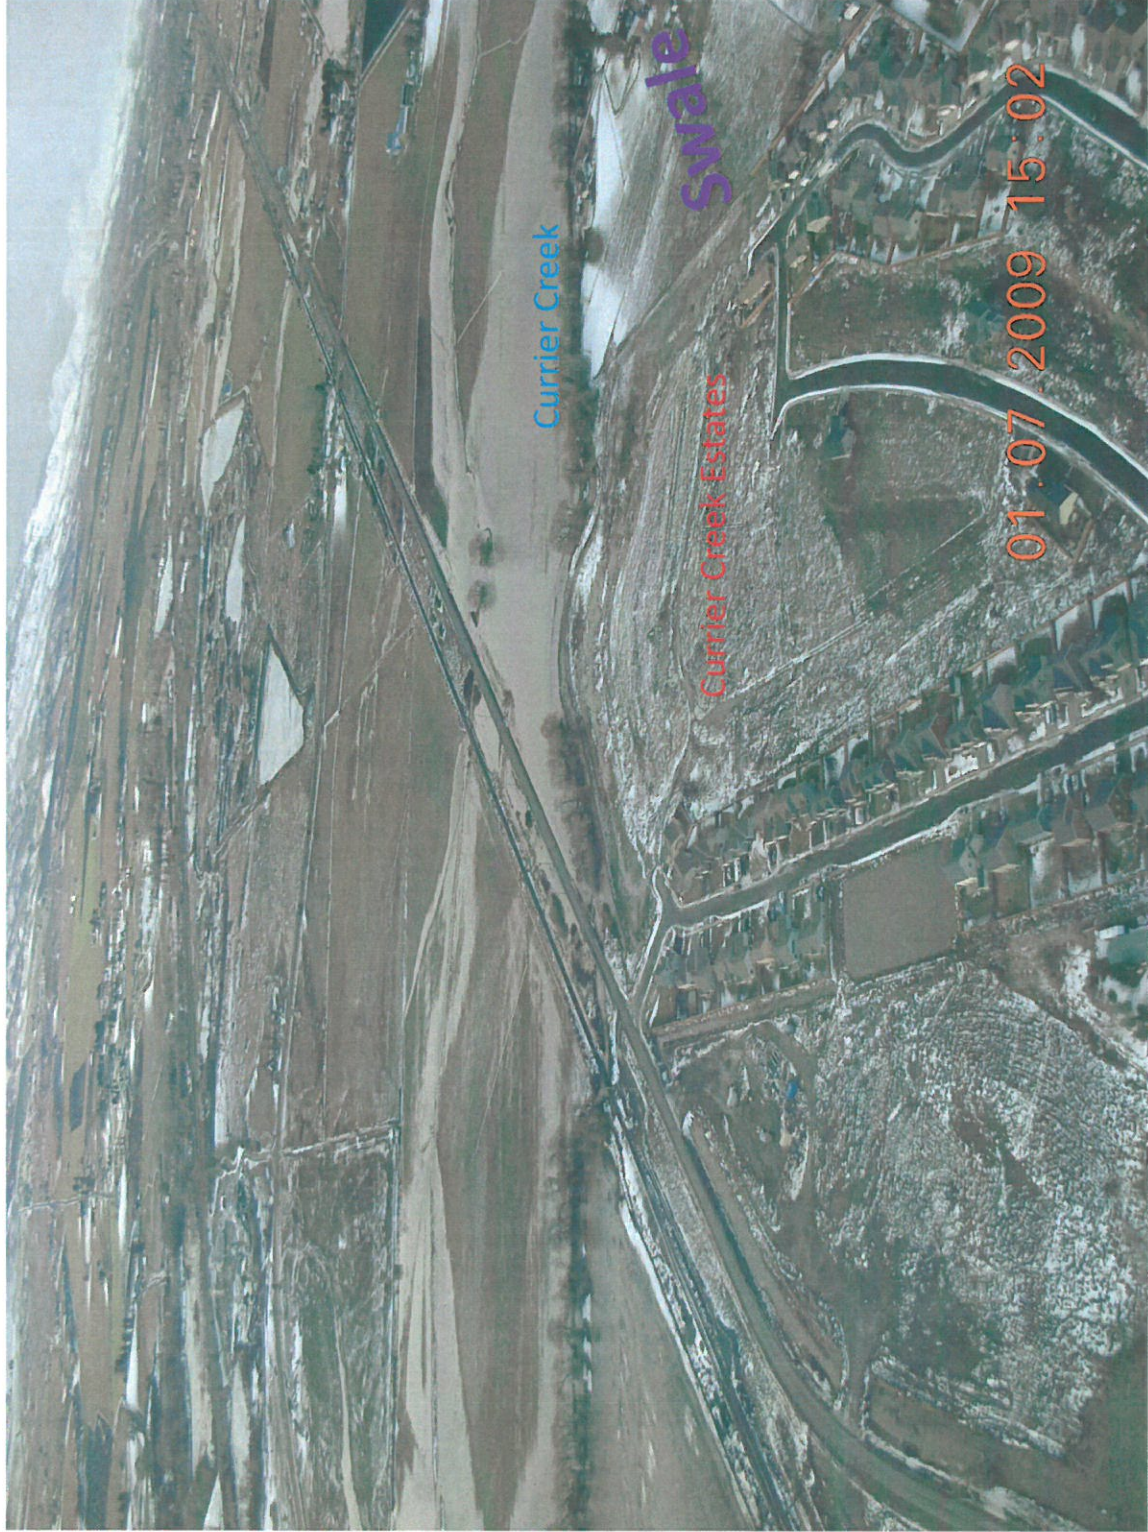
This is an aerial photo of the Currier Creek Estates development and the MDJ proposed development shortly after the peak of the January 2009 flood event. Areas that do not have snow, were inundated with surface water during the peak. You can see that the swale on the MDJ property flows southwest toward Currier Creek prior to construction of the unauthorized berm and Phases 3 & 4 of Currier Creek Estates.

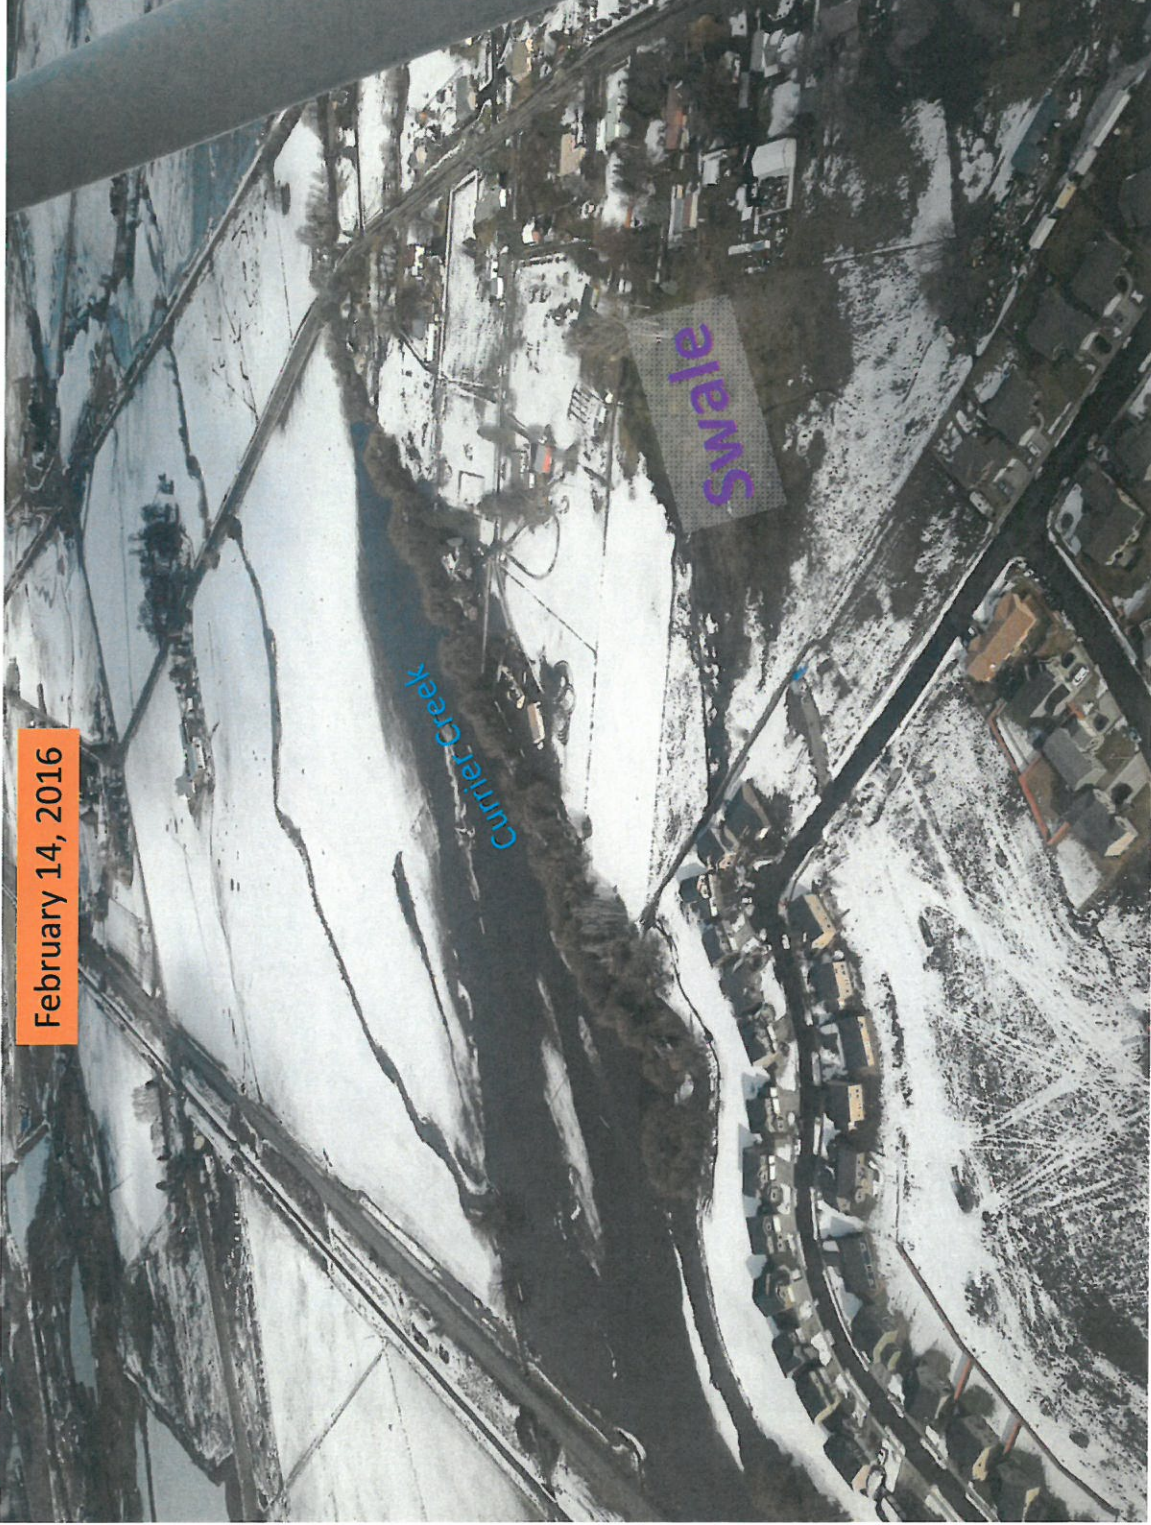
This aerial photo from February 2016 clearly shows the flooding that occurred at 2115 and 2117 Creeksedge Way in the Currier Creek Estates Development came from the swale on the MDJ property and not overland flow from Currier Creek. The snow covered ground clearly shows where surface water was not present during this event and much of the MDJ parcel proposed for development is snow free—indicating it was inundated to some extent with surface water, similar to the 2009 event.
