State of Washington
DEPARTMENT OF FISH AND WILDLIFE

RE: WDFW comments on PD-16-00001 and LP-17-00004 MDJ Rezone and Long Plat near Currier Creek

Subject: SEPA, Application for Long Plat – Reinstatement of the Currier Creek Estates project adjacent to Currier Creek, North of Highway 10 near Ellensburg, Sections 27 and 28, T18N, R18E

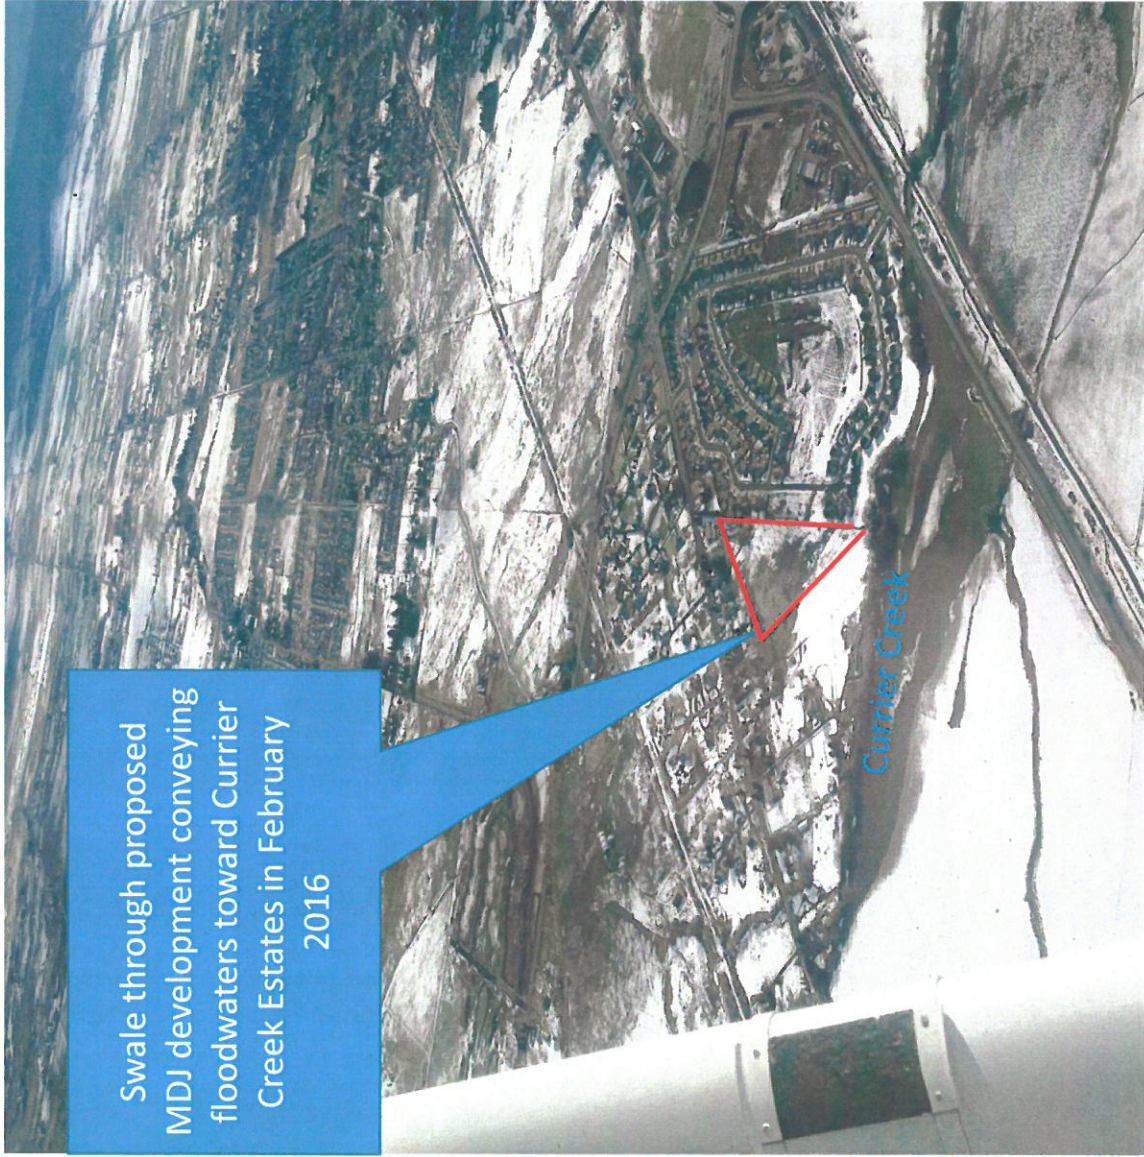
Swale through proposed
MDJ developments conveying
floodwaters toward Currier
Creek Estates in February
2016

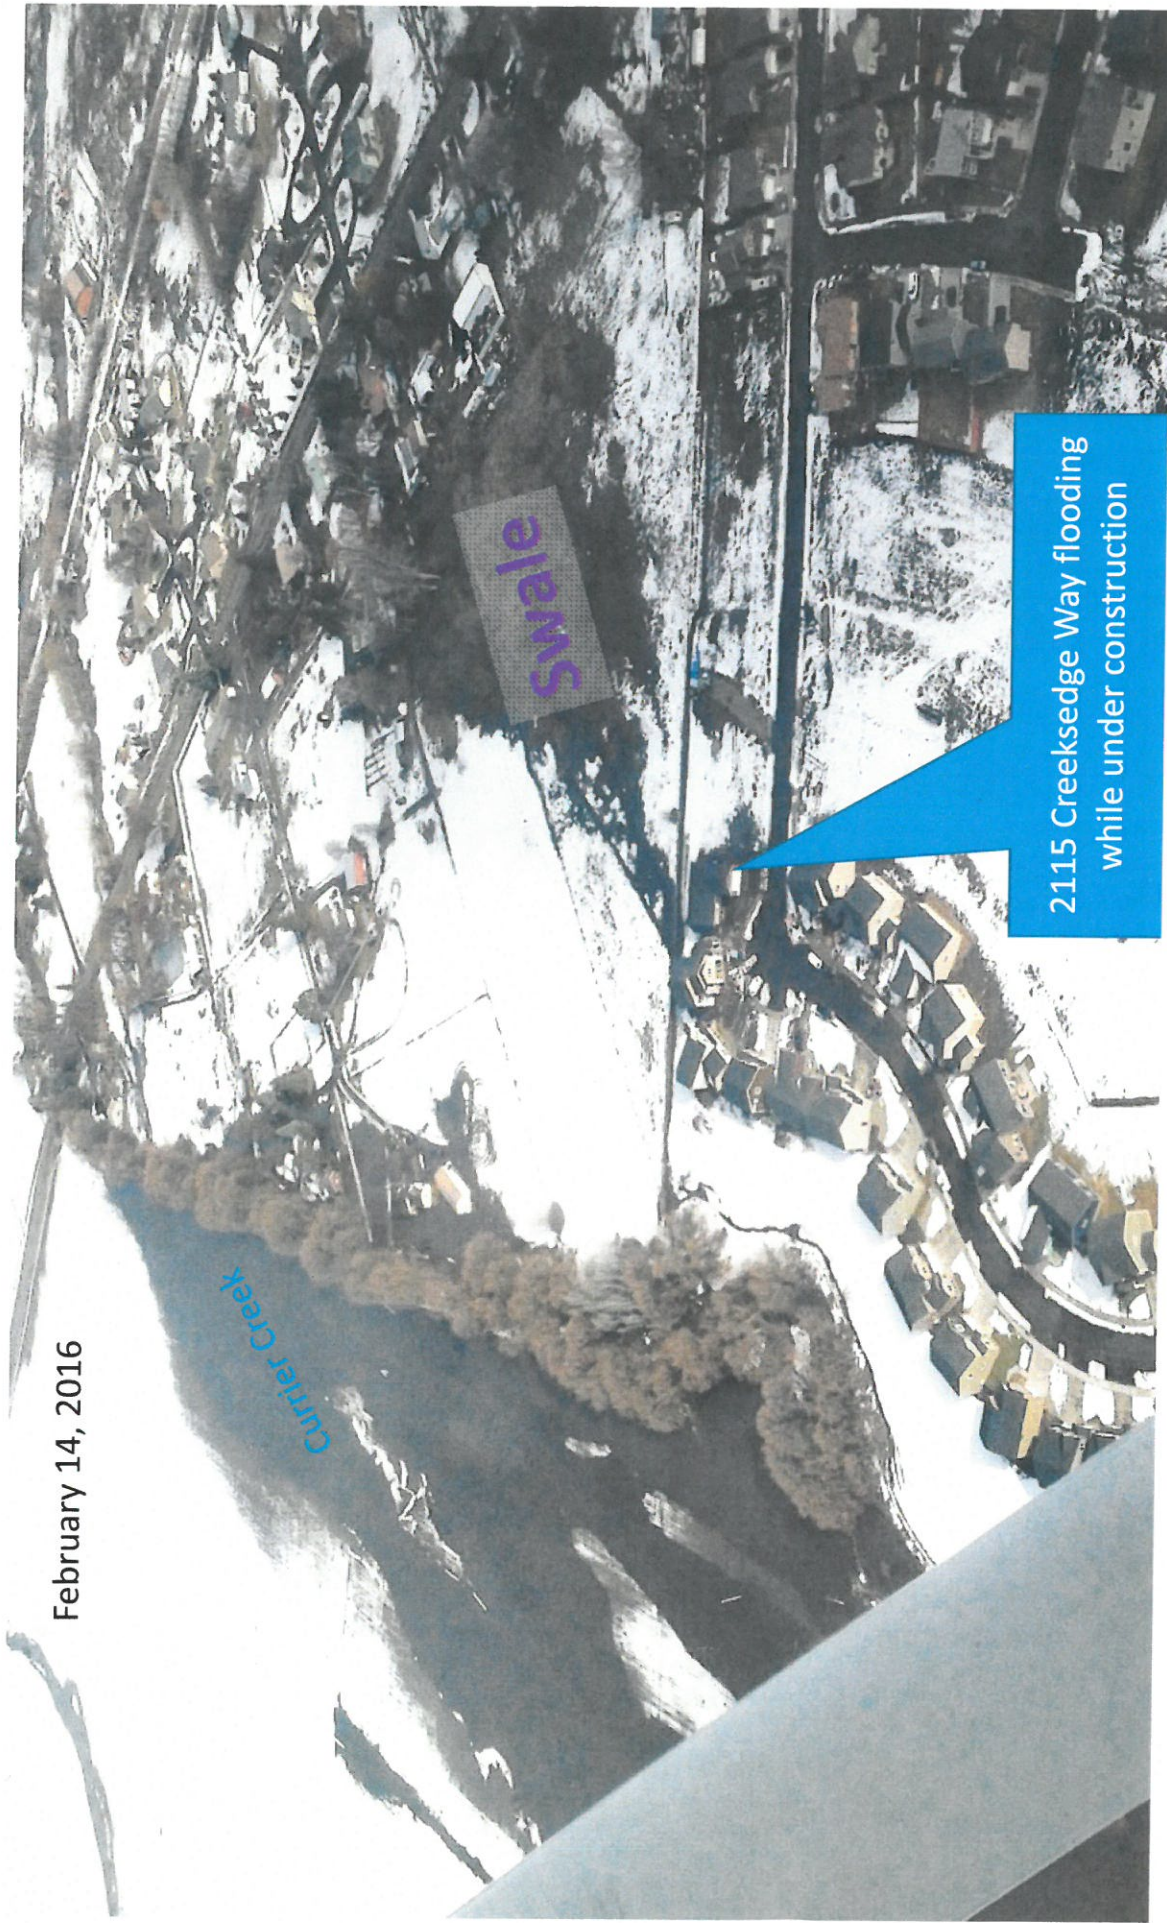
2115 Creeksedge Way flooding while under construction

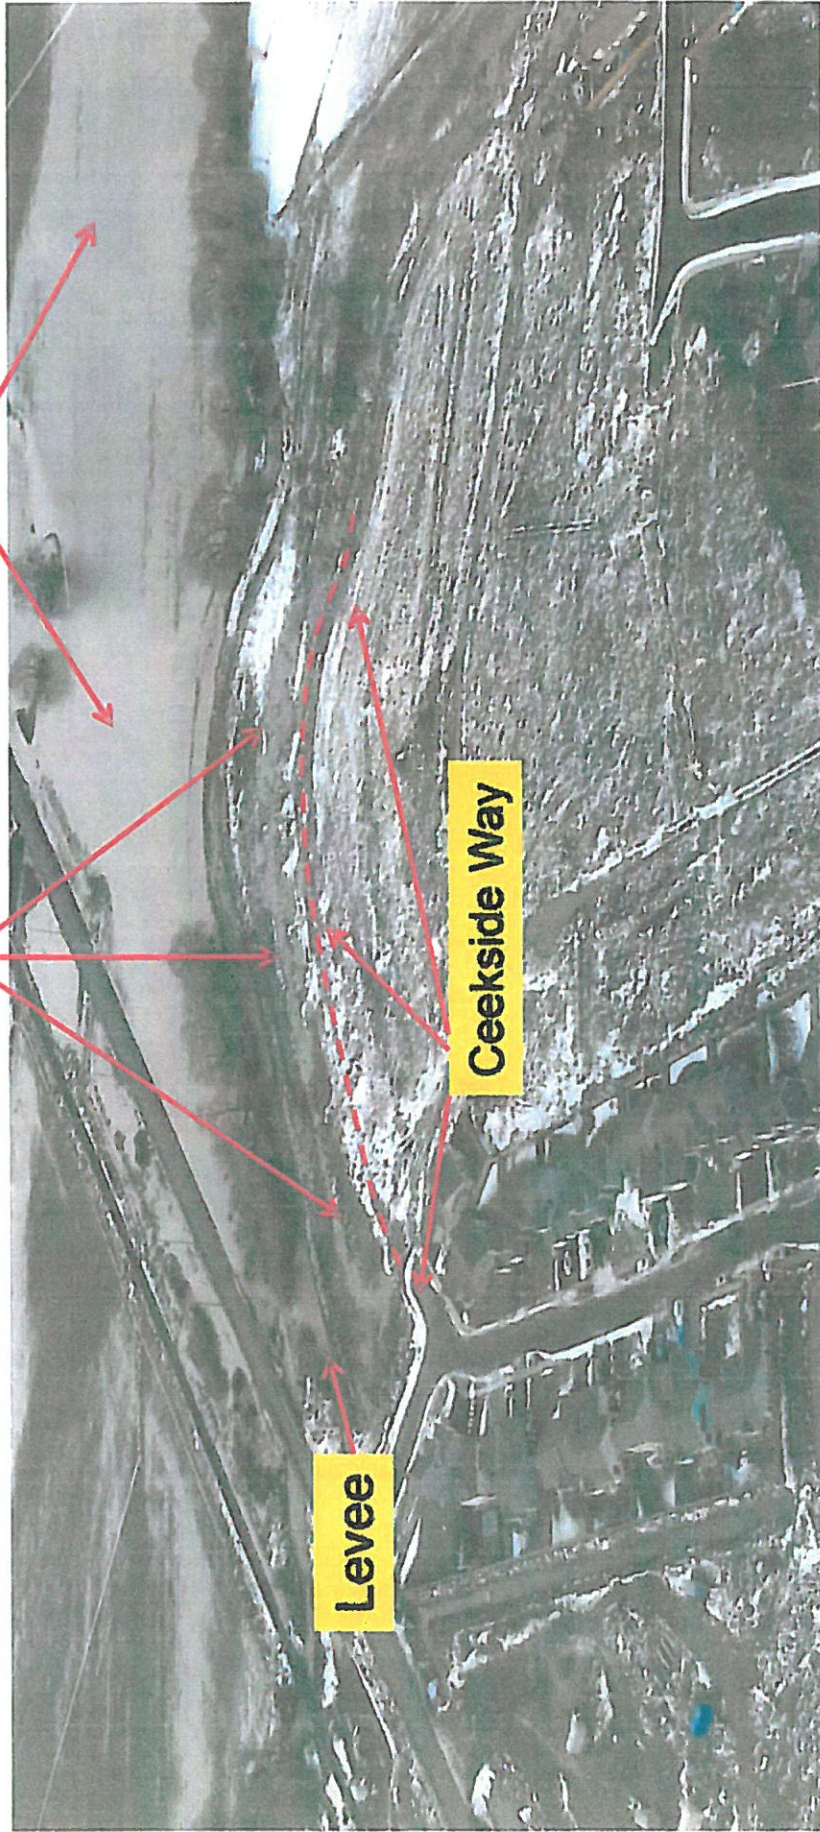
FEMA Floodplain at Currier Creek Estates

I have attached a picture of the FEMA floodplain map of the site and some annotated photographs taken during the January 2009 flood as flood waters were receding. Note that the unauthorized Currier Creek Estates levee is visible in the photograph. Note also that the floodplain map does not correctly show the area inundated by floods and that portions of most of the Currier Creek Estates lots west of Creekside Way were inundated with water.

Additional Area Flooded in 2009

Inundated Areas not on flood map

floodplain mapping, Kittitas County and the developer reconsider the lot density west of Creekside Way and the suitability of the lots.

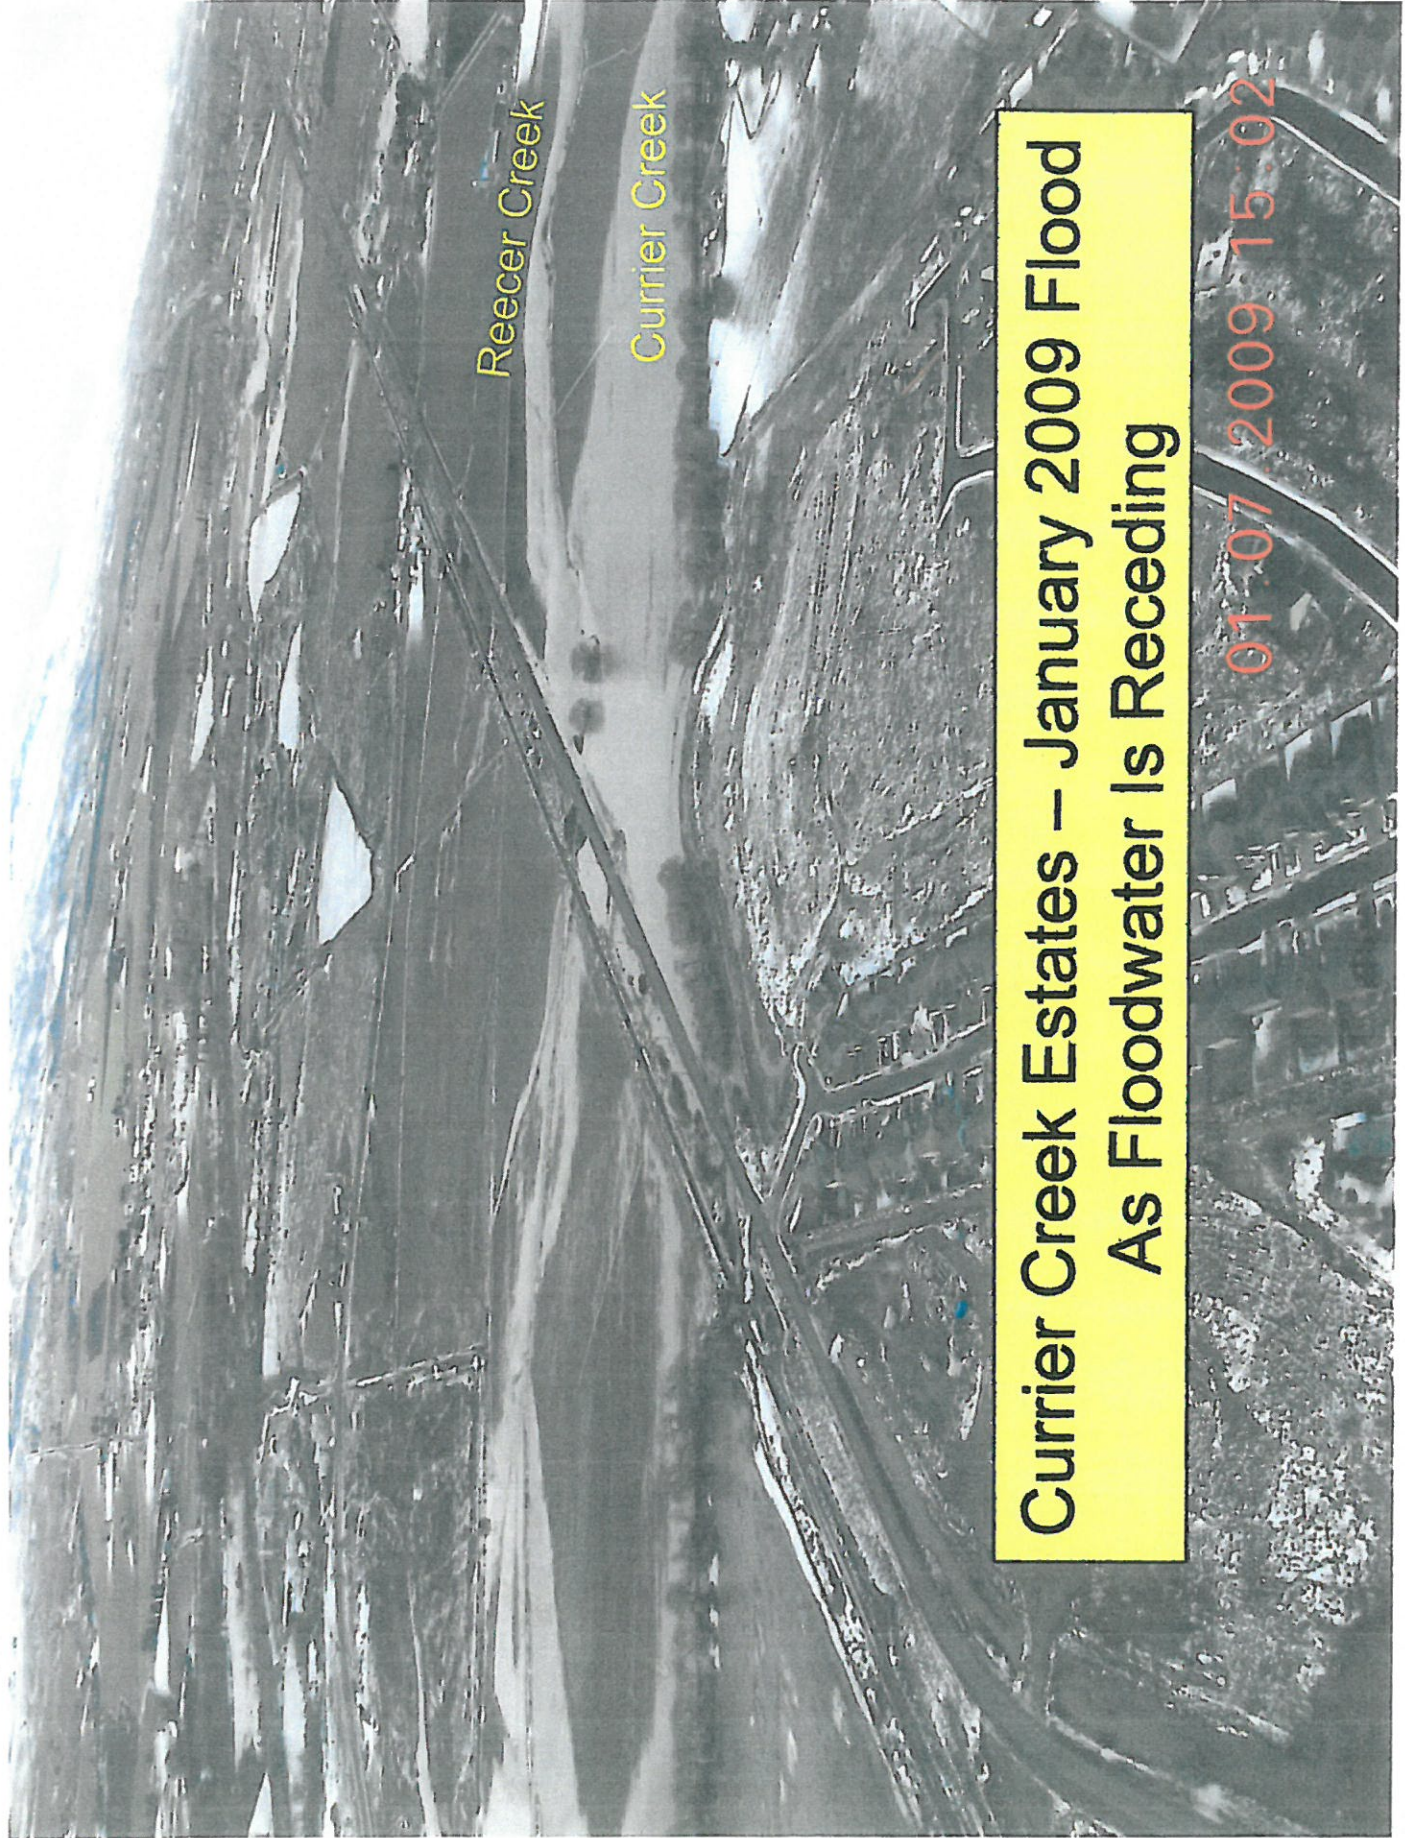
**Currier Creek Estates Looking west
January 2009 Flood**

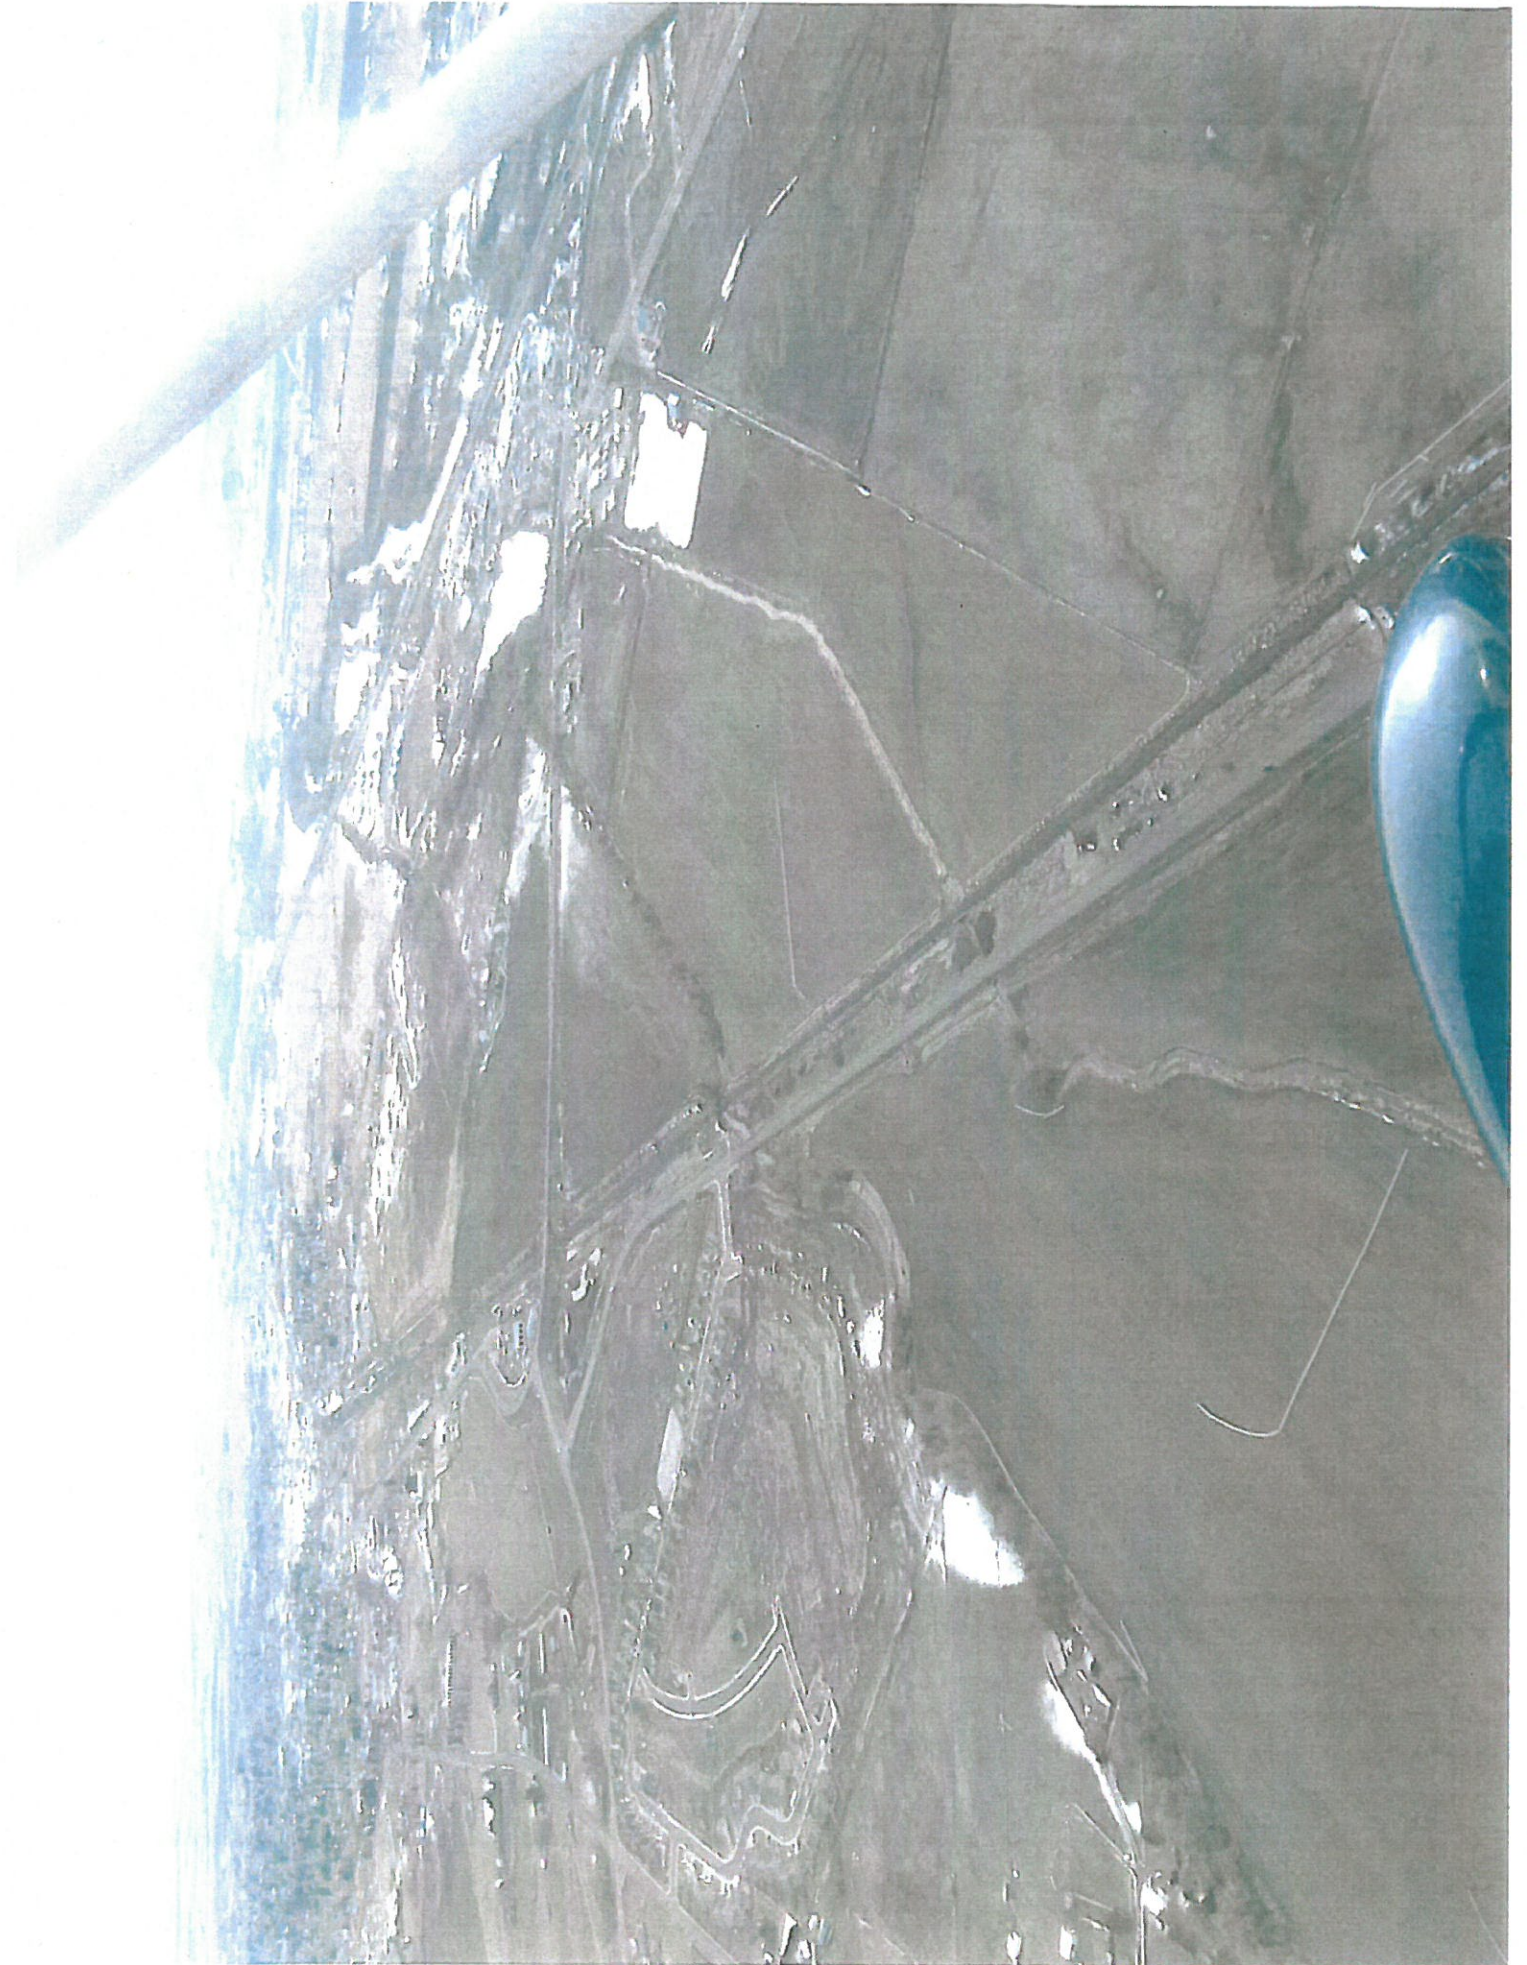
**Currier Creek Estates – January 2009 Flood
As Floodwater Is Receding**
