Draft Technical Memorandum:

Habitat Assessment - Yakima River Hansen Pits to Yakima Canyon

Kittitas County, Washington

Prepared by
Herrera Environmental Consultants

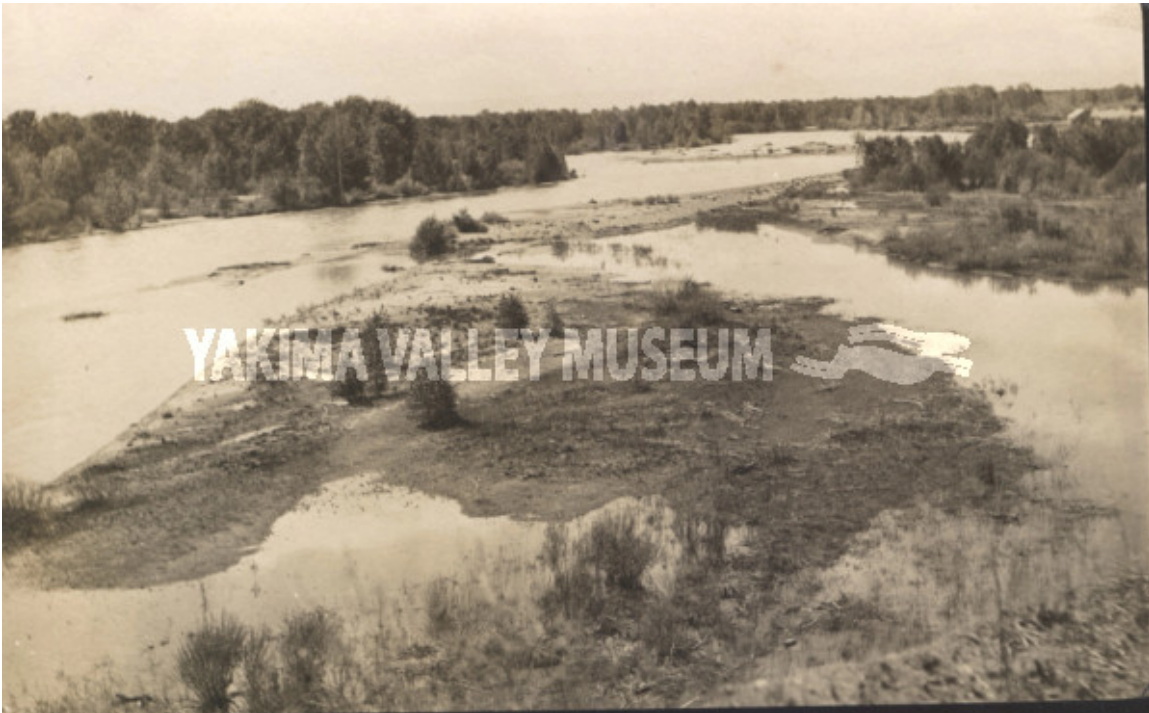
Source: Yakima Memory (2014)

Figure 2. Historical Photo Showing Riparian Vegetation Conditions Near Ellensburg, Washington. Date unknown.

While historical vegetation conditions in the project reach are not well documented in existing literature, a basic description can be developed based on observation of existing conditions, evidence or lack thereof of floodplain logging of ponderosa pine, and a limited number of historical photos (Figures 2 and 3). A review of the earliest available aerial photographic record shows that riparian canopy density and extent was significantly less in 1954 than it is at present. This suggests that there was at least some level of logging or other

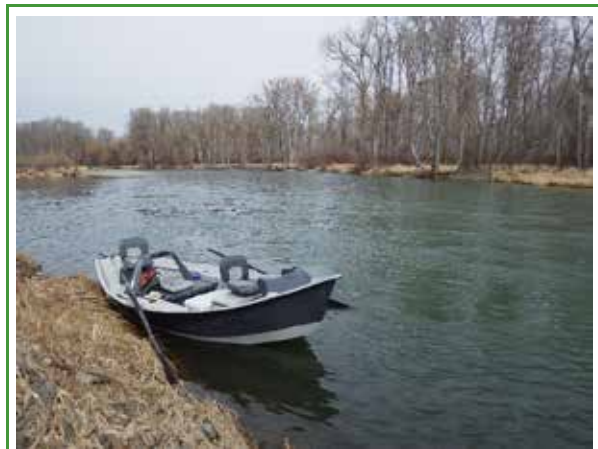
Photo 1. Typical main stem channel and riparian condition.

Photos 1 and 2 show typical habitat conditions in the main stem within the project reach.

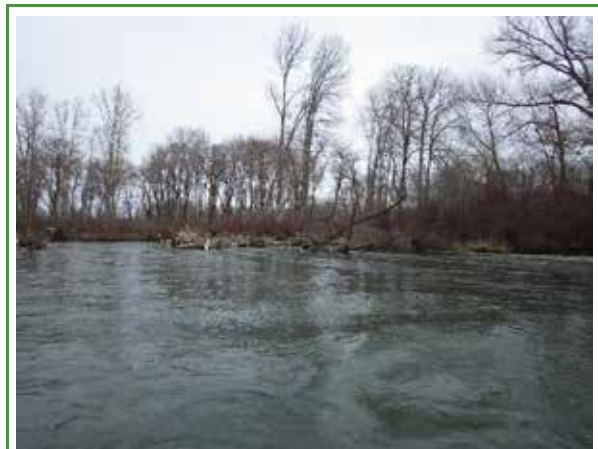
Photo 2. Typical main stem channel condition including LWD accumulations.

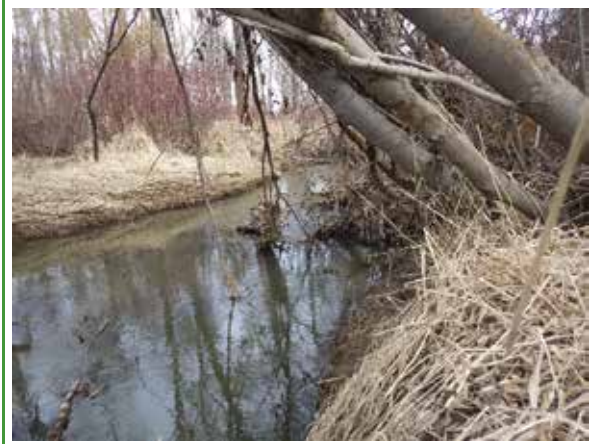
Photo 3. Low gradient and low velocity side channel habitat with bank vegetation dominated by invasive reed canarygrass.

Photos 3 through 7 show typical side channel habitat conditions within the project reach.

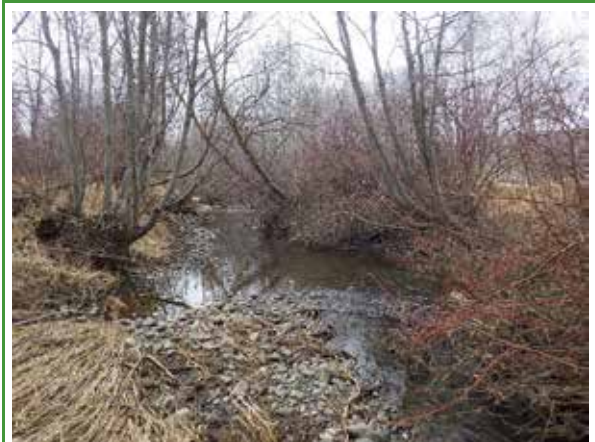
Photo 4. Side channel with typical gravel and cobble bed conditions and relatively dense woody vegetation on banks. Multi stemmed tree physiology is common when plants are subjected to heavy deer, elk, and beaver browse.

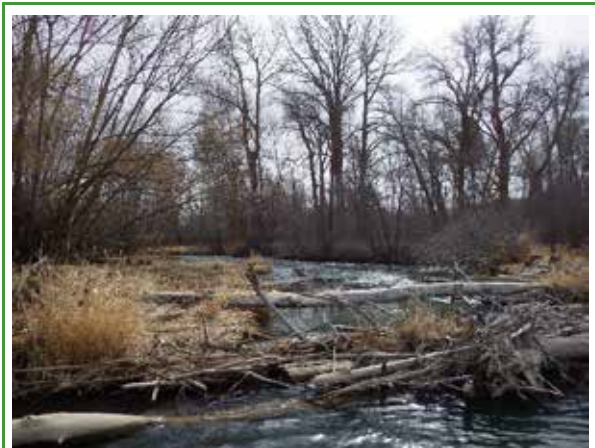
Photo 5/ Typical side channel conditions with an accumulation of LWD at the side channel inlet from the main stem.

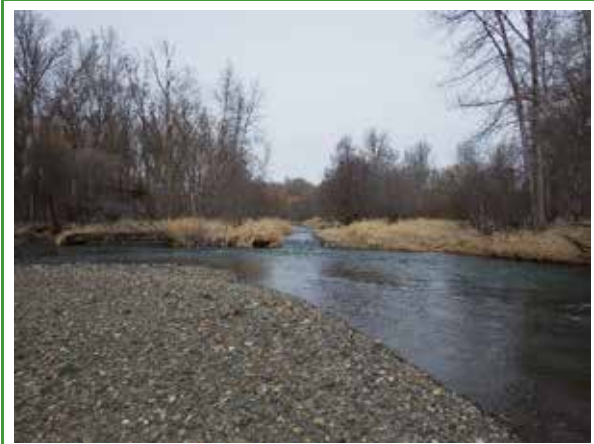
Photo 6. Confluence of two active side channels. Note lack of LWD in most side channels as well as typical cobble and gravel substrate on the bar and riparian understory with ubiquitous reed canarygrass.

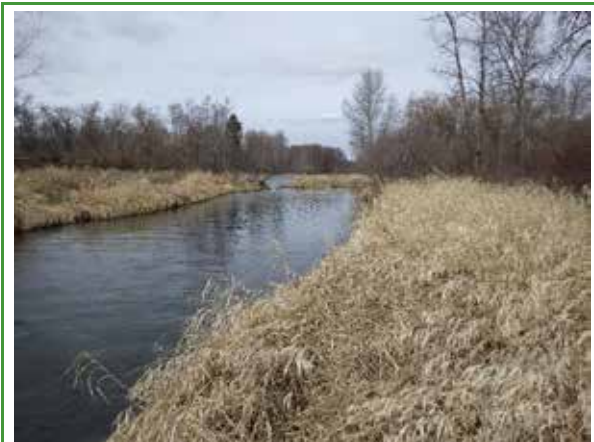
Photo 7. Side channel lacking LWD and woody bank vegetation.

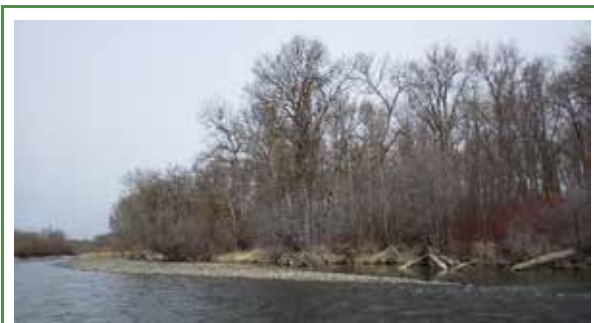
Photo 8. Narrow braid of the main stem isolated at low to moderate flows by a low gravel bar.

Photo 8 shows typical habitat conditions of braids within the project reach.

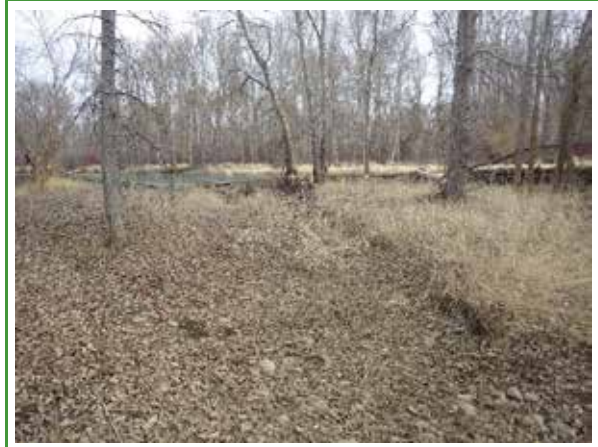
Photo 9. Typical overflow channel inlet near the upstream end of the project reach.

Photos 9 through 12 show typical habitat conditions of overflow channels within the project reach.

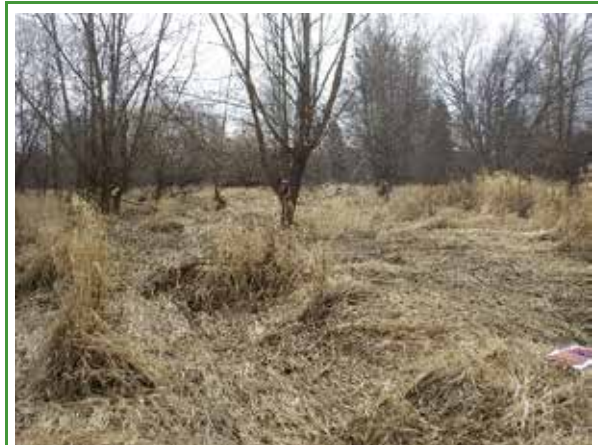
Photo 10. Overflow channel swale dominated by invasive reed canarygrass.

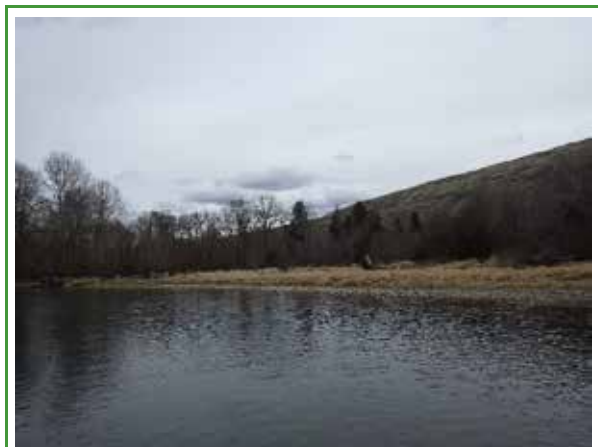
Photo 11. Inlet area of a large overflow channel near the downstream end of the project reach.

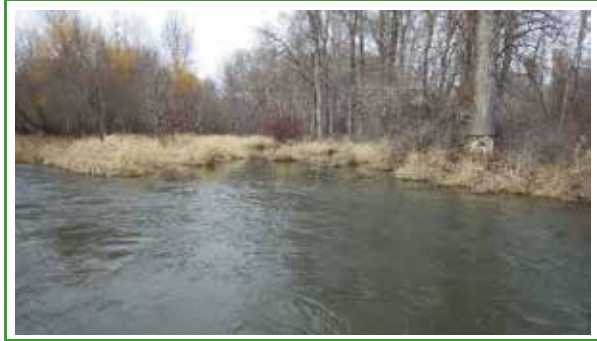
Photo 12. Downstream end of overflow channel providing alcove habitat. Bank vegetation dominated by invasive reed canarygrass.

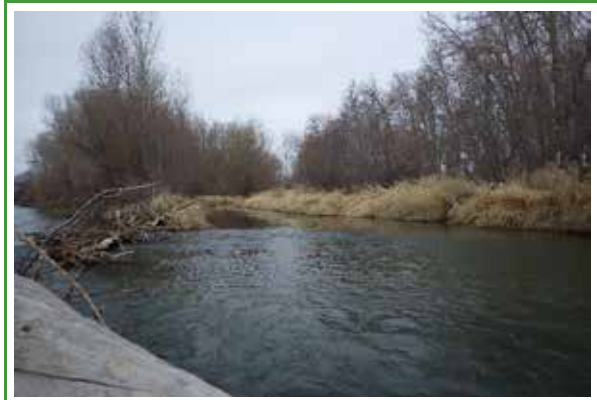
Photo 13. Groundwater channel outlet with banks dominated by invasive reed canarygrass.

Photos 13 through 15 show typical habitat conditions of groundwater channels within the project reach.

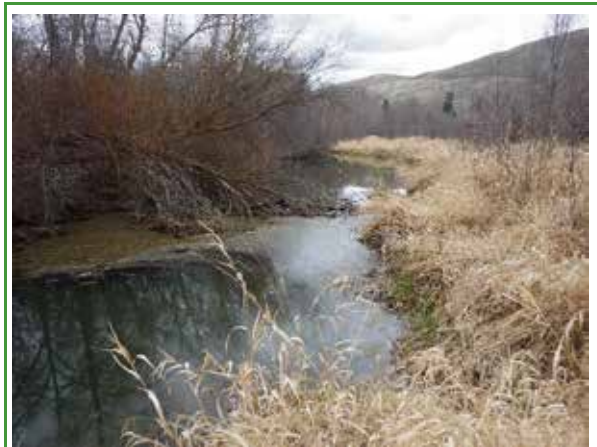
Photo 14. Groundwater channel exhibiting both ideal bank vegetation (left) and poor vegetation conditions dominated by reed canarygrass (right).

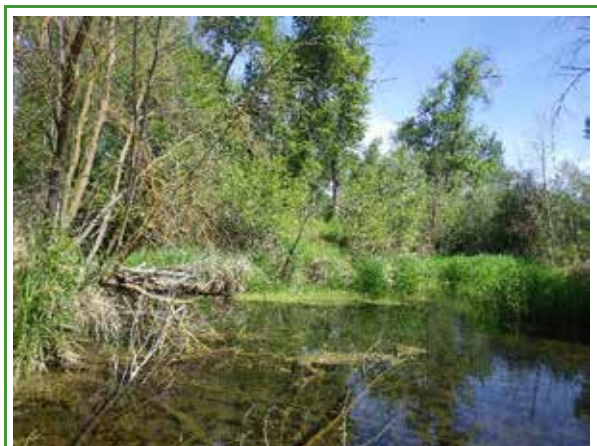
Photo 15. Groundwater channel east of the main river. Water was extremely clear and cold despite lack of riparian shading, and numerous juvenile salmonids were observed around complex woody debris. Note encroachment of reed canarygrass degrading edge habitat in the right side of the photo.

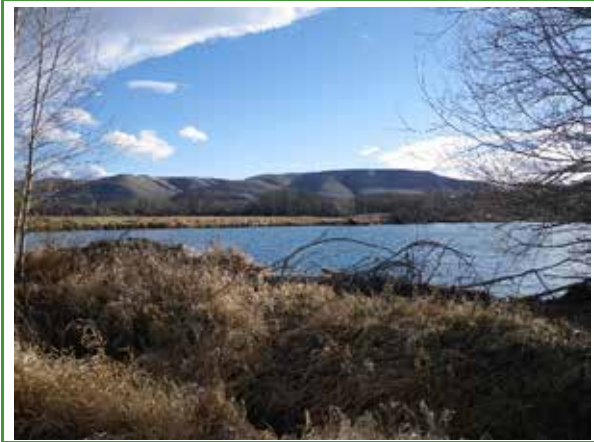
Photo 16. Floodplains ponds in the project reach are virtually all man made, remnants of old gravel pits or irrigation ponds.

Photos 16 through 18 show typical habitat conditions of floodplain ponds within the project reach.

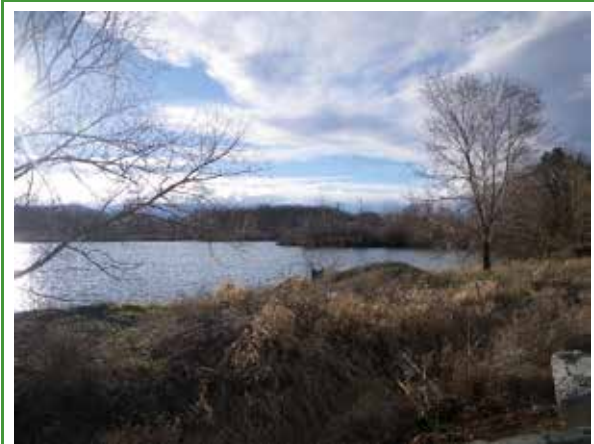
Photo 17. Typical vegetation conditions on all observed floodplain ponds were similar to those at the Hansen Pits.

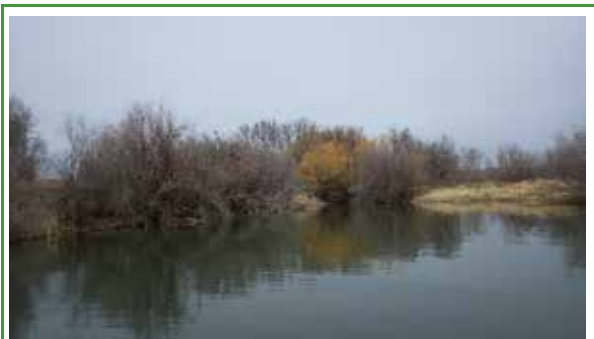
Photo 18. View of the Hansen Pit that has been captured by the mainstem channel.

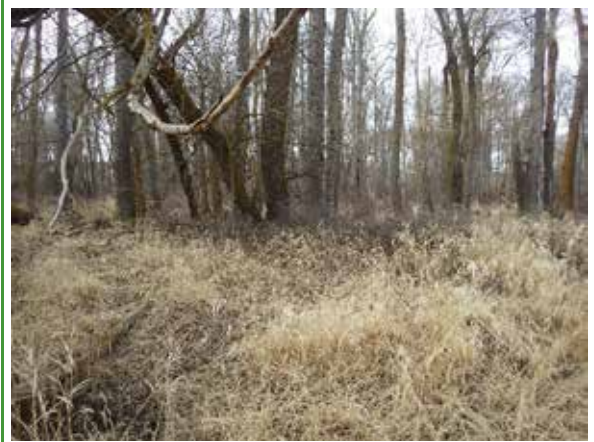
Photo 19. Deciduous forest habitat type with large mature cottonwoods dominating the canopy and understory dominated by reed canarygrass.

Photos 19 and 20 show typical habitat conditions of deciduous forest within the project reach.

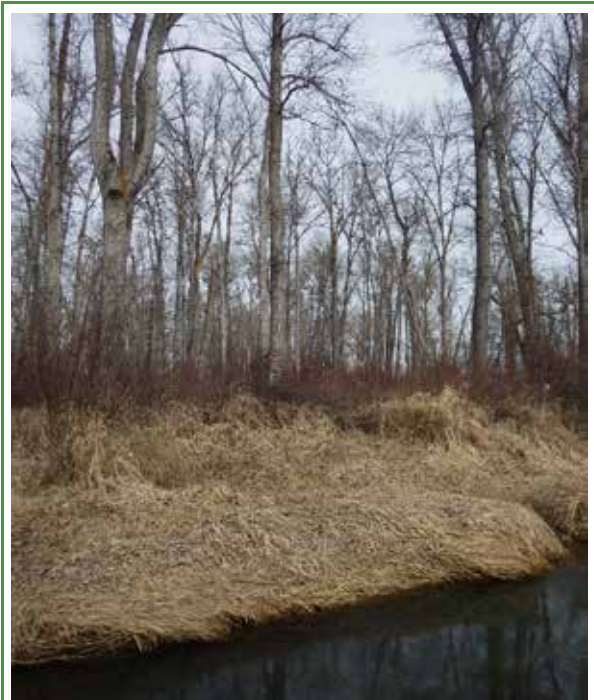
Photo 20. Deciduous forest habitat type with understory dominated by red osier dogwood and other shrubs. Reed canarygrass is predominant in the foreground of the photo on the river banks.

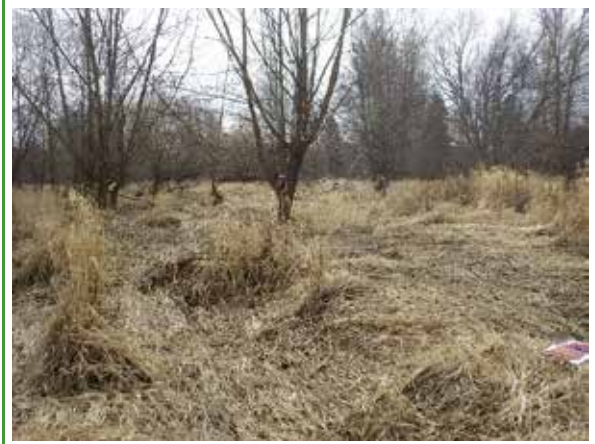
Photo 21. Woodland habitat type with primarily mid-sized deciduous trees widely spaced and understory dominated by reed canarygrass.

Photos 21 and 22 show typical habitat conditions of woodlands within the project reach.

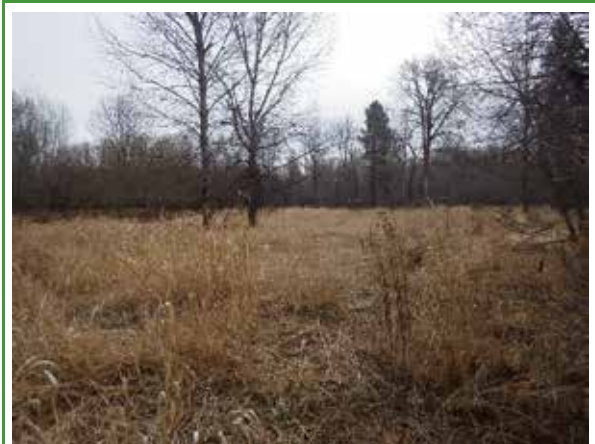
Photo 22. Woodland habitat type with understory dominated by reed canarygrass. Sparse tree canopy made up of large cottonwoods and the occasional ponderosa pine.

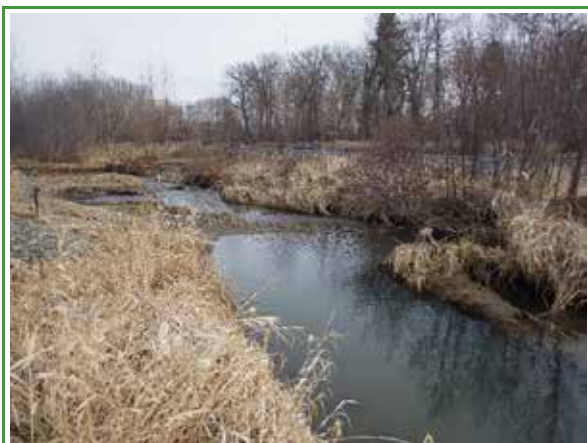
Photo 23 Sparse scrub-shrub habitat on a small island separating a side channel from the main channel.

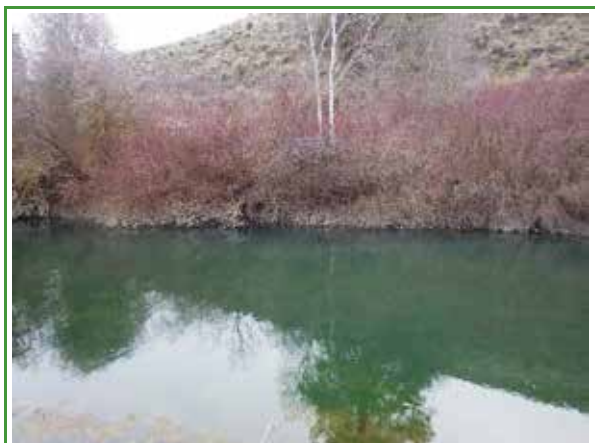
Photo 24. Dense scrub-shrub habitat lining a groundwater channel.

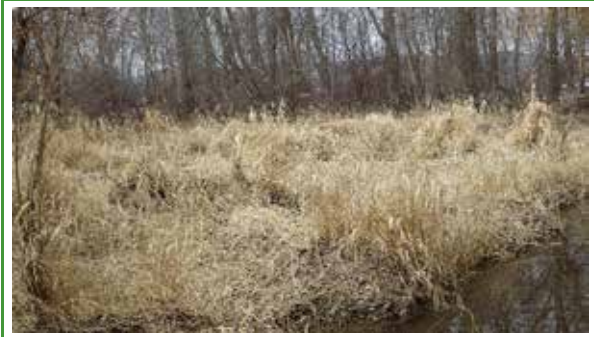
Photo 25. Prairie habitat type in the foreground is dominated by invasive reed canarygrass. Habitat type transitions to deciduous forest in the background.

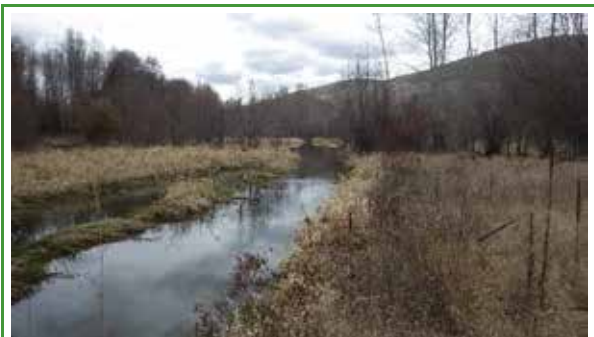
Photo 26. Prairie habitat type in the foreground on both sides of a groundwater channel is dominated by invasive reed canarygrass and other non-native species including tansy ragwort and woolly mullen. Habitat type transitions to scrub-shrub and deciduous forest in the background.

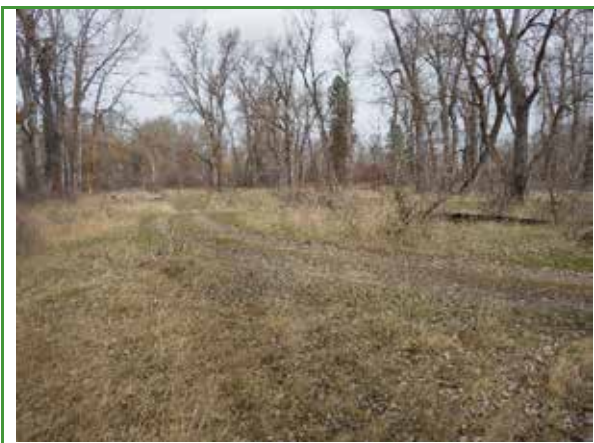
Photo 27. Typical bare ground habitat type along a heavily used 2 track unimproved road.

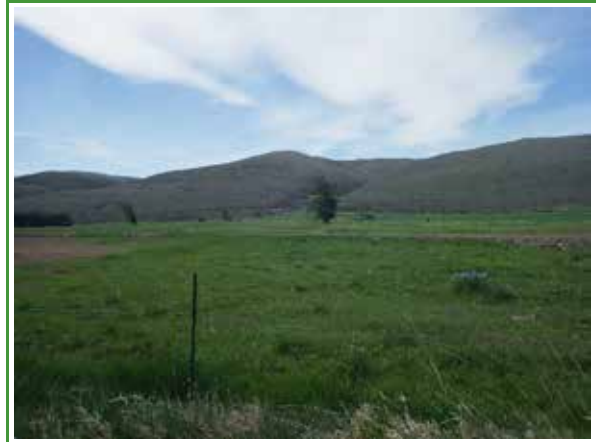
Photo 28. Typical agricultural land conditions within the project reach.

Agricultural areas provide poor floodplain habitat conditions with low hydraulic roughness when inundated during overbank flow events. Such areas may also act as a source of runoff, sediment, and nutrients to the river. Hay fields and pastures in the project reach (Photo 28) are used by wild ungulates (deer and elk) for grazing.
