RE: Ross Outdoor Training Center, PM-23-00015

The purpose of this technical memorandum is to address the designation of Type 2 (F) water as identified on parcels 880833 and 840833 by the DNR Water Type layer in the Kittitas County COMPAS (Map 1). Parcel 890833 does not indicate this feature.

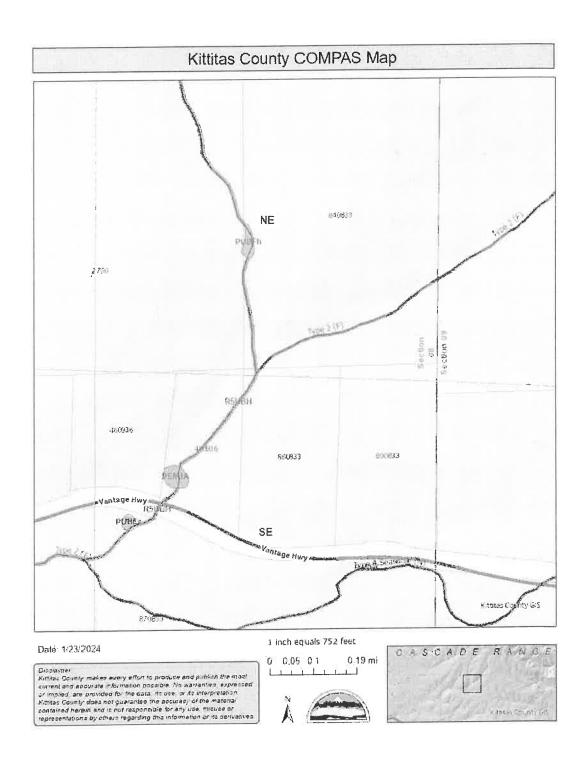
The line identified as Type 2 (F) water on COMPAS is not a water feature found on these parcels. There is no feature that exhibits the characteristics of a stream, wetland type habitat, or a riparian zone. Further, there is no water that can be classified as Type 3, 4, or 5. There is no habitat to support fish at any time of the year and there are no fish indicated on the WDFW Priority Habitat and Species lists for this area.

Map 1. Parcel overview with DNR water type and wetland layers.
