**Ball Property Wetland Reconnaissance, OHWM
Determination and Mitigation Plan
Ronald, Washington**

Submitted to:
The Ball family
18401 Salmon La Sac Road
Ronald, Wa, 98940

COOKE SCIENTIFIC
4231 NE 110th Street
Seattle, WA 98125
(206) 695-2267

BALL PROPERTY OHWM DELINEATION WETLAND RECONNAISSANCE AND MITIGATION PLAN

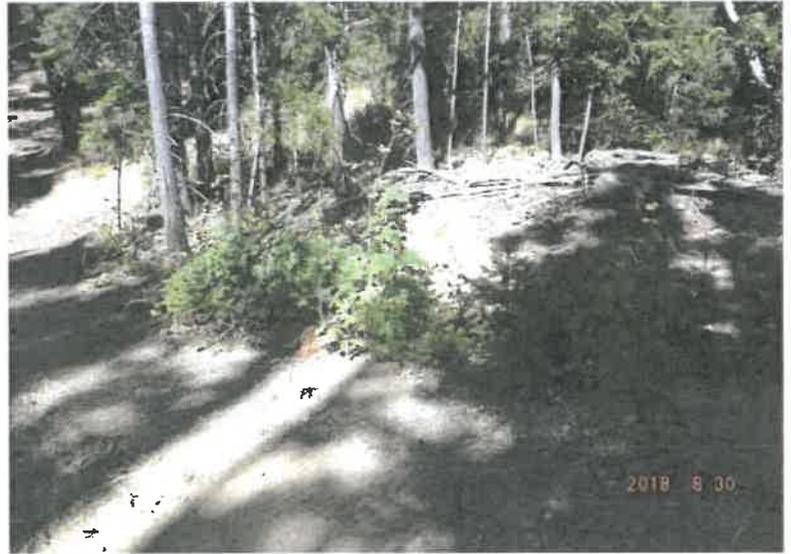
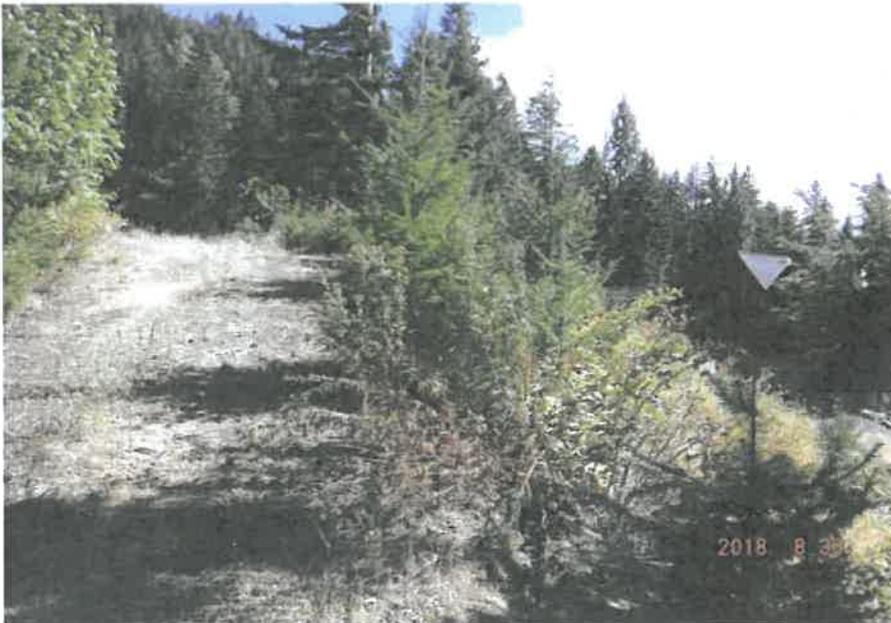
Native veg on the Property

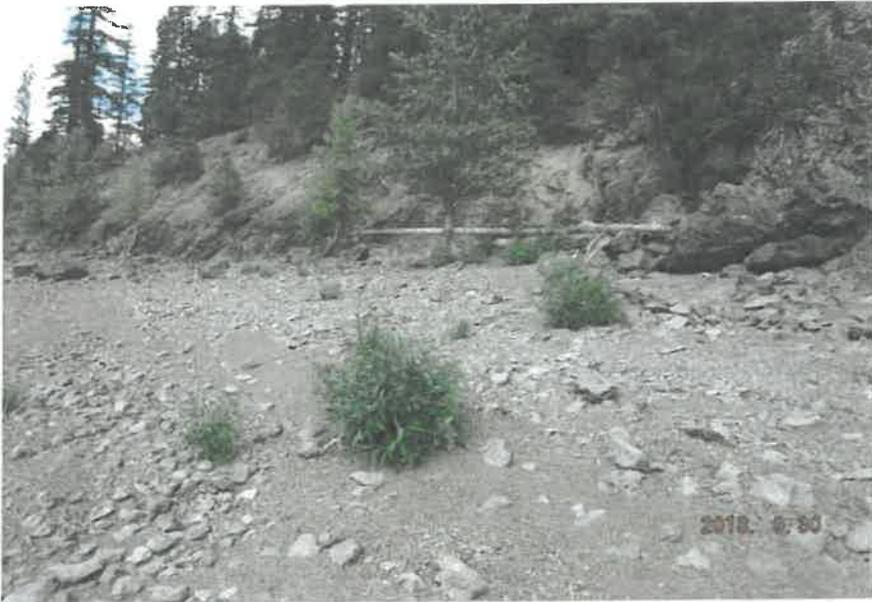
Native veg on the Property

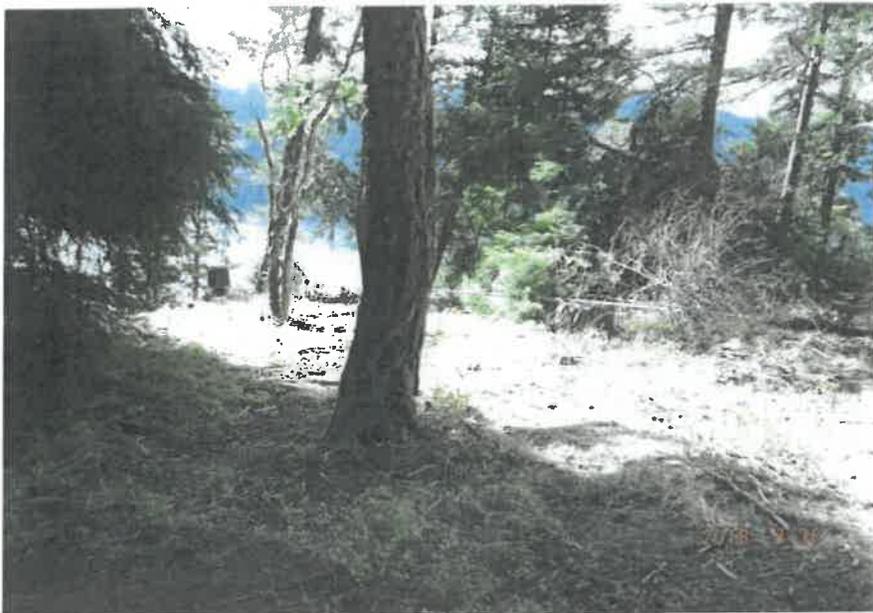
Few Willows on beach

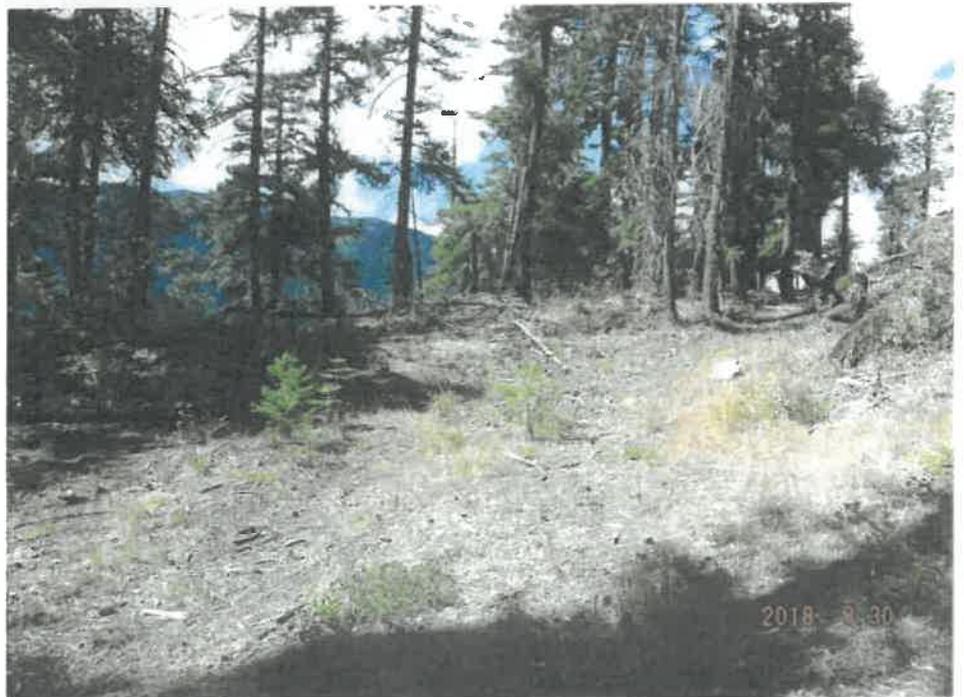
**Photo Page 2. Ball Property,
Anna Bell Plat, Kittitas County, Wa**

Is currently somewhat open, as is typical with east-side forests. It is still vegetated with a few trees (mapped on Figure 3, photo on Photo page 2) and understory vegetation consisting of shrubs and forbs. As is the area to the north that will be set aside for mitigation (Figure 5b).

House Site

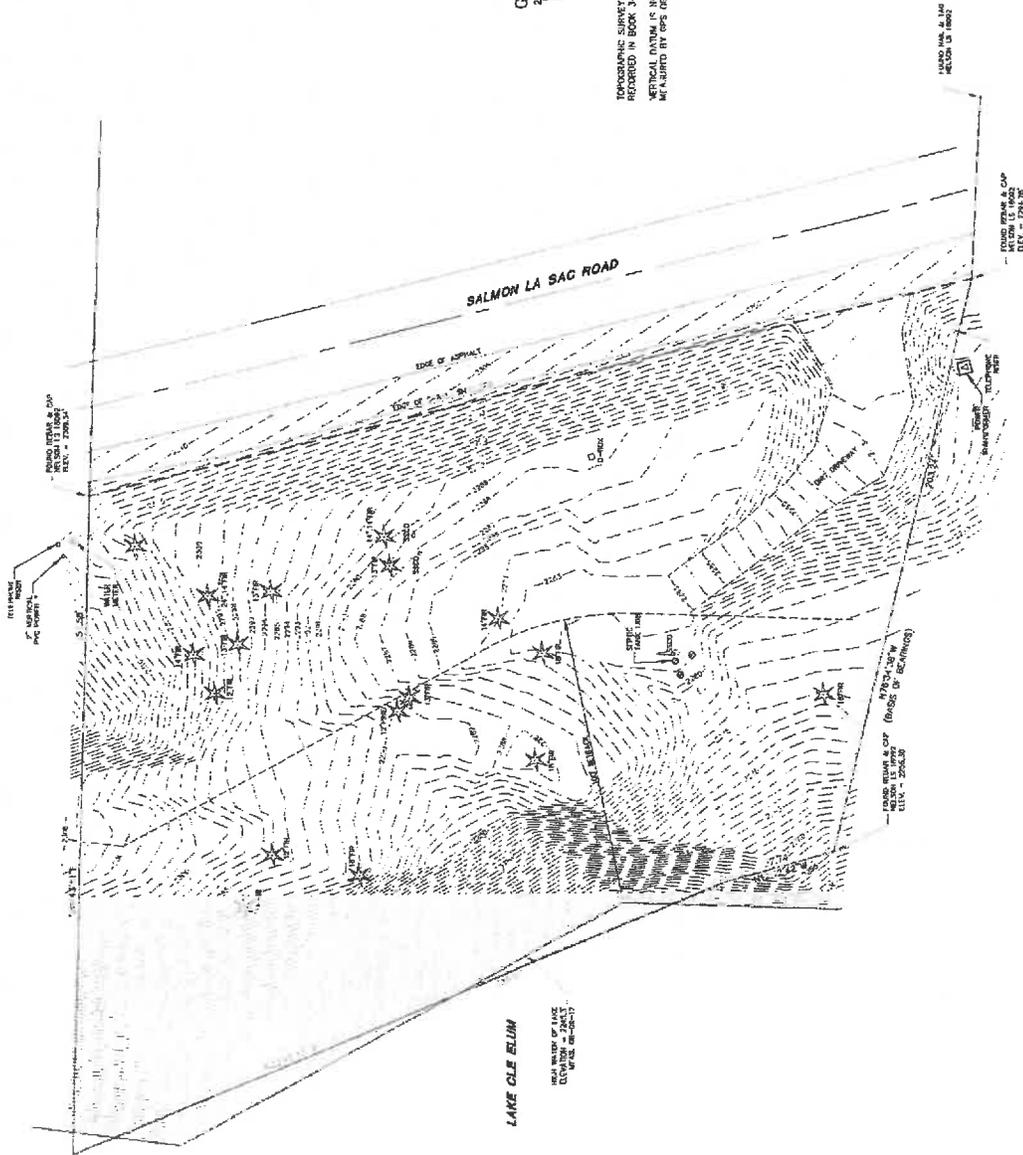
Figure 3. Ball Property, Topography and Tree Mapping

The property is part of the Anna Bell plat that was recorded in 2006. The Ball property is recorded as Lot #6 (See Figure 1). Although the actual lot is an oddly shaped property (seen on Figures 6-9), the actual development area is only that part identified on Figures 3 and 5, west of the road.

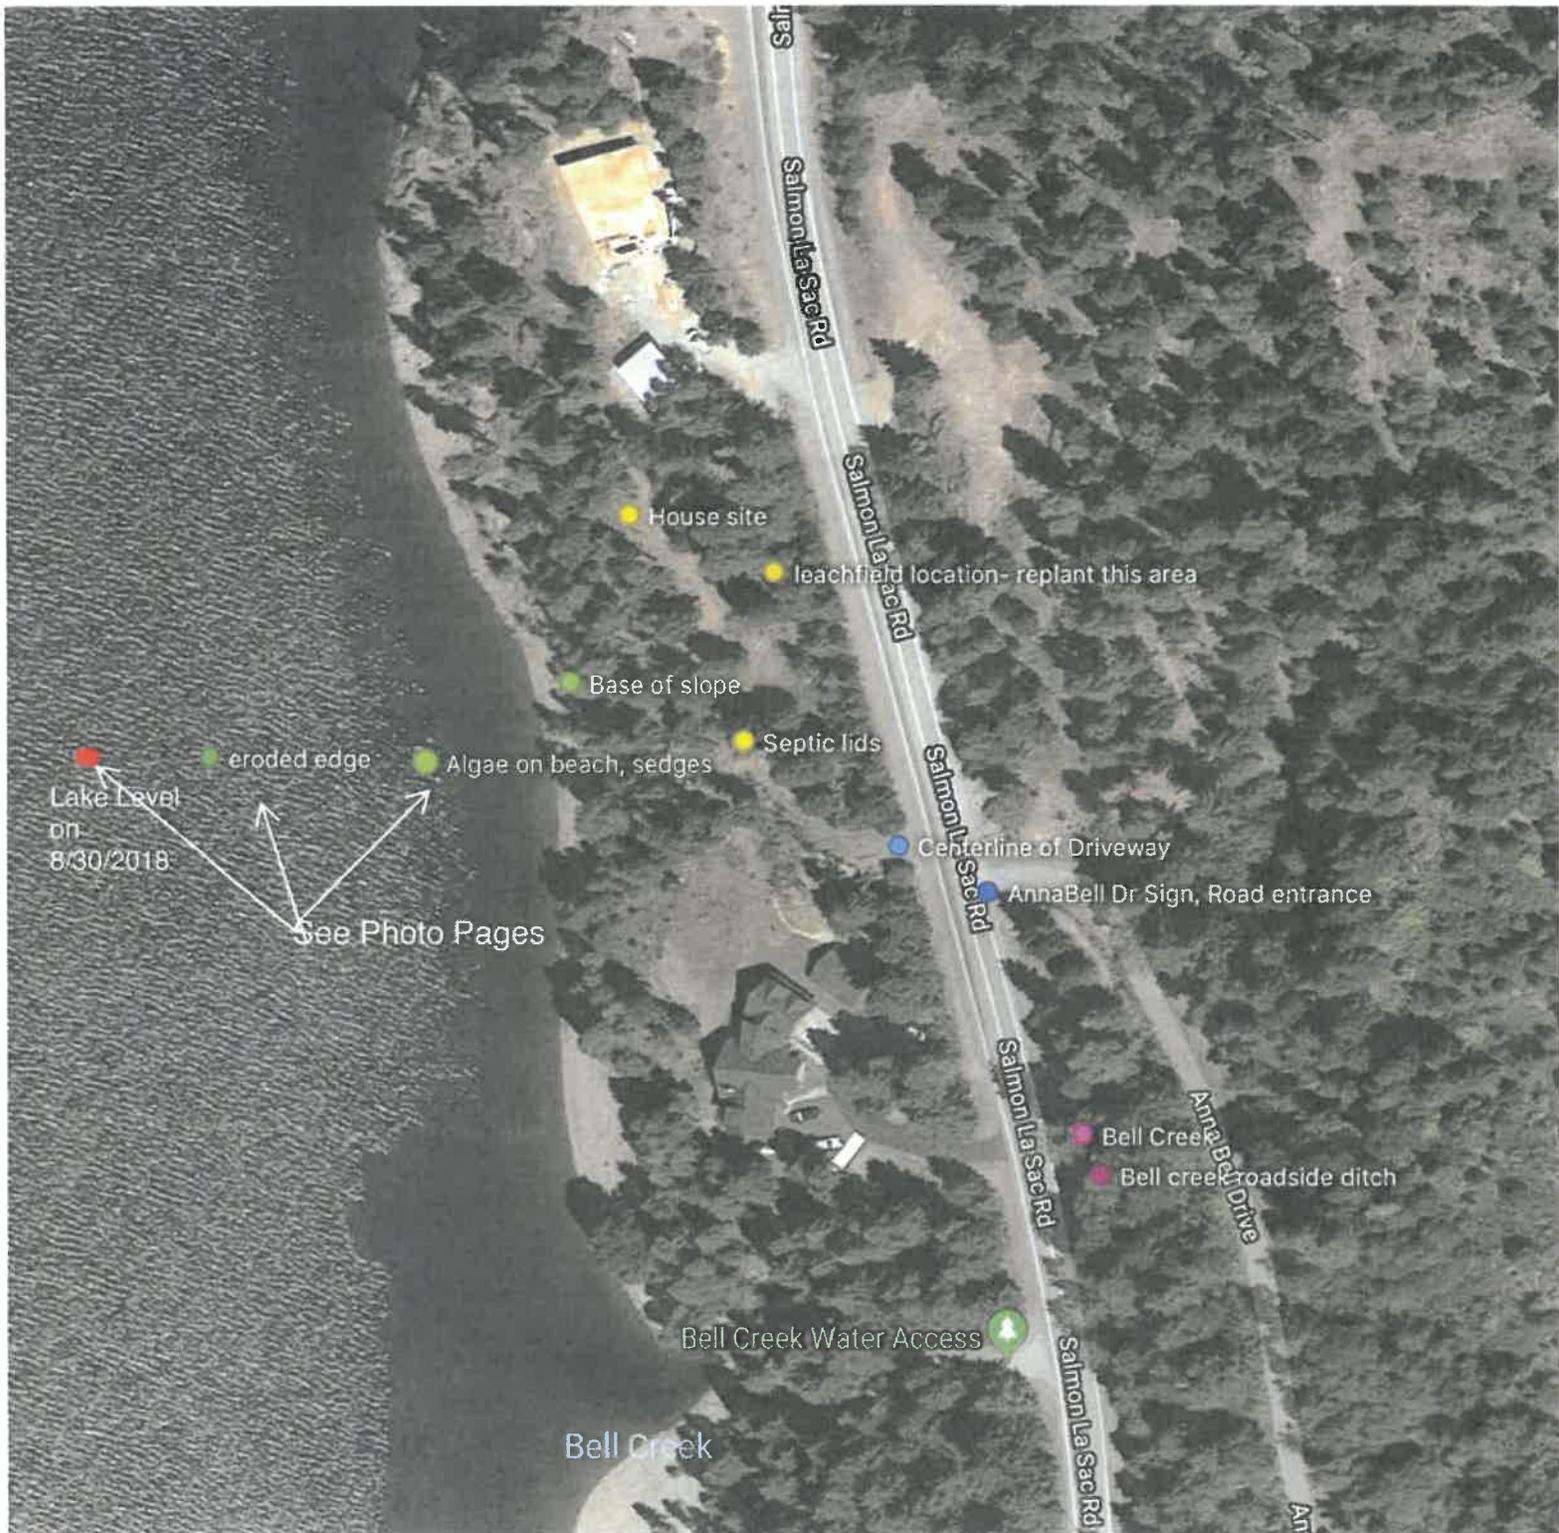
Figure 4. Ball Property, GPS mapping from Site Assessment, Key to Photographs

Streams: Since the stream was east of the Road and no development is proposed in that area, no evaluation was made for an OHWM for Bell Creek as defined by the Revised Code of Washington (RCW) 90.58.030 and the Washington Administrative Code (WAC) 220-660-030. Had there been a stream within the Ball property west of the Road, the methodology used to evaluate it would have been that developed by the Washington State Department of Ecology (WDOE Publication # 16-06-029 2016. *Determining the Ordinary High-Water Mark for Shoreline Management Act Compliance in Washington State*). The protocol requires examination of the stream bed and bank physical characteristics, the associated vegetation, and the indicators of the hydrology present during regular normal rain events. Bell Creek is shown on Figures 4 and 8.

The leachfield is located outside of the buffer zone (Figures 2, 4, 5; and Photo Page 3) but this area will be replanted as compensation for the disturbance that occurred as a result of the recent disturbance in situ and the future construction of the house and driveway. The rest of the site minus where the house is to be built and the existing driveway is fully vegetated and so there is really nowhere else to plant. The following will be planted: (in the rectangle identified on Figure 5b)

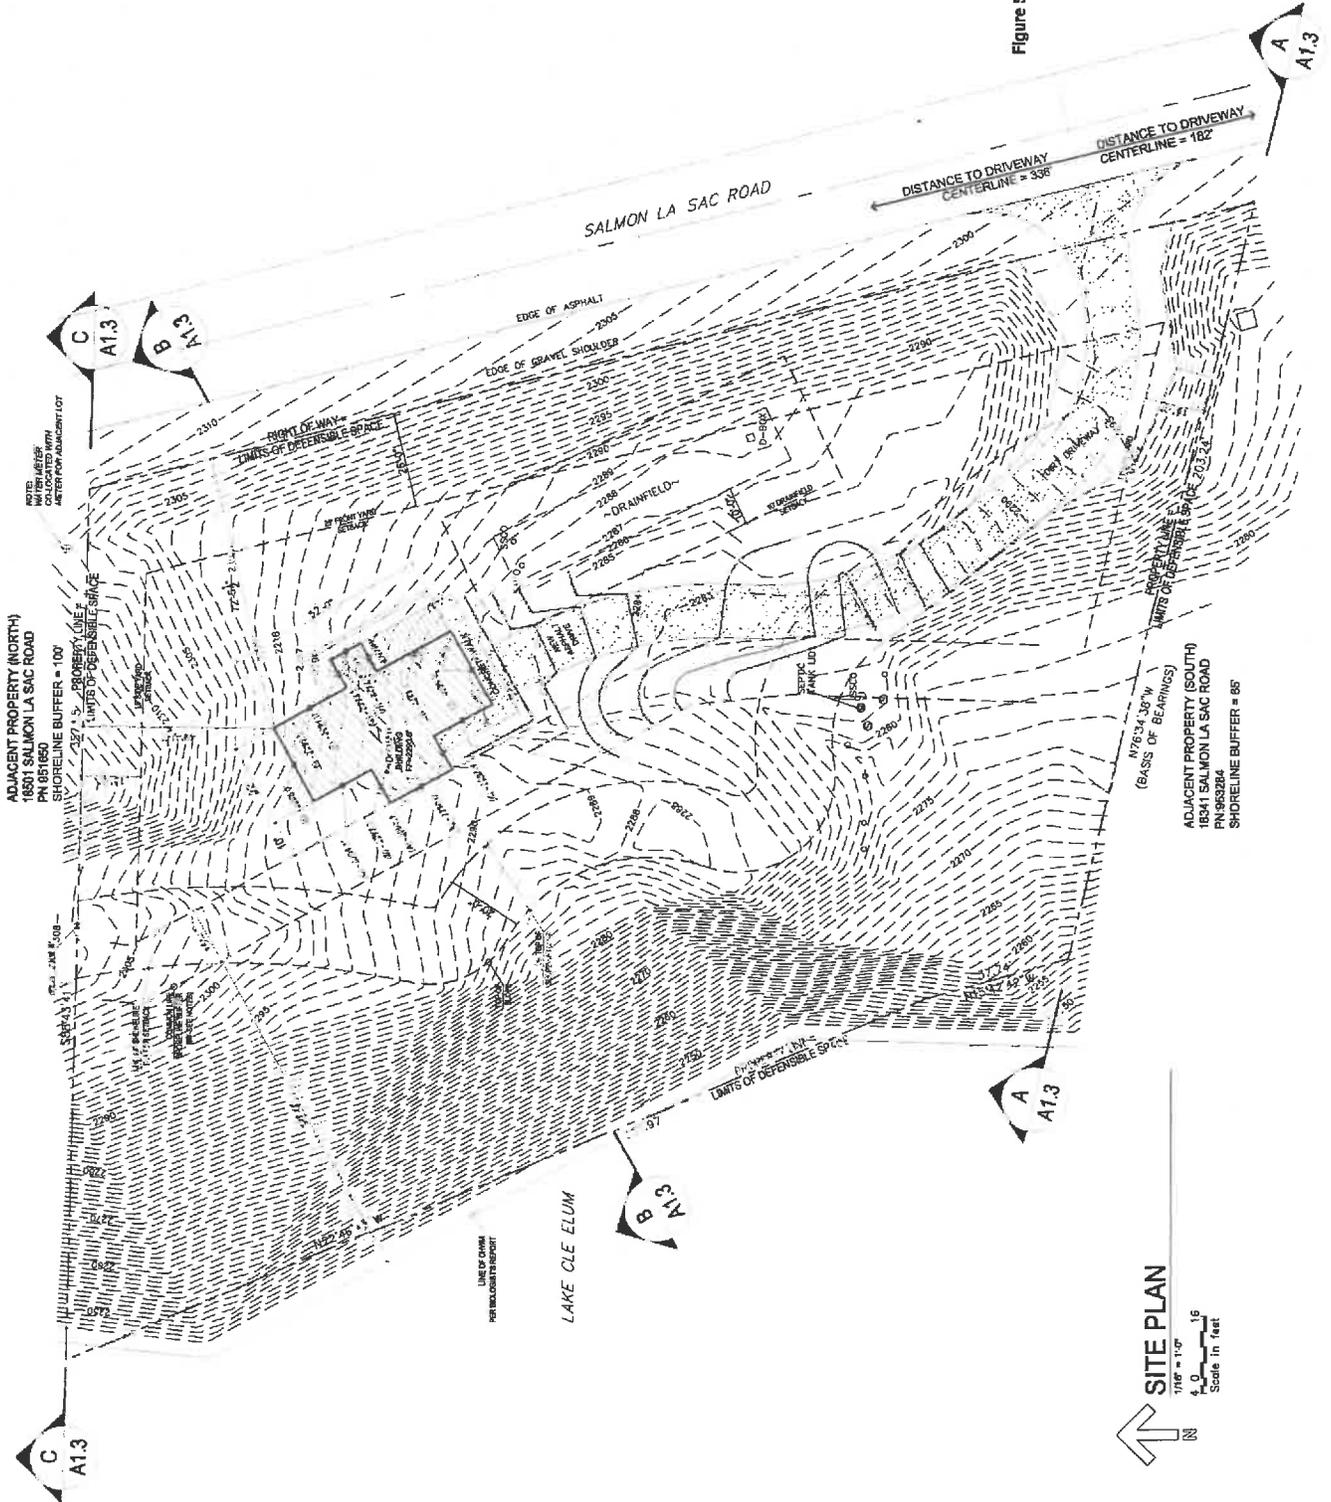
Figure 5 - Ball Property Site Plan

Cooke Scientific staff investigated the property for wetlands Steams and OHWM on August 30, 2018. We found no wetlands on the property on top of the slope and no wetlands within the zone identified on Figure 9 as having wetlands See Figures 2-4 and Photo Pages). The area between the toe of slope and the lower lake level lacks soils and vegetation criteria and the hydrology indicators are only present when the Lake level is high (See Figure 3 and Photo Pages 4 and 6). There are no streams on the property west of the Salmon La Sac Road (Figure 8). The stream crosses from the property east of the road, passes under the road and exits to the Lake via Lot 12. The OOHWM is not at the top of the slope as shown on the County map (Figure 7) but is actually where it is shown on Figure 10. This was difficult to determine because it lacked the usual criteria ("a mark upon the land as identified by the soils and vegetation" or secondary characteristics as seen in aerials from 7/15/14, and 7/13/17 and the ground shots shown on Photo pages 4 and 5), but the Washington State Department of Ecology has determined that it is at the toe of the slope as shown on Figure 10 and the Google aerial from 7/10/12 and the Site plan (Figure 5a).

In exchange for the "impact" to the septic pit area 100-foot Shoreline buffer, an equivalent area (28' x 28' = 784 FT²) will be set aside north of the house (as shown on Figures 5a and 5ba and 5b) that will not be developed, nor cleared and left in a "natural" state with native trees and shrubs and forbs). This will be set aside as a permanent "no touch" buffer and will be recorded on the plat map on file with the County. Photo page 2, (lower photo) shows this area. The existing natural vegetation will be left untouched and no future activity will be planned that will affect this area. As shown on the photo, the septic area is after 10 years, fully vegetated and so needs no additional plantings in-situ.

2. **Documenting weeds and any open spaces larger than 3-feet in diameter** on a detailed site map (using Figure 5 as the base map) and developing a plan for removing the weeds and planting in any “open” spaces. This should be done as early in April as possible after the April monitoring, and in October/November, after the August monitoring. The number of open spaces will be identified and plants from the table shown above can be selected – one per open space 3-feet in diameter will be ordered and installed. Any native volunteer plants will count towards the plantings and seedings may be transplanted form elsewhere into this area.
