**RE: Winemaker's Cabins at Swiftwater Cellars  
Preliminary Plat  
Water and Sewer Utility Infrastructure  
A portion of SEC 20, T20N, R15E, Kittitas County, WA  
Owner: Swiftwater Cellars Properties, LLC**

**Report  
Geological Engineering Services  
Coal Mine Hazard Assessment  
Ground Proofing Program  
Suncadia Phase 1  
Proposed Rope Rider Ridge  
Residential Development Area  
Kittitas County, Washington**

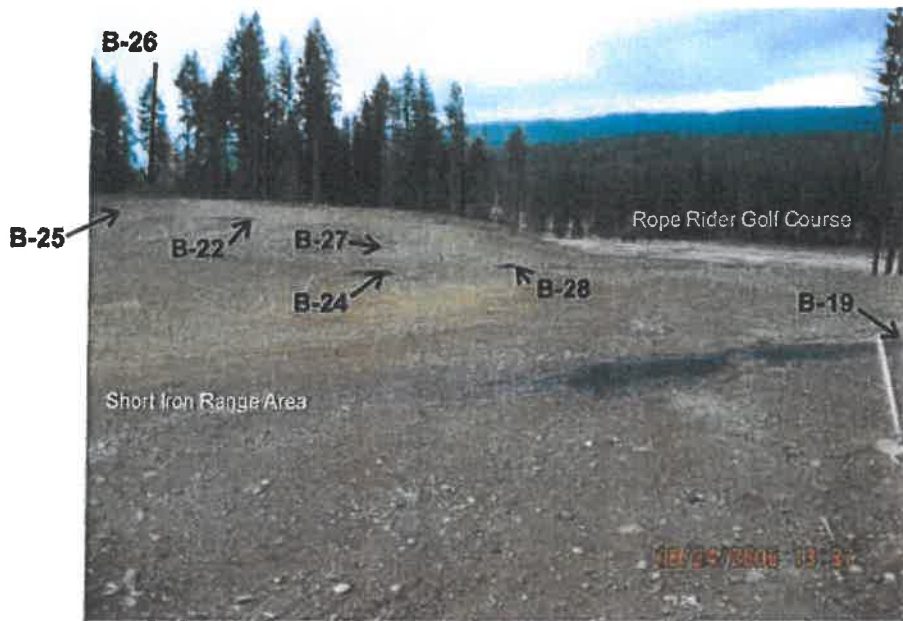
View looking northwest across the proposed residential development area with the test boring locations (October 24, 2006)

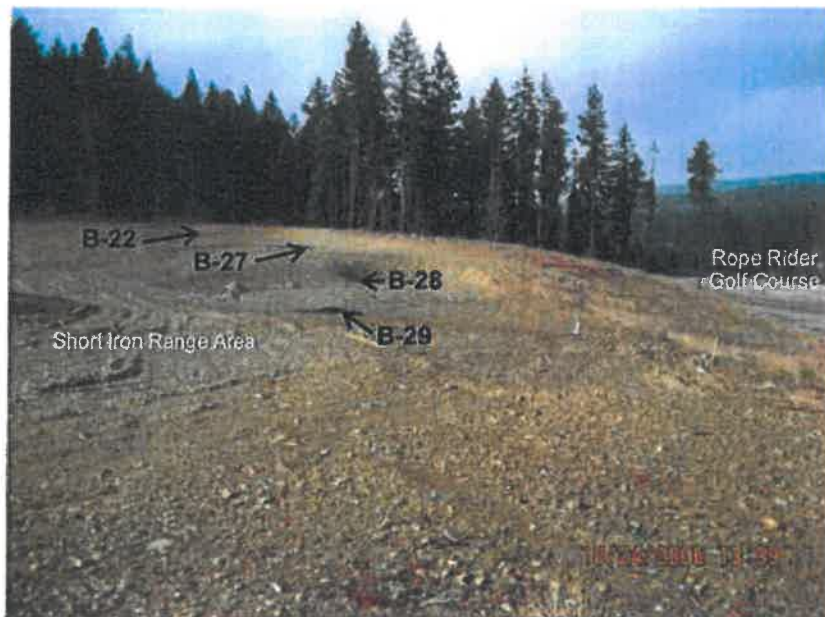
View looking northwest across the proposed residential development area and the slope/Rope Rider Golf Course to the northeast (October 24, 2006)

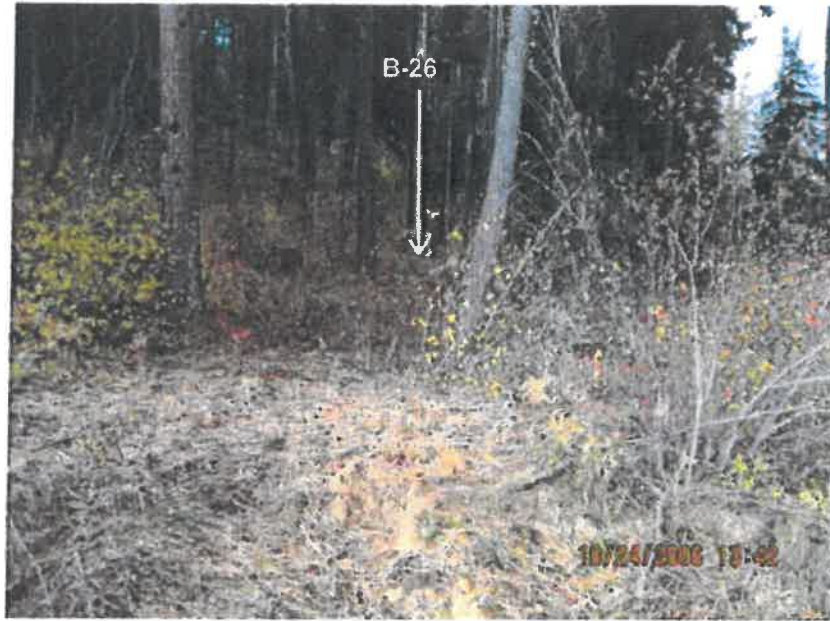
**View looking west at the west end of the proposed residential development area  
(October 24, 2006)**

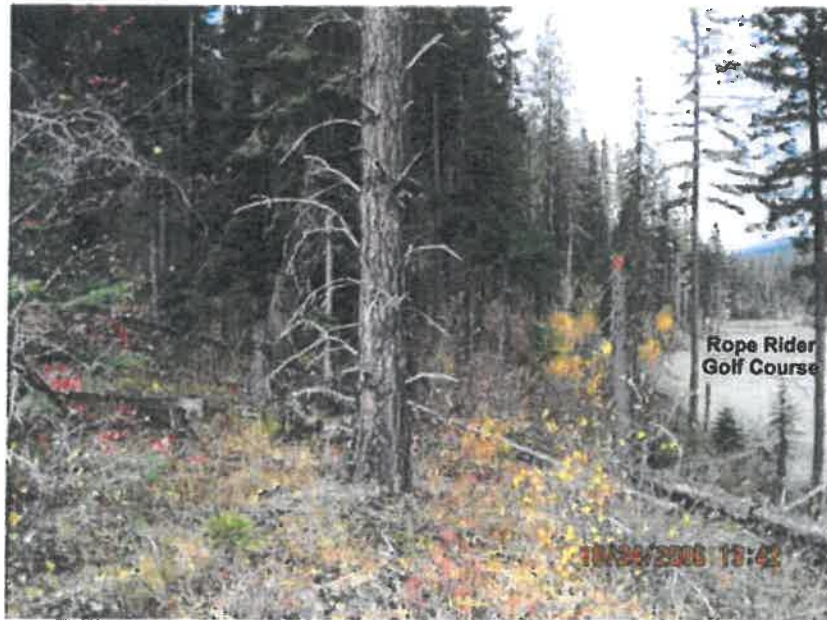
**View looking northwest at the west end of the proposed residential  
development area along the slope/Rope Rider Golf Course area  
(October 24, 2006)**

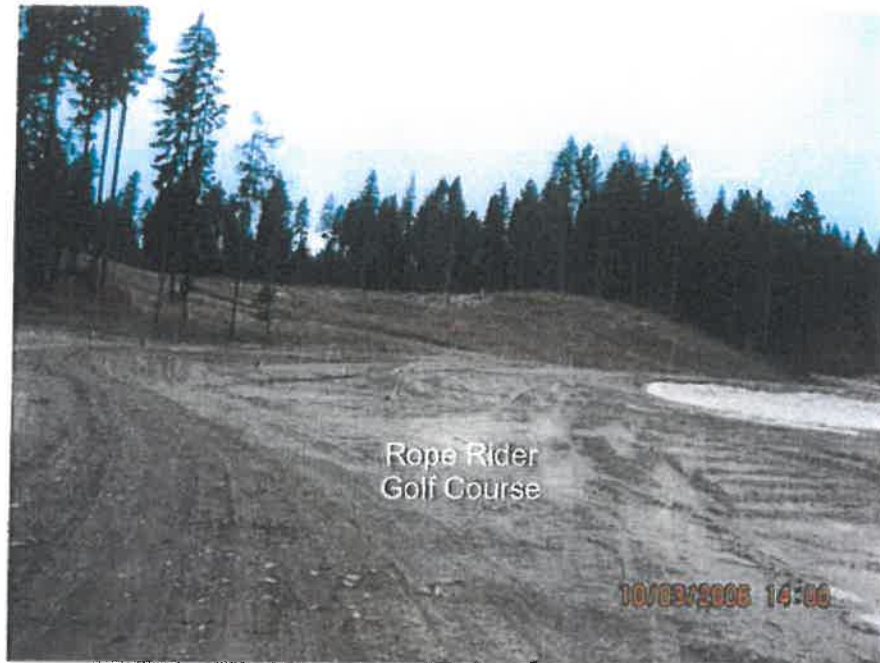
**View looking west from the Rope Rider Golf Course at the hillside that borders the proposed residential development area (October 24, 2006)**

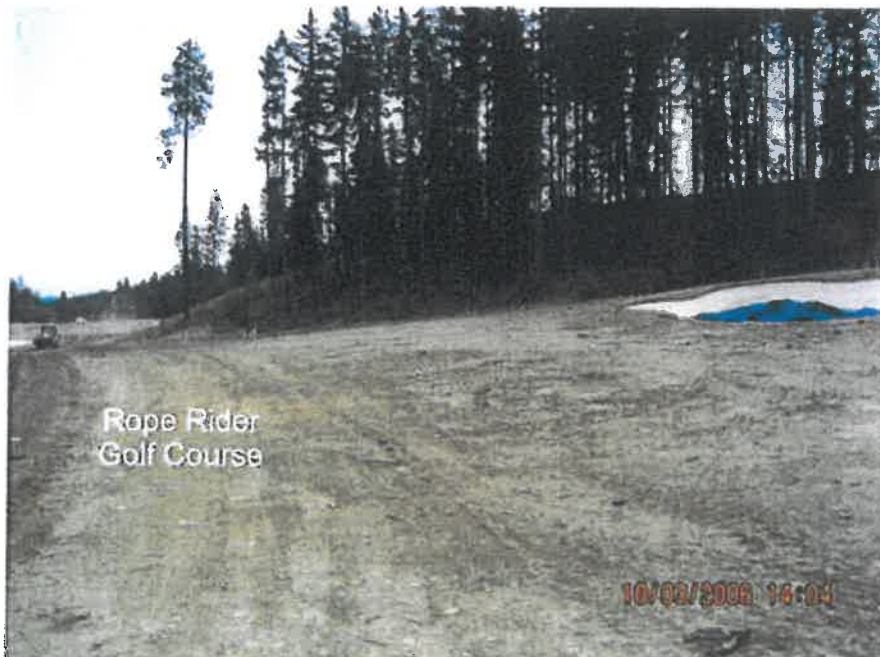
**View looking southeast from the Rope Rider Golf Course at the hillside that borders the proposed residential development area (October 24, 2006)**
