**RE: INFILTRATION TESTING RESULTS; COTTAGE GROVE RESIDENTIAL
DEVELOPMENT, KITTITAS COUNTY, WASHINGTON**

At your request, Baer Testing, Inc. conducted an infiltration test on June 20 and 21, 2018 at the Cottage Grove residential development site to satisfy Kittitas County requirements.

1.0 PROJECT OVERVIEW

The proposed developed site will include approximately 5.77 acres. The developed site will include 34 new single family lots detached cottage units, and approximately 3,098 lineal feet of roadway with associated utilities. The access to the site will enter the property from Dry Creek Road, approximately 1,400' northwest of the intersection of Reecer Creek Road and Dry Creek Road. See Figure RD-01 for the proposed site layout.

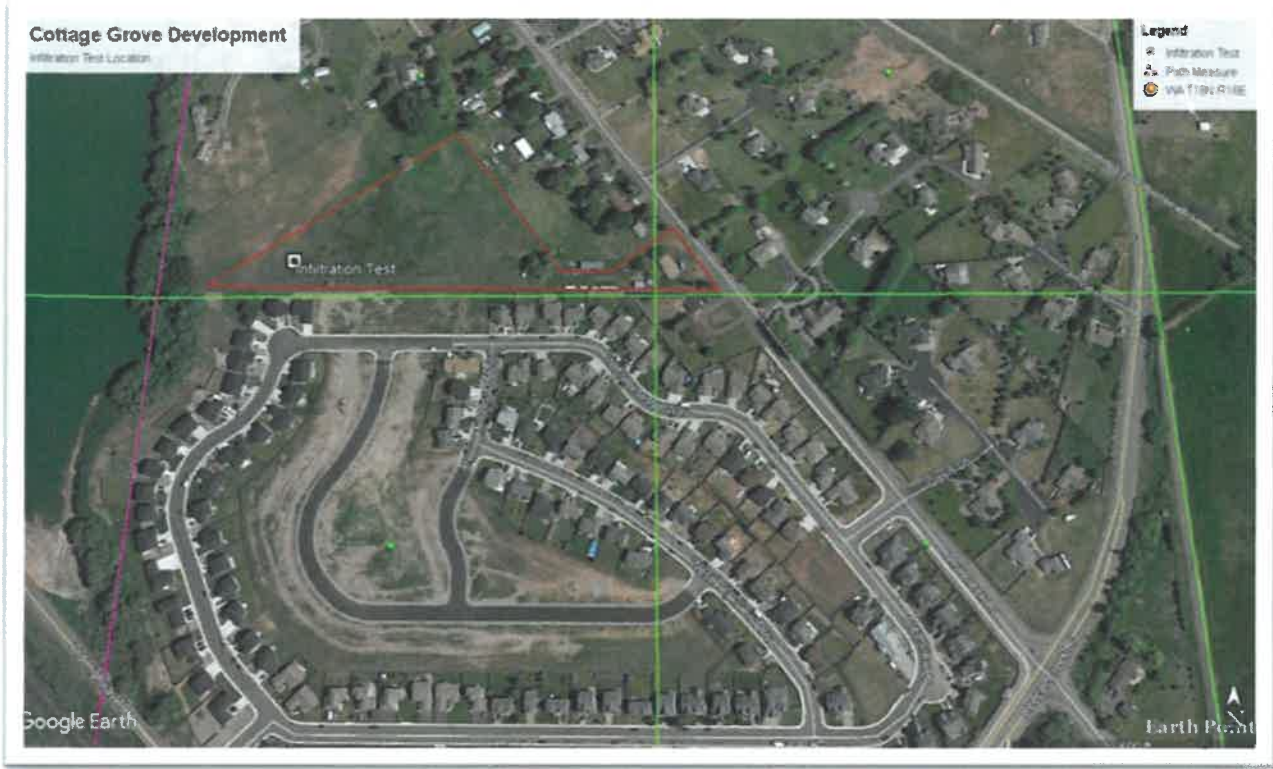
Figure 1 – Test Location

The infiltration test location was selected by the civil design consultant in an area designated for stormwater retention. The test location is shown in Figure 1. MDJ Development excavated the test pits using a CAT excavator with a 2-foot bucket.

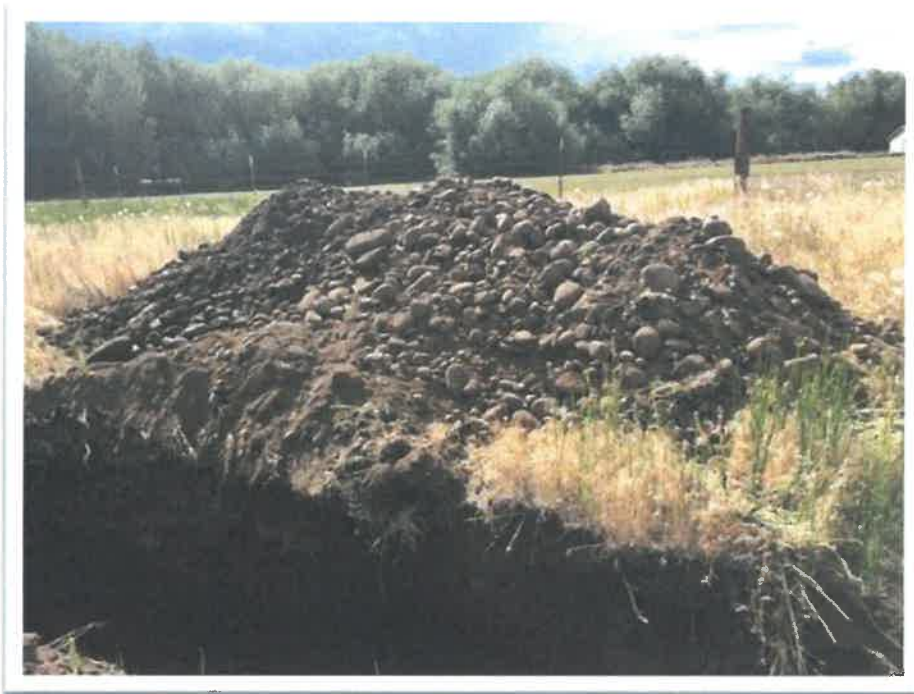
Photo 1 – Material from Test Pit

Initially, a test pit was excavated to identify the depth to groundwater. Groundwater was encountered 8 feet below the existing surface. A second test pit extending to the proposed 4- to 5-foot infiltration depth was then excavated for testing. A soil sample was obtained from the approximate infiltration depth for gradation testing. The subsurface conditions encountered in both test pits consisted of very dense, moist, poorly-graded gravel with cobbles up to approximately 12 inch size in a tightly packed silt/sand matrix. Photos 1 & 2 show materials excavated from the deeper test pit.
