The Commons at Dry Creek

Preliminary Drainage Report

July 13, 2017

Job No: 16-115A

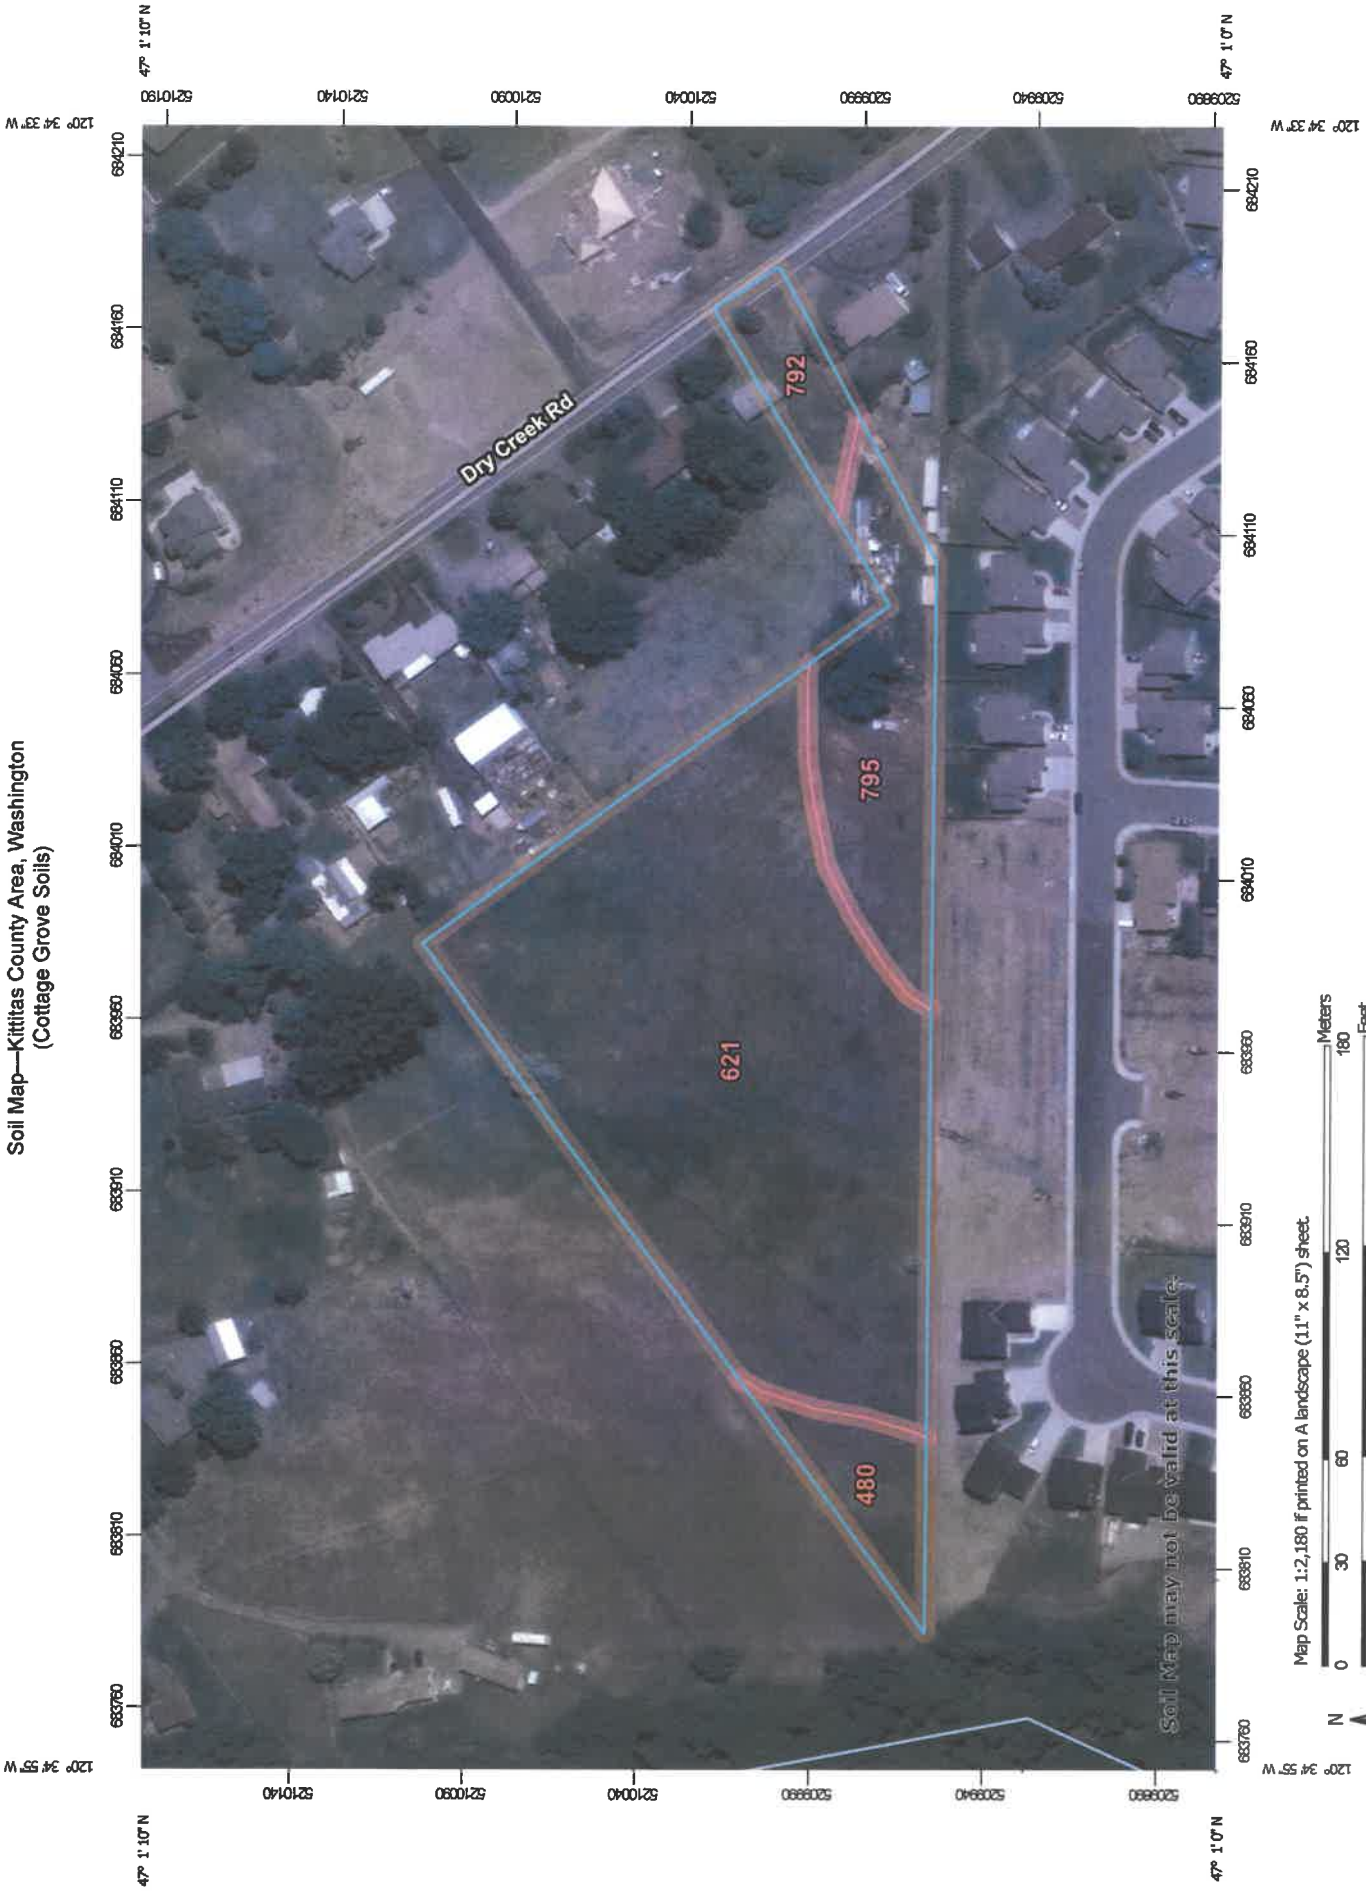
Soil Map—Kittitas County Area, Washington
(Cottage Grove Soils)

Map Scale: 1:2,180 if printed on A landscape (11" x 8.5") sheet.

Enlargement of maps beyond the scale of mapping can cause misunderstanding of the detail of mapping and accuracy of soil line placement. The maps do not show the small areas of contrasting soils that could have been shown at a more detailed scale.

According to the SCS soil survey for Kittitas County the proposed development area of the site is underlain by Mitta Ashy Silt Loam, Nack-Opnish Complex, Brickmill Gravelly Ashy Loam, and Nanum Ashy Loam, see figures in Appendix 1-A.

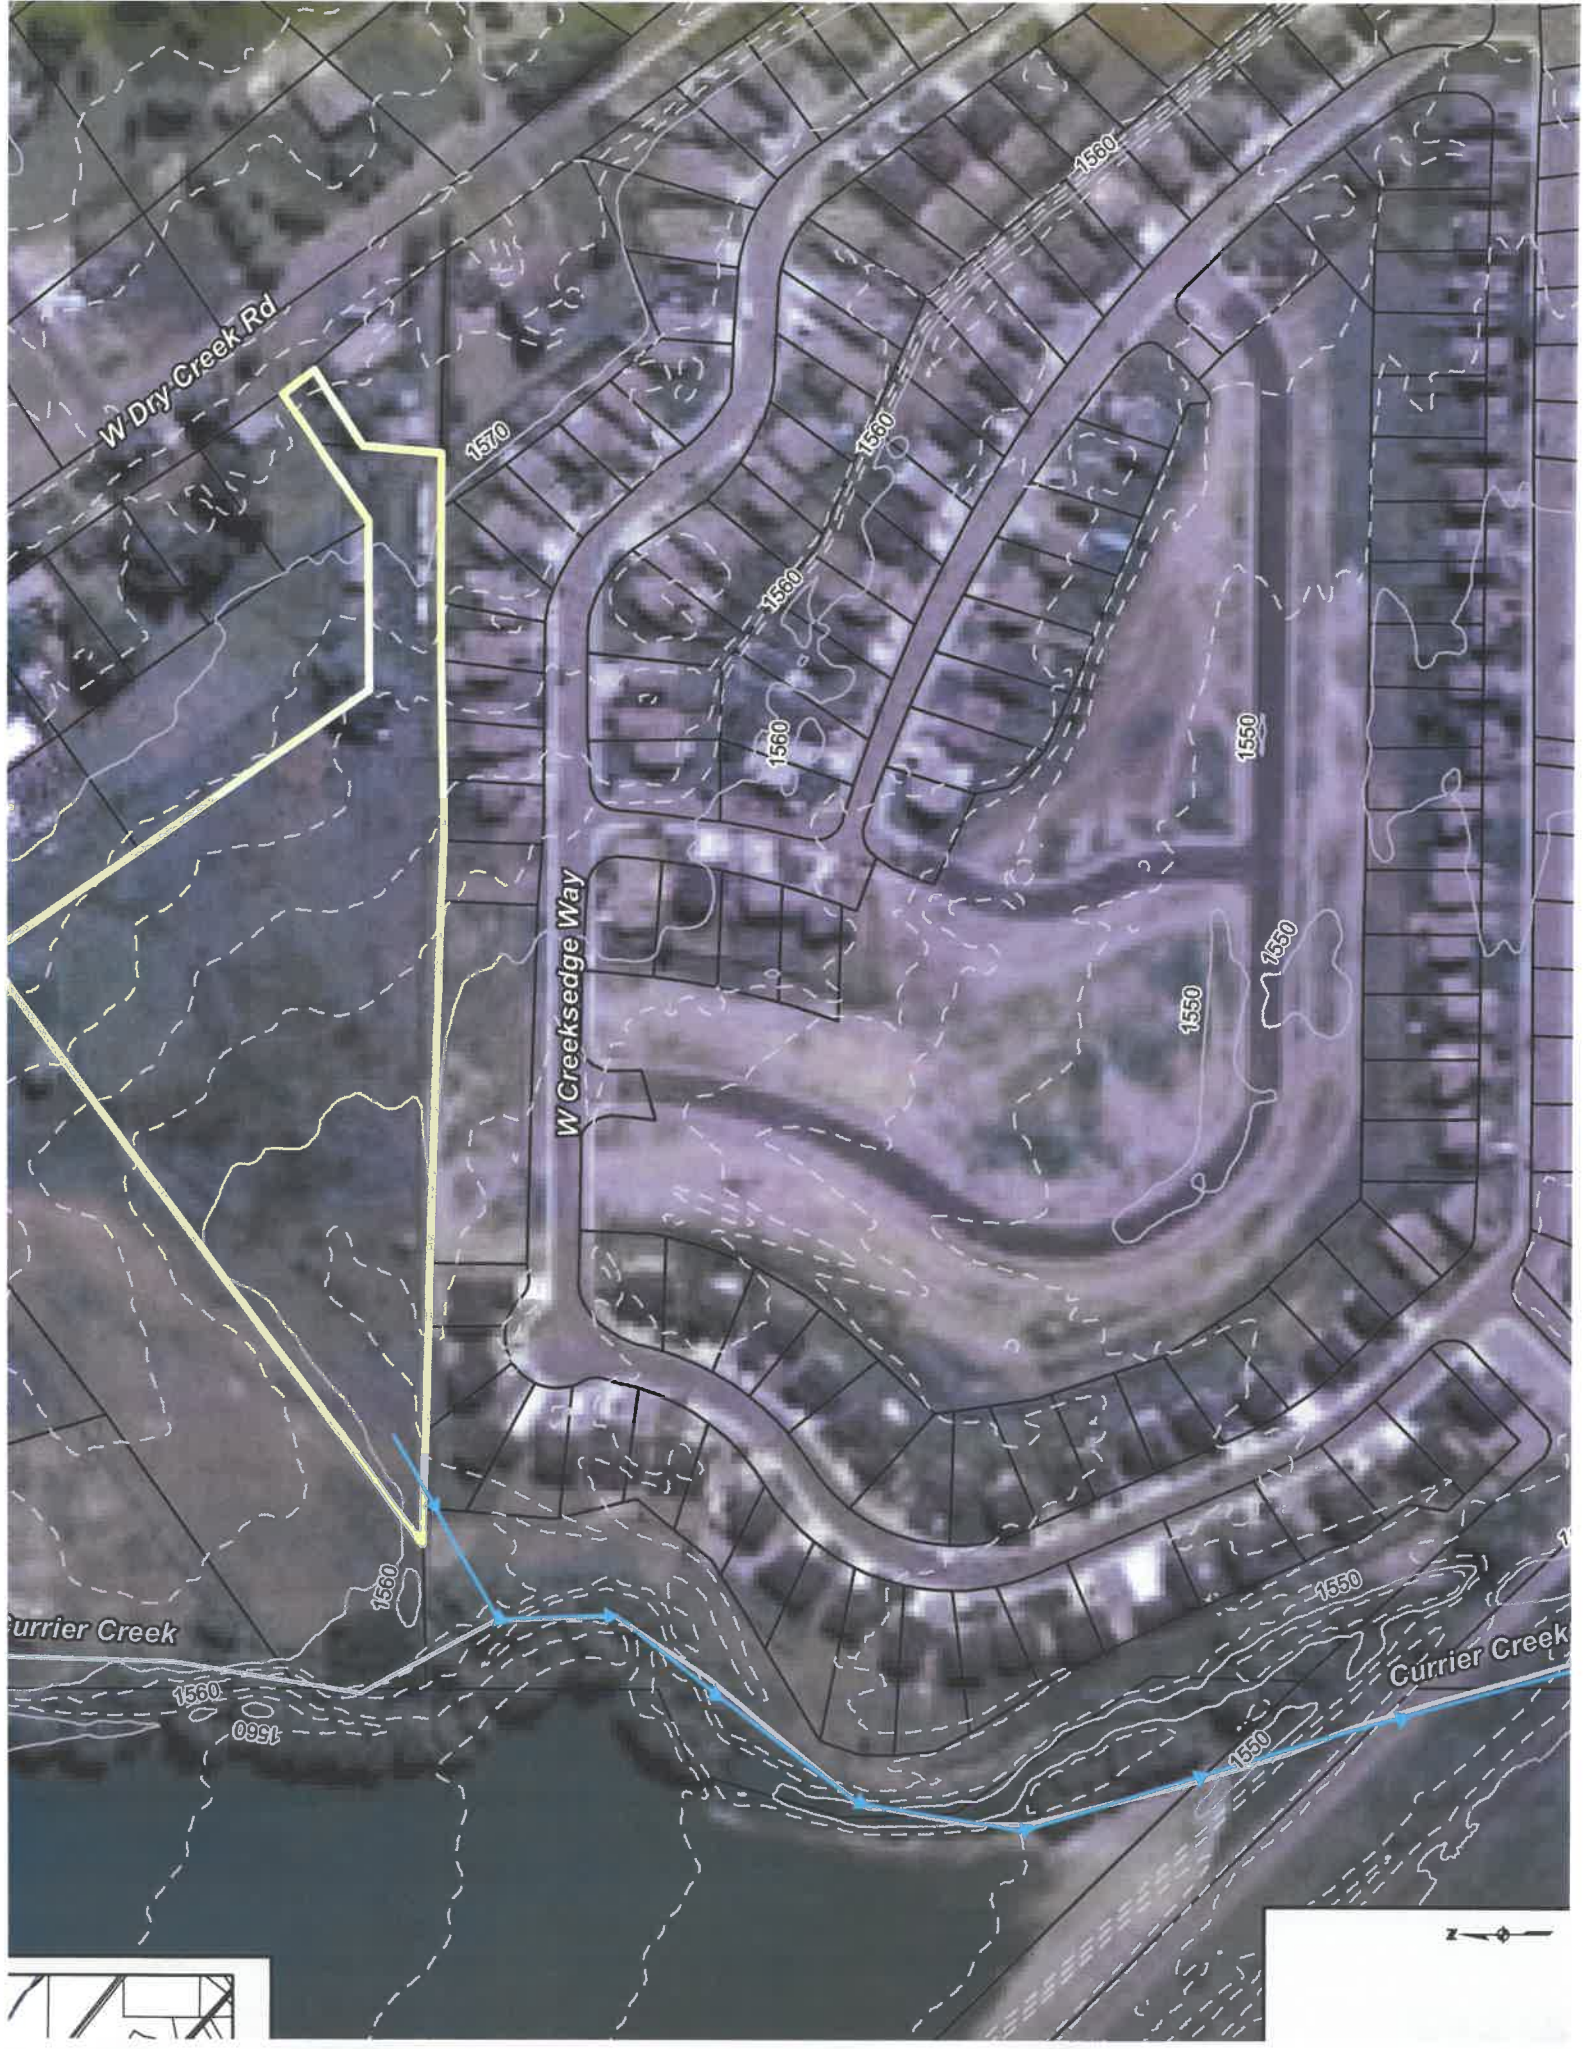
The existing site lies within the Yakima River sub-basin which is part of the Columbia basin. The existing site runoff is best described as overland sheet flow which moves southwesterly. It appears that all storm water either infiltrates or exits the site to the southwest. Any water leaving the site as overland flow would combine with Currier Creek within approximately 150'-200' of the wester property boundary. Currier Creek continues to the south until eventually passing the quarter mile buffer. Additional verification of downstream conditions will be provided with construction documentation. Please see Figure 3.0 for a depiction of the downstream flow path.

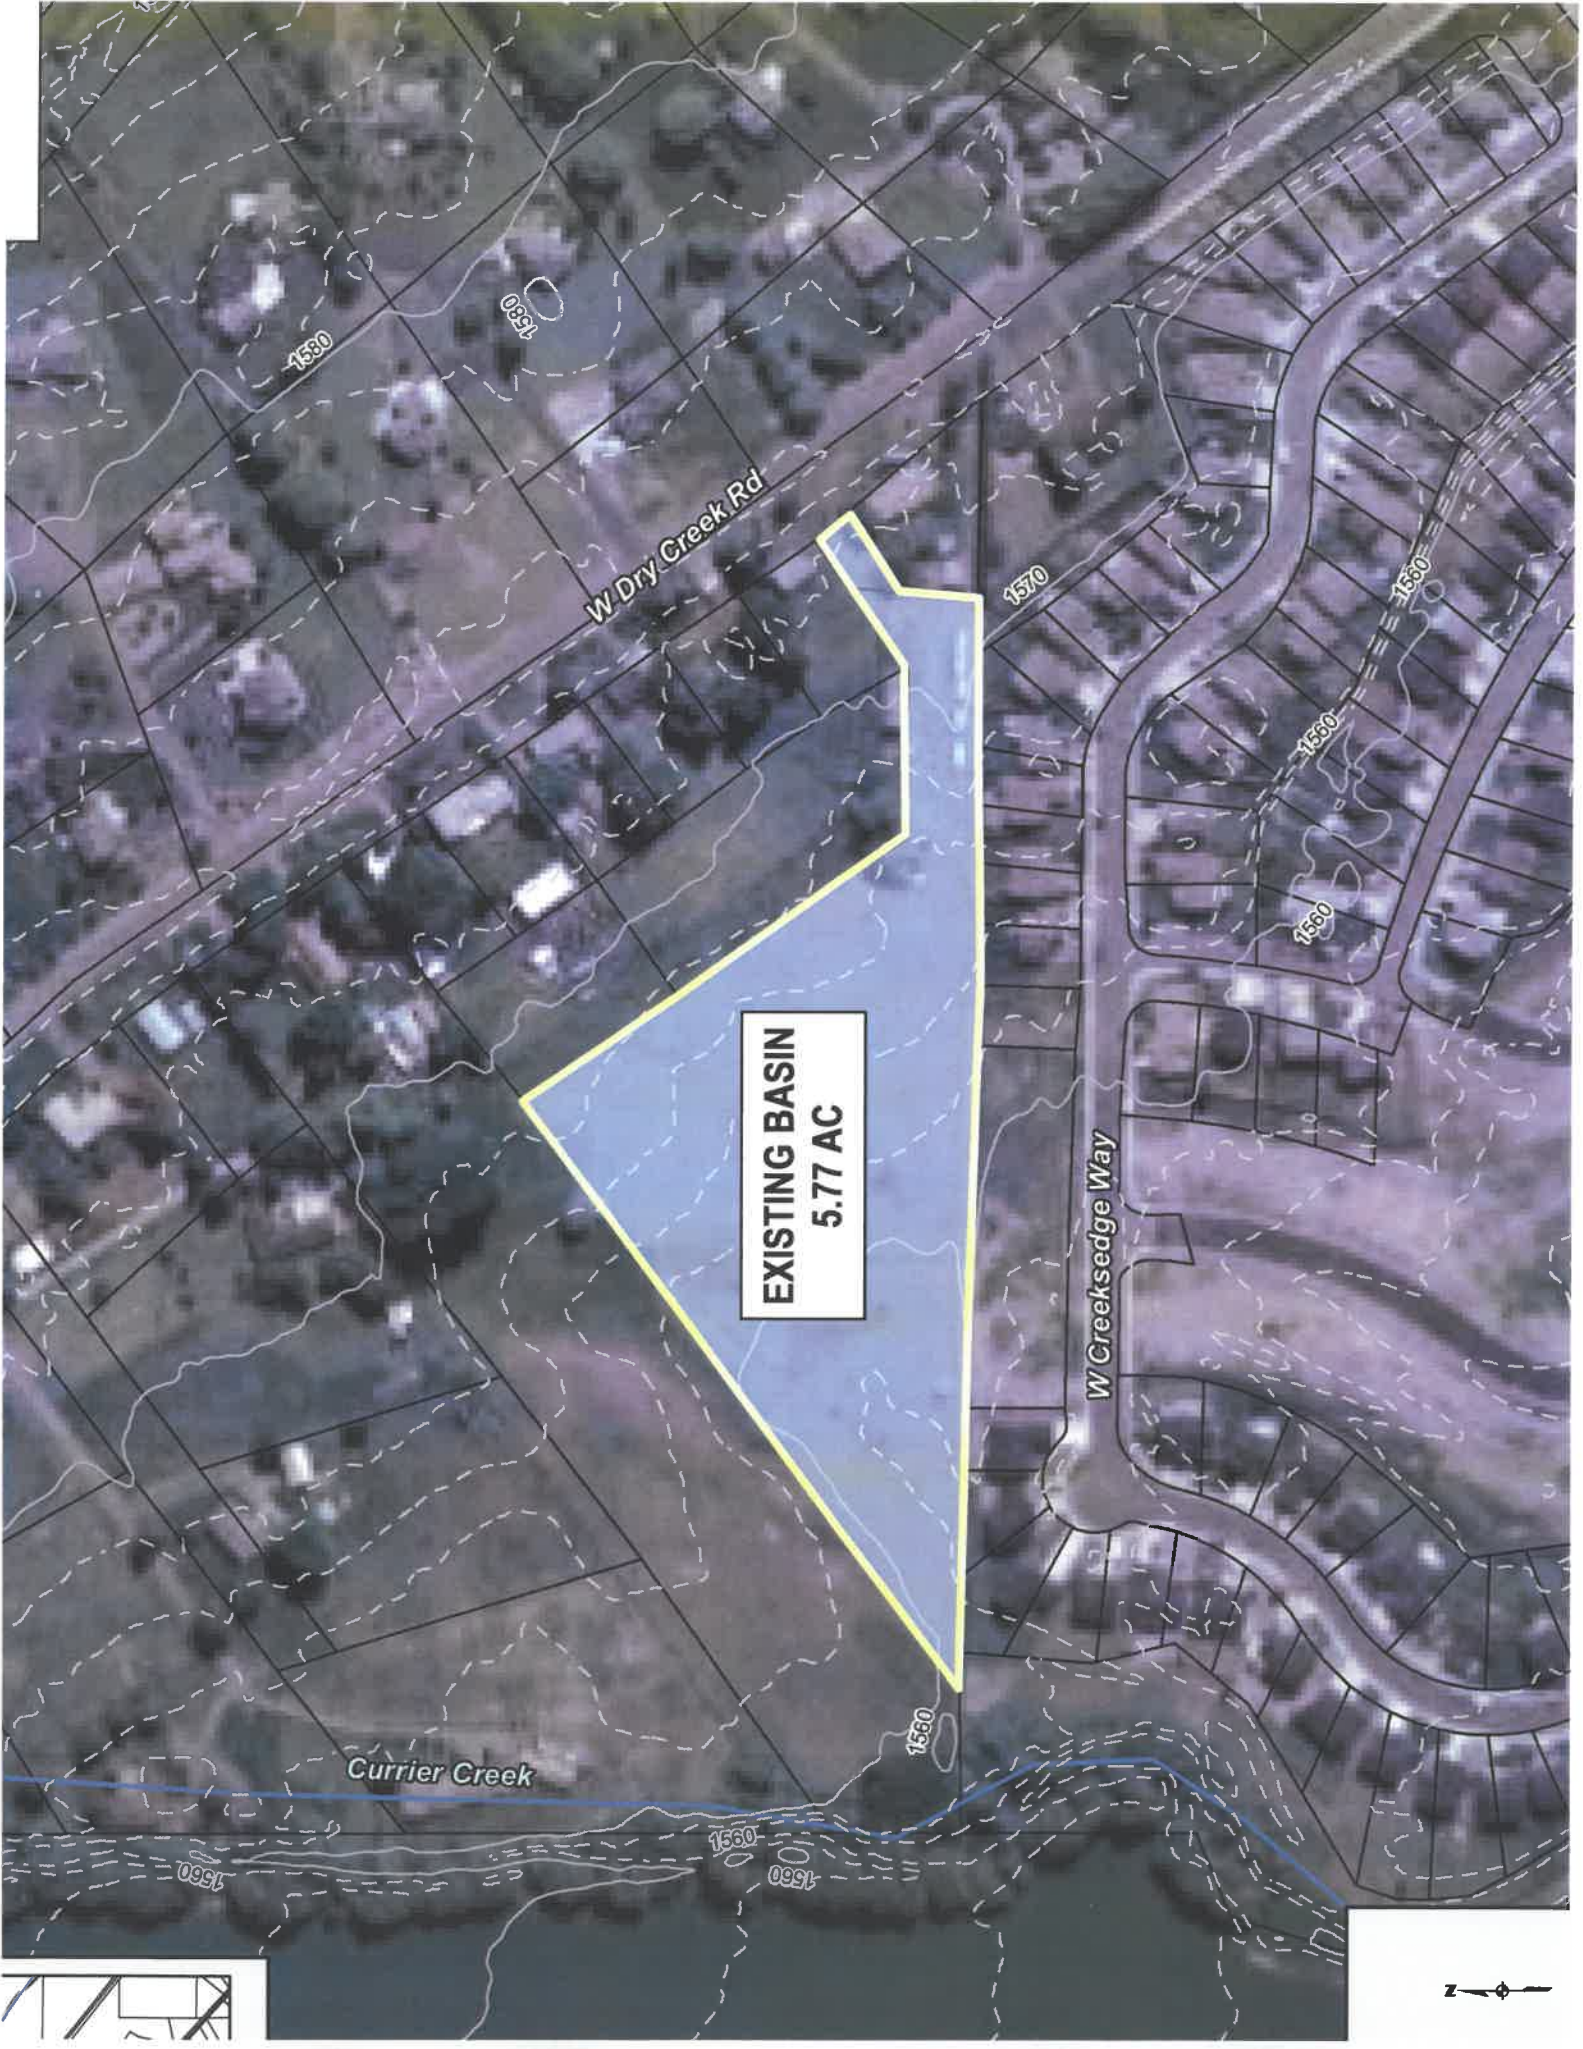
EXISTING BASIN
5.77 AC

The existing site is predominately pasture. There are currently no existing single-family residences on the property. Please refer to Figure 4.0 for a depiction of the existing site conditions.

The existing site is predominately pasture and gently slopes from east to west. There are currently no existing single-family residences on the property. The existing site is shown in Figure 4.0.

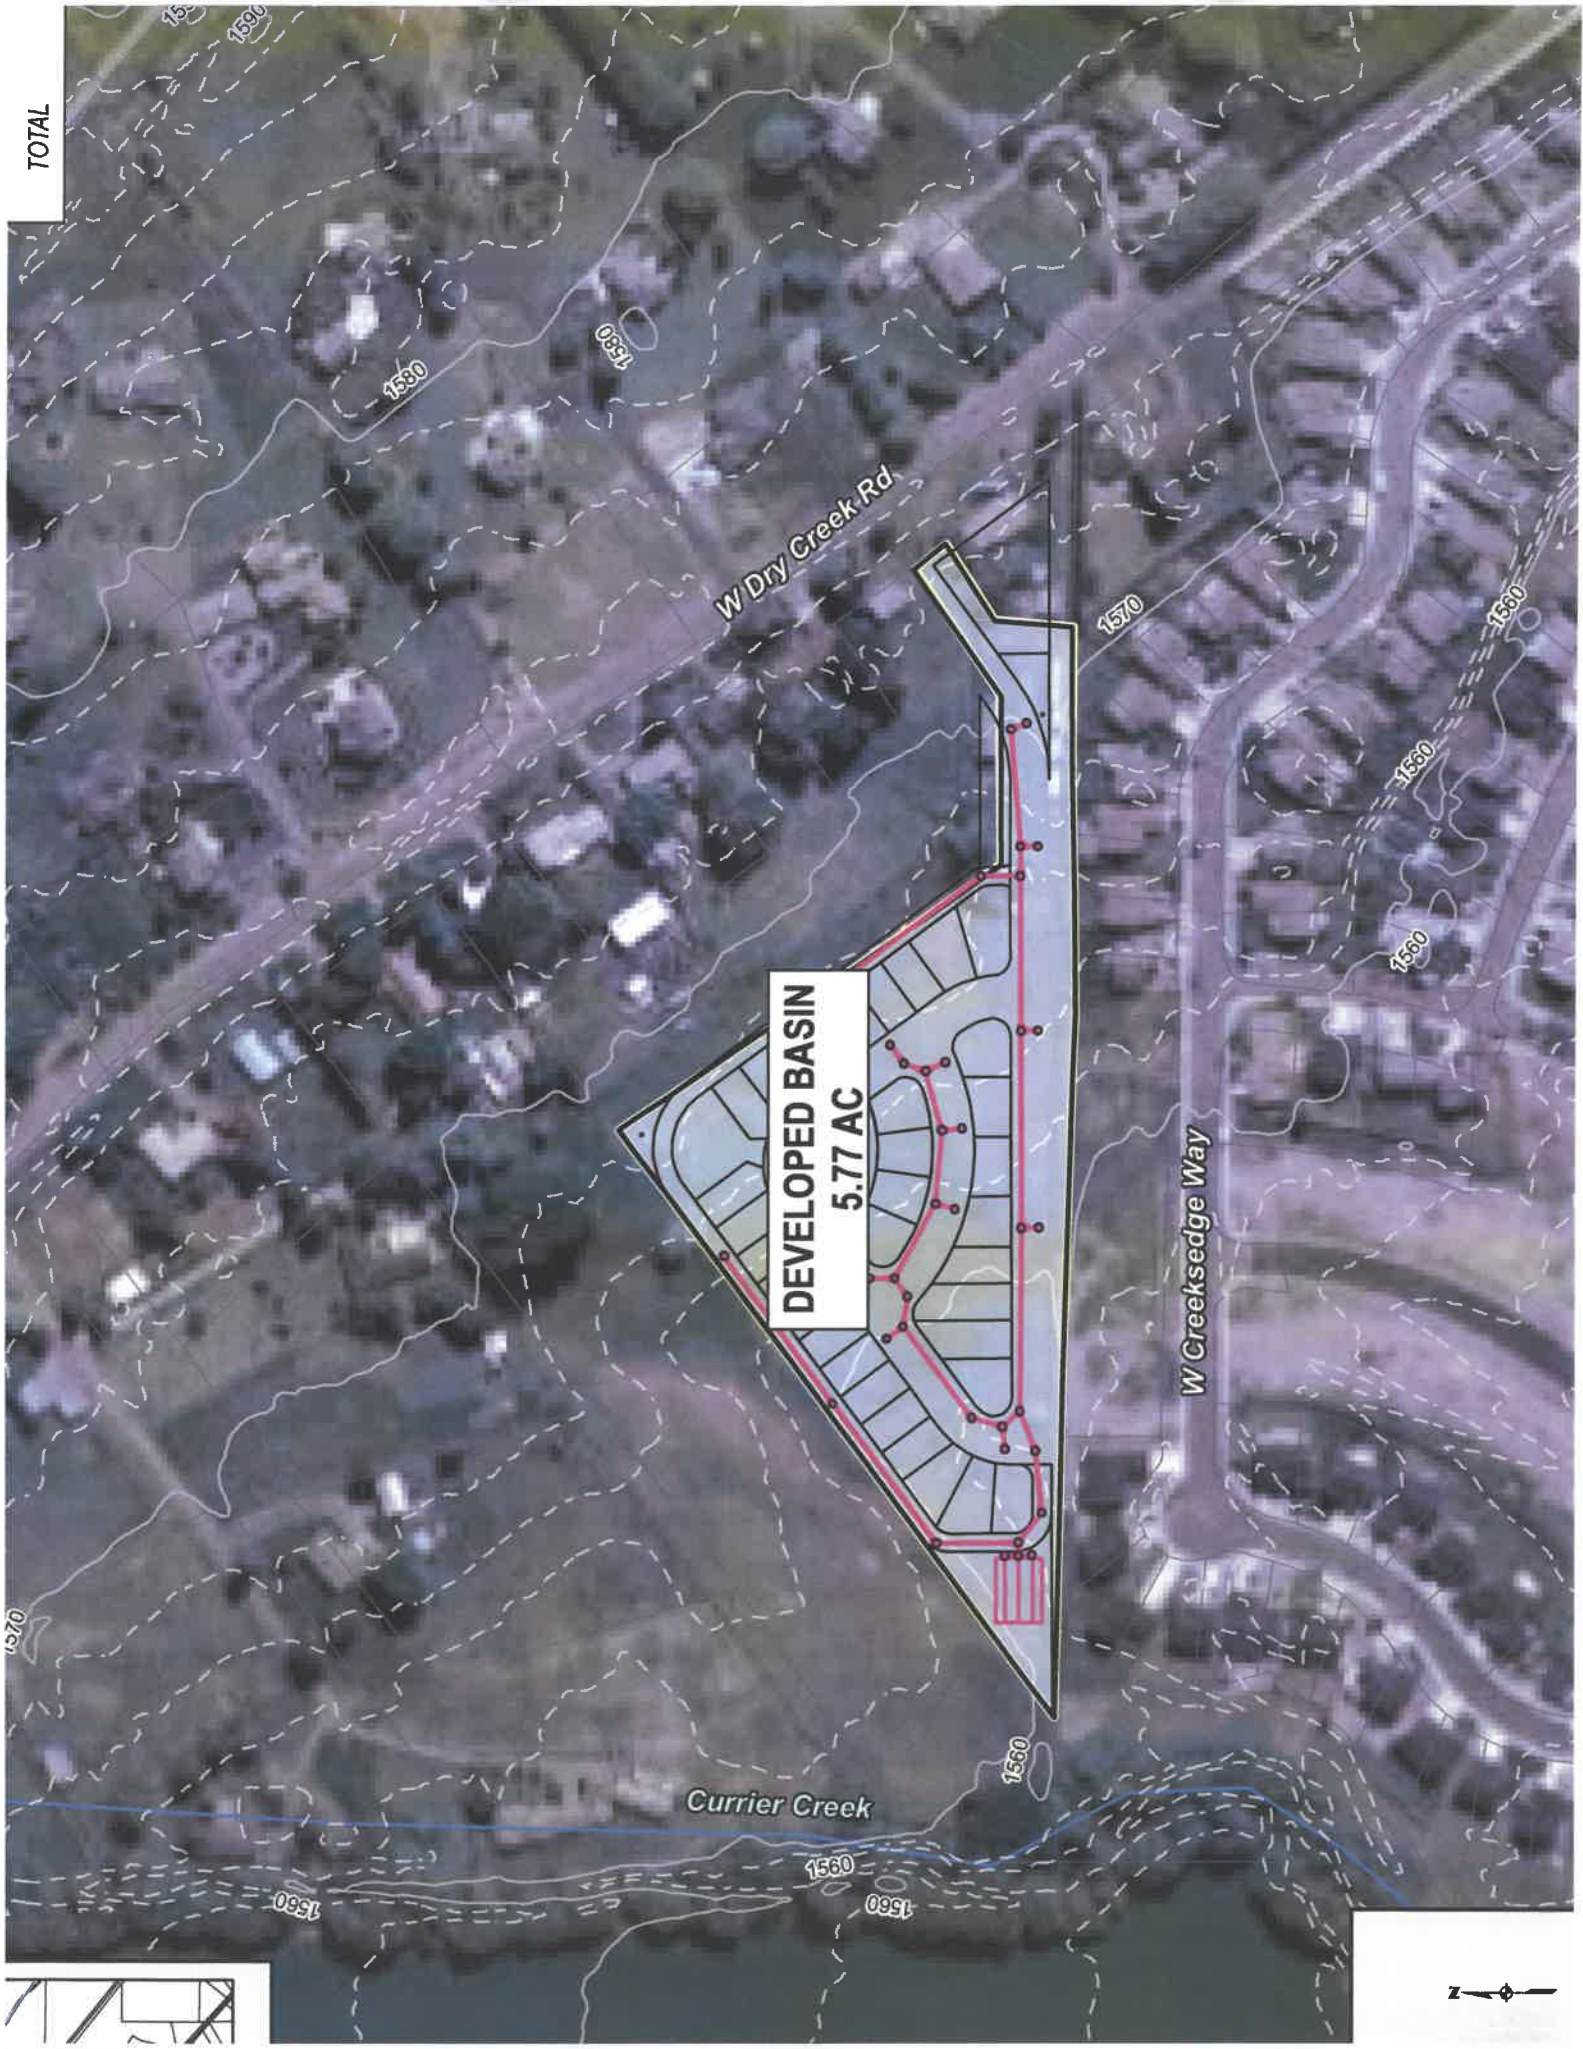
DEVELOPED BASIN
5.77 AC

The proposed developed site will include approximately 5.77 acres. The developed site will include 34 new single family lots detached cottage units, and approximately 3,098 lineal feet of roadway with associated utilities. The access to the site will enter the property from Dry Creek Road, approximately 1,400' northwest of the intersection of Reecer Creek Road and Dry Creek Road. The developed site is shown in Figure 5.0.
