### 3.11 GEOLOGY, TOPOGRAPHY, AND SOILS

#### 1 What are the geologic, topographic, and soil conditions in the area?

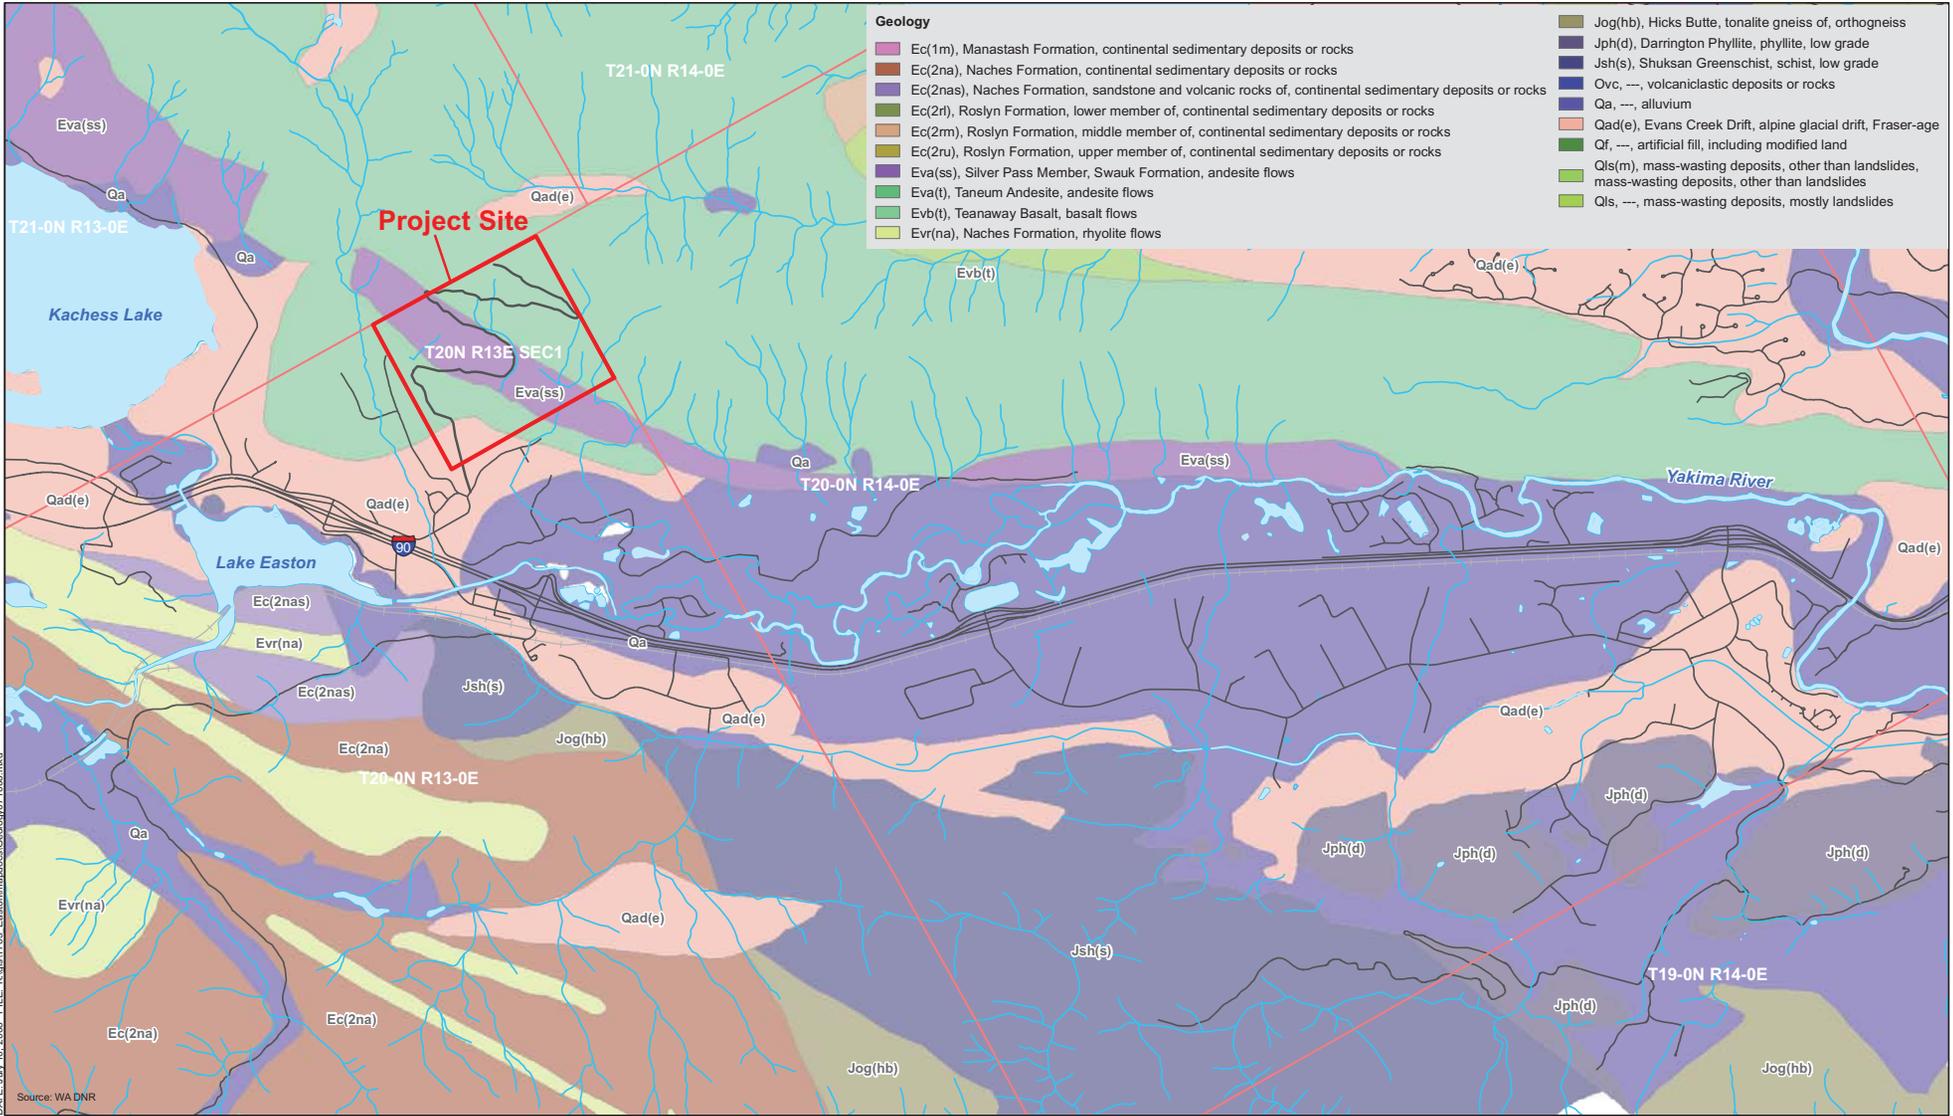
Source: WA DNR

The site topography and geology are typical of the Roslyn Basin of the Upper Yakima River Watershed, which is a classic U-shaped, glacially scoured valley. Figure 3-30 maps the geology in the vicinity. The valley was occupied by a large glacier complex that included coalescent glaciers from the Keechelus Lake, Kachess Lake, and Cle Elum Lake drainages. Deposits of at least three major glacial intervals have been mapped. These are the Lakedale Drift (15,000 years before present), the Thorp Drift (>700,000 years before present), and the Kittitas Drift (120,000 years before present). During Thorp and Kittitas times, the glaciers extended down the valley as far as the Teanaway River. The most recent glacial advance (the Fraser glaciation/Lakedale Drift) extended just east of the Easton area.

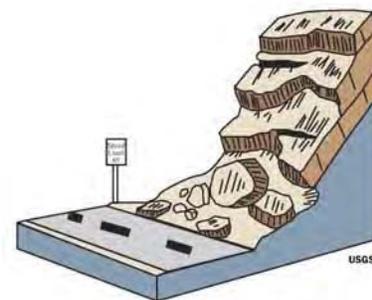
**Rockfall** includes freefall, tumbling, and rolling of fragments of rock or highly compact soils. Rockfalls typically originate from steep cliffs or features created by human activities such as road cuts. Material strength, surface gradient, joint pattern and spacing, geologic contacts, groundwater, and faulting are some of the primary factors related to rockfall occurrence. Run-out from the source area can extend quite far on steep slopes (Norman et al. 1996; Chatwin et al. 1991).

Typically, debris form a wedge or debris fan at the toe of the source area. An example of this feature is the talus slopes on the site. Other rockfall is related to road construction or other human-induced disturbance.

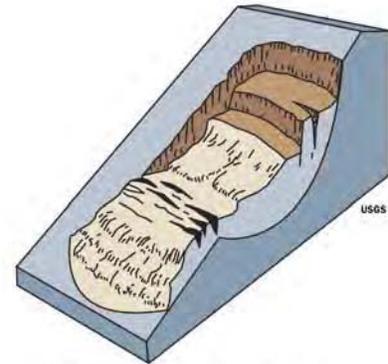
**Rotational landslide**

**Deep-seated rotational slides** are relatively deep movements that often occur slowly over time. These slides typically involve deep deposits and have a bowl-shaped or broad curving failure surface with a steep headwall scarp and additional scarps in the slide mass. Rotational slumps can be small, covering only a few yards (as is common along overly steep road cut and fill slopes), or they can be very large, covering many square miles. Source areas are associated with over-steepened valley walls with thick glacial and weathered bedrock deposits, geologic contacts and faults, and areas with concentrated groundwater conditions.

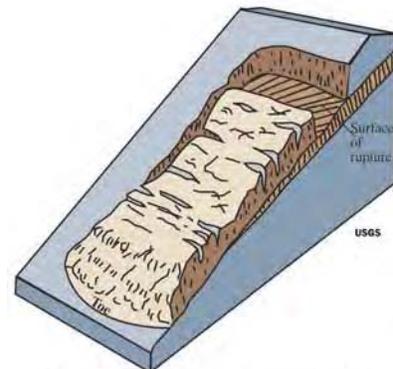
**Translational landslide**

**Translational slides** occur along relatively shallow, fairly planar failure surfaces. A planar surface is a relatively even sloping surface. Shallow rapid translational slides often occur on shallow deposits over bedrock. Some of the causes of slides include:

- Alteration of the moisture content of the overlying material that forms a lubricated layer between the upper deposits and relatively impermeable deposits below.
- Additional weight on the overlying material that overcomes the friction between the upper and lower surfaces.
- Removal of materials at the toe of a slope that previously held the deposit in place.

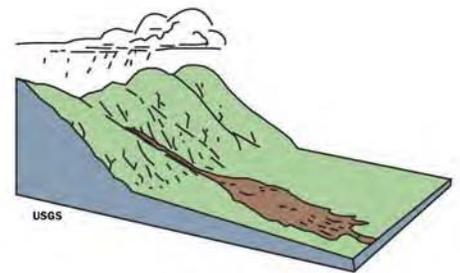
**Debris flow**

**Debris flows and alluvial fans** refer to the mechanism and the typical deposit of these types of geological hazards. They are generally associated with an episode of high water runoff that can be associated with storms, or they may be associated with other landslide types that suddenly release a large amount of mixed earth and water that move rapidly downhill. The characteristic deposit is the alluvial fan that is found at the point where a steep valley reaches a valley bottom and drops its load of heavy materials, spreading out in a fan shape. There is an

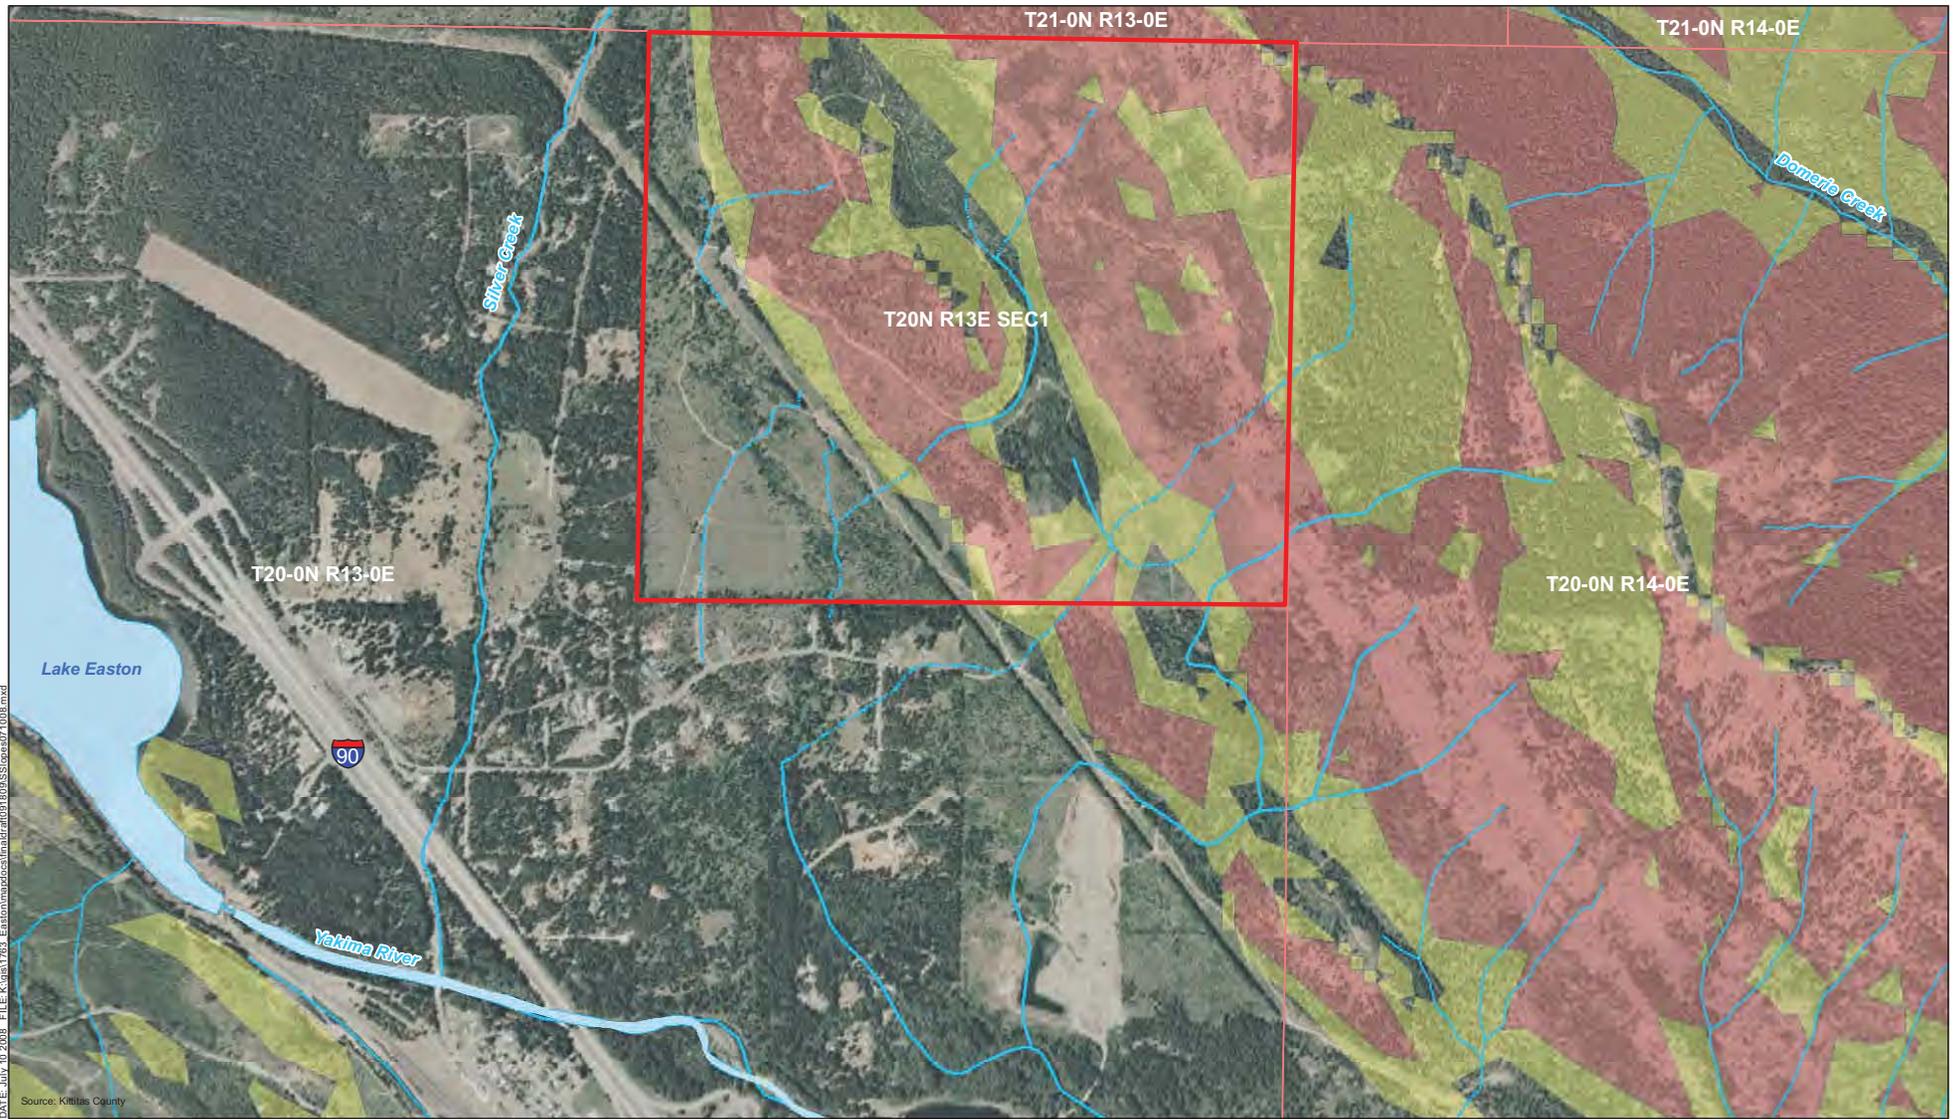
**Figure 3-32**  
Marian Meadows  
Steep Slopes and Geologic Hazards

| <span style="border: 2px solid red; display: inline-block; width: 15px; height: 10px; vertical-align: middle;"></span> Project Site | <b>Streams</b> | <span style="background-color: yellow; border: 1px solid black; display: inline-block; width: 15px; height: 10px; vertical-align: middle;"></span> Hazardous Slope |

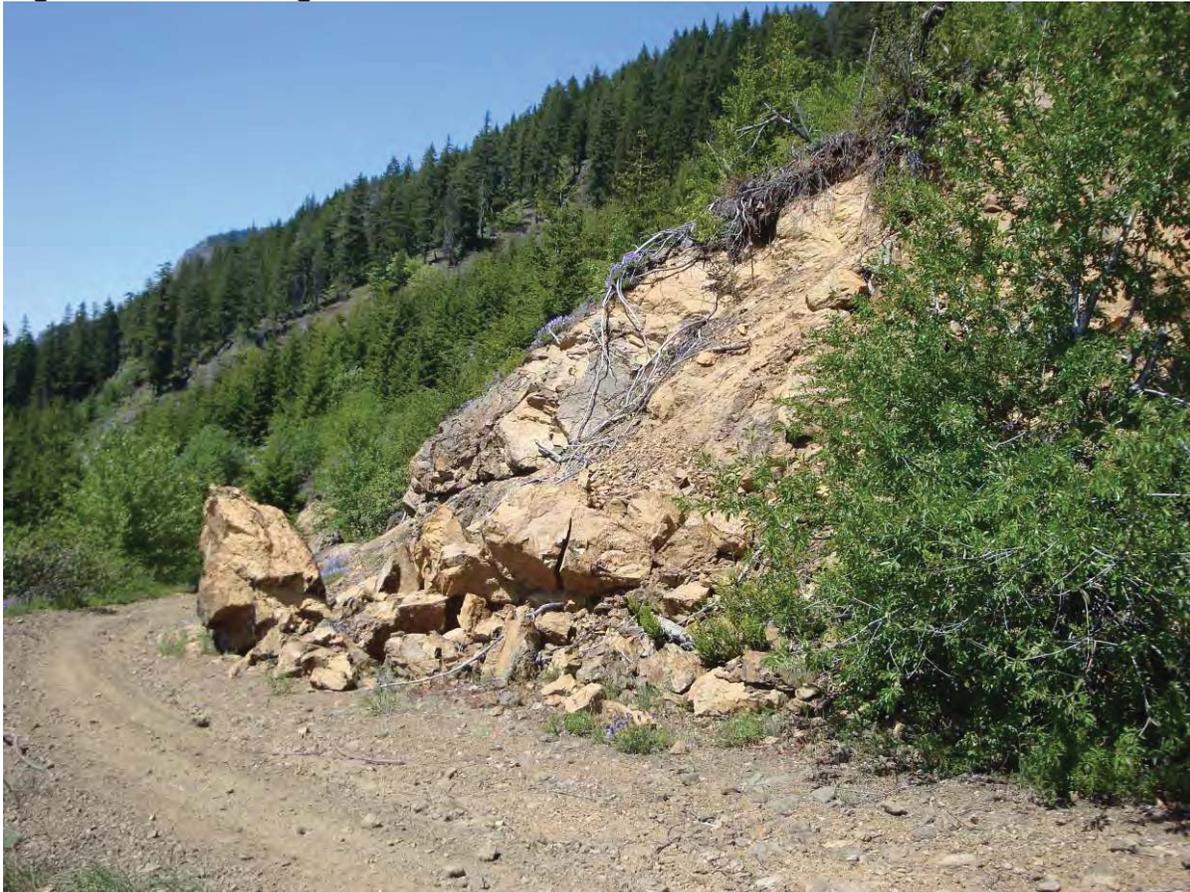
**Figure 3-33 Existing Rockfall on Marian Meadows Site**

Rockfall hazards are present in any case where bedrock is disturbed on slopes and rock is not removed to a stable surface. There are, however, limitations on the accuracy of field work and assessment in reliably identifying the extent of removal needed to achieve a stable rock face. Rockfall is common in the area and is present on the site, as indicated in Figure 3-33, on existing logging roads on the eastern portion of the site. These roads, however, were constructed to lesser standards for temporary use than would be expected for permanent subdivision roads.
