OPEN MINE WORKINGS WITHIN AREA 2
 Winemaker's Cabins at Swiftwater Cellars
 301 Rope Rider Drive, Cle Elum, Washington

PROJECT NO. 217-871
 DATE: 6/4/2018
 FIGURE NO. 6

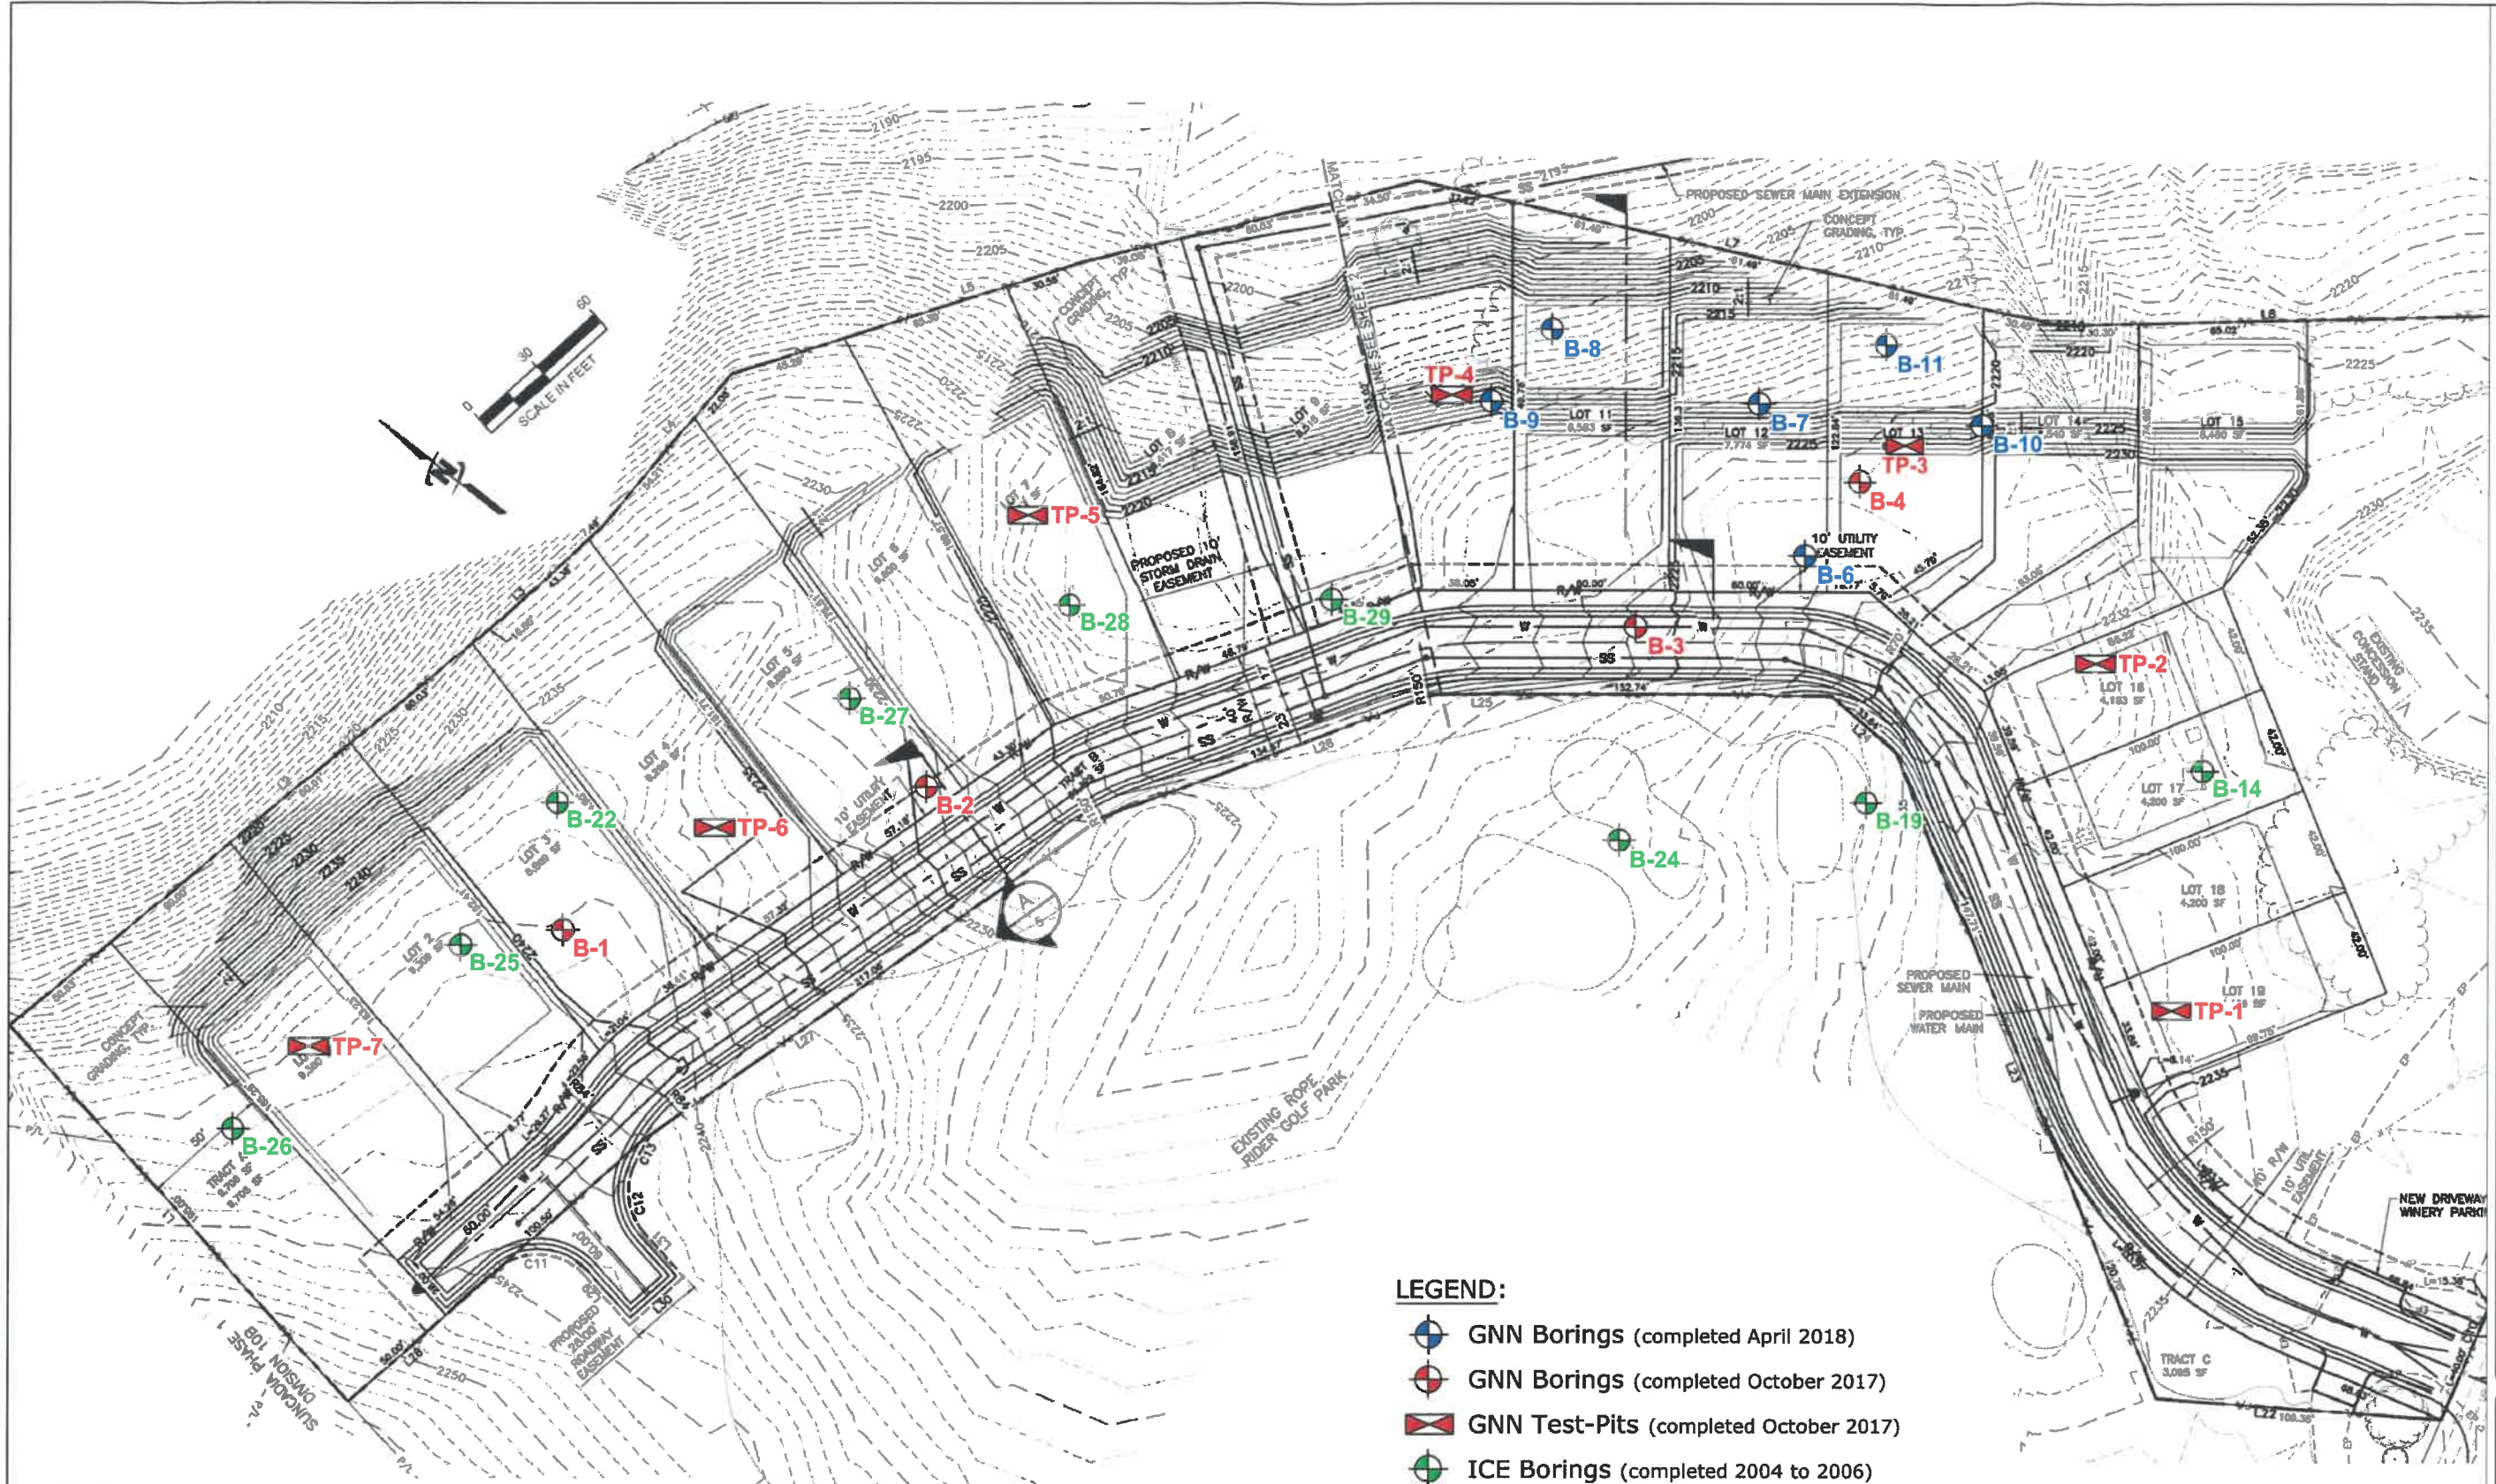
GNN Borings (completed April 2018)
 -

GNN Borings (completed October 2017)
 -

GNN Test-Pits (completed October 2017)
 -

ICE Borings (completed 2004 to 2006)

NOTE:
 Combined base maps extracted from *Preliminary Utilities and Grading plans* (Sheets 2 & 3) prepared by JUB Engineers, Inc. dated 8/1/2017.

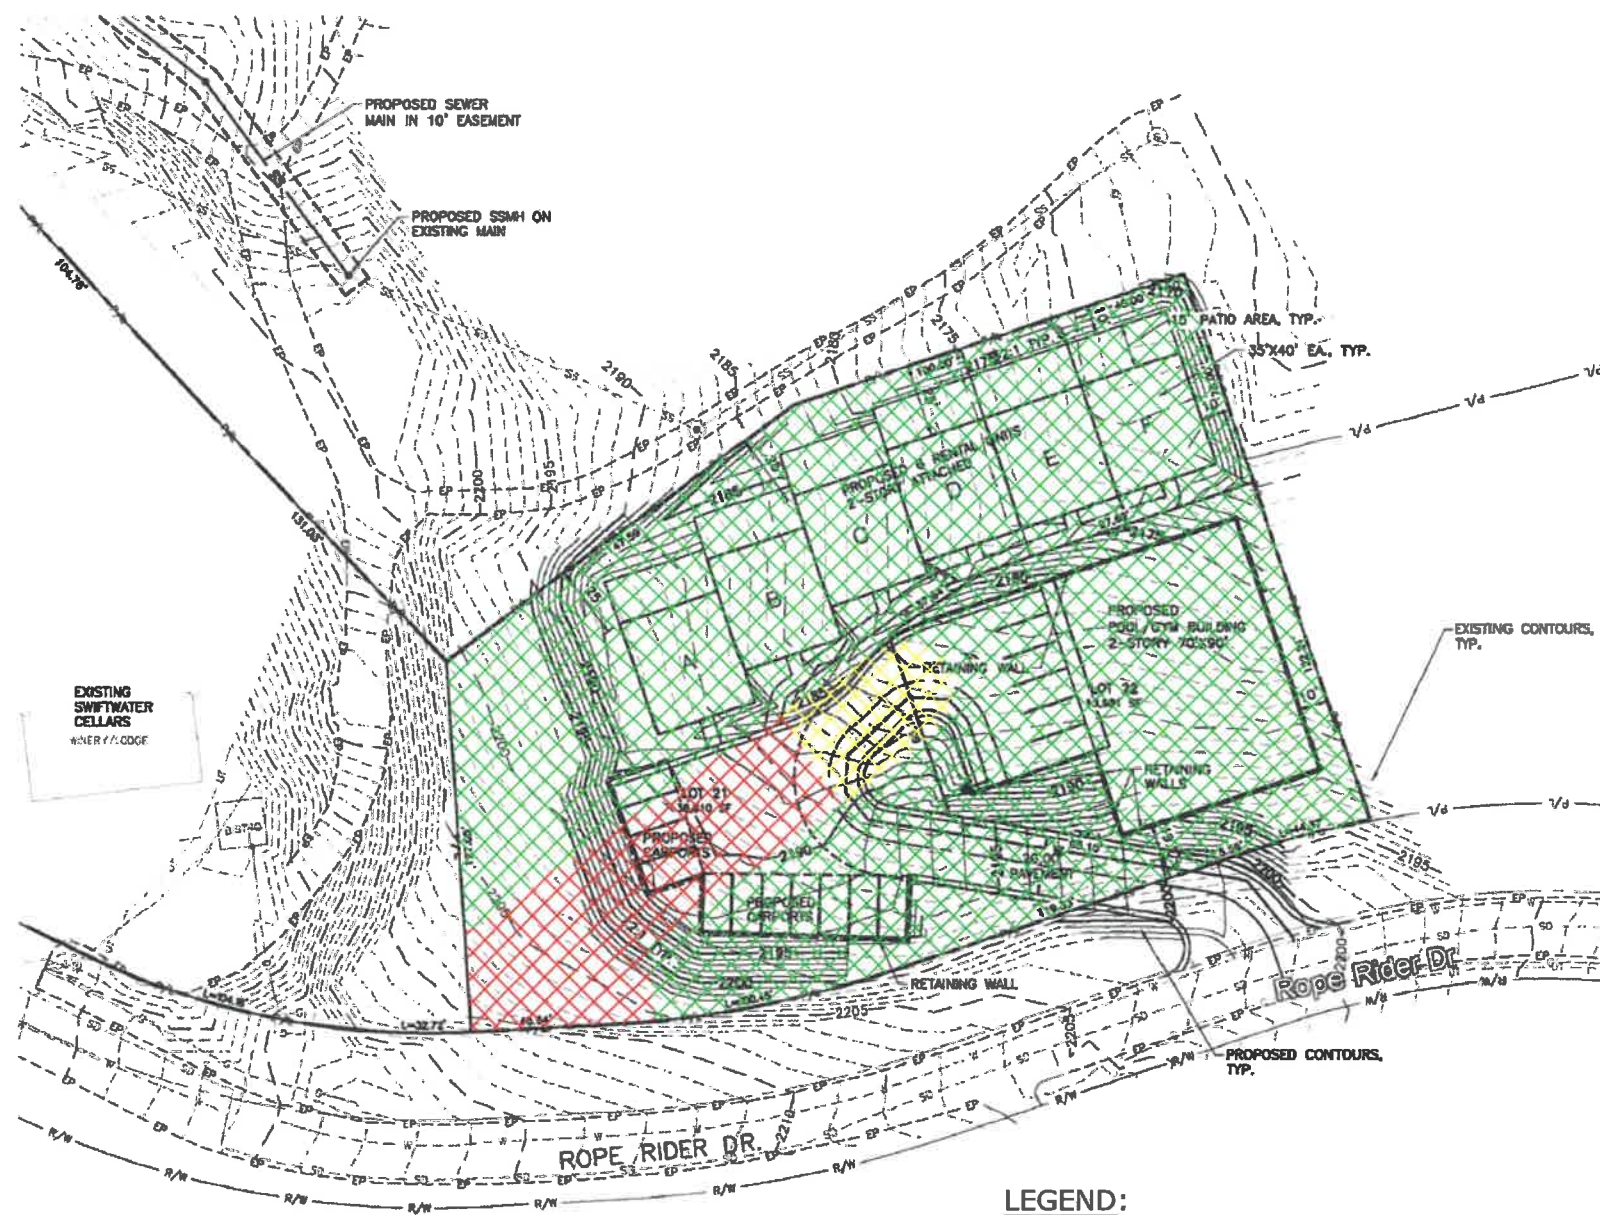
- LEGEND:**
- "Declassified" No Significant Mine Hazard - Buildable Areas
 - Low Mine Hazard - Buildable Areas with Mitigation
 - Moderate to Severe Mine Hazard - Unbuildable Areas*
- (* refer to the geotechnical report for special mitigation measures)

NOTE:
 Base map extracted from *Preliminary Utilities and Grading plan* (Sheet 4) prepared by JUB Engineers, Inc. dated 7/27/2017.
