## Soil Log Evaluation for Land Use

Owner Name: Thorp Landing LLC

Plat Name (map must be included): Thorp Landing LP-23-00001

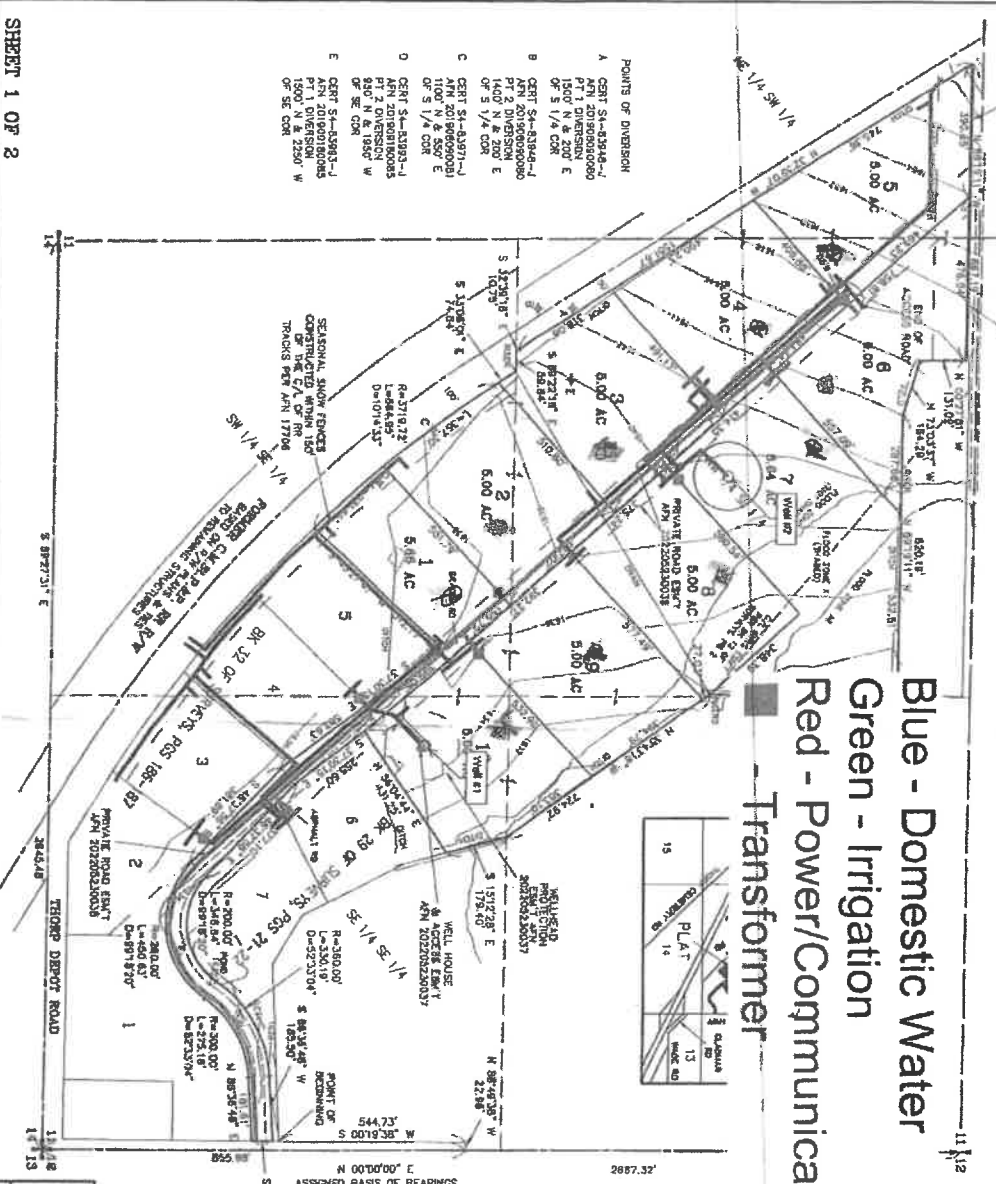
THORP LANDING  
 PART OF SECTION 11, T. 18 N., R. 17 E., W.M.  
 KITTITAS COUNTY, WASHINGTON  
 - PRELIMINARY PLAT -

X = Soil Log
