Wanapum boat  
launch restroom rep

## **Scope of work**

### **Project:**

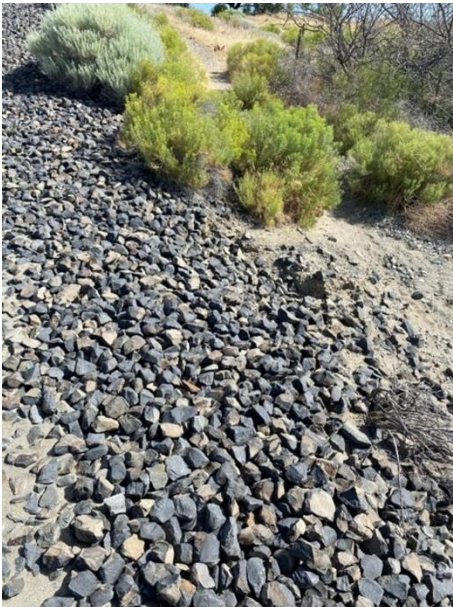
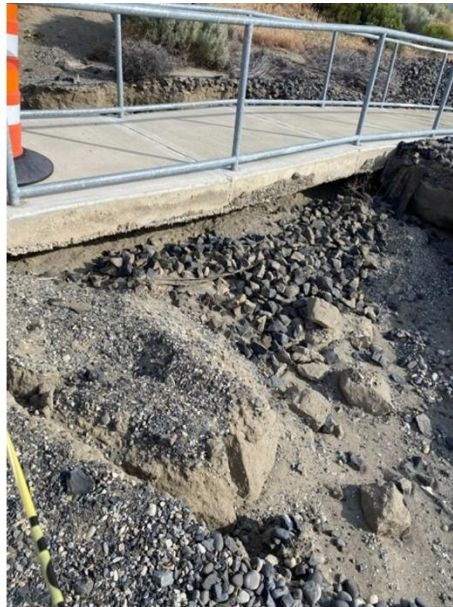
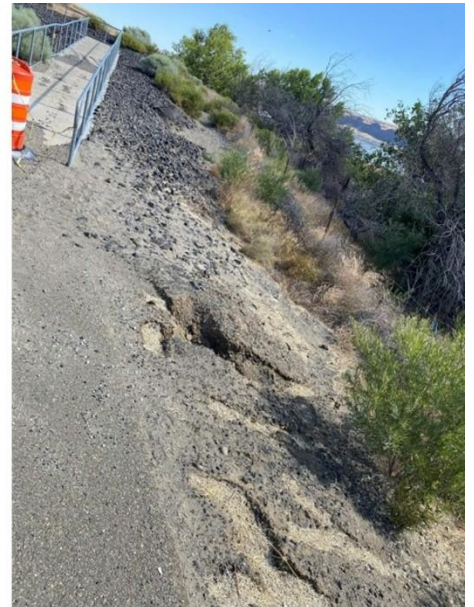
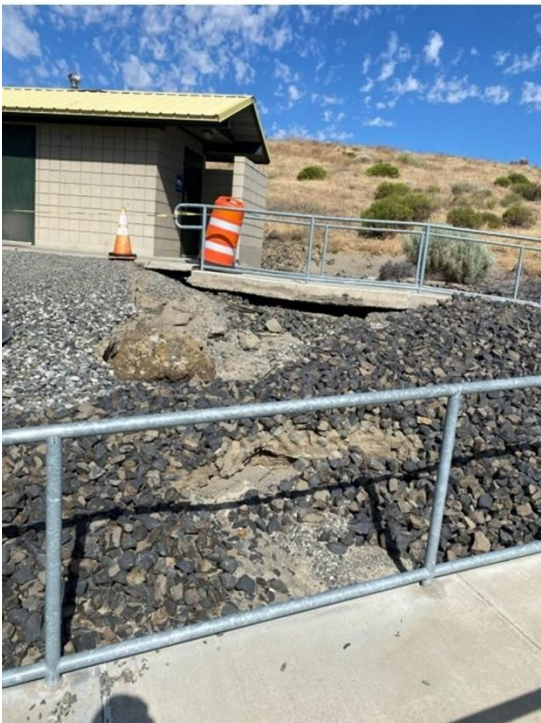
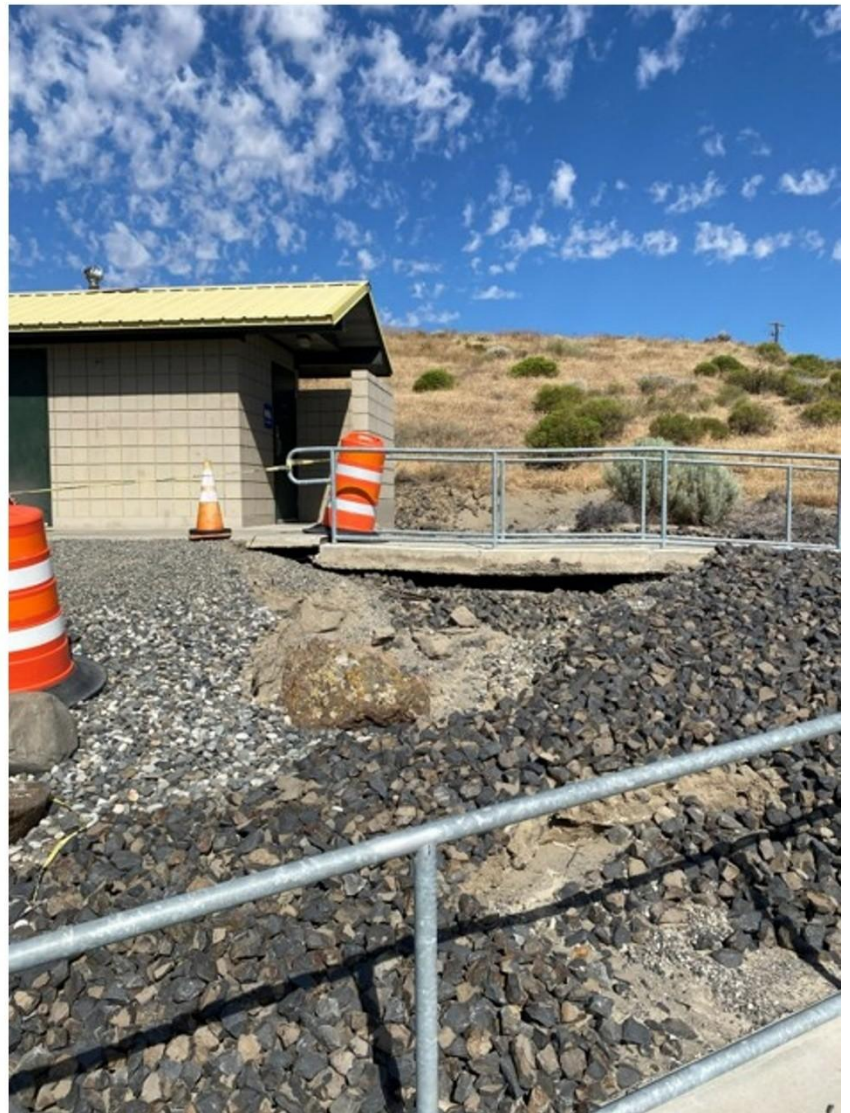
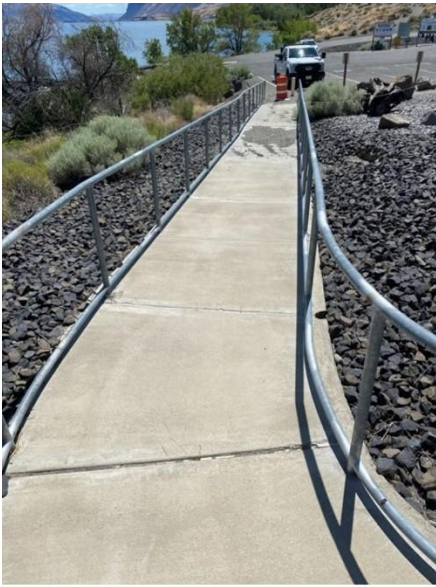
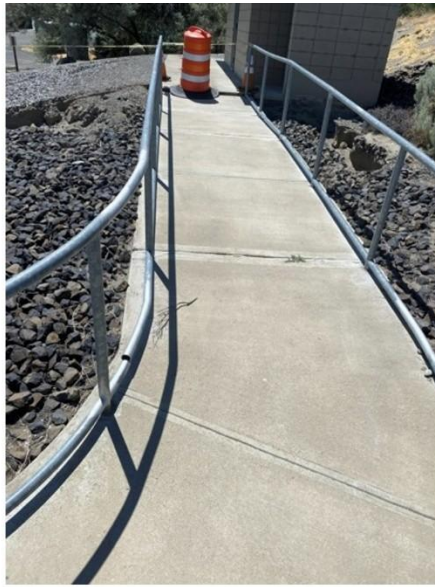
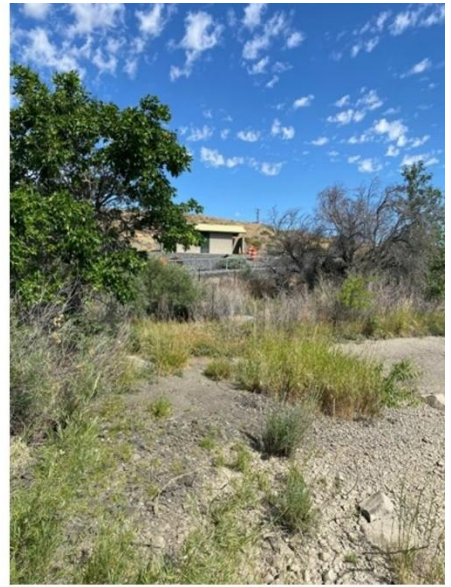
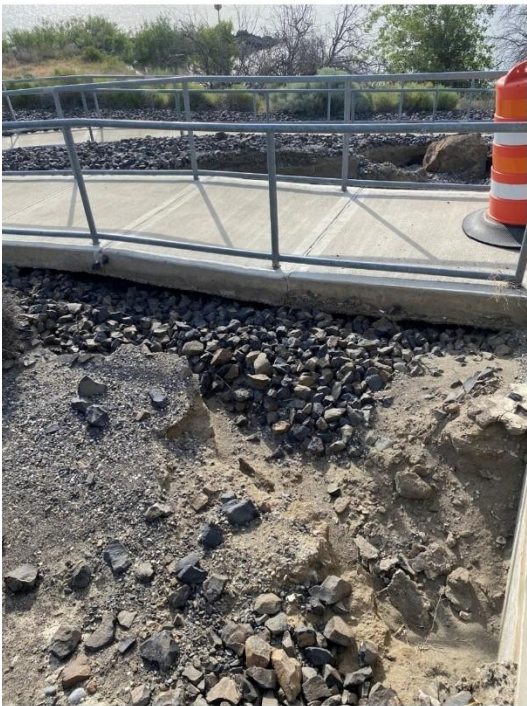
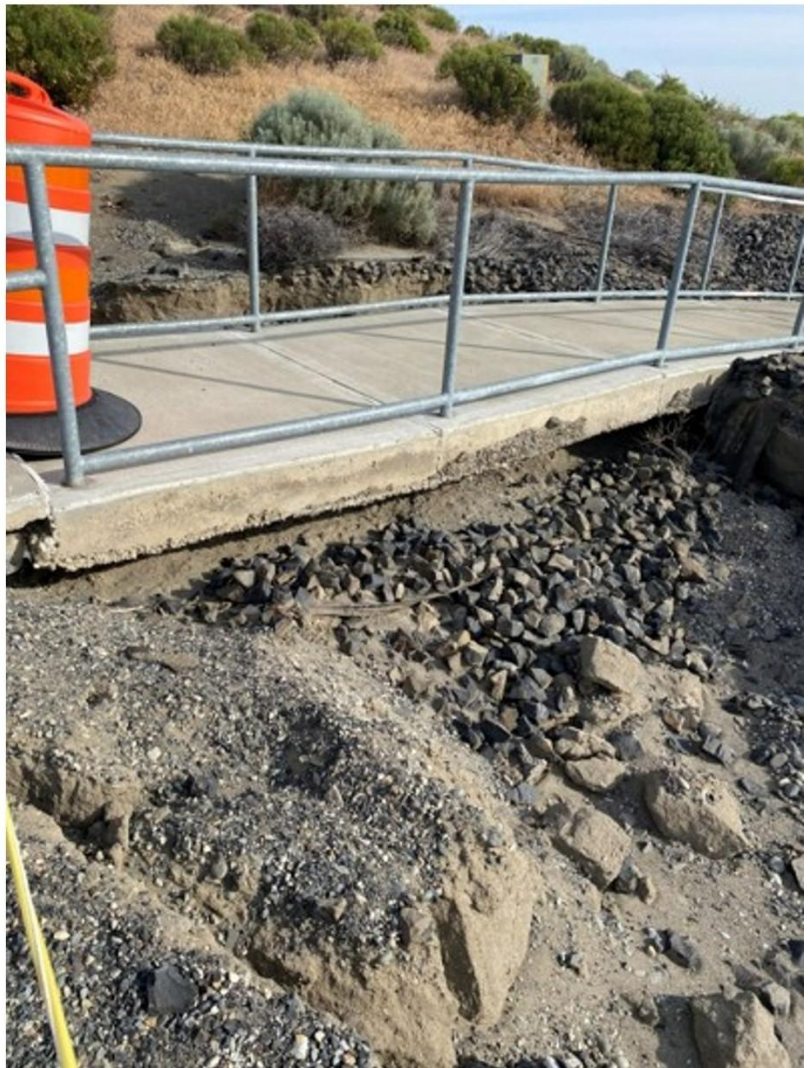
Under fill a 15' section of an ADA ramp that leads up a hill to a restroom. This area had a washout from a waterline break. The slab was undermined and is being held up by its hand railing. The plan is to form the sides of the walkway and pour cement under. Once cured, hire a company to come and slab jack this section back to existing grade. Also slab jack one other section back into place to maintain accurate grade. Material will have to be imported to fill the sides along the walkway where it was washed away. Once filled large cobble rock will be placed back over to match existing. About 10 yards of fill material and 5 yards of rock will be hauled in and placed with about 6 yards of cement poured.
