**Figure F-10**  
**Flood and Erosion Overlay**  
**Canyon and Fan**  
**Expansion Reaches**

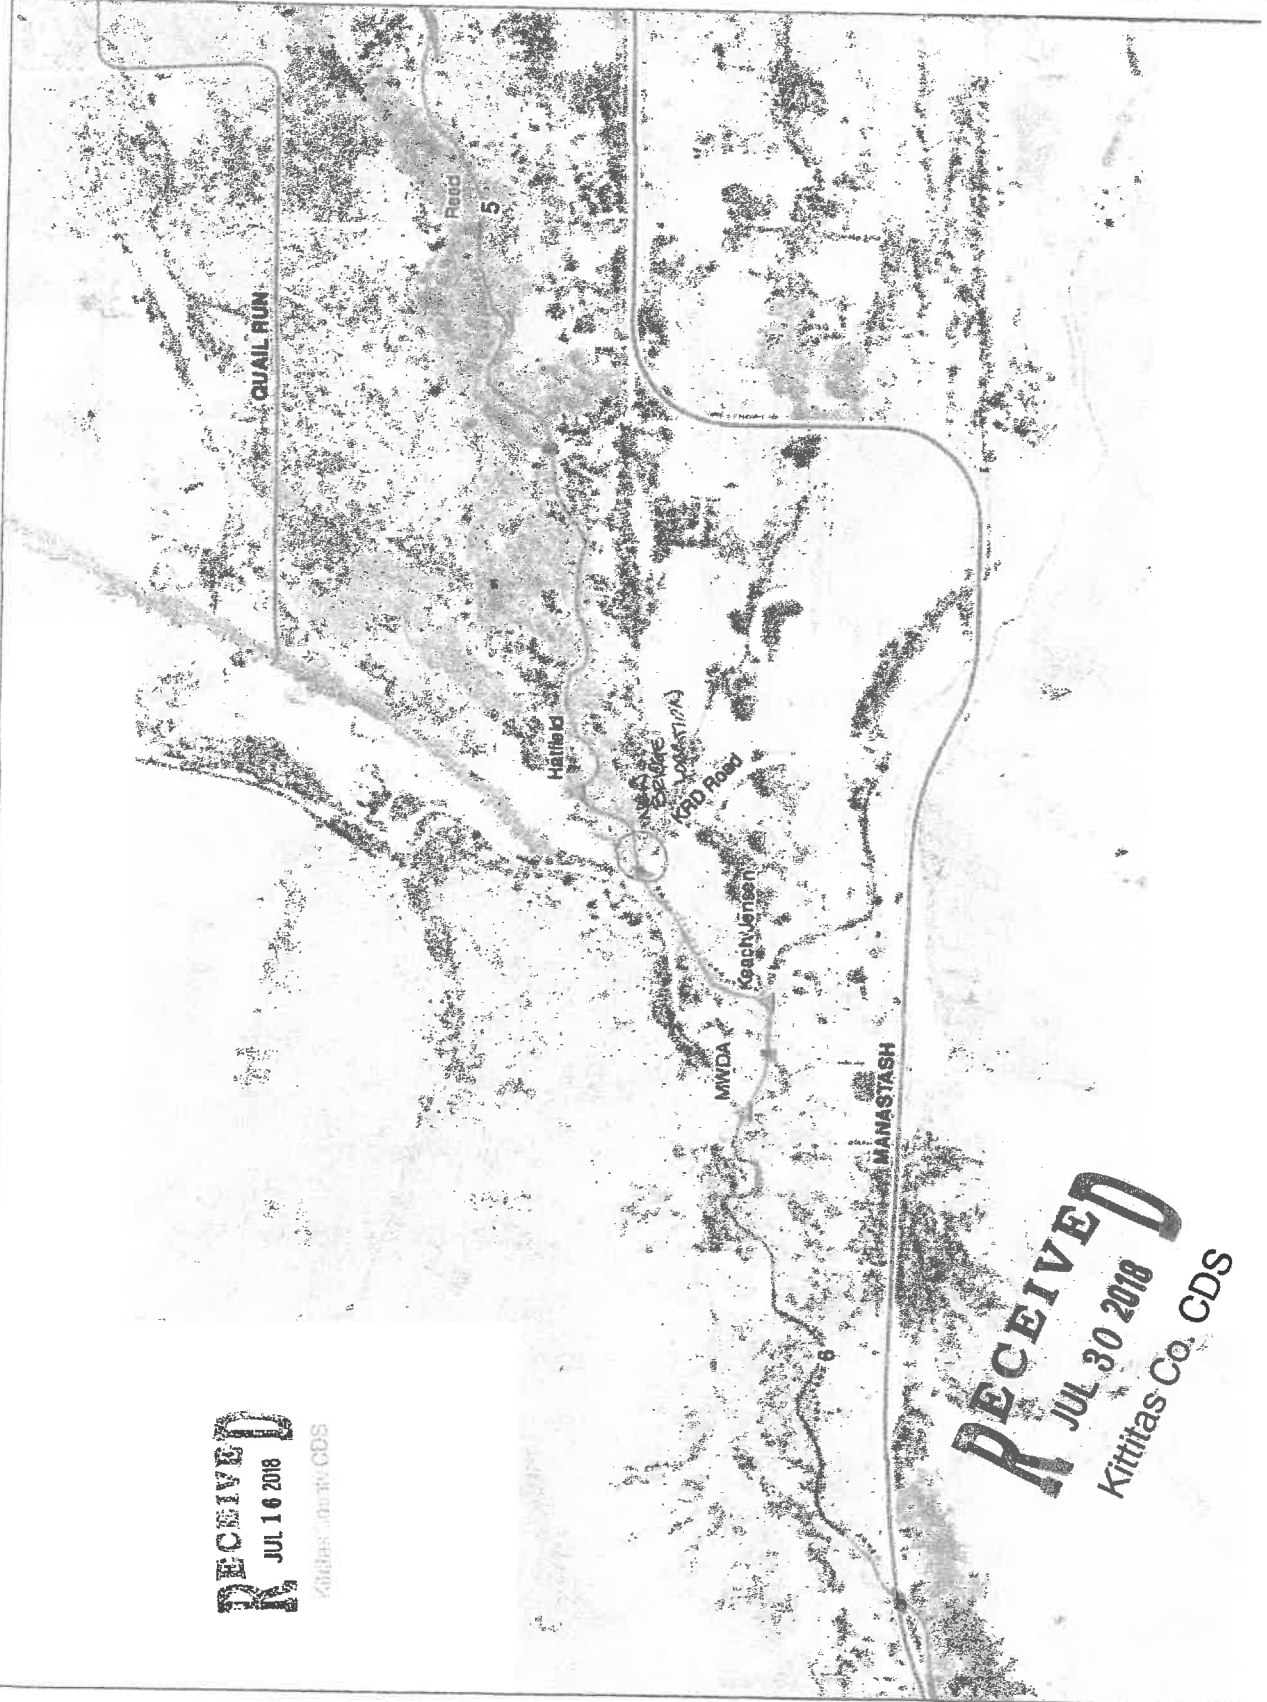
**Note:**  
 Layers including Berms, Revetment, Sediment, and Flooding approximations based on available topography and accurate or complete in a. River mile stationing included Manastash centerline.
